Subject: **Arborist Report**  
2213 & 2221 4<sup>th</sup> St., 2212 and 2216 5<sup>th</sup> St. (Phase III), Berkeley CA

Steelwave is working on the proposed parking structure to be constructed on the subject addresses, in Berkeley CA (aka The Lab Phase III). HortScience | Bartlett Consulting, Divisions of the F. A. Bartlett Tree Expert Co., was asked to prepare a **Tree Inventory Report** for the site. This letter responds to that request.

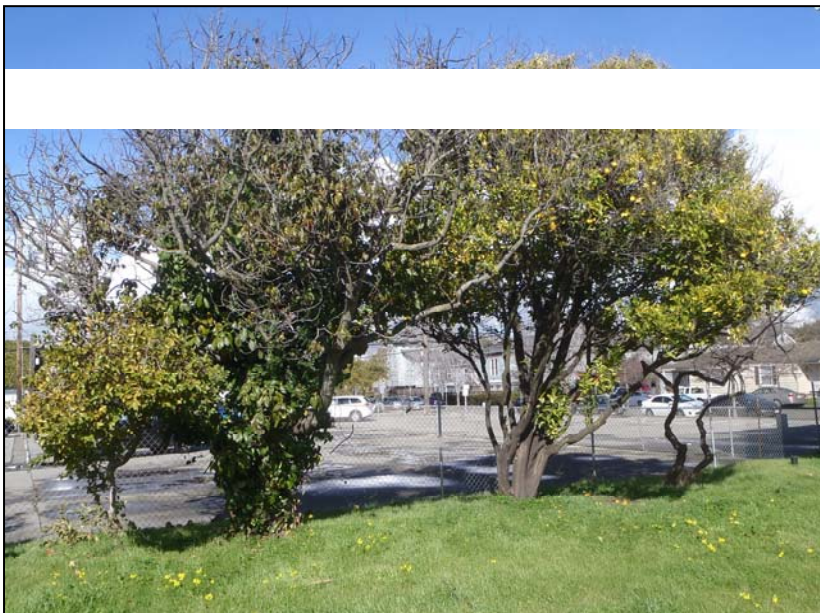
The trees included two lemons (*Citrus limon*) and an avocado (*Persea americana*) growing along the northern property line. All three trees were mature in form and development, with multiple trunks measuring from 1” to 14” in diameter. Both lemons were in fair condition and the avocado was in poor (**Photo 1**). The lemons showed moderate dieback of small twigs and branches and the avocado was all but dead, with most of the green in the crown coming from English ivy.

**Photo 1:**  
Looking northeast at lemon #98 (R) and avocado #99 (L). The lemon was in fair condition, with moderate twig dieback.

The avocado was in poor condition, with most of the green that can be seen in its crown coming from English ivy.

Based on my review of the plan, all three trees would be removed to allow for site demolition and construction of a new parking structure.
