## **Berkeley Waterfront Specific Plan**

## **Draft Overview of Berkeley Waterfront Sea Level Rise AB 691 Assessment Study**

# DRAFT Berkeley Marina Sea Level Rise AB 691 Assessment Study

August 30, 2019

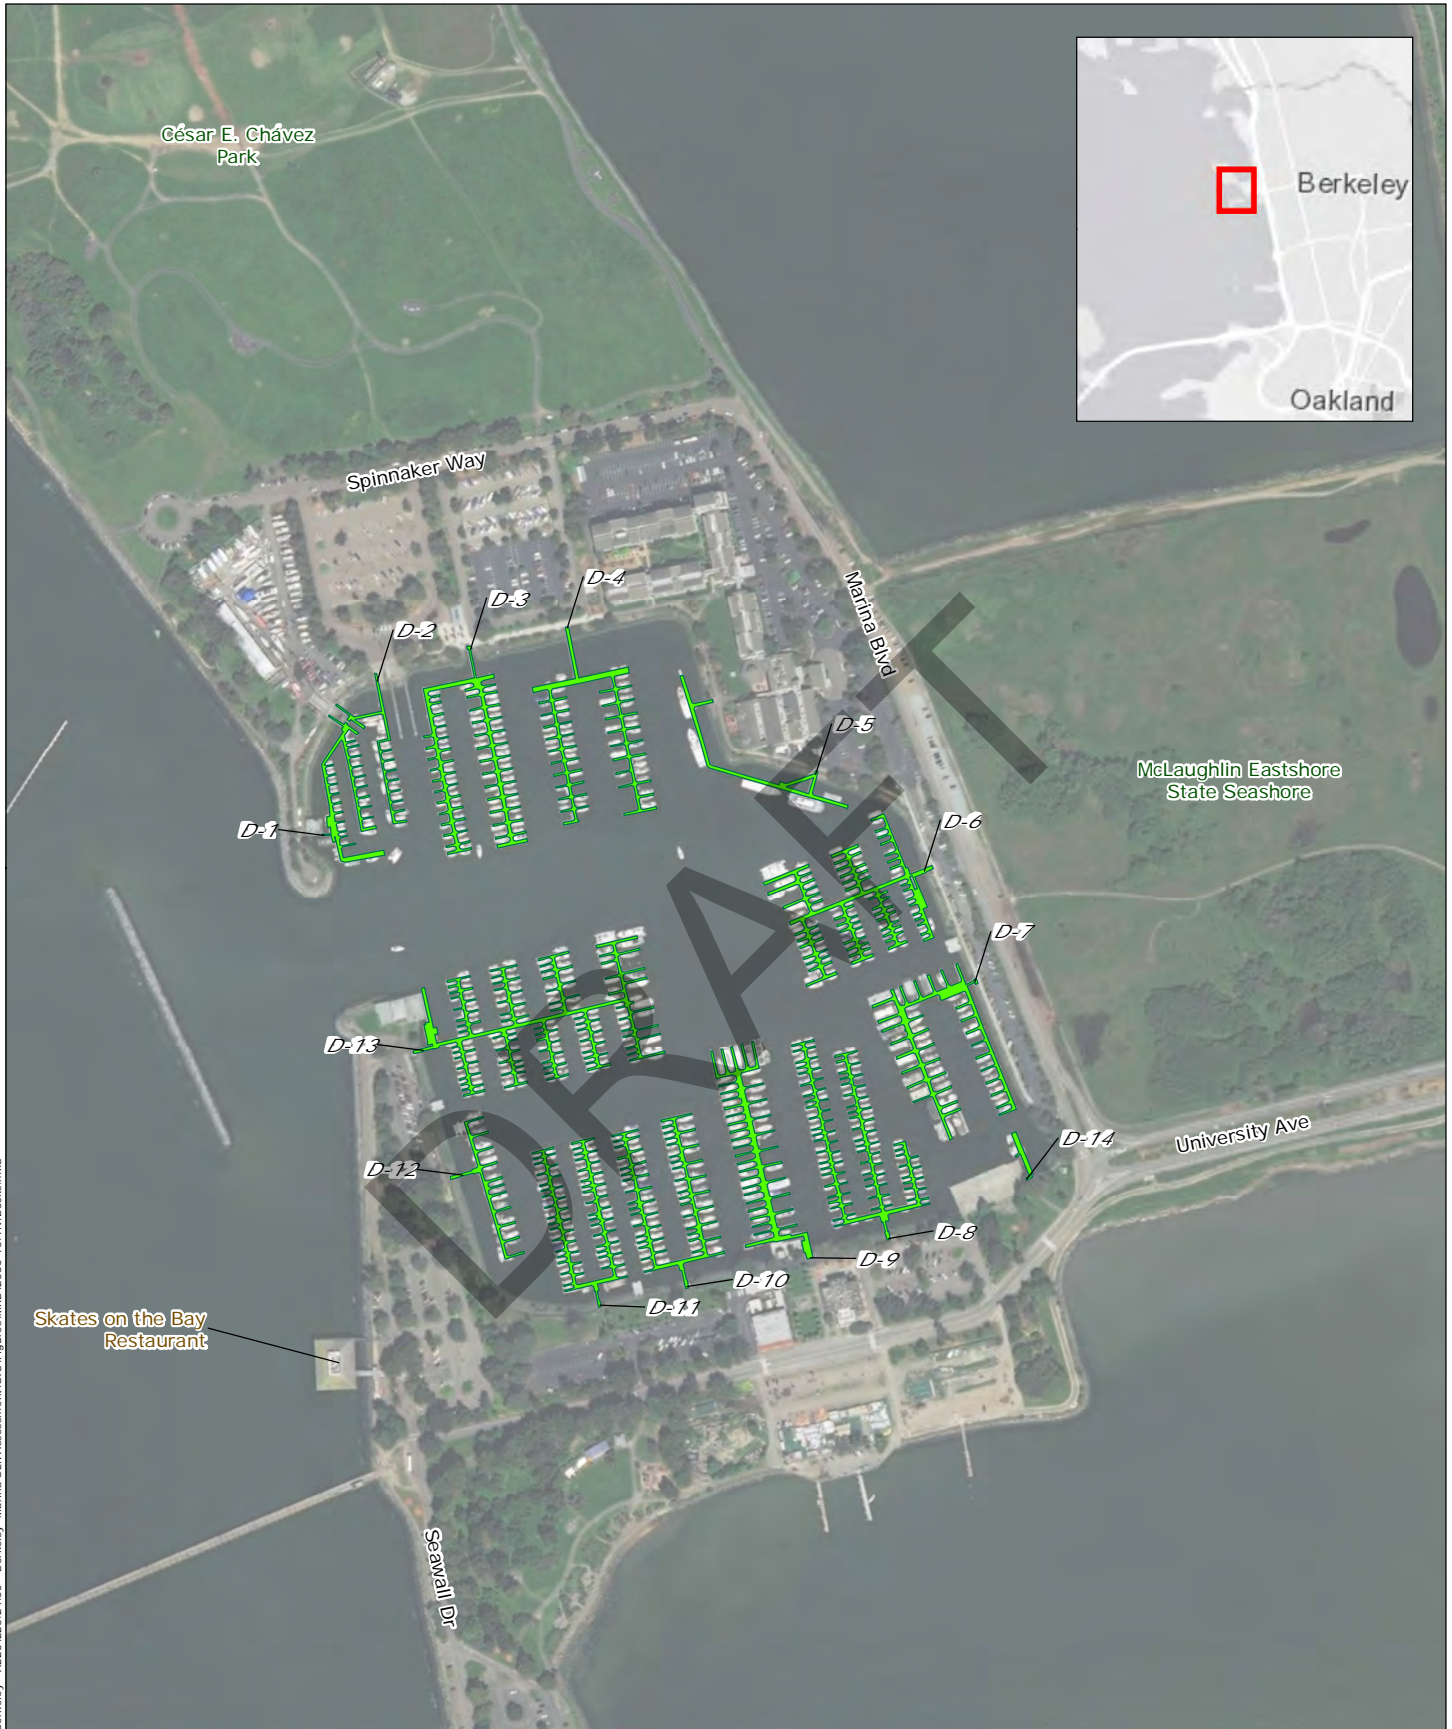
<p style="text-align: center;">FIGURE <b>3.7</b></p>
<p>SOURCE ESRI World Imagery basemap</p>	<p>JOB NUMBER 226.24.55</p>	<p>DRAWN skobs</p>	<p>DATE 8/27/2019</p>	<p>REVISED 8/27/2019</p>
<p>APPROVED mhorvath</p>

Damages to the Berkeley Marina are projected to be moderate by 2030 and rise considerably by the end of the century without mitigation. By 2030 there will be some roadway and parking facility inundation, particularly on Marina Boulevard and northeast of the protected area of the Marina, and flooding of McLaughlin Eastshore State Seashore. By 2050, parts of the Double Tree buildings will be flooded with finished floor elevations below the projected water surface elevation, as well as most of Marina Boulevard, portions of the San Francisco Trail, parking areas near the Doubletree Hotel, most of the McLaughlin Eastshore State Seashore and the revetment protecting University Avenue. By 2100, most of the land surrounding the protected area of the Marina, several buildings, significant parking areas, and the majority of University Avenue and Marina Boulevard will be inundated. By that time, there will be significant risk to the revetment, particularly by wave action and storm surge. Access to the Berkeley Marina via University Avenue will begin to be an issue periodically by 2030 and become more consistently difficult by near the end of the century. By 2050, access to some existing docks will be inundated and by 2100, the access to all the docks in the protected area of the Marina will be impacted by high water.

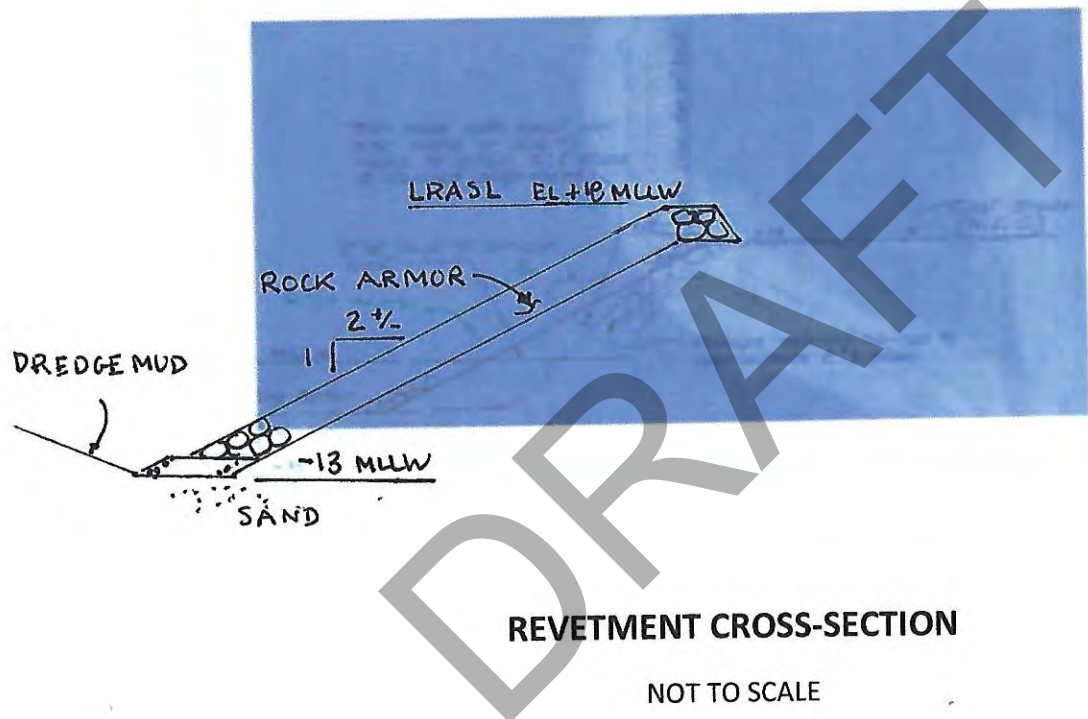
Figure 5.1 - Revetment Upgrade South of Marina Entrance - West Side

- **Shoreline Zone 1- From Southwest Corner to Berkeley Municipal Pier:** The length of revetment from the southwest corner to the Berkeley Municipal Pier is in relatively poor condition with a slope that is slightly steeper than elsewhere and has variable rock size and thickness. Larger sized rock was placed at the bottom of the slope with smaller sized rock to the crest. The underlying rockfill has been placed at close to its natural slope of 1.3:1 horizontal to vertical and the revetment armor placed as a wedge of material reducing at the top of the slope. The upper rock appears to be generally of single layer thickness and gaps are present which expose underlying rockfill material.

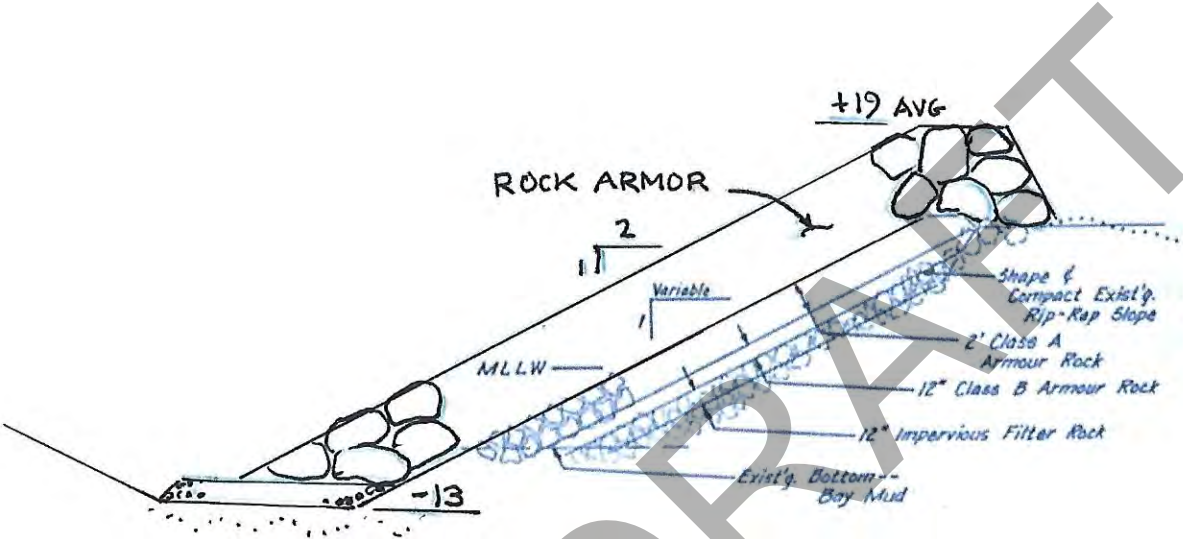
Figure 5.3 - Revetment Upgrade North of Marina - West, North, and East Sides

- **Shoreline Zone 5 -West Side from Spinnaker Way to the Northwest Corner of the Marina Bay Area:** In 1976, the riprap slopes of most of the landfill area were compacted and covered with 12 inches of impervious filter rock and 3 feet of armor rock with a variable slope. A typical cross section of the improvement is shown in the Waterfront Park - External Seal & Armor Protection Typical Section included in **Appendix C**. Rock has been added to fill in eroded and worn-down areas near the Perimeter Trail on the west side of the landfill. The Perimeter Trail along the back of the revetment along this length is at a high elevation at Spinnaker Way and then falls to a low of about +12 foot NAVD 88 near the northwest corner.

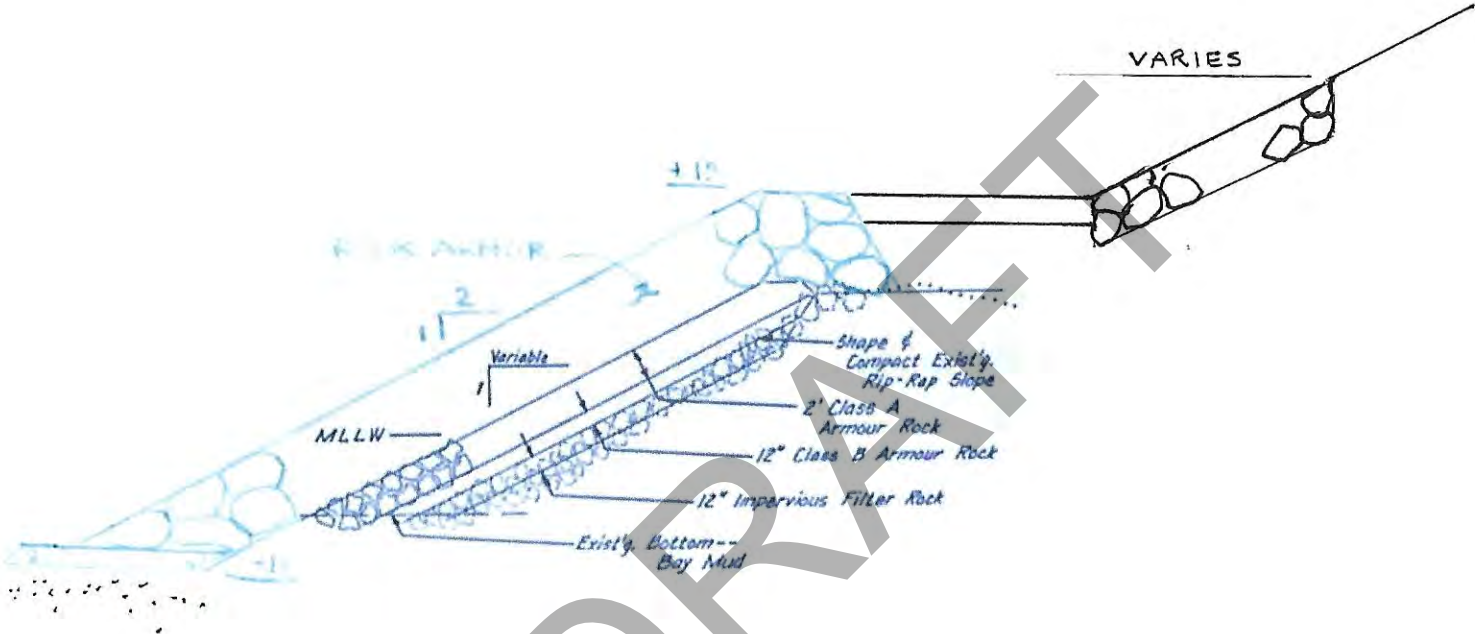
Figure 5.4 Revetment Raising North of Marina - West, North, and East Sides

- **Shoreline Zone 6 - North Side and northern 800 feet along East Side of the Marina Bay Area:** The revetment along this stretch is similar to Shoreline Zone 5. The 400-foot length of revetment next to the northeast corner has a lower top elevation than the length to the west. Recent minor repairs have been made to the rip-rap protected slope along the east side. The lowest Perimeter Trail elevation along this stretch of the east side of César E. Chávez Park is +18-foot NAVD 88.
