Waterfront Specific Plan for the City of Berkeley Public Tidelands Area

BERKELEY MARINA AREA specific plan

INFRASTRUCTURE ASSESSMENT

may 14, 2021

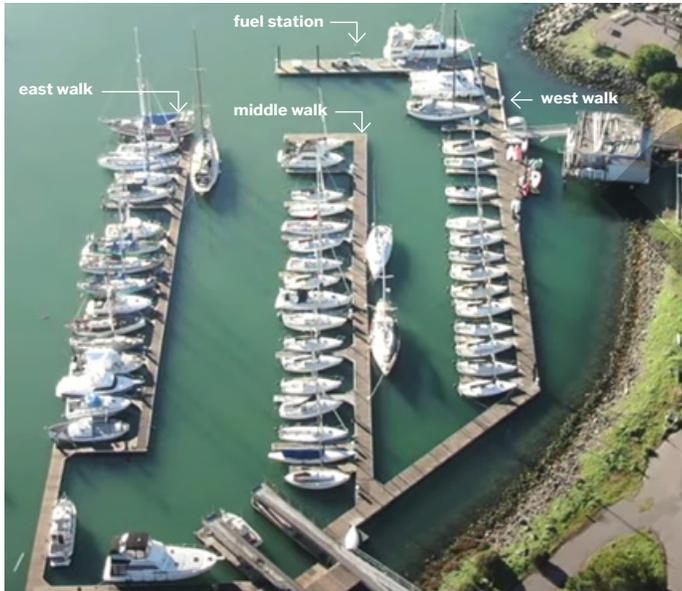
aerial photo of A Dock

A Dock is located in the northwest corner of the marina harbor. The three main walkways (East Walk, Middle Walk, and West Walk) are connected to each other by a marginal walkway which runs parallel to the shoreline. Slip lengths here range from 25' to 40'. The East Walk at A Dock is directly connected to the westernmost dock of the Boat Launch Facility. A Dock is in good condition.

The Middle and East Walks at A Dock were upgraded within the last five years. These upgrades included new timber framing and decking as well as new electrical power pedestals at the West and Middle Walks. A Dock has a marine fueling station located on its West Walk's last finger. The fueling station is in good condition and is

the docks adjacent to the fuel station consists of plywood boards so that the fuel line can be easily accessed underneath the deck, if need be. Some other fingers at this dock had plywood boards replace the original timber plank deck surface as well. A few of the fingers at A Dock are slightly warped, but most fingers are in excellent condition. One finger at the East Walk had missing deck panels which should be replaced.

The piles at this dock are made of either concrete, steel pipe, or timber. The concrete piles are in excellent condition, the steel piles are corroding but not showing signs of significant damage, and the timber piles vary between good and moderate condition. The last finger at the middle dock has an empty pile guide, with no indication of a stub timber pile below the water line.

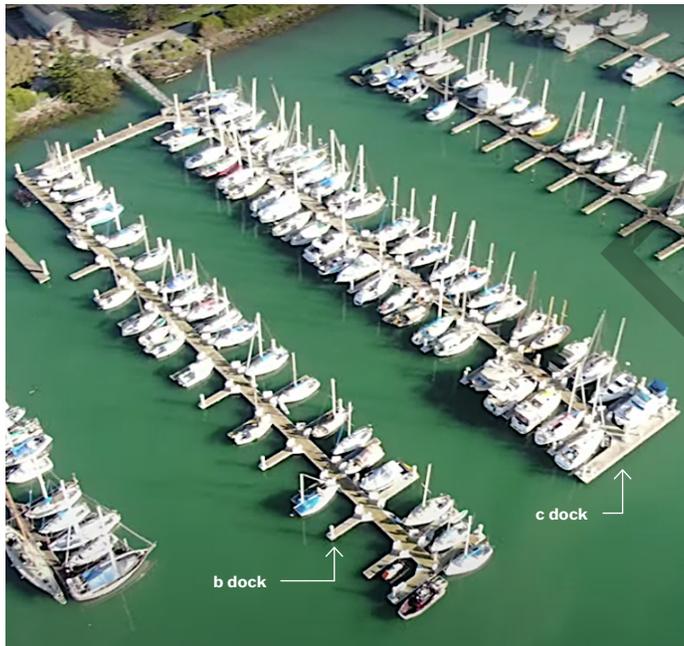
aerial photo of B and C Docks

B and C Docks were replaced in 2007. The slips range in length from 25' to 36'. The two docks are connected to each other via a marginal walkway which runs parallel to the Harbor Basin's north shore. The main walkways for each dock are perpendicular to the marginal walkway. B and C Docks are in excellent condition.

B and C Docks are comprised of concrete dock modules made by Bellingham Marine, Inc. The dock modules are in excellent condition with no observable defects in the concrete or floatation. Piles at this dock are all precast concrete with no signs of any damage or wear.

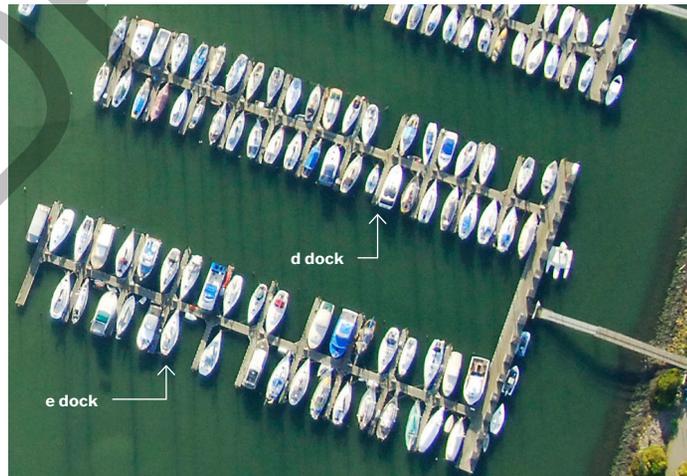
aerial photo of D and E Docks

D and E Docks were constructed in the 1960's and are the oldest remaining docks at the marina. They were originally slated for replacement in 2000 with B and C Docks, but insufficient funding led to D and E being excluded from that project. Funding for the project has recently been secured by the City in the form of a \$5,000,000 Department of Boating and Waterways (DBW) loan. D and E Docks have a similar configuration to B and C Docks. Slip lengths at these docks range from 32' to 40'. D and E Docks are in poor condition.

D and E Docks are comprised of timber framing and decking. The deck is comprised of staggered 2" x 6" timber planks, which run parallel to the dock's long axis rather than perpendicular (as seen in the other timber docks at the marina). The decking is showing signs of heavy wear and deterioration, often having holes and checks in the timber planks and a rough texture. Individual planks have been replaced at various locations along the dock and these can be identified by their noticeable color difference compared to the original planks. These repairs work well and highlight one of the advantages of having a timber deck in comparison to concrete. The southern end of E Dock is blocked off to the public. Despite the various issues with these two docks, they remain stable during use.

Appurtenances (pile guides, rub strips, corner bumpers, and cleats) at these two docks are in poor condition. Most of the pile guides at these docks are heavily corroded and have lost significant portions of their cross-section. Rub strips and corner bumpers are detached at many locations. Occasionally, cleats were found to be improperly mounted or detached from the deck entirely.

Piles at D and E are in poor condition. Many piles are exhibiting significant section loss in the tidal zone, due to a combination of marine borer infestation and rot. During storm events, piles have recently fallen at these docks due to their weak cross-sectional strength. The piles at D and E Dock will be replaced as part of the proposed dock

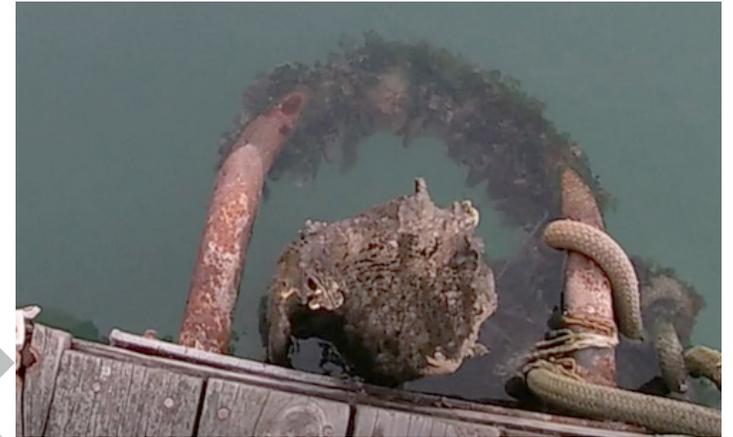
Stub pile and corroded guide at E Dock

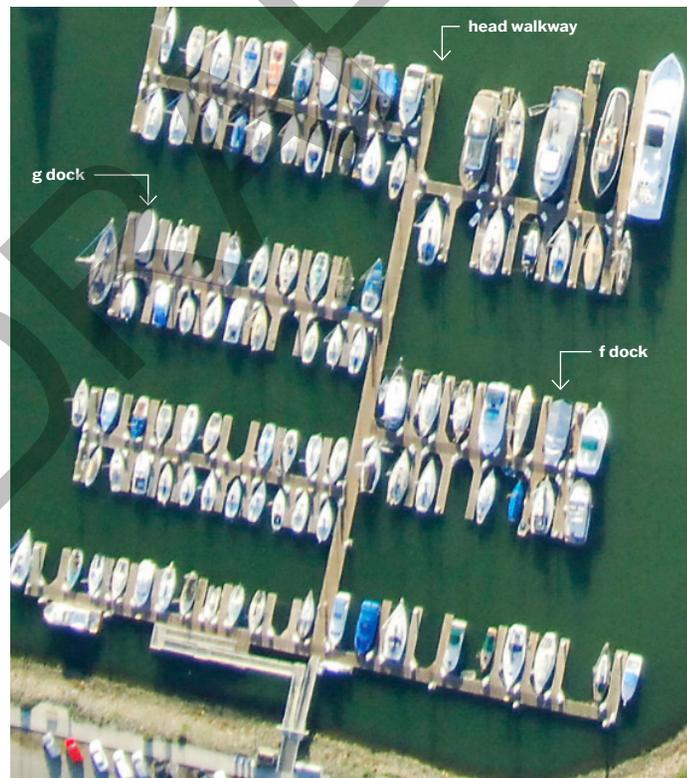
Aerial photo of F and G Docks

F and G Docks were replaced in 1999. These two docks are located in the upper portion of the Harbor Basin's east side, just south of the DoubleTree Hotel. The docks branch from a shared head walkway perpendicular to the shore. F Dock is located on the north side of the head walkway and G Dock is on its south side. Slip lengths range from 22' to 84'. F and G Docks are in good condition.

The decking for F and G Docks is made of timber which runs perpendicular to the long axis of the dock. The frames for the docks are made of timber. The majority of the decking is in excellent condition, but there are a few locations at the end of fingers where the wood is starting to show signs of decay. The decaying wood is found at fingers which are exposed to waves generated by vessels traversing the harbor's interior channel. When the waves splash water onto the docks and it is allowed to pond, the water slowly rots the timber deck. While the damage observed from this is minor, this should be monitored to see if the condition of the timber worsens over time. Some fingers at F and G Docks have begun to exhibit twisting and deformation; however, it is minimal, and the fingers remain stable to walk on.

The piles at F and G Docks are all precast concrete and are in excellent condition. The pile guides are made of galvanized steel rings with HDPE rub block attachments to prevent direct contact between the concrete pile and steel ring. Similar to the decaying wood of the decks exposed to wave action, the pile guides at the exposed locations are showing signs of corrosion damage. While no significant section loss was observed at the guides, the corrosion should be monitored for changes to the condition of the rings.

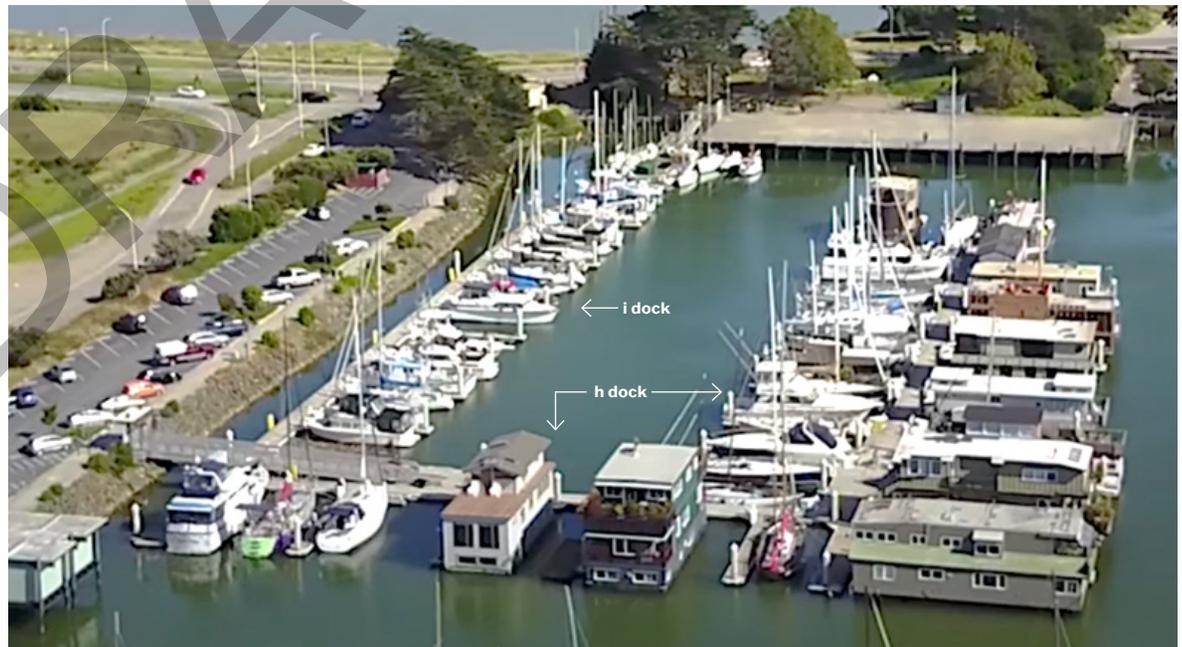
H and I Docks were replaced in 2009 and are the newest docks at the Berkeley Marina. The docks are located in the southeast corner of the Harbor Basin and share a marginal walkway perpendicular to the shore. Slip lengths range from 40' to 60'. H Dock is the only dock at the marina which accommodates houseboats and as a result the walkways at H Dock are wide and very stable. H and I Docks are in excellent condition.

Aerial photo of H and I Docks. Note: The house boats on H Dock

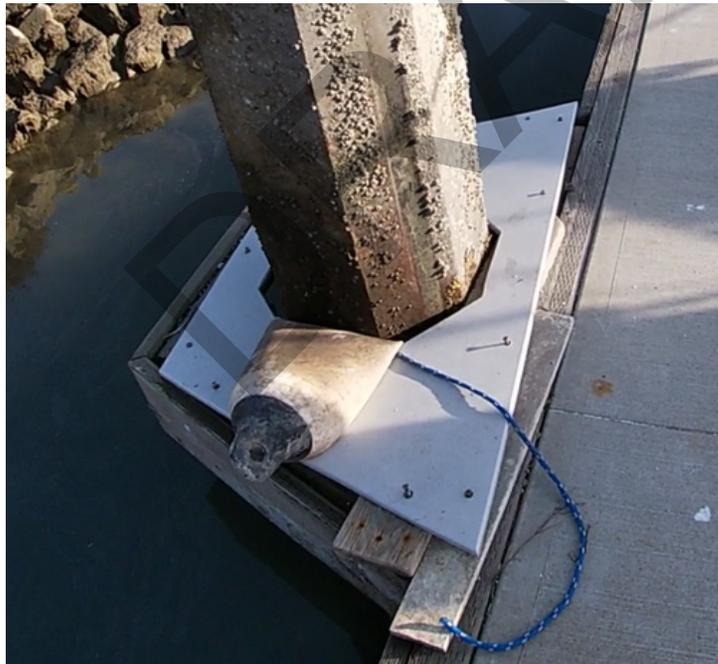
Damaged guide at I Dock. It appears the buoy is acting as a temporary replacement for rub strips

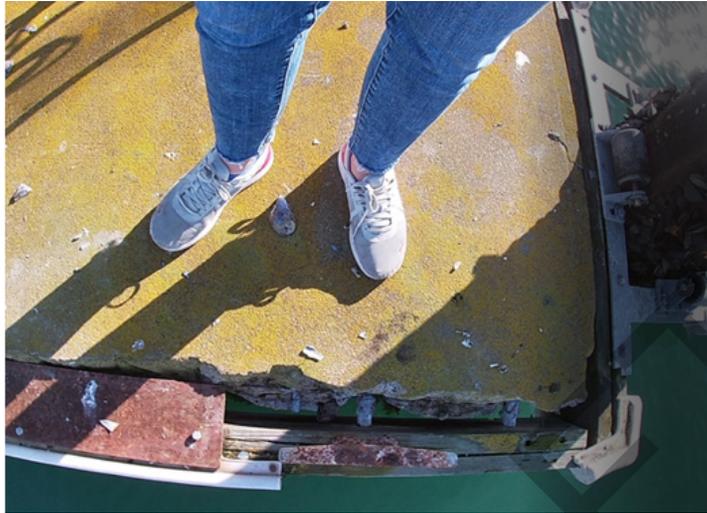
Typical cracking and spalling at finger ends. Note the cracking occurs on the perimeter of the concrete float module

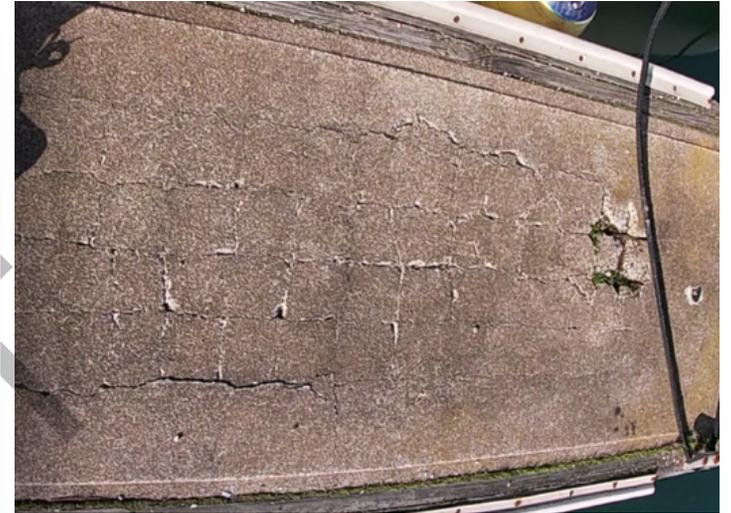
Delamination of the concrete dock module. This damage is typically covered by plywood or steel and is not visible

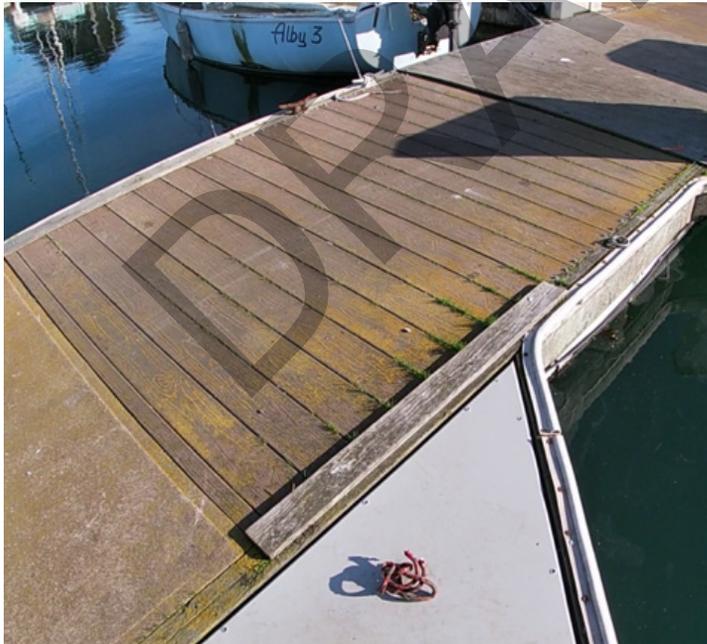
Concrete float replaced with timber deck on main walkway

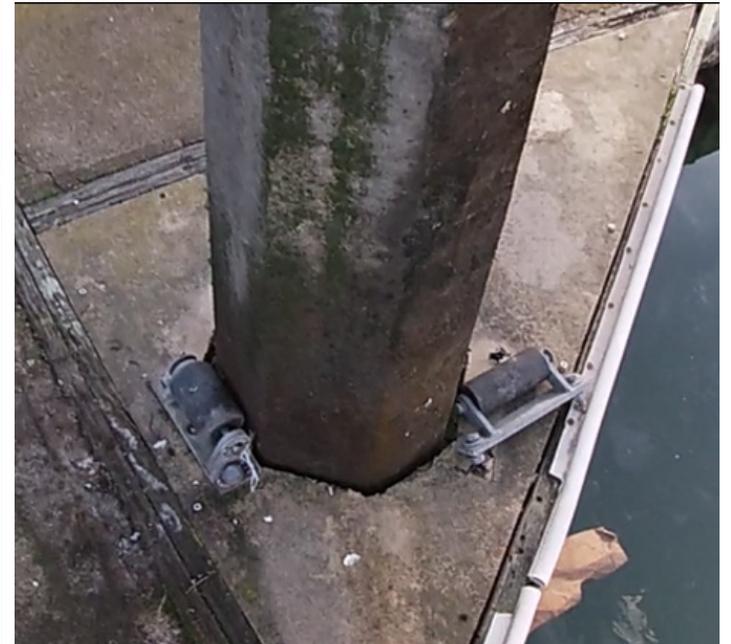
Internal pile guide. Note the unattached pile roller assembly, allowing the pile to make direct contact with the plywood

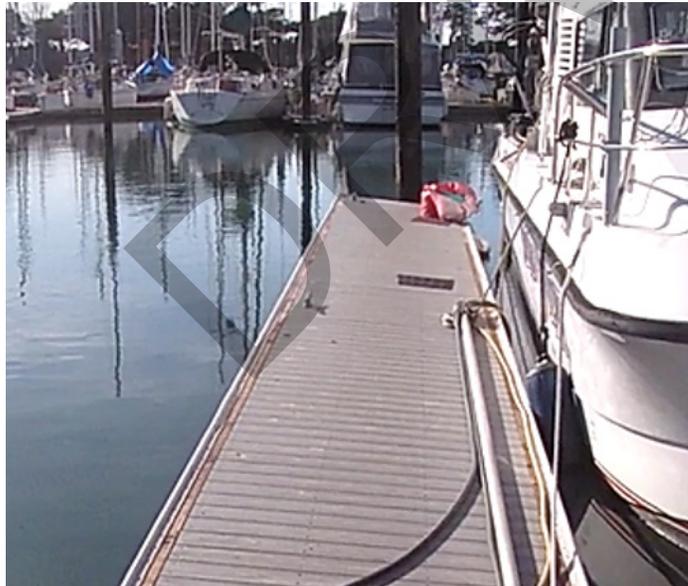
New finger part of the finger dock replacement project. Note how it is already twisted significantly

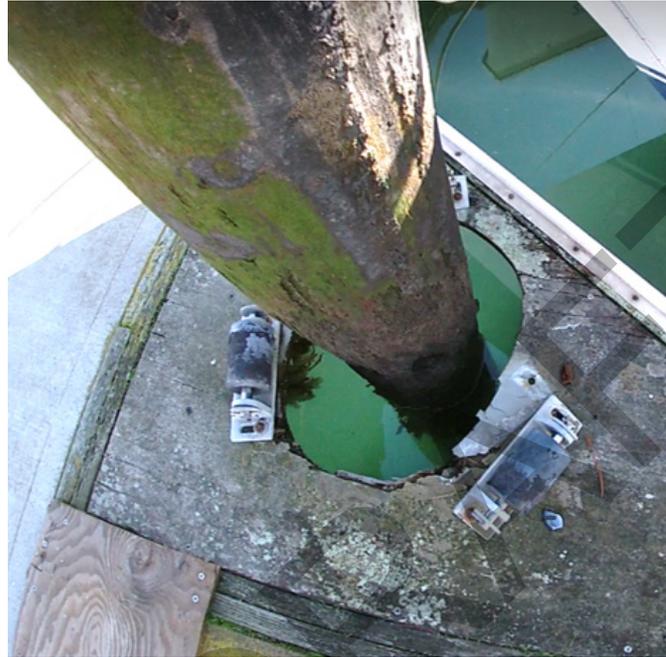
The pile guides at L Dock are in poor condition. The steel hoops on the external pile guides are heavily corroded and there were many instances of dismantled pile roller assemblies at the internal pile guides. The plywood cover boards to which the roller assemblies should be attached show damage from direct contact with the pile.

Damaged internal pile guide. Note the unattached pile roller assemblies and widening hole in the plywood

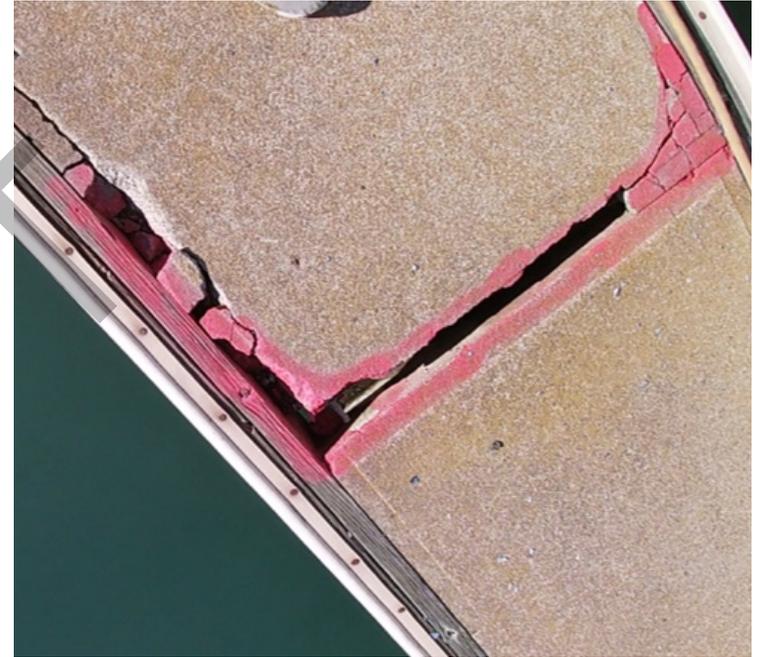
Typical cracking at edges of concrete float module

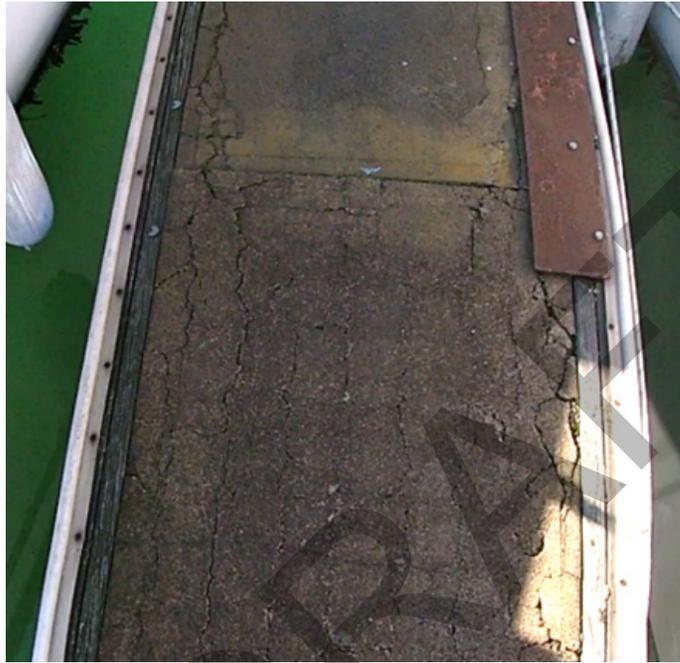
Delaminated finger between slips 139 and 141. The cracking on the walking surface is typical of delamination.

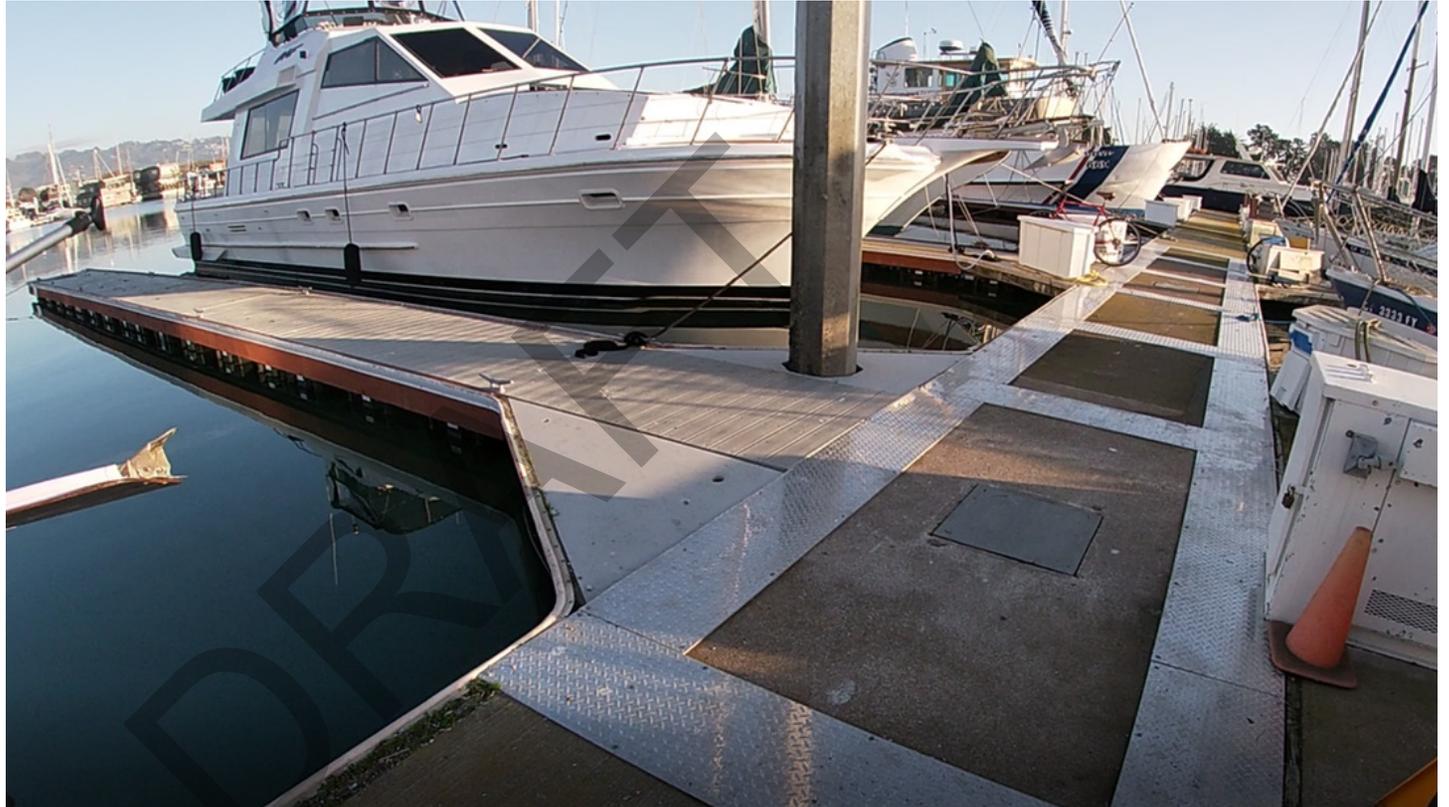
Diamond plate sheet covers and a newly replaced finger along O Dock's eastern edge.

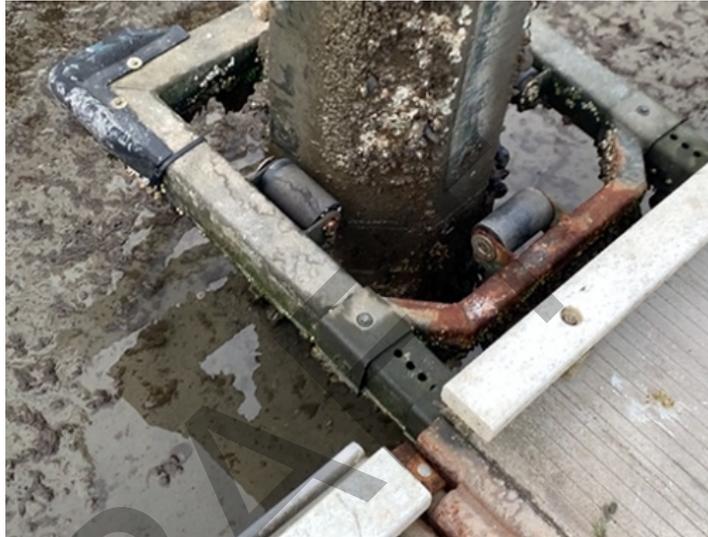
Corroding steel hinge and pile guide

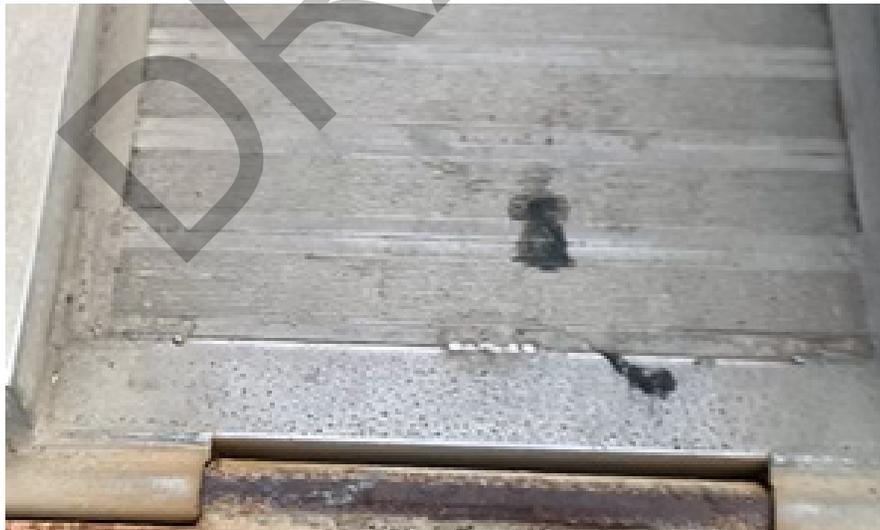
Corroding hinge at the top of the non-ADA accessible gangway.

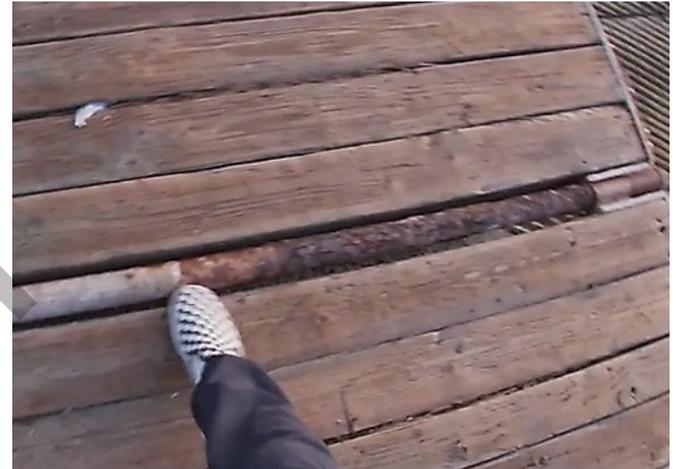
Corroding hinge between boarding float modules

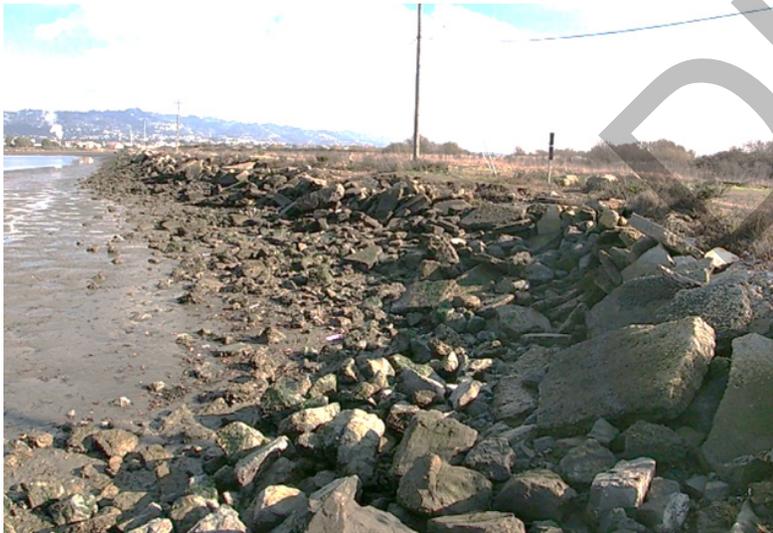
There are occasional scarps (eroded slopes) in the southern 500' of this segment. At these scarps, the smaller 15" rocks have dislodged and fallen to the revetment toe. There are two additional areas where riprap was missing at top of the revetment, approximately 1200' south of the northeast corner of Cesar Chavez Park.

Low elevation area at the shoreline where Marina Blvd meets Virginia St Ext

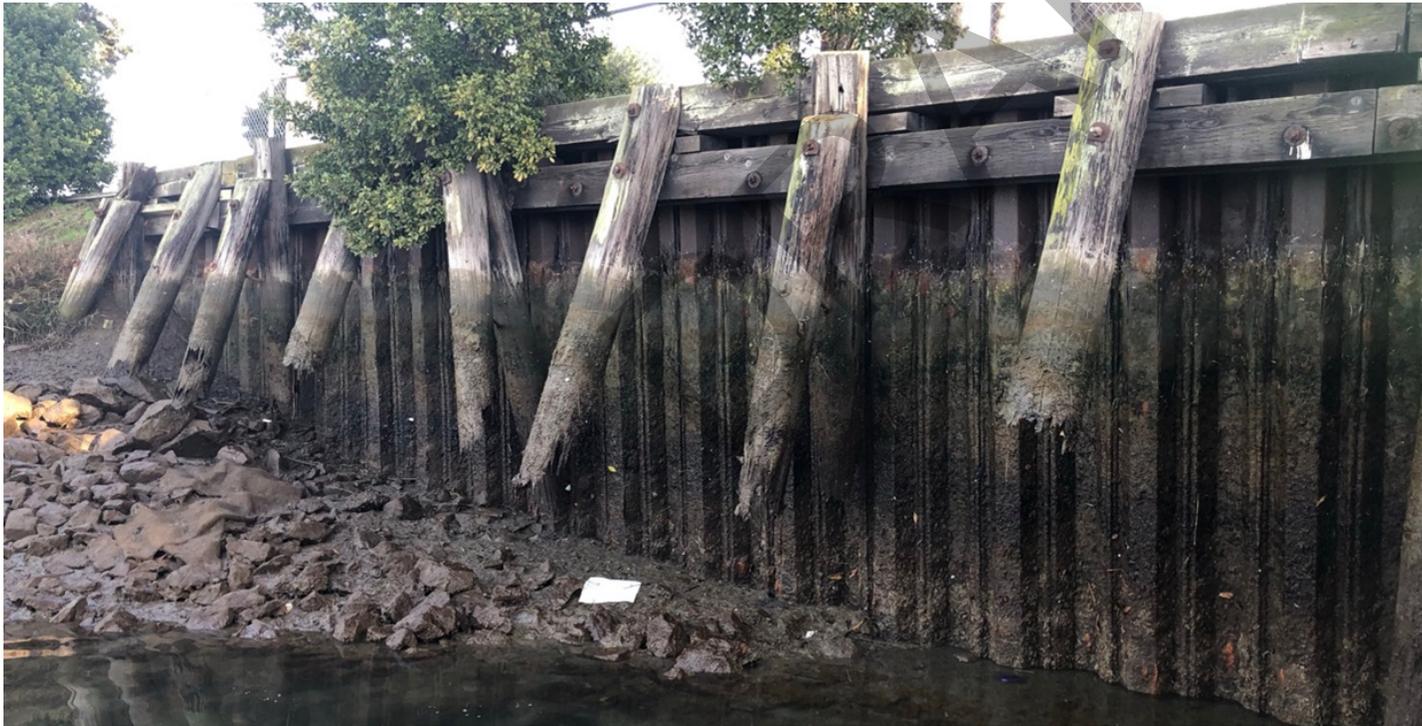
The Harbor Basin Bulkhead Wall is in fair condition. The wall is located along the south shore of the Harbor Basin on both sides of and beneath the Wharf. The bulkhead is comprised of steel sheet pile and timber batter piles which connect to large timber walers at the top of the wall. It is likely that the batters and walers acted as braces to stabilize the wall against the retained soils. All of the timber batter piles at the retaining wall have broken and the wall is bowing outward as a result. The sheet piles are beginning to corrode but are not near the level of damage exhibited by the seawall at the South Sailing Basin.

Harbor Basin Bulkhead Wall. Note the broken batter piles

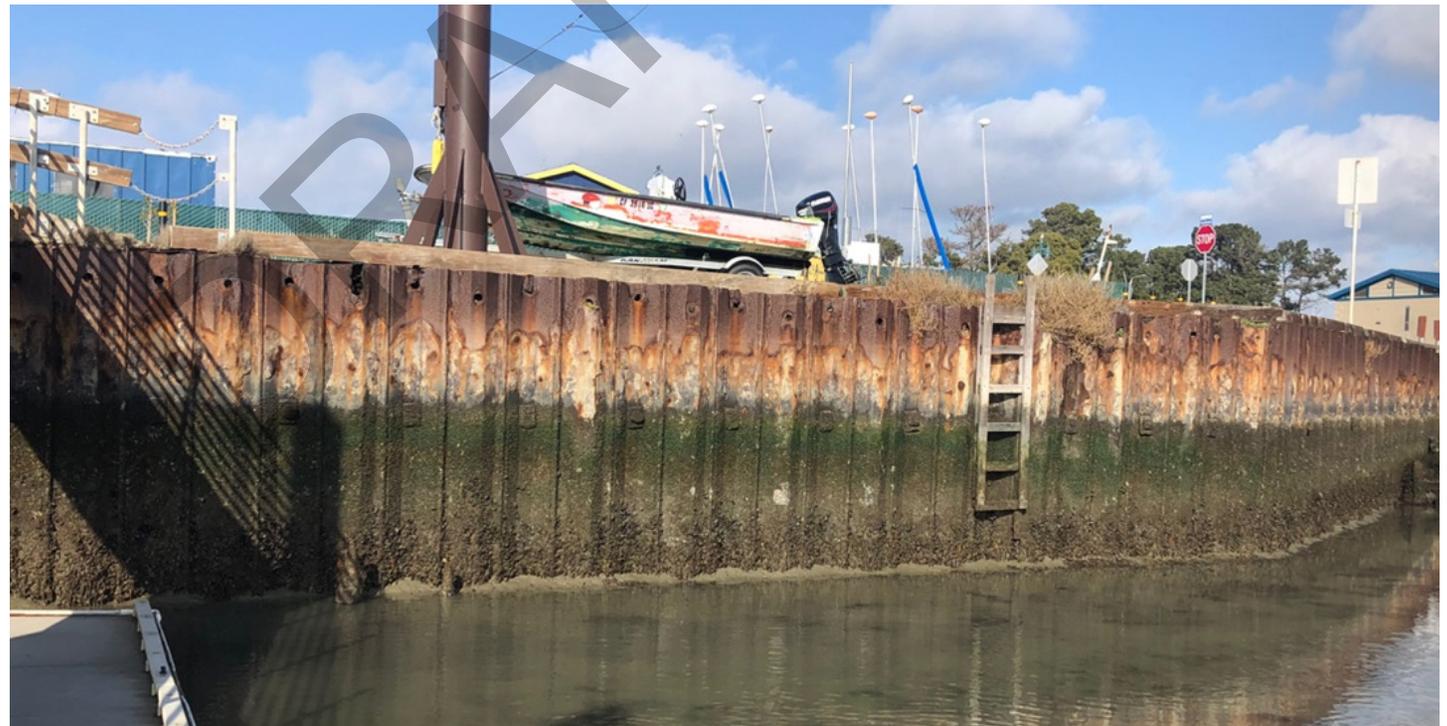
Figure 1-35 South Sailing Basin Seawall

South Sailing Cove Seawall. Note the heavily corroded steel of the sheet piles.

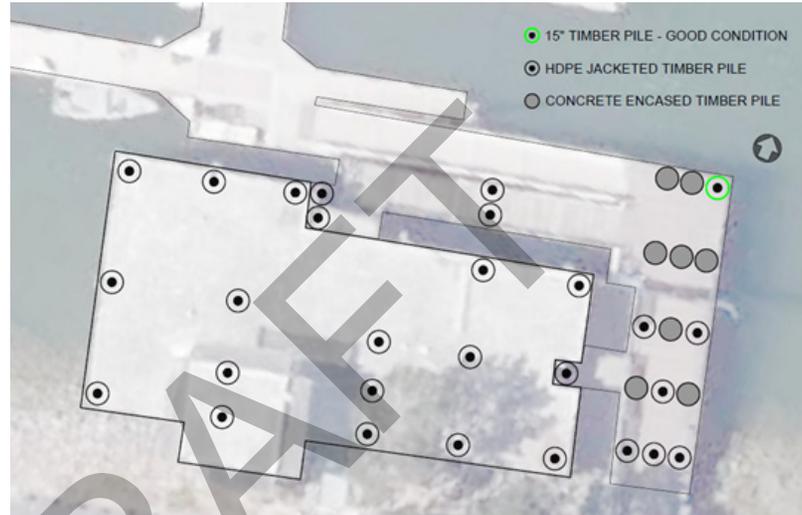
Pile map and condition summary for the Harbormaster's Office

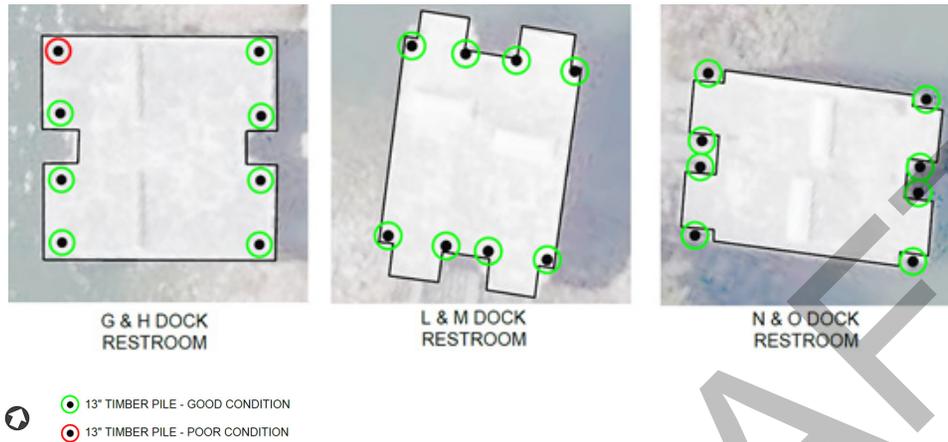
Pile maps and condition summary for the Over-Water Restrooms

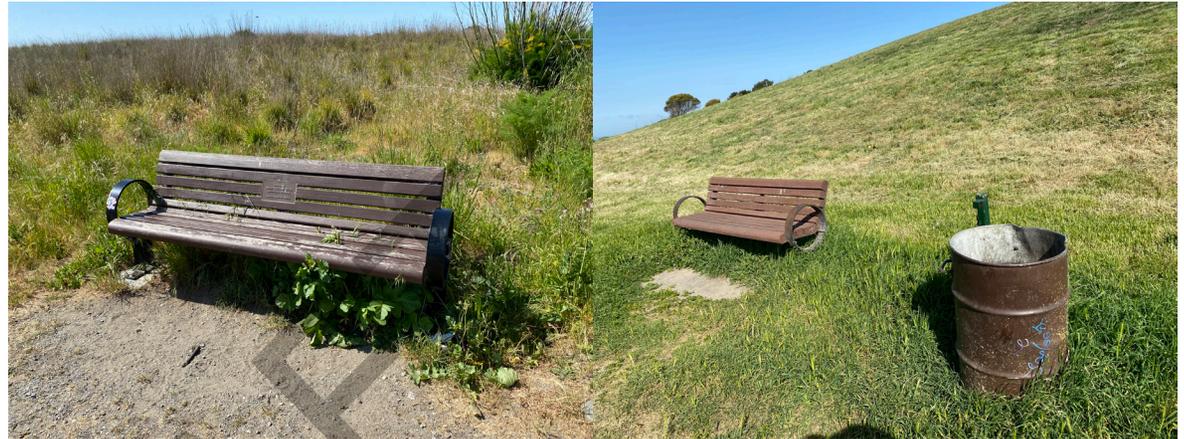
Several park furnishings are in disrepair and inaccessible

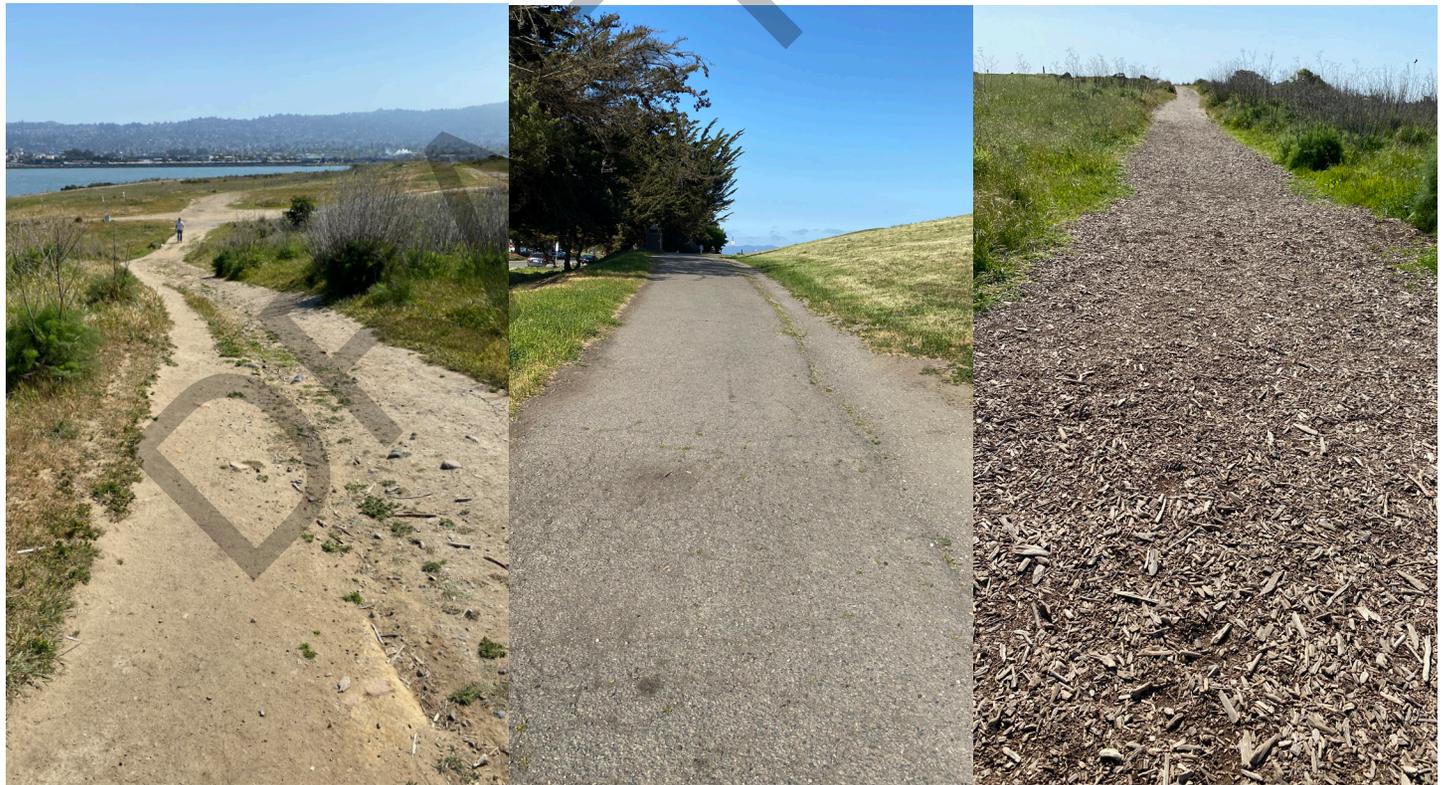
Pathways are inconsistently paved throughout the park causing access and accessibility issues
