LANDMARKS  
PRESERVATION  
COMMISSION  
STAFF REPORT

## 1401 Le Roy Avenue – John Galen Howard House

**Structural Alteration Permit (#LMSAP2024-0002) to alter the roofing material and to complete an exterior façade restoration at a City Landmark property.**

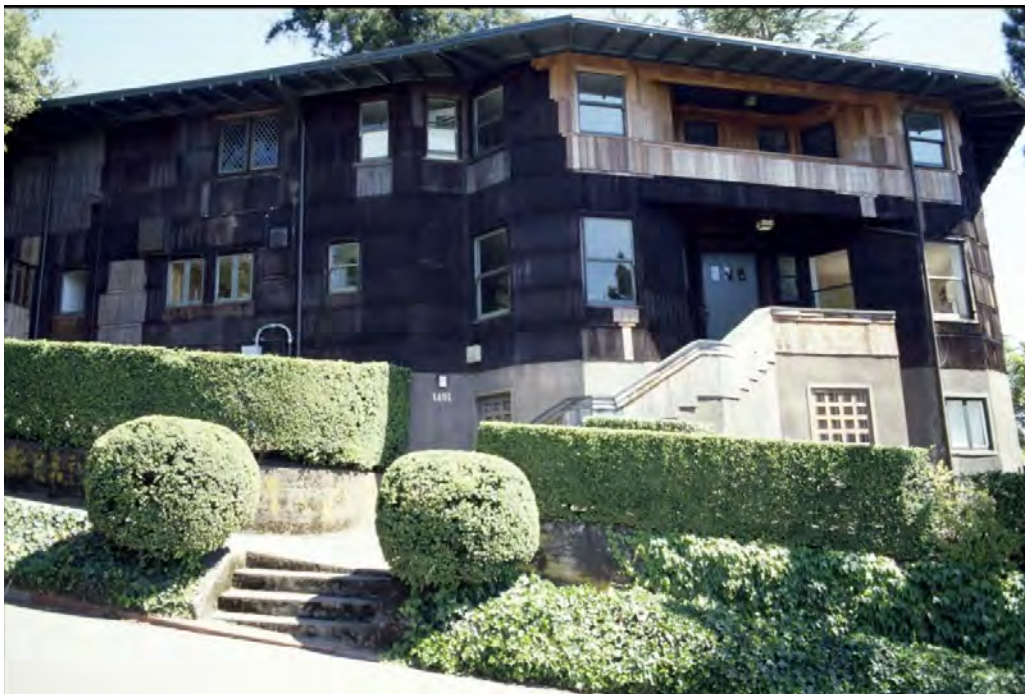
View of main entrance at corner of Le Roy Avenue & Rose Street (2001) (note: replacement shakes in cedar.)

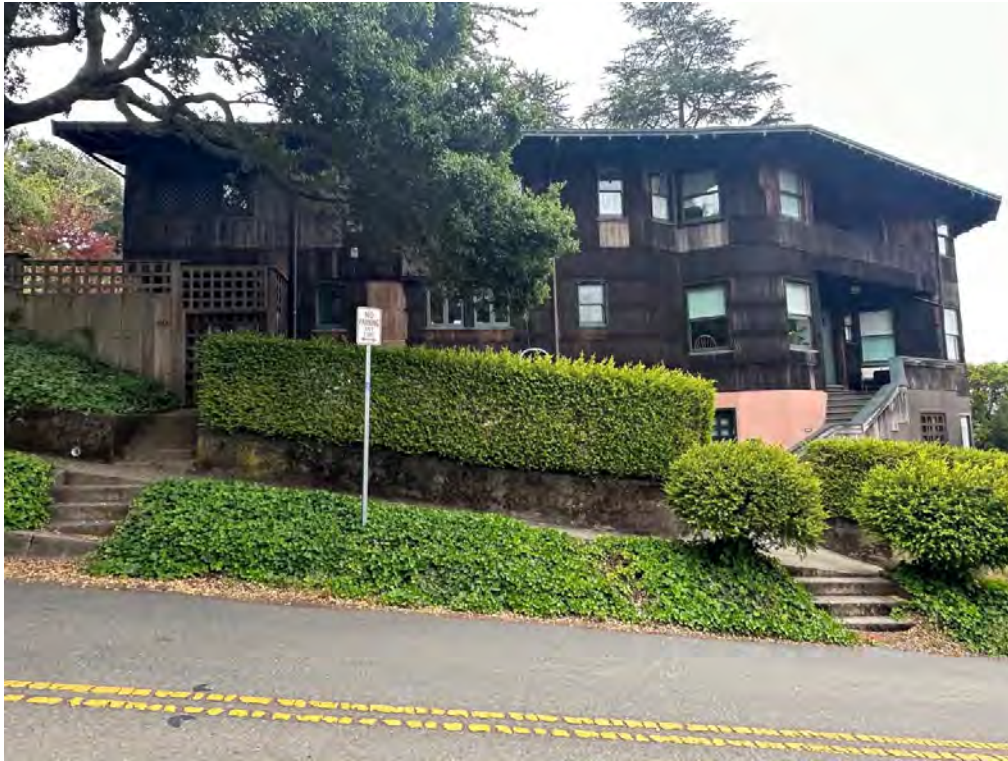
View along Rose Street (note: replacement shakes in cedar.)

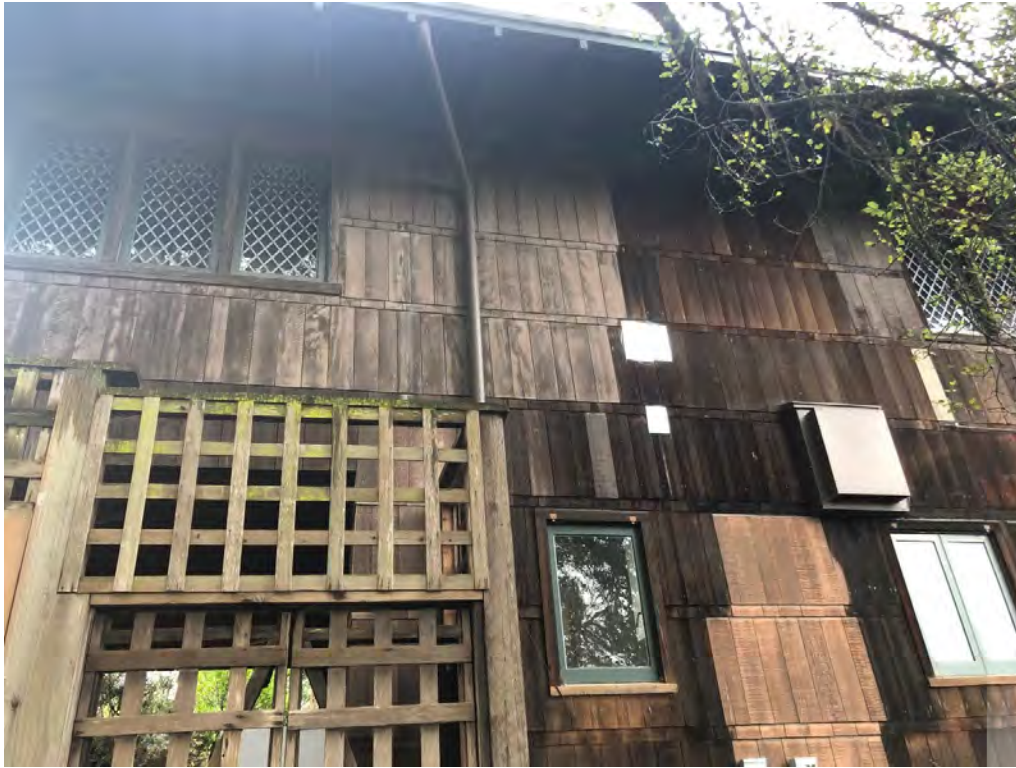
Patchwork of redwood shakes (original) and cedar shingles (replacement).

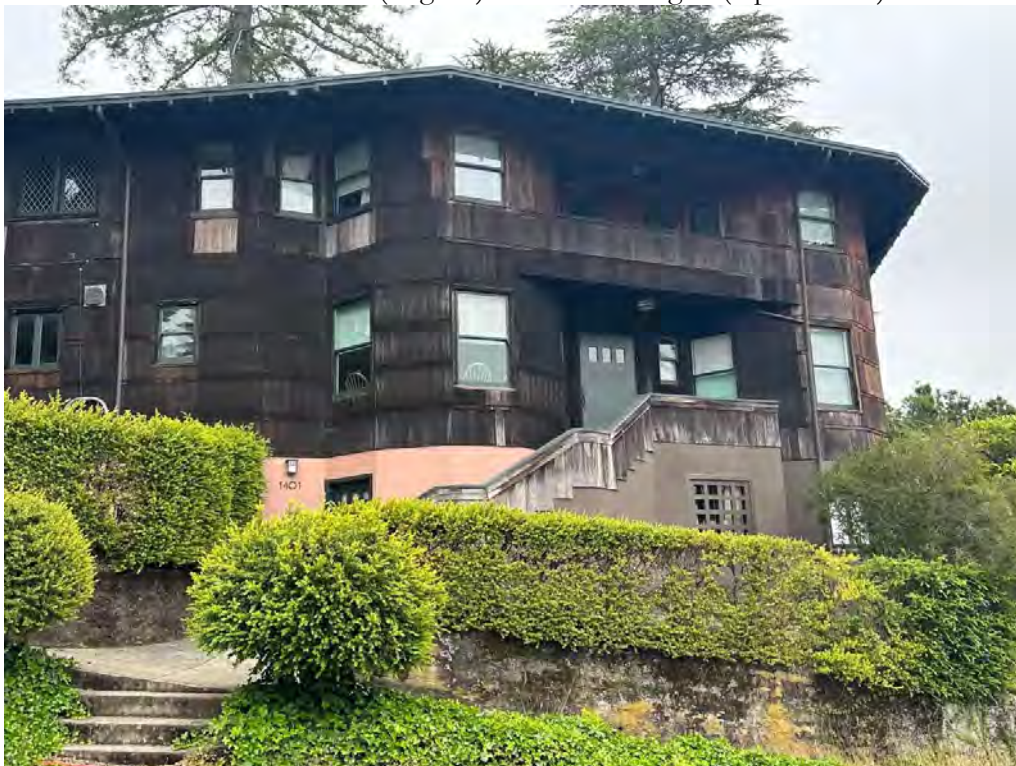
Circled windows proposed for replacement. Dry rot on most trim at sills and sashes.

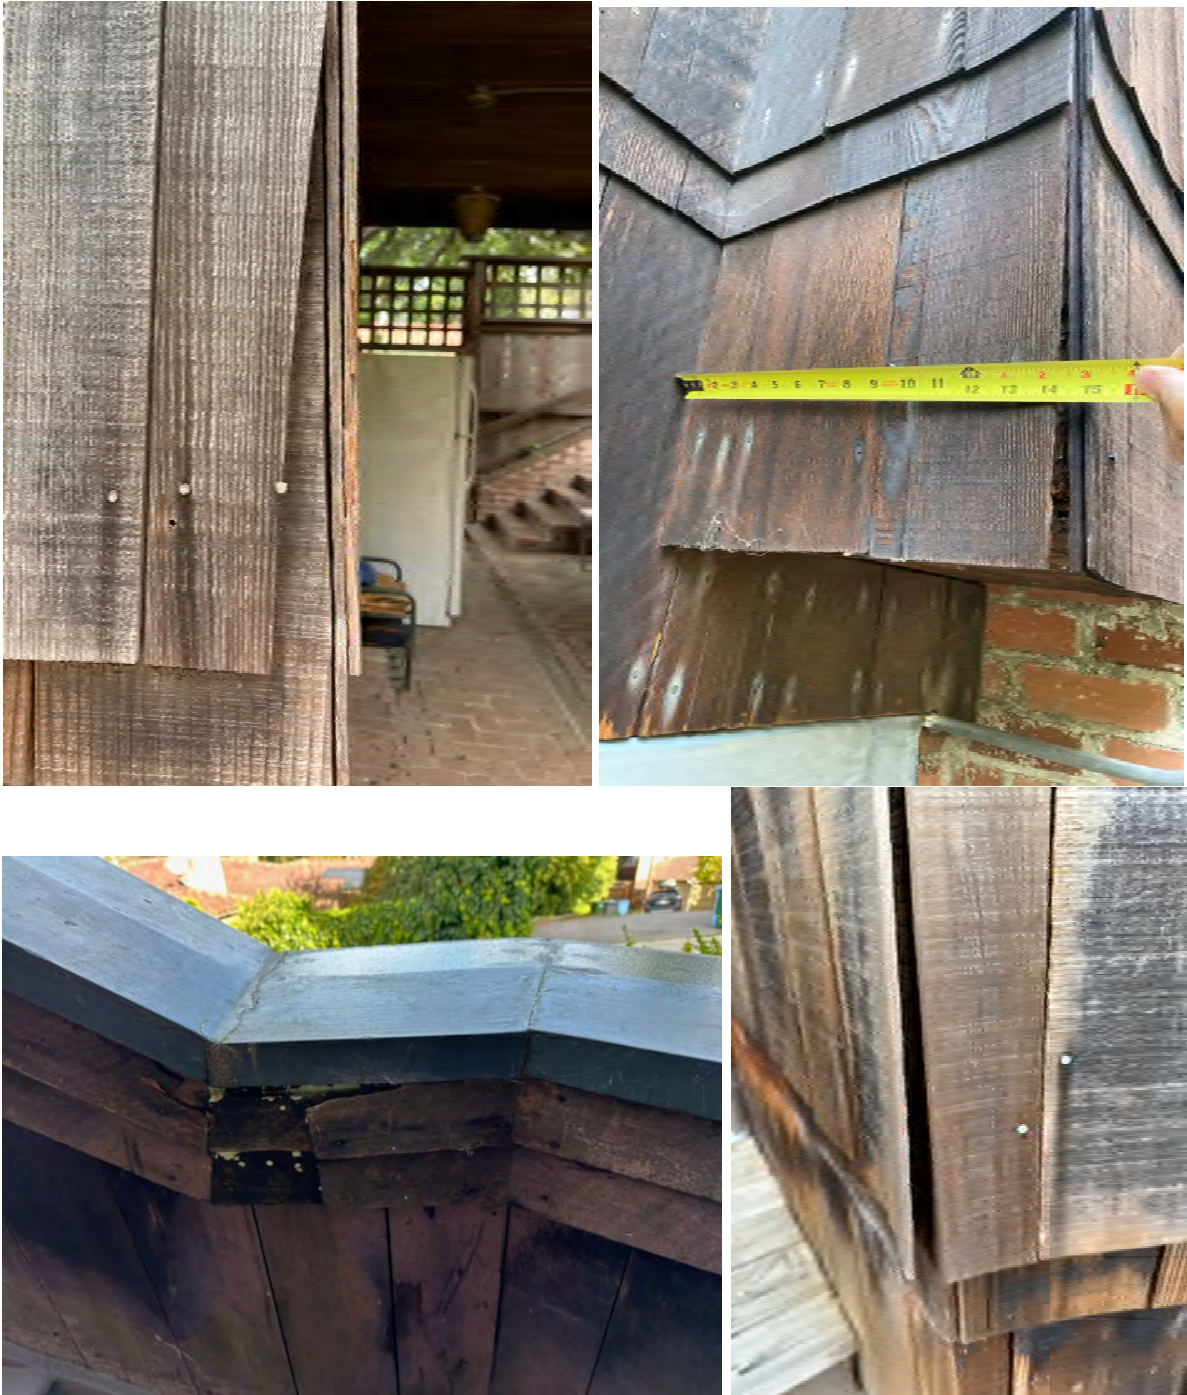
Shakes in various state of disrepair, age.

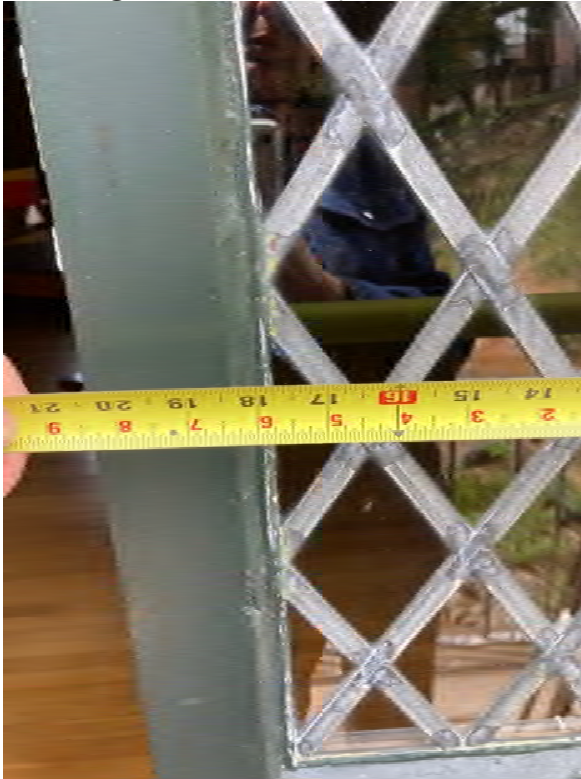
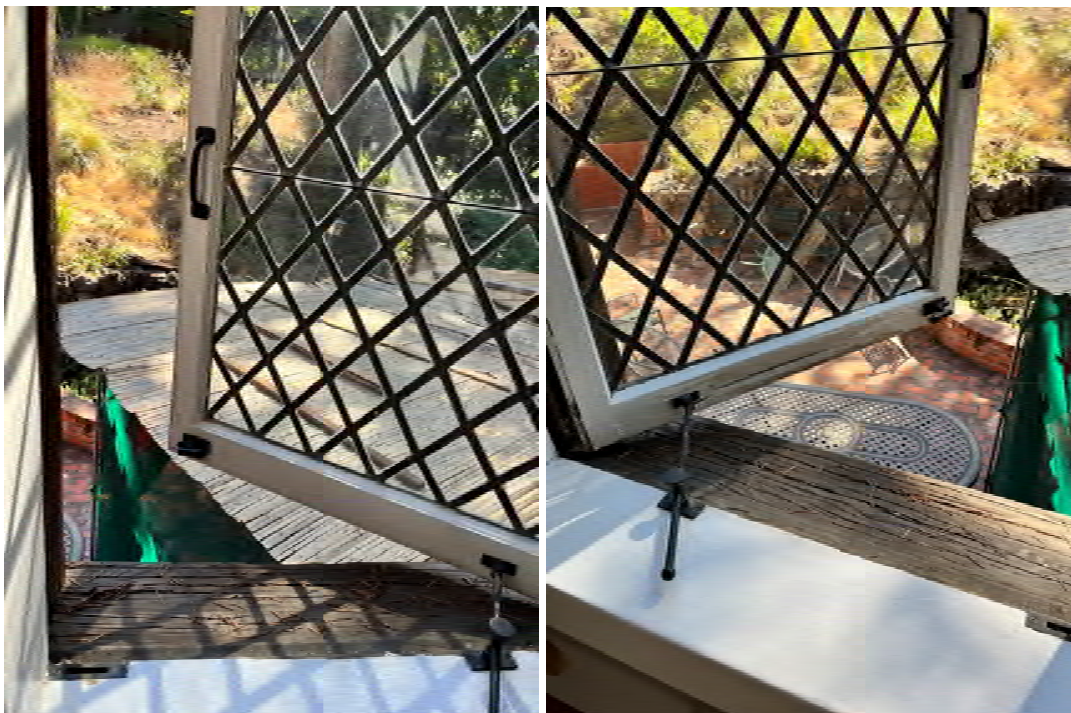
Detail views of leaded glass windows at stair. Note glass “sagging”/pulling away from wood sash, dry rot at wood sash and exterior sill.

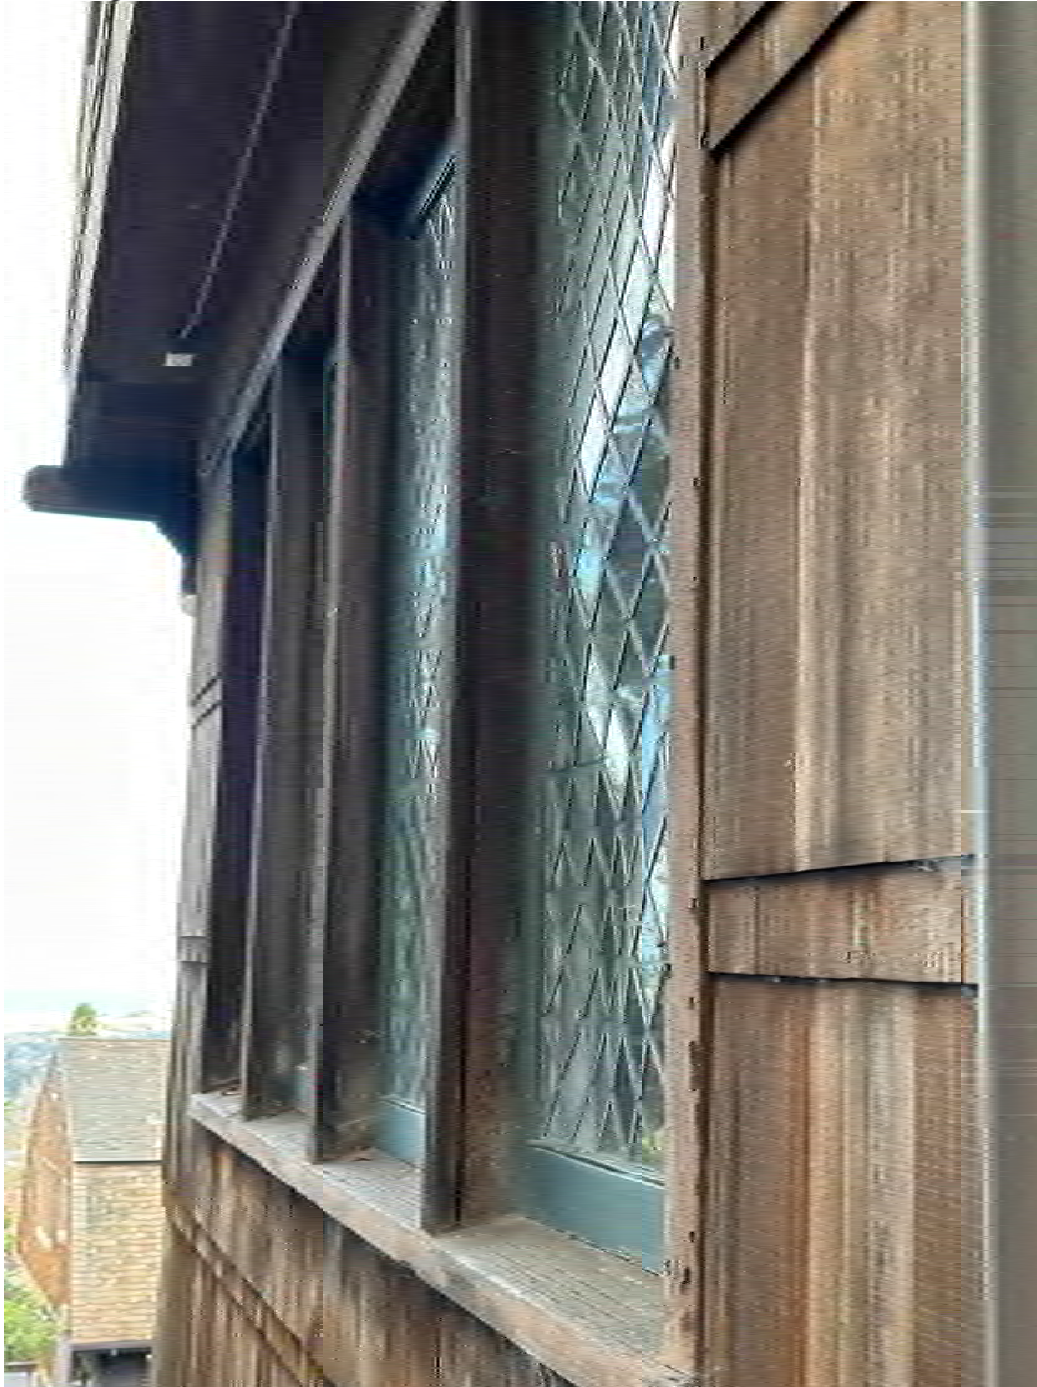
Note leaded glass pulling away from wood sashes. Dry rot on trim.

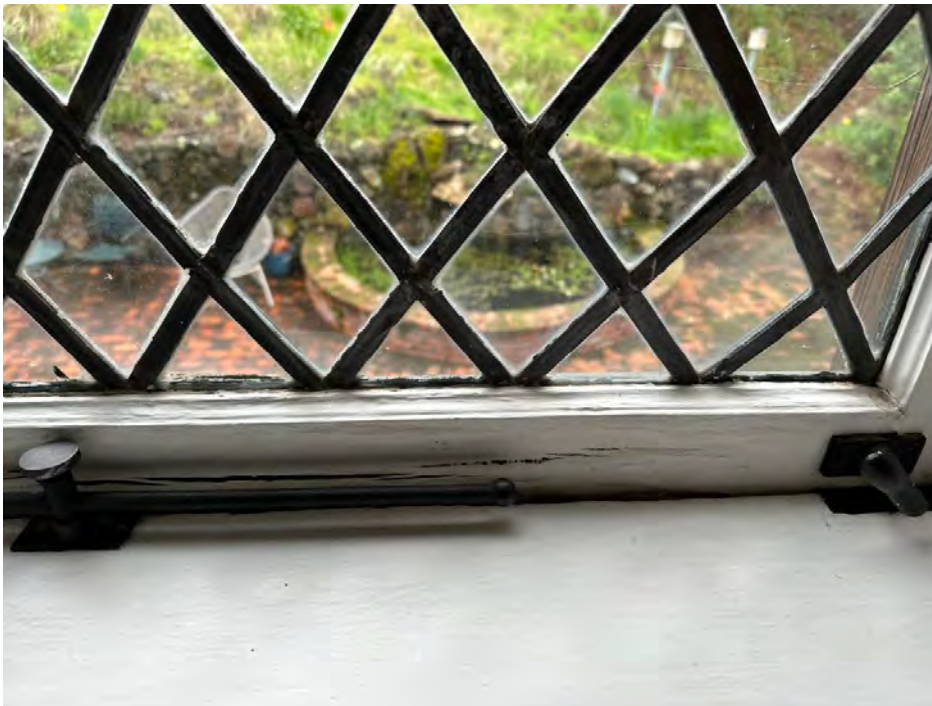
View of leaded glass windows on south façade. Note leaded glass pulling away from wood sashes.

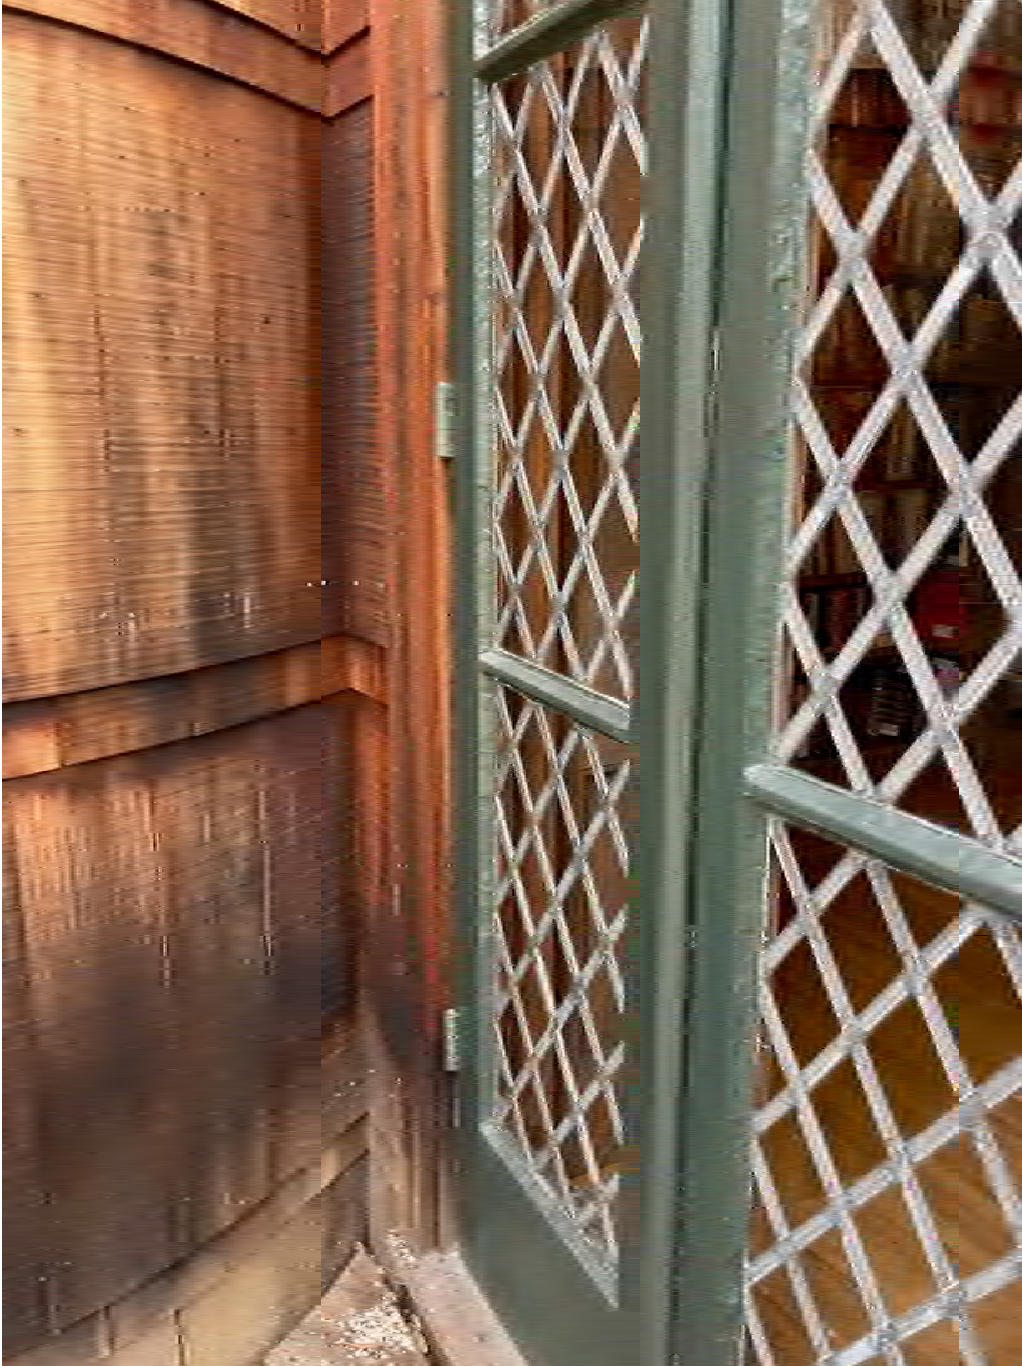
Dry rot at sill.

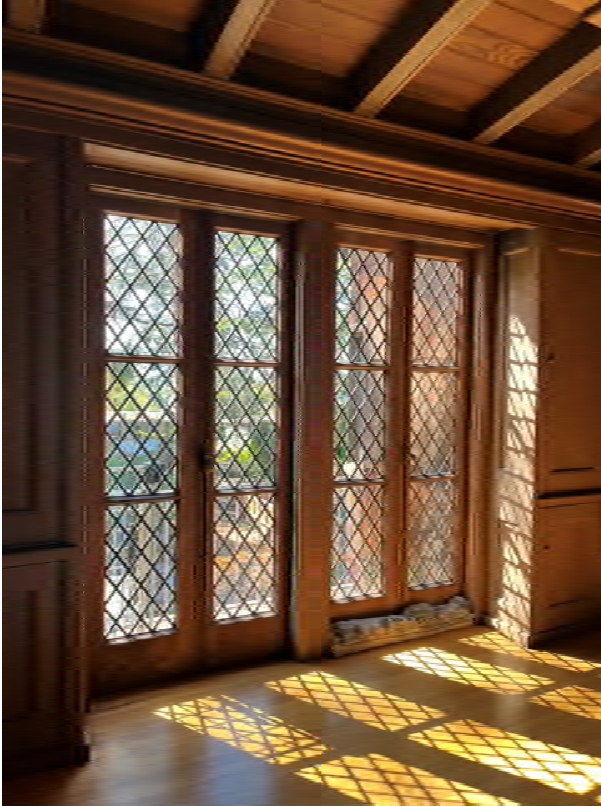
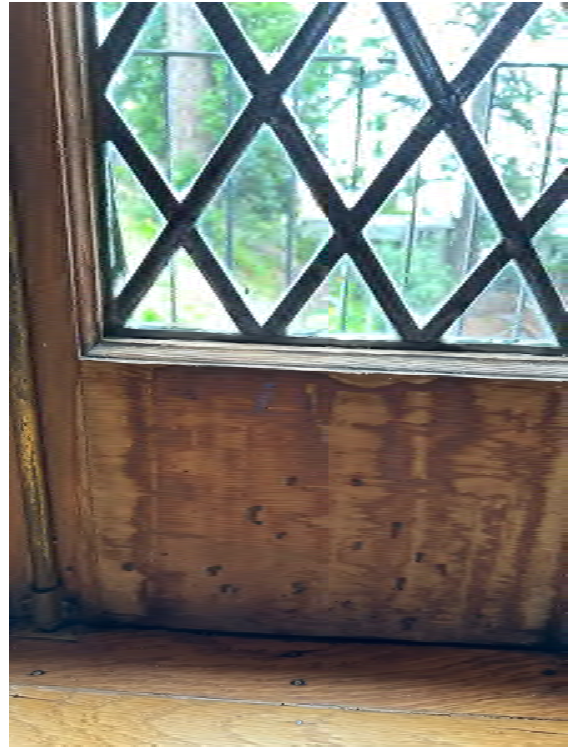
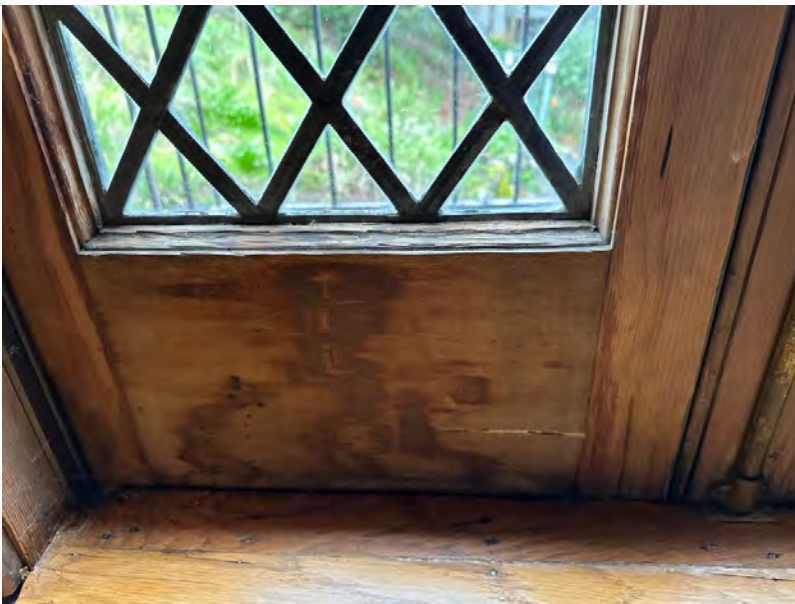
Glass is “sagging” and pulling away from water damaged wood door rails. Water damage/dry rot at door rails.

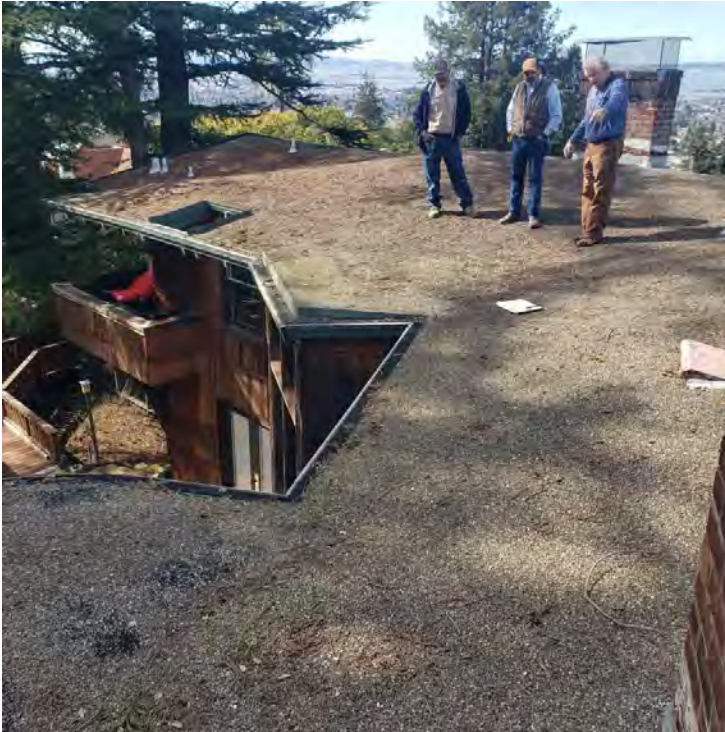
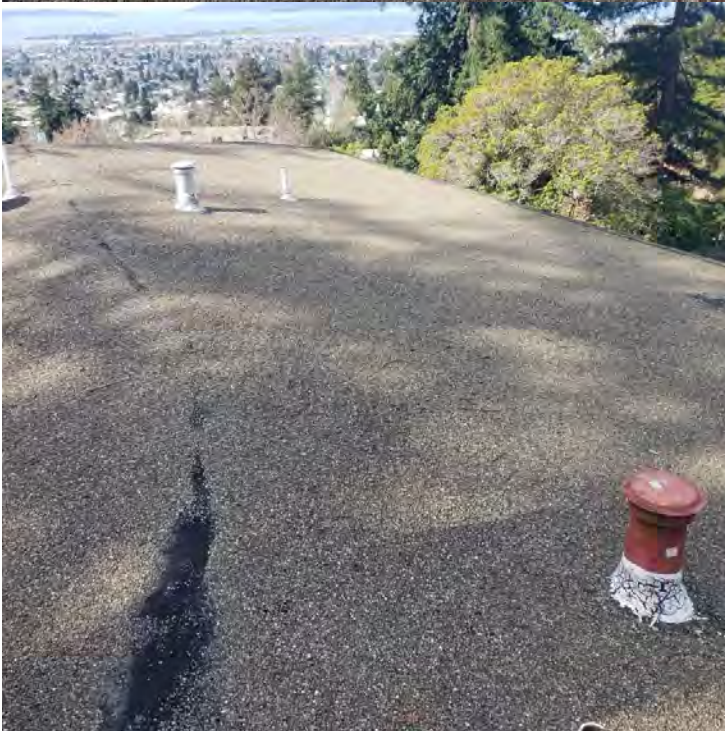
Existing tar and gravel roof. Not visible from the public right of way.

While the low-pitched gable roof is a character-defining feature, the existing tar-and-gravel roof covering is not a character-contributing historic material. The proposed metal roofing is found to be a compatible material with the First Bay Tradition style of the residence because: its thin profile and setback placement will continue the flat historic appearance of the roof; the deep tones and matte finish are harmonious with the patina that the redwood siding will weather into; and the linear shape of the standing seams and the flat metal panels echo the straight lines found in the ribbon coursing of the wood shingle pattern of the exterior facades.

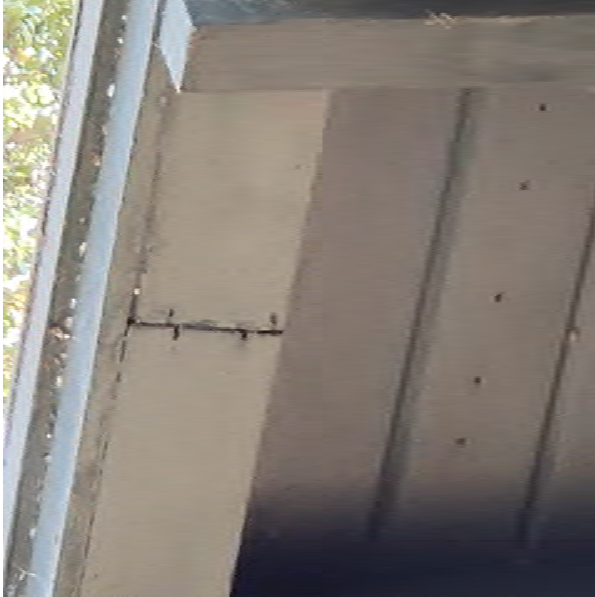
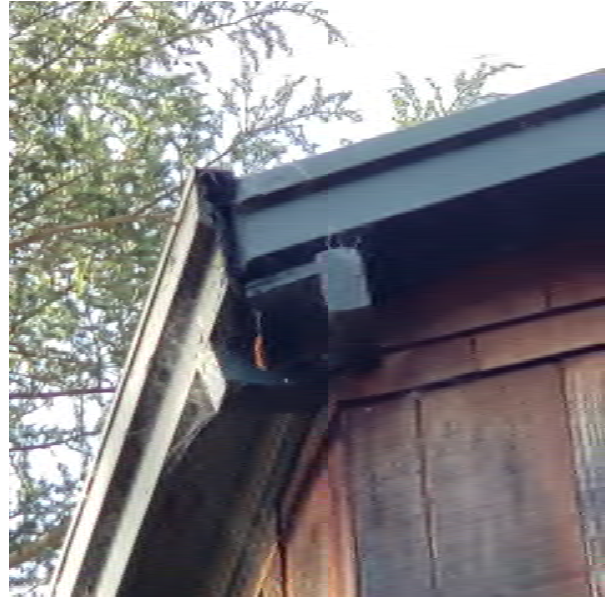
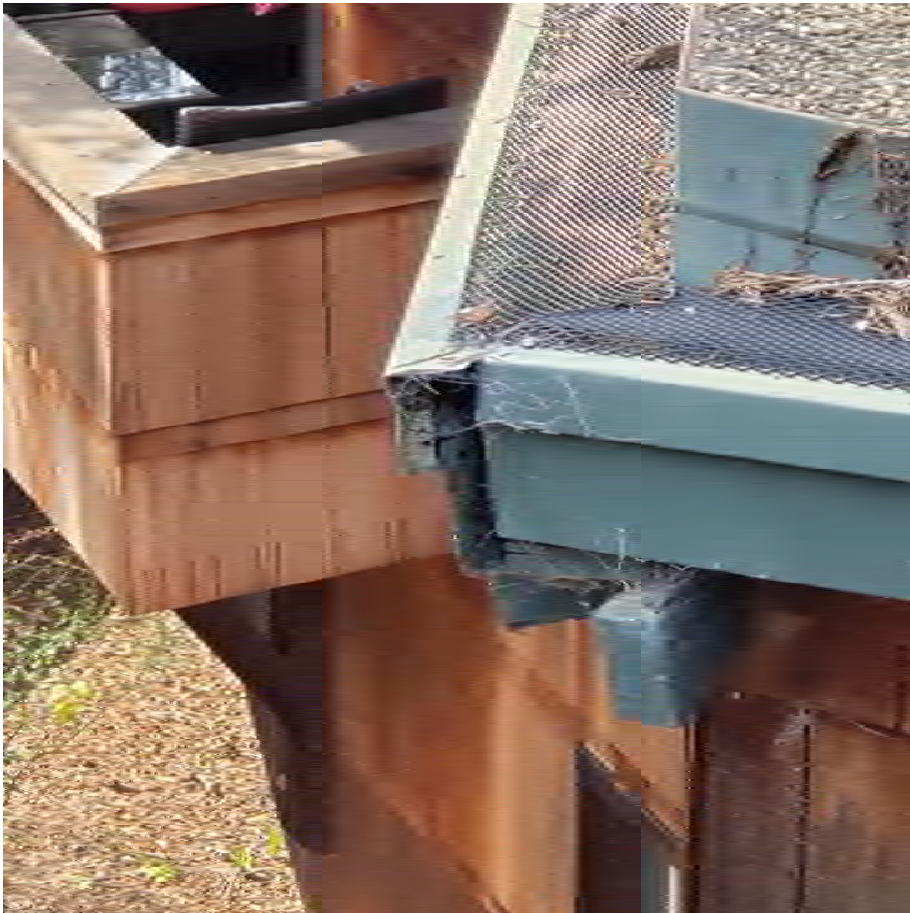
**Dry rot at eave, fascia, and integral wood gutter (typ.).**

| Area of Work | Elevation | Scope of Proposed Work | | |
|---|---|---|---|---|
| | | Replace wood fascia and eaves in kind | | |

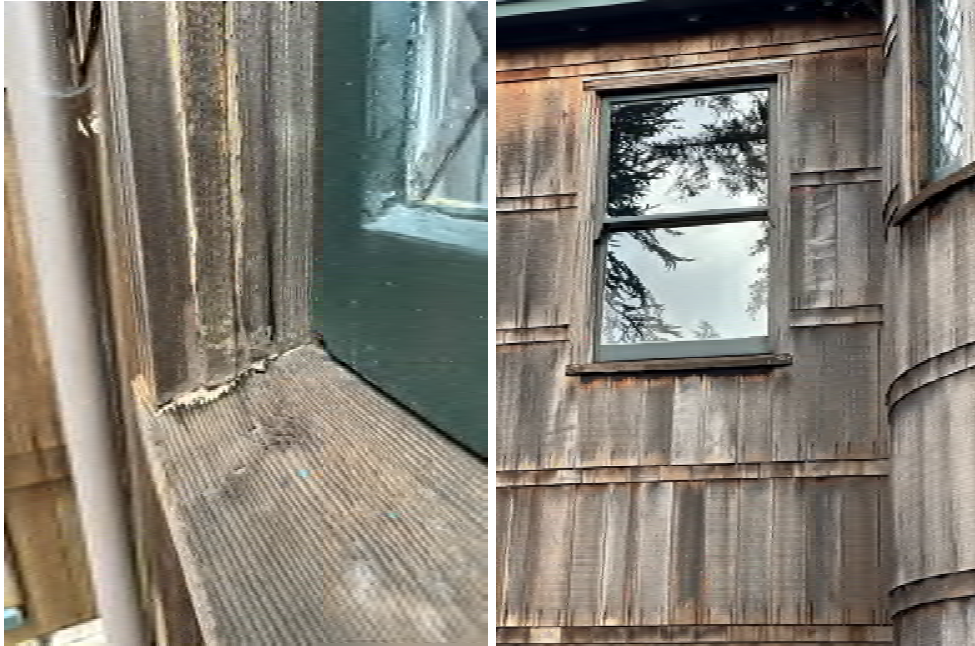
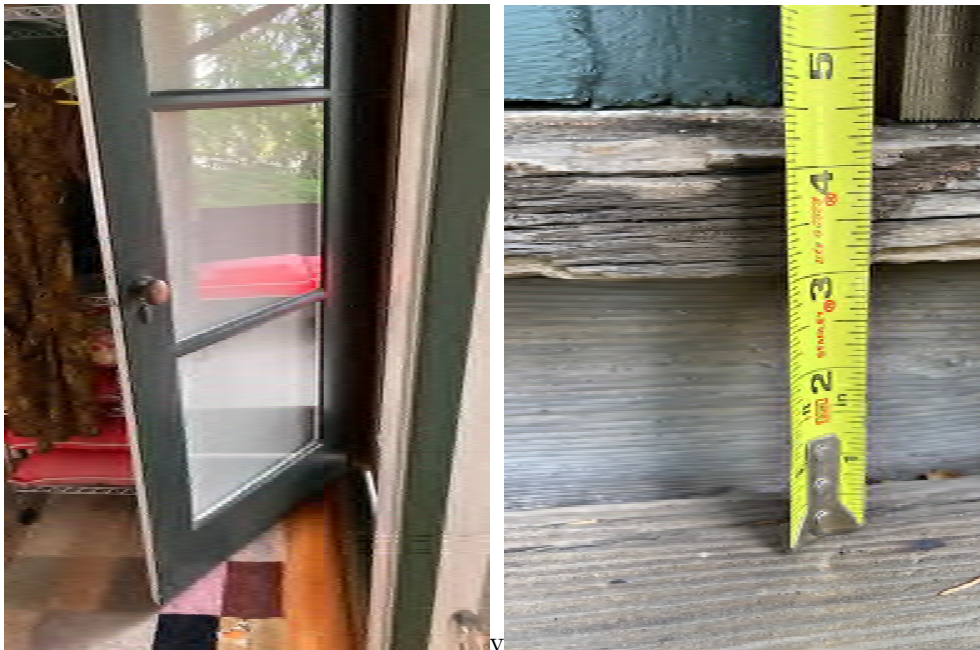
Dry rot at sills
