Asbestos, Lead, and Other Hazardous Building Materials Investigation

City of Berkeley Corporation Yard
Assembly Building
1326 Allston Way
Berkeley, CA

February 2021

Acumen Project No. COB 2125

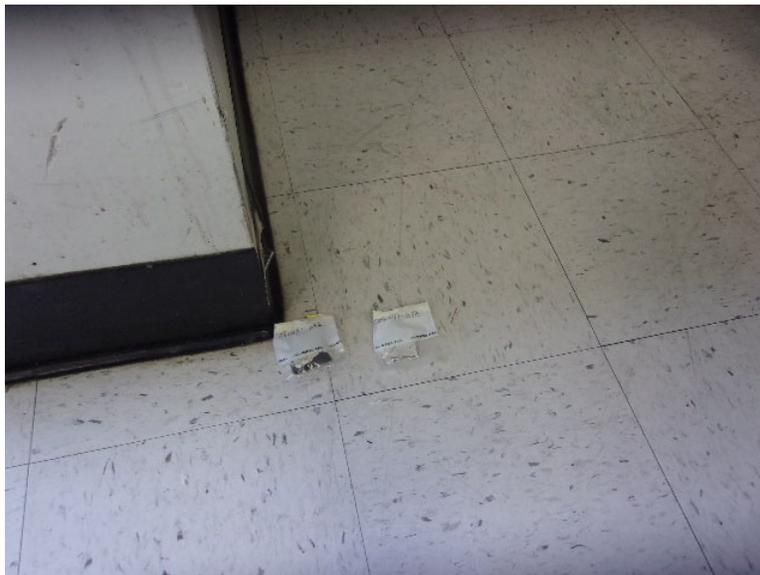
Photo 2

- Black mastic contains up to 8% asbestos (samples COB2125-05A, COB2125-05B, COB2125-11A, COB2125-11B, COB2125-12A and COB2125-12B, Photo 2). This material was found under two layers of 12x12-inch vinyl floor tiles throughout the building. There are approximately 1,800 square feet of this Category I non-friable material present in the building. All black mastic, regardless of its locations, would need to be abated down to the concrete floor substrate.
- Mastic under ceramic floor tiles contains 2% asbestos (sample COB2125-13A, Photo 3). This material was found in the two restrooms. There are approximately 600 square feet of this Category I non-friable material present throughout the building. All mastic under all ceramic floor tiles, regardless of its location, would need to be abated down to the concrete floor substrate.

Black mastic contains up to 8% asbestos under two layers of vinyl floor tiles.

1. Notify potential demolition or renovation contractors of the presence of ACMs at the Site. Disturbance of ACM requires special training and procedures. A Cal/OSHA registered asbestos contractor is required for ACM removals. BAAQMD regulations require that ACM be properly removed and disposed, prior to demolition or renovation where they would be disturbed. This work will require notification to the BAAQMD 10-days prior to removal if mechanical methods will be used to remove floor mastics.

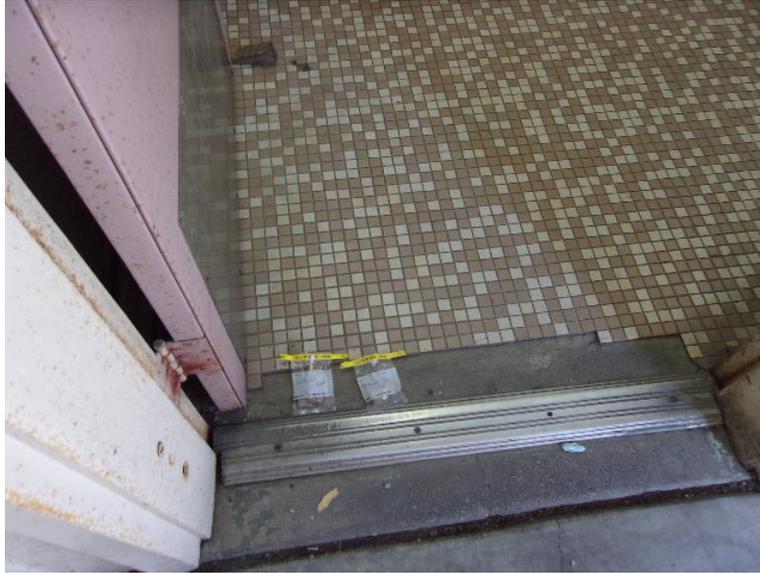
Photo 3

Mastic under ceramic floor tiles contains 2% asbestos that was found in restrooms.

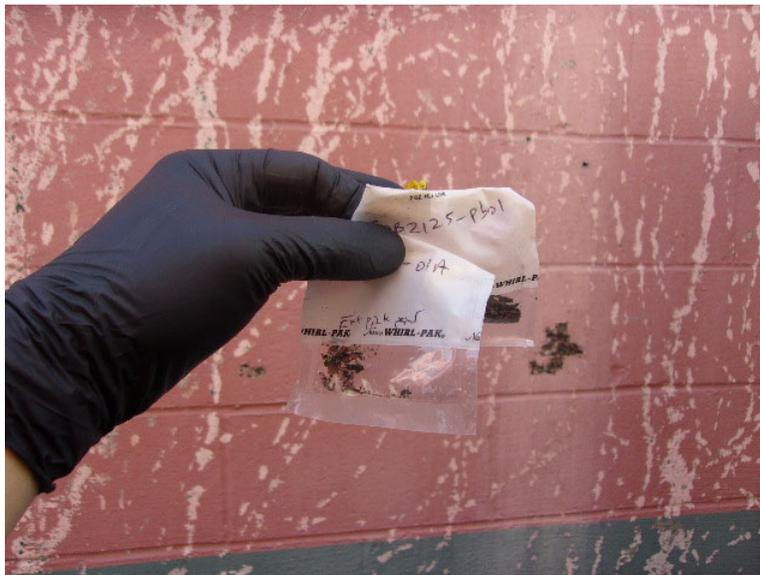
Photo 4

- Tar underneath exterior paint contains less than 1% asbestos (samples COB2125-01A, and COB2125-01B, Photo 4). This material was found on the exterior CMU perimeter walls. If perimeter CMU is to be disturbed during current scope of renovations, then additional bulk sampling should be taken for confirmation. There are approximately 5,900 square feet of this not likely RACM present around the exterior of the building.
- Suspect roofing materials are assumed (not sample) to contain asbestos and should be sampled to prove otherwise. Roof survey should be conducted if current scope of work is expanded.

Tar underneath exterior paint contains less than 1% asbestos. Additional bulk sampling should be taken for confirmation and point count.

6. Since exterior paint on concrete masonry unit was found to contain less than 1% (trace) asbestos and point count analysis was not possible, additional bulk sample should be taken for confirmation.

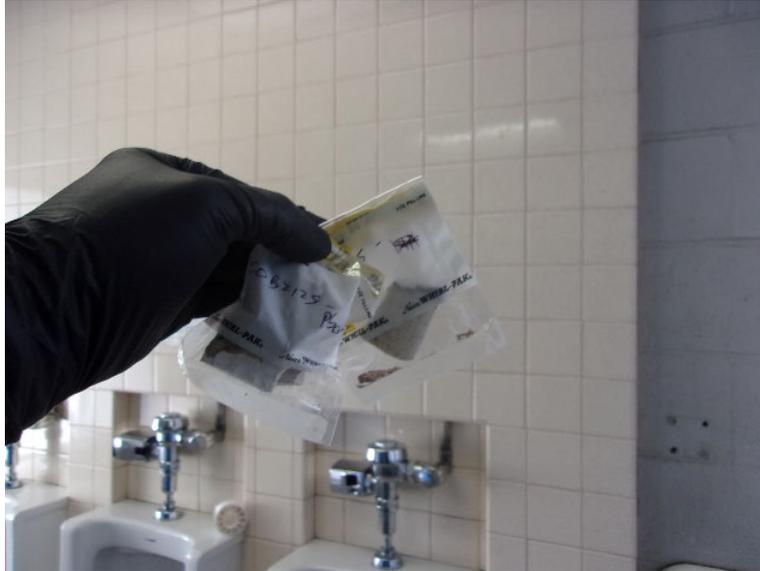
Photo 5

- Exterior pink paint on concrete masonry unit contains 270 ppm lead. This paint is intact and does not require paint-stabilization.
- 4x4-inch beige with dots ceramic wall tile contains 310 ppm lead (sample COB2125-PB06, Photo 5). There are approximately 600 square feet that require removal and waste testing or disposal as a hazardous waste.

4x4-inch beige with dots ceramic wall tile contains 310 ppm lead.

3. Notify potential demolition or renovation contractors of the presence of lead-containing ceramic tile at Site. Disturbance of the tile requires compliance with Cal/OSHA’s lead in construction regulation. Waste that are more than 50 ppm lead but less than 1,000 ppm lead would need to be characterized by STLC/LCLP, to determine waste categorization.

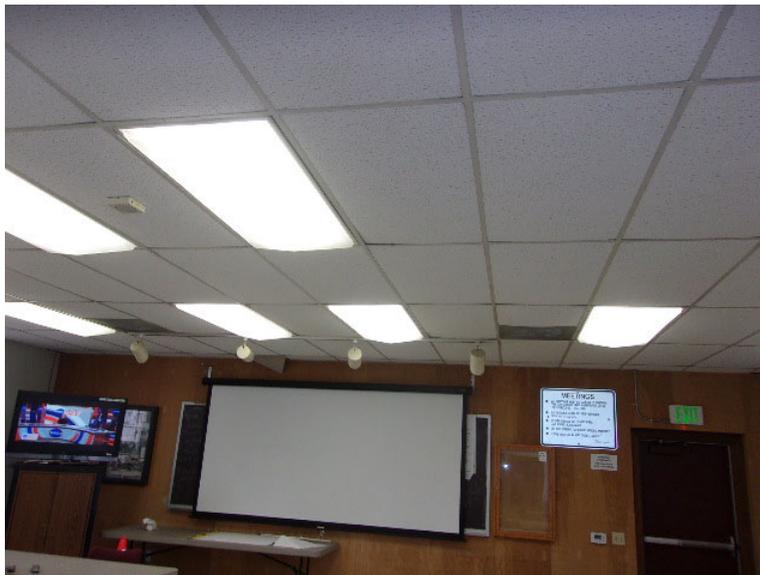
Photo 6

- Approximately 30 fluorescent light fixtures with assumed PCB ballasts were found throughout the building (Photo 6).
- Four (4) exit signs with batteries were found throughout the building.

Fluorescent light fixtures with assumed PCB ballasts.

5. The fluorescent lights and exit signs with batteries at Site will require dismantling and recycling. The fluorescent light ballasts may contain PCBs, which require inspection to determine proper waste disposal.
