February 19, 2025

**RE:** Follow-up Asbestos Roof Inspection  
Corporate Yard Building B  
1326 Allston Way  
Berkeley, California  
Acumen Proposal No. COB 2125A

## **Asbestos, Lead, and Other Hazardous Building Materials Investigation**

Asbestos, Lead, and Other Hazardous Building Materials Investigation  
City of Berkeley Corporation Yard  
Assembly Building  
1326 Allston Way  
Berkeley, CA

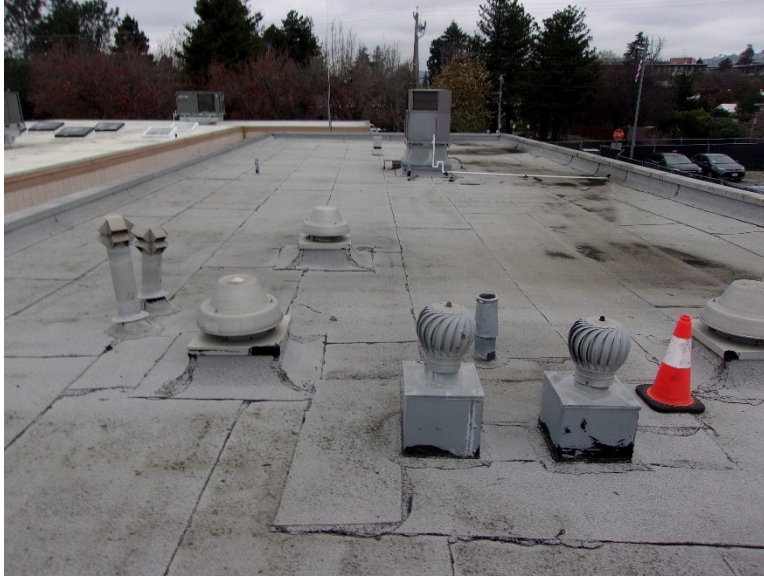
**Photo 1**

1326 Allston Way – Corporate Yard Building B Roof.

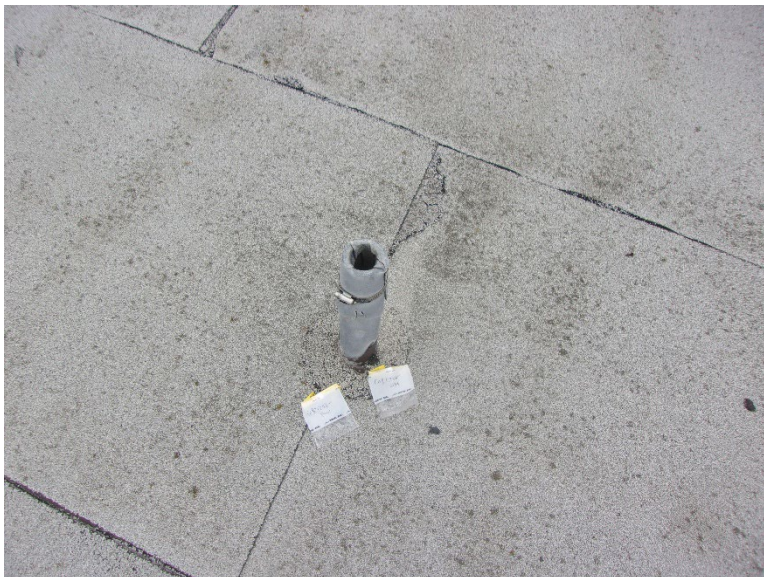
**Photo 2**

- Flashing contains up to 1,000,000 parts per million (ppm) of lead (samples COB2125A-PB01, Photo 2). This flashing can be found at roof penetration throughout the roof such as around pipes, vents, electrical conduits, and other penetrations. There are approximately 6 lead flashings that require to be removed prior to demolition, regardless of their location. The removal work is regulated under the Cal/OSHA standard 8CCR1532.1 for worker protection from lead-hazard exposure. If disposed, it is considered California and Federal hazardous waste. This material should be separated for recycling, rather than disposed of as a hazardous waste.

Lead-containing materials (LCM) that have a concentration above 50 parts per million (ppm) must be segregated for waste characterization or recycled according to the California Department of Toxic Substances Control. LCM with a concentration above 1,000 ppm are considered hazardous waste in California, unless they can be recycled, and therefore they are not a waste.

Flashing contains up to 1,000,000 parts per million (ppm) of lead.

Construction work that disturbs lead-materials (including flashings) will need to be conducted in accordance with Cal/OSHA's lead in construction regulations (8CCR1532.1). These regulations apply to any material that contains detectable amounts of lead. In theory, this should not pose a significant problem as this regulation has been in effect since 1992. The Cal/OSHA lead in construction standard requires a contractor whose work involves disturbing lead-containing materials to develop and implement a lead compliance plan. The written lead compliance plan would essentially acknowledge the presence of lead and would describe procedures to minimize airborne lead exposures. The flashing waste should be recycled

- Notify potential renovation or demolition contractors that asbestos was not discovered on the roof.
- Notify potential renovation or demolition contractors of the presence of lead-containing flashing on the roof. Disturbance of the lead flashings requires compliance with Cal/OSHA's lead in construction regulation. The lead flashings should be removed and recycled, rather than disposed as a hazardous waste.
- If additional suspect materials were discovered during demolition, these materials should be sampled to confirm that they do not contain asbestos or lead prior to their removal.
- Prior to submitting bids to perform lead flashing removal work, abatement contractors should field verify all the estimated quantity of lead flashing stated in this report. The abatement contractors

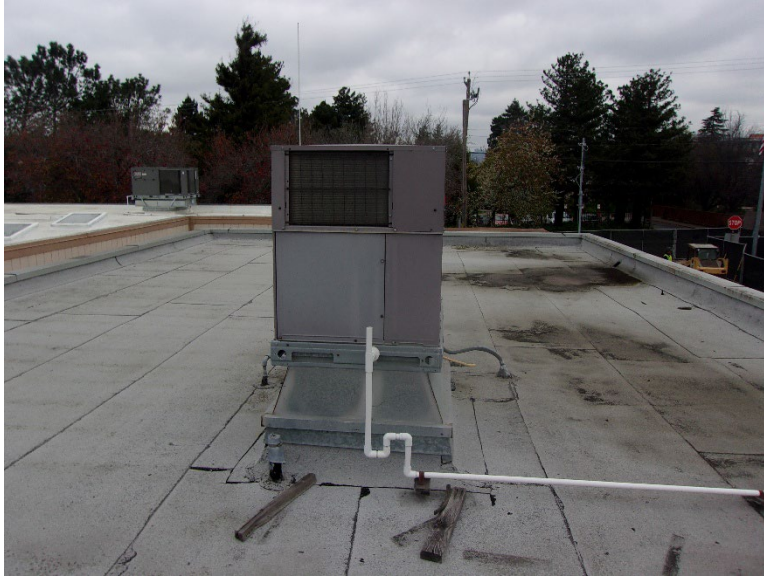
**Photo 3**  
HVAC unit with Freon.

Roof mount heating, ventilation, air conditioning (HVAC) units contain Freon, which will require recycling prior to demolition.

- One (1) HVAC unit with Freon (Photo 3).

- The demolition contractor can recycle other universal hazardous wastes such as Freon, if specifically included in their scope of work.

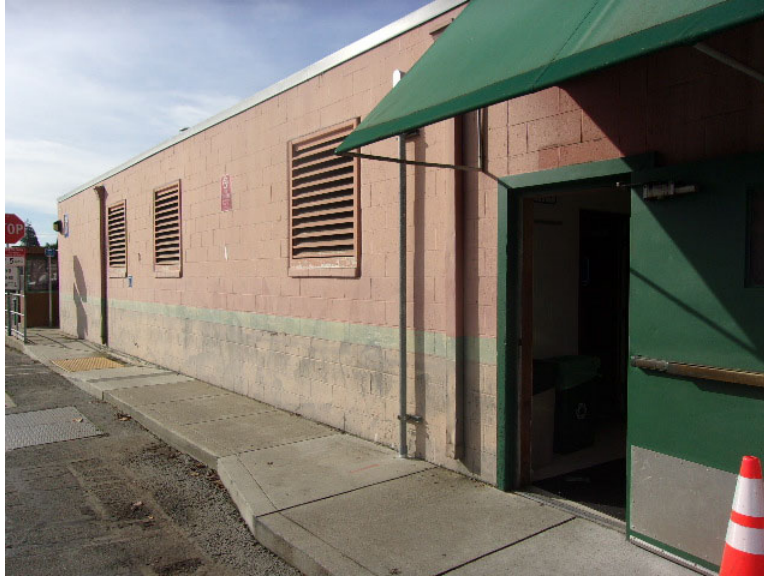
**Photo 1**

The one-story assembly building was built slab-on grade with concrete masonry unit (CMU) perimeter walls (Photo 1). According to records, this building was last remodeled back in 1992. Interior finishes of the building consist of painted drywall with taping mud that were found not to contain asbestos. The flooring throughout the building consists of vinyl floor tile and ceramic floor tile that were both found not

1326 Allston Way, Berkeley, CA – Berkeley Corporation Yard Assembly Building.

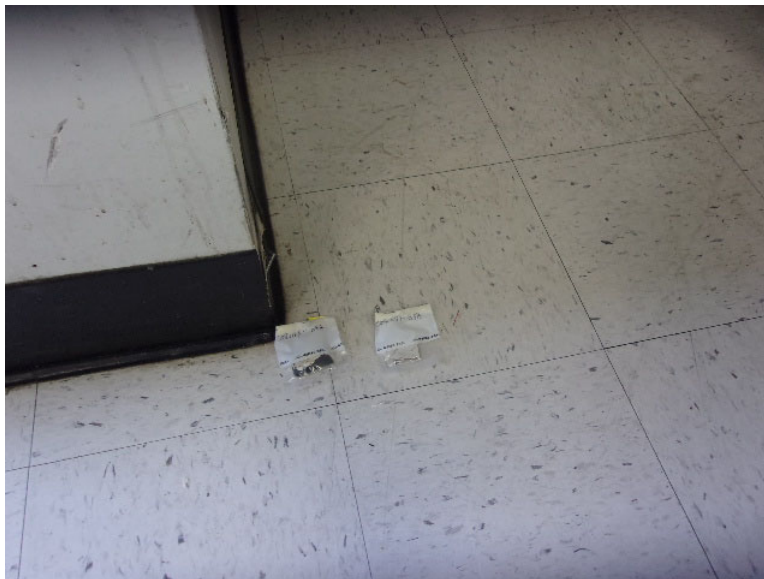
**Photo 2**

- Black mastic contains up to 8% asbestos (samples COB2125-05A, COB2125-05B, COB2125-11A, COB2125-11B, COB2125-12A and COB2125-12B, Photo 2). This material was found under two layers of 12x12-inch vinyl floor tiles throughout the building. There are approximately 1,800 square feet of this Category I non-friable material present in the building. All black mastic, regardless of its locations, would need to be abated down to the concrete floor substrate.
- Mastic under ceramic floor tiles contains 2% asbestos (sample COB2125-13A, Photo 3). This material was found in the two restrooms. There are approximately 600 square feet of this Category I non-friable material present throughout the building. All mastic under all ceramic floor tiles, regardless of its location, would need to be abated down to the concrete floor substrate.

Black mastic contains up to 8% asbestos under two layers of vinyl floor tiles.

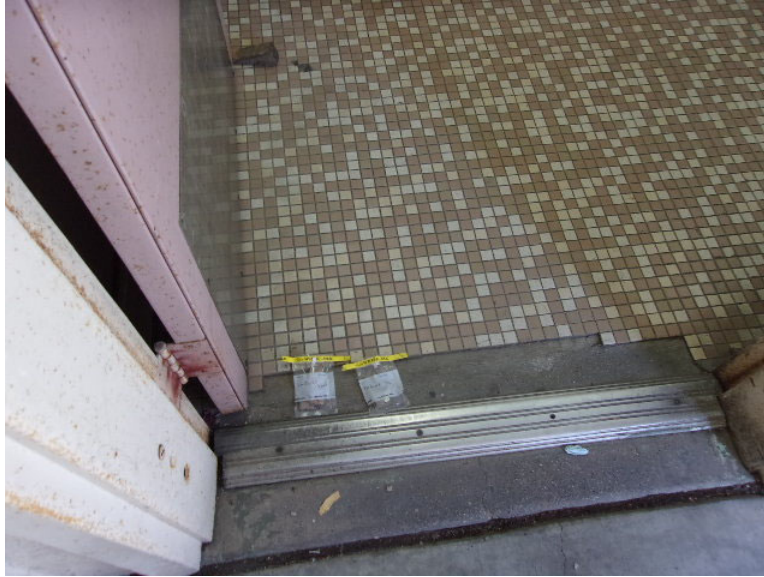
**Photo 3**

Mastic under ceramic floor tiles contains 2% asbestos that was found in restrooms.

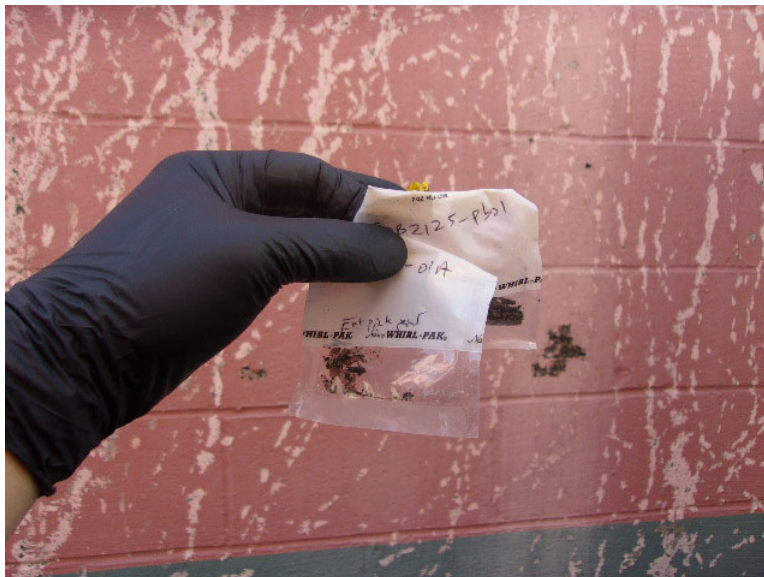
**Photo 4**

- Tar underneath exterior paint contains less than 1% asbestos (samples COB2125-01A, and COB2125-01B, Photo 4). This material was found on the exterior CMU perimeter walls. If perimeter CMU is to be disturbed during current scope of renovations, then additional bulk sampling should be taken for confirmation. There are approximately 5,900 square feet of this not likely RACM present around the exterior of the building.
- Suspect roofing materials are assumed (not sample) to contain asbestos and should be sampled to prove otherwise. Roof survey should be conducted if current scope of work is expanded.

Tar underneath exterior paint contains less than 1% asbestos. Additional bulk sampling should be taken for confirmation and point count.

6. Since exterior paint on concrete masonry unit was found to contain less than 1% (trace) asbestos and point count analysis was not possible, additional bulk sample should be taken for confirmation.

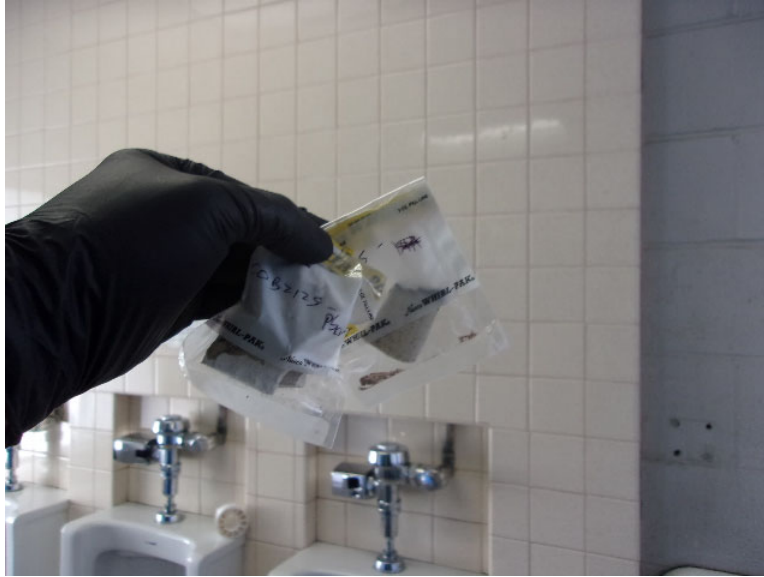
**Photo 5**

- Exterior pink paint on concrete masonry unit contains 270 ppm lead. This paint is intact and does not require paint-stabilization.
- 4x4-inch beige with dots ceramic wall tile contains 310 ppm lead (sample COB2125-PB06, Photo 5). There are approximately 600 square feet that require removal and waste testing or disposal as a hazardous waste.

4x4-inch beige with dots ceramic wall tile contains 310 ppm lead.

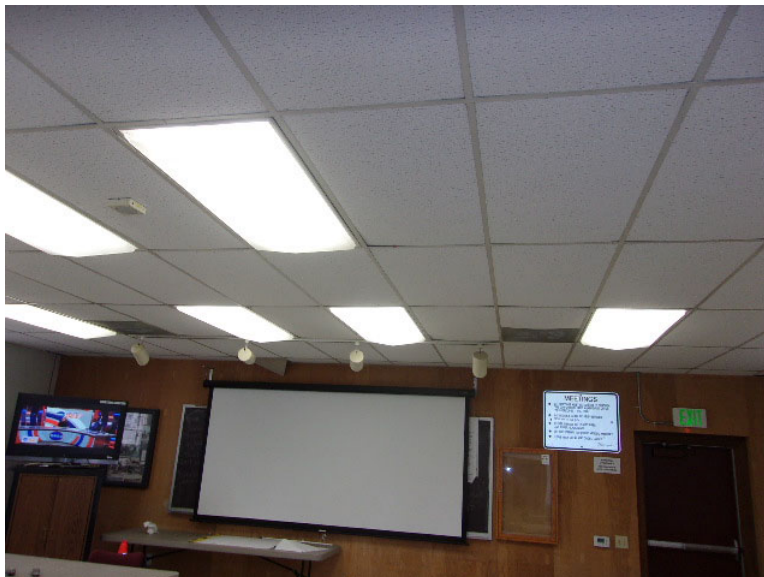
**Photo 6**

Acumen visually assessed the Site and found fluorescent light fixtures that will require inspection and disposal as hazardous waste if they contain PCBs. The abatement contractor will need to assess ballasts and segregate those without the “No PCB” labeling for proper storage and disposal. The fluorescent light tubes are regulated because of their mercury content but these can be recycled instead of disposal as hazardous waste. Although recycling may be more expensive than disposal, it avoids the perpetual liability associated with the generation and disposal of hazardous wastes. Emergency exit signs contain batteries, which should be recycled as well.

- Approximately 30 fluorescent light fixtures with assumed PCB ballasts were found throughout the building (Photo 6).
- Four (4) exit signs with batteries were found throughout the building.

Fluorescent light fixtures with assumed PCB ballasts.
