Asbestos, Lead, and Other Hazardous Building Materials Investigation

MLK Jr. Youth Services Center
1730 Oregon Street
Berkeley, CA

February 2023

Acumen Project No. COB 2230

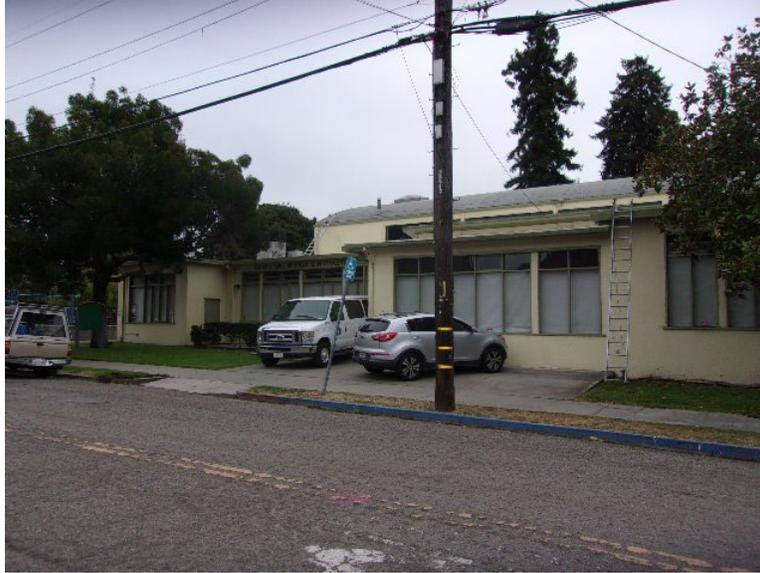
Photo 1

The one-story building with gymnasium was built slab-on grade with stucco perimeter walls (Photo 1). Interior finishes of the building consist of painted drywall with taping mud. Taping mud on non-asbestos drywall contains 2% asbestos. However, the composite analysis of the drywall and taping mud is less than 0.25% asbestos as determined by point counting analysis. Various floor tiles and floor black mastic contains up to 10% asbestos. Due to restrooms that are still in use, we were not able to perform destructive sampling of ceramic floor and wall tiles, spray applied acoustical ceiling and ceiling tile with adhesive. These materials are assumed to contain asbestos and lead until proven otherwise. Interior paints were found to be intact.

MLK Jr. Youth Services Center is a one-story building with a gymnasium located at 1730 Oregon Street in Berkeley, California.

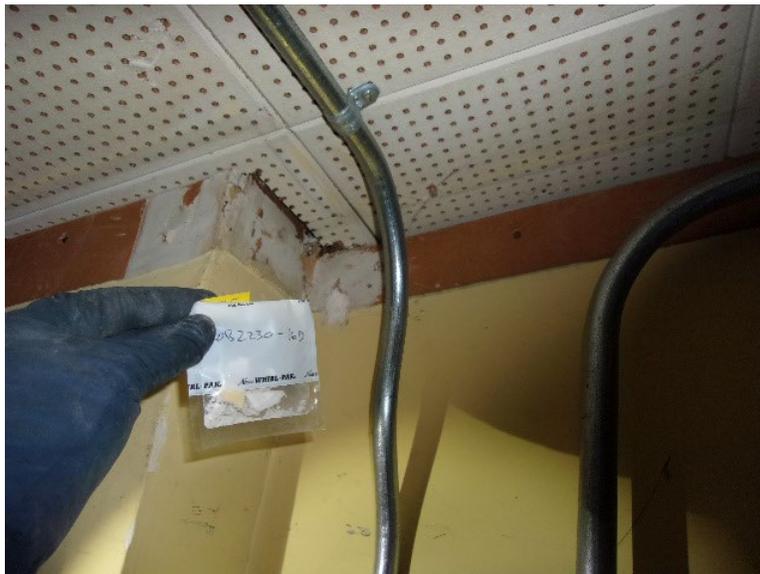
Photo 2

- Taping mud contains 2% chrysotile asbestos (sample COB223016D, Photo 2) on non-asbestos drywall. Although it is considered friable, the material is exempt from BAAQMD regulations because the composite analysis of drywall and taping mud is less than 1% asbestos (<0.25%) as determined by 400 point counting analysis. The material is therefore considered non-RACM. We estimate there are approximately 9,000 square feet of this material present throughout the building.

The taping mud is not considered RACM because the composite point counting results are less than 1% asbestos (less than 0.25% asbestos). BAAQMD allows the composite analysis of drywall and taping mud materials that are present throughout the Site. Since the composite result is less than 1% as determined by point count analysis, the wall system is non-RACM and is not regulated by this Agency. It is not considered a hazardous waste but is a construction waste. However, Cal/OSHA does not recognize composite analysis of materials and considers the taping mud an asbestos containing material because it contains up to 2% asbestos. The removal of this taping mud will need to be consistent with Cal/OSHA requirements for Class II work.

Taping mud contains 2% chrysotile asbestos on non-asbestos drywall.

The removal of this taping mud is considered Cal/OSHA Class II abatement procedures and the waste is considered construction debris.

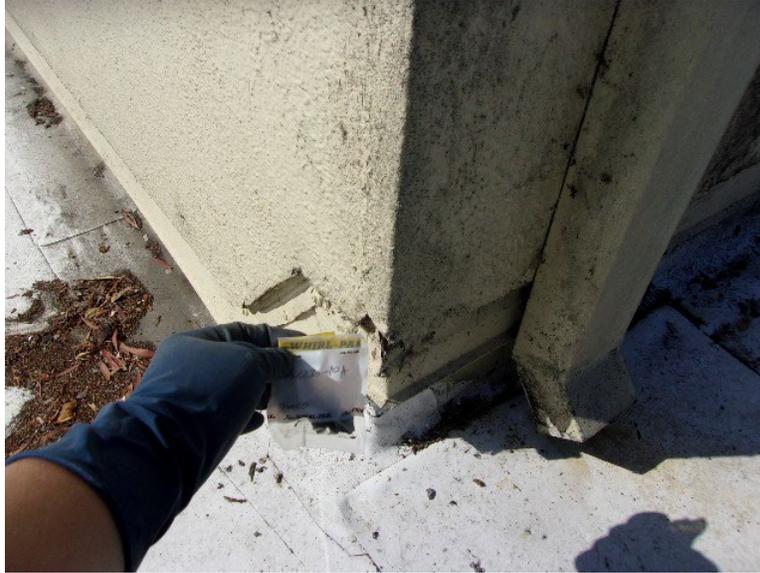
Photo 3

- Paint/Coating on non-asbestos stucco (samples COB2230-10A, COB2230-10B, COB2230-10C and COB2230-10D, Photo 3) contains up to 1.36% asbestos as determined by 400 point counting analysis. There are approximately 11,000 square feet of this RACM present throughout the building. The removal of this material is considered Cal/OSHA Class I asbestos abatement.

Paint/Coating on non-asbestos stucco contains up to 1.36% asbestos as determined by 400 point counting analysis.

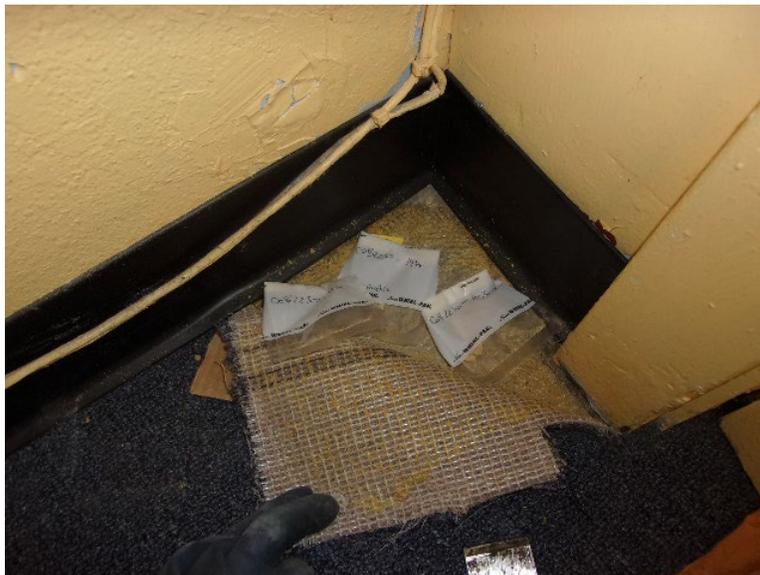
Photo 4

- 12-inch beige vinyl floor tile and its associated black mastic contain up to 10% asbestos (samples COB2230-12A and COB2230-12B, Photo 4). There are approximately 1,800 square feet of these Category I non-friable materials present throughout the building and under carpet. The removal of these materials is considered Cal/OSHA Class II asbestos abatement. All black floor mastic and vinyl floor tile, regardless of their locations, would need to be abated down to the concrete floor substrate.

12-inch beige vinyl floor tile and its associated black mastic contain up to 10% asbestos.

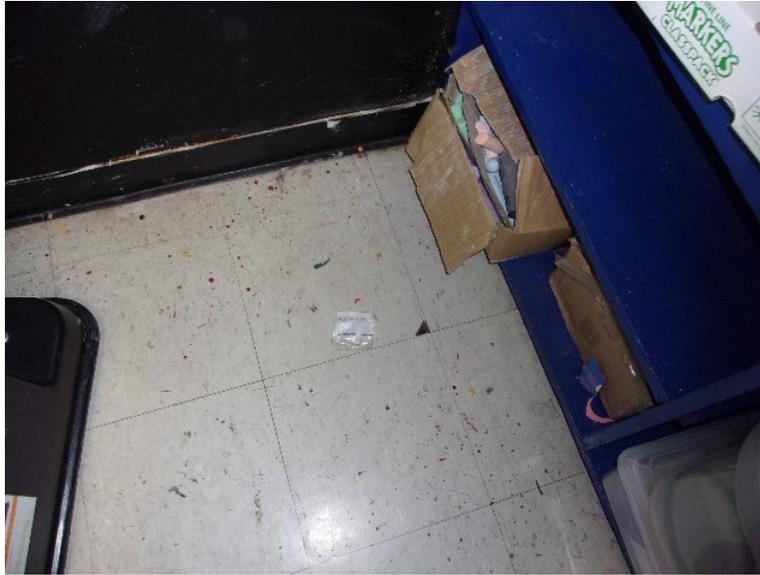
Photo 5

- Black mastic contains up to 2% asbestos (samples COB2230-15A, COB2230-15B and COB2230-19A, Photo 5). This material was found under 12-inch white vinyl floor tiles. There are approximately 1,500 square feet of this Category I non-friable material present throughout the building. The removal of this material is considered Cal/OSHA Class II asbestos abatement. All black floor mastic, regardless of its locations, would need to be abated down to the concrete floor substrate.

Black mastic contains up to 2% asbestos. This material was found under 12-inch white vinyl floor tiles.

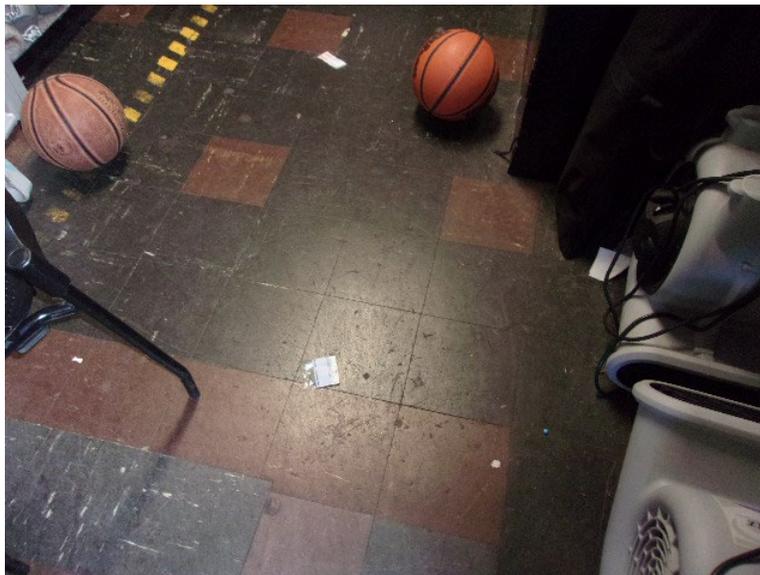
Photo 6

- 9-inch red and black vinyl floor tile contains 5% asbestos (samples COB2230-20A and COB2230-20B, Photo 6). There are approximately 250 square feet of this Category I non-friable material present throughout building. The removal of this material is considered Cal/OSHA Class II asbestos abatement. Since black floor mastic from other locations was found to contain asbestos, black floor mastic under this 9-inch tile would need to be abated as well. All black floor mastic and vinyl floor tile, regardless of their locations, would need to be abated down to the concrete floor substrate.

9-inch red and black vinyl floor tile contains 5% asbestos.

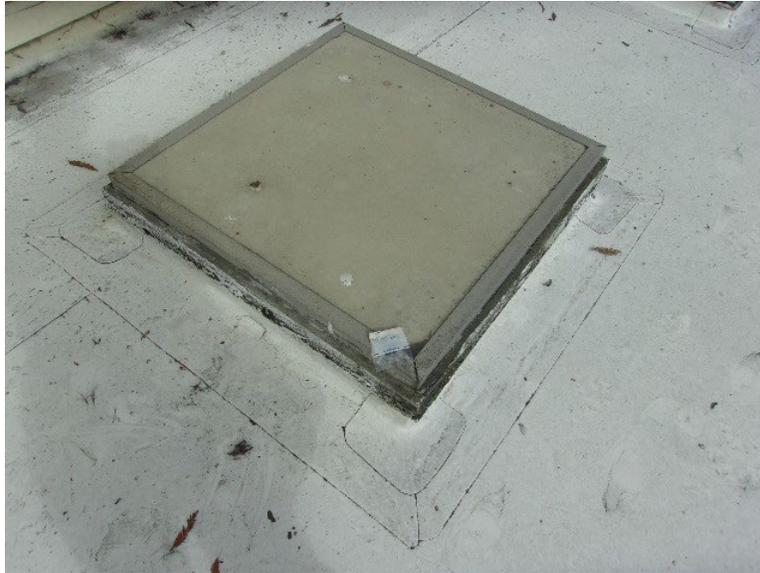
Photo 7

- Black mastic on the roof contains 5% asbestos (samples COB2230-05C, COB2230-08A and COB2230-08B, Photo 7). This material was sampled at the skylight and its curb. There are approximately 800 square feet of this Category I non-friable material present throughout the roof. The removal of this material is considered Cal/OSHA Class II asbestos abatement. All black mastic, regardless of its locations, would need to be abated and down to the roof substrate, if applicable.

Black mastic on the roof contains 5% asbestos. This material was sampled at the skylight and its curb.

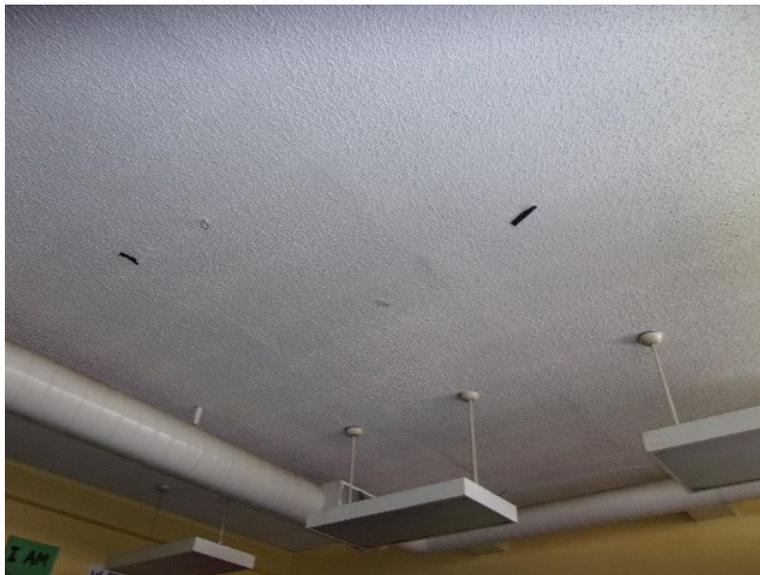
Photo 8

- Suspect spray applied acoustical ceiling is assumed (not sample) to contain asbestos (Photo 8) and it should be sampled to prove otherwise. There are approximately 2,000 square feet of this RACM material present throughout building. The removal of this material is considered Cal/OSHA Class I asbestos abatement.

Suspect spray applied acoustical ceiling is assumed (not sample) to contain asbestos and it should be sampled to prove otherwise.

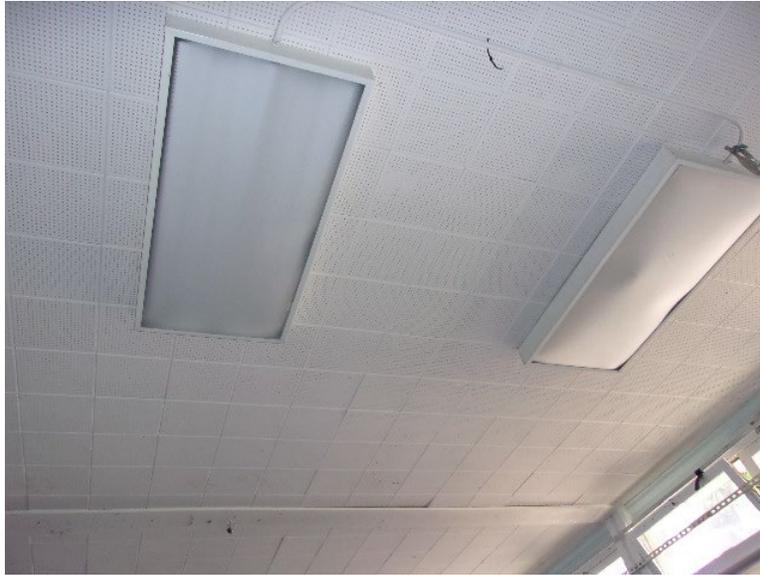
Photo 9

- Suspect 12-inch white ceiling tile with adhesive ceiling are assumed (not sample) to contain asbestos (Photo 9) and should be sampled to prove otherwise. There are approximately 1,200 square feet of these Category I non-friable materials present throughout building. The removal of these materials is considered Cal/OSHA Class II asbestos abatement.

Suspect 12-inch white ceiling tile with adhesive ceiling are assumed (not sample) to contain asbestos and they should be sampled to prove otherwise.

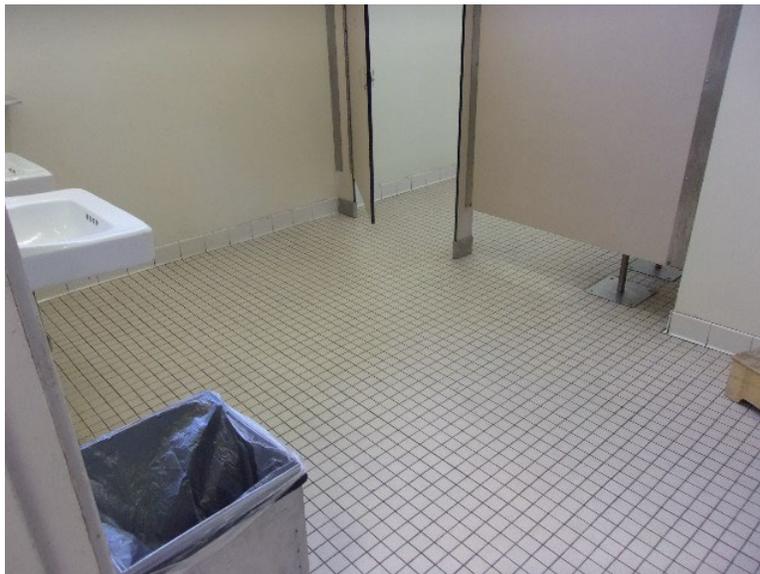
Photo 10

- Suspect ceramic wall and floor tile grout and mortar found in restrooms are assumed (not sample) to contain asbestos (Photo 10) and they should be sampled to prove otherwise. There are approximately 1,700 square feet of these Category I non-friable materials present throughout building. The removal of these materials is considered Cal/OSHA Class II asbestos abatement.

Suspect ceramic wall and floor tile grout and mortar found in restrooms are assumed (not sample) to contain asbestos and they should be sampled to prove otherwise.

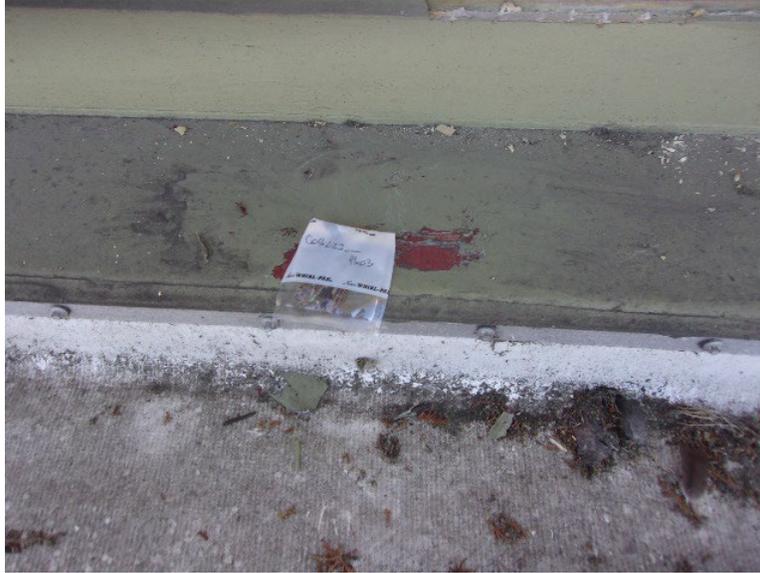
Photo 11

- Exterior green paint on wood windowsill contains 3,200 ppm lead (sample COB2230-PB03, Photo 11). There are approximately 50 square feet of this deteriorated (loose and flaking) paint present throughout the building that will require paint-stabilization and dispose as a hazardous waste.
- Beige paint with orange paint on wood contains 120 ppm lead. This paint is intact and does not require paint-stabilization.

Exterior green paint on wood windowsill contains 3,200 ppm lead. This paint is deteriorated (loose and flaking) throughout the building that will require paint-stabilization and dispose as a hazardous waste.

2. Notify potential demolition or renovation contractors of the presence of lead-based and lead-containing paints. Deteriorated lead paint would need to be stabilized. Disturbance of the lead paints requires compliance with Cal/OSHA's lead in construction regulation. The paint chip waste is considered California hazardous waste based on its high lead-content.

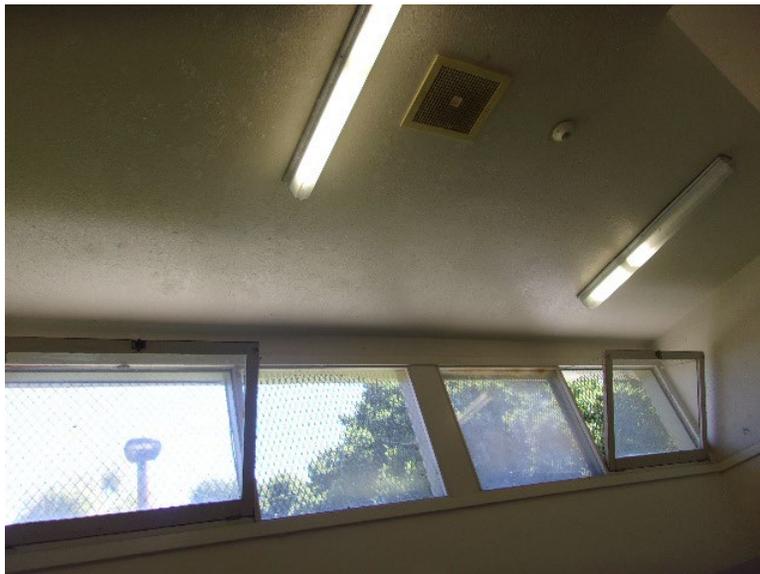
Photo 12

Acumen visually assessed the Site and found fluorescent light fixtures that will require inspection and disposal as hazardous waste if they contain PCBs. The abatement contractor will need to assess ballasts and segregate those without the “No PCB” labeling for proper storage and disposal. The fluorescent light tubes are regulated because of their mercury content but these can be recycled instead of disposal as hazardous waste. Although recycling may be more expensive than disposal, it avoids the perpetual liability associated with the generation and disposal of hazardous wastes. High-intensity discharge lamps, emergency exit signs and smoke detectors contain batteries, which should be recycled as well. We also observed there is a heating, ventilation, air conditioning (HVAC) system on the roof that contains Freon, which will require recycling if the HVAC system was to be removed.

Fluorescent light fixtures with assumed PCB ballasts.

5. The fluorescent lights, HID lamps, exit signs and smoke detector with batteries at Site will require dismantling and recycling. If not recycled, they would need to be disposed as universal or hazardous waste. The fluorescent light ballasts may contain PCBs, which require inspection to determine proper waste disposal.

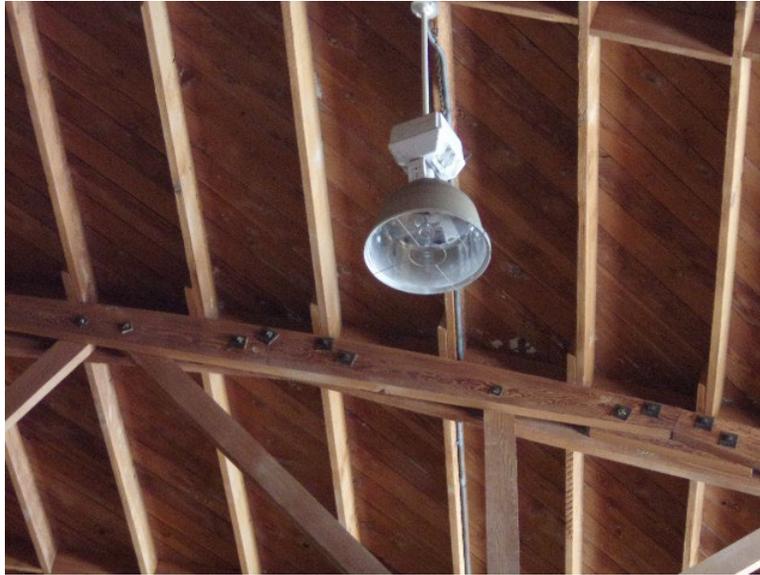
Photo 13
High-intensity discharge lamps.

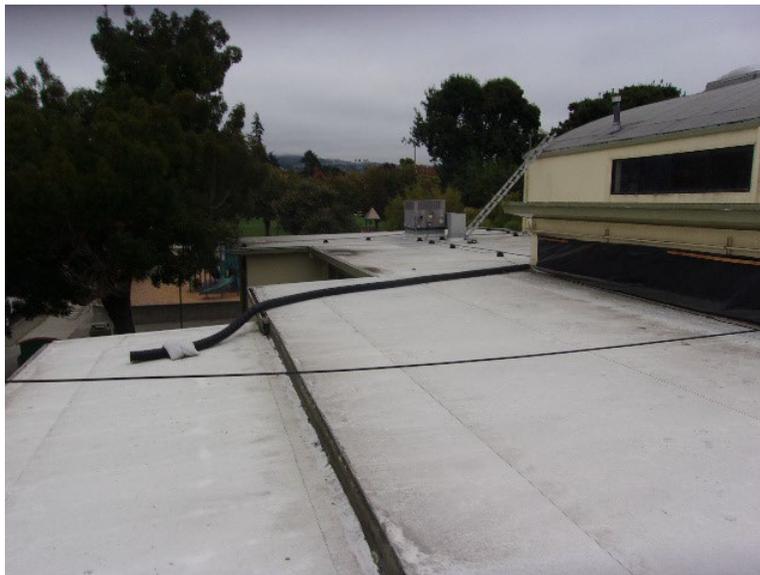
Photo 14
HVAC unit with Freon.

8. The demolition or renovation contractor can recycle other universal hazardous wastes such as Freon, if specifically included in their scope of work.
