DATE February 28, 2025

PROJECT NO A203047

## City of Berkeley East Timber Docks at South Sailing Basin Inspection Report

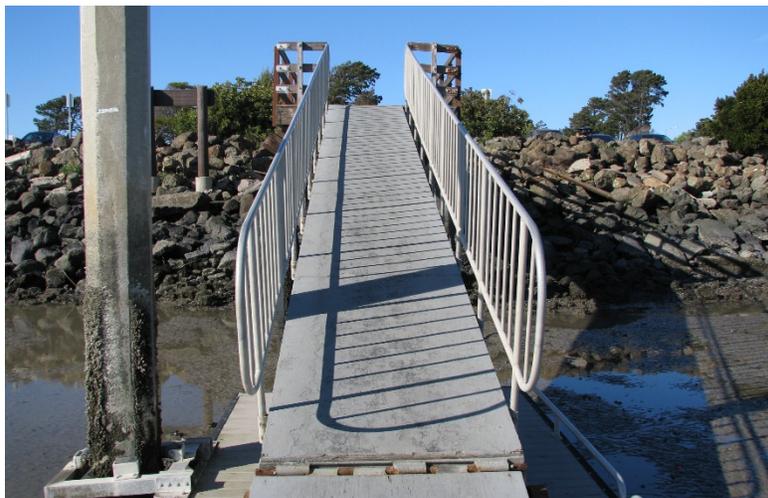
*Photo 1: Ramp to Dock Approach*

We found damage requiring repair at all four timber piles and all of the diagonal bracing at both pile bents of the timber Dock Approach. There was also damage logged at both pile caps, but it is of a moderate rating and can be repaired in place.

We recommend that the pier be closed to the public until such time that repairs can be completed.

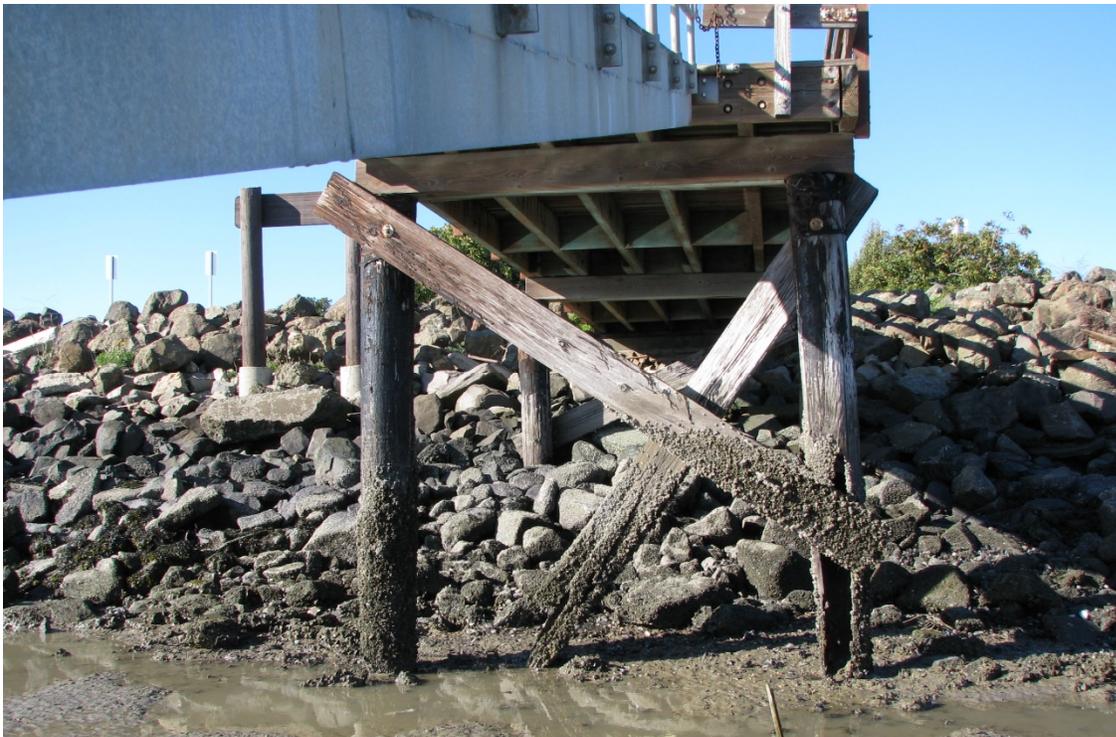
*Photo 2: View of Outboard (Southern) Row of Timber Piles and Bracing at Dock Approach Looking North*

All 4 timber creosote piles contain damage and will require replacement or the installation of grout-filled fiberglass sleeves. Grout filled sleeves will not require the use of piledriving equipment. We recommend the sleeves extend 2 feet below the mudline to preclude future damage from marine borers.

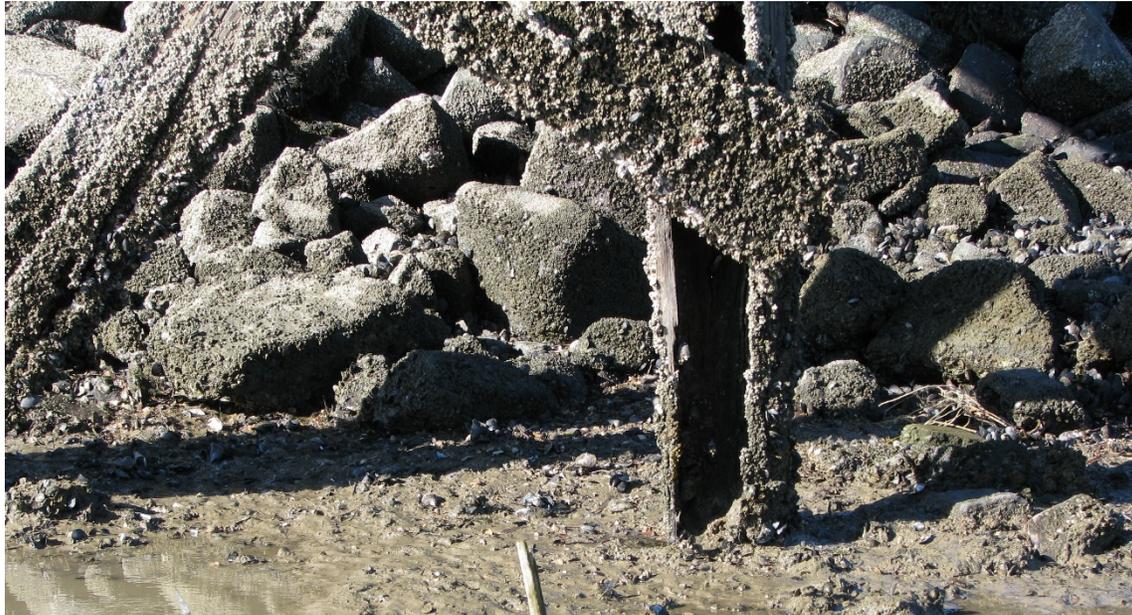
*Photo 3: Close-up of South-East Timber Pile at Dock Approach*

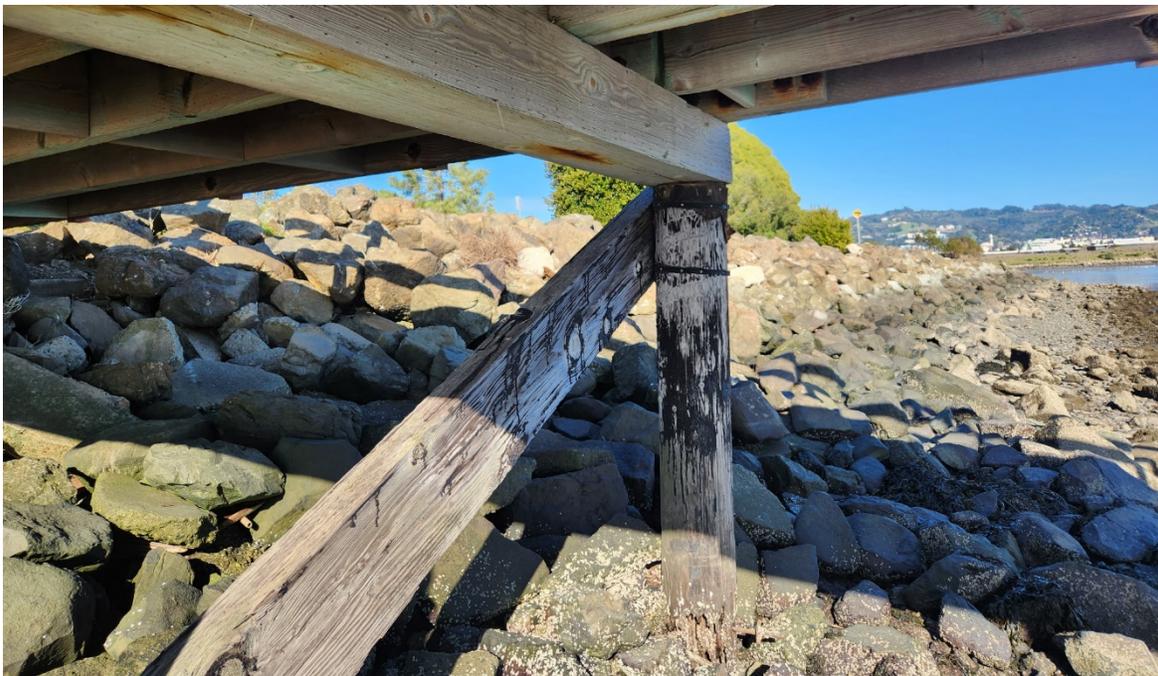
*Photo 4: North-East Pile at Dock Approach*

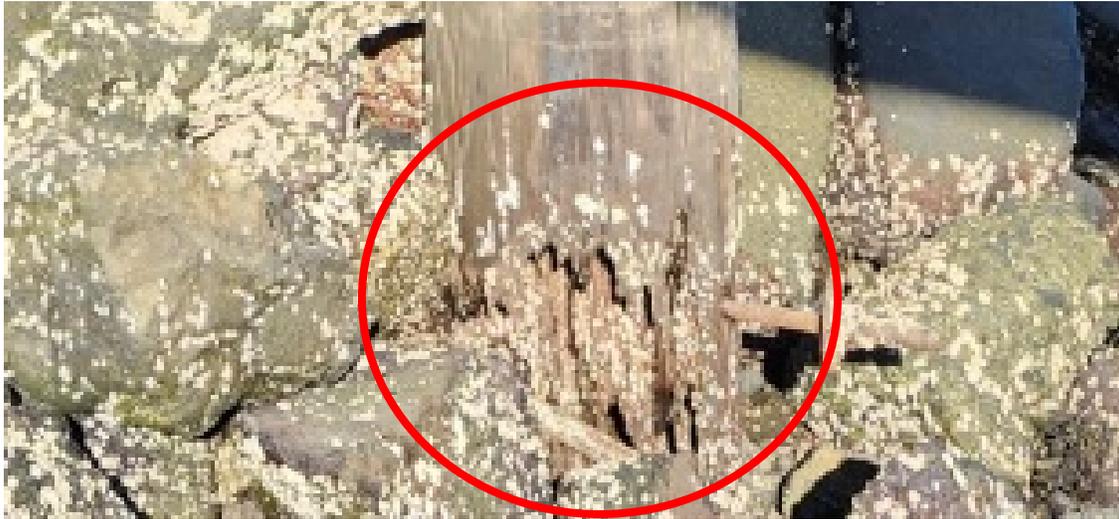
*Photo 5: Close-Up of Damage at North-East Pile at Rip Rap*

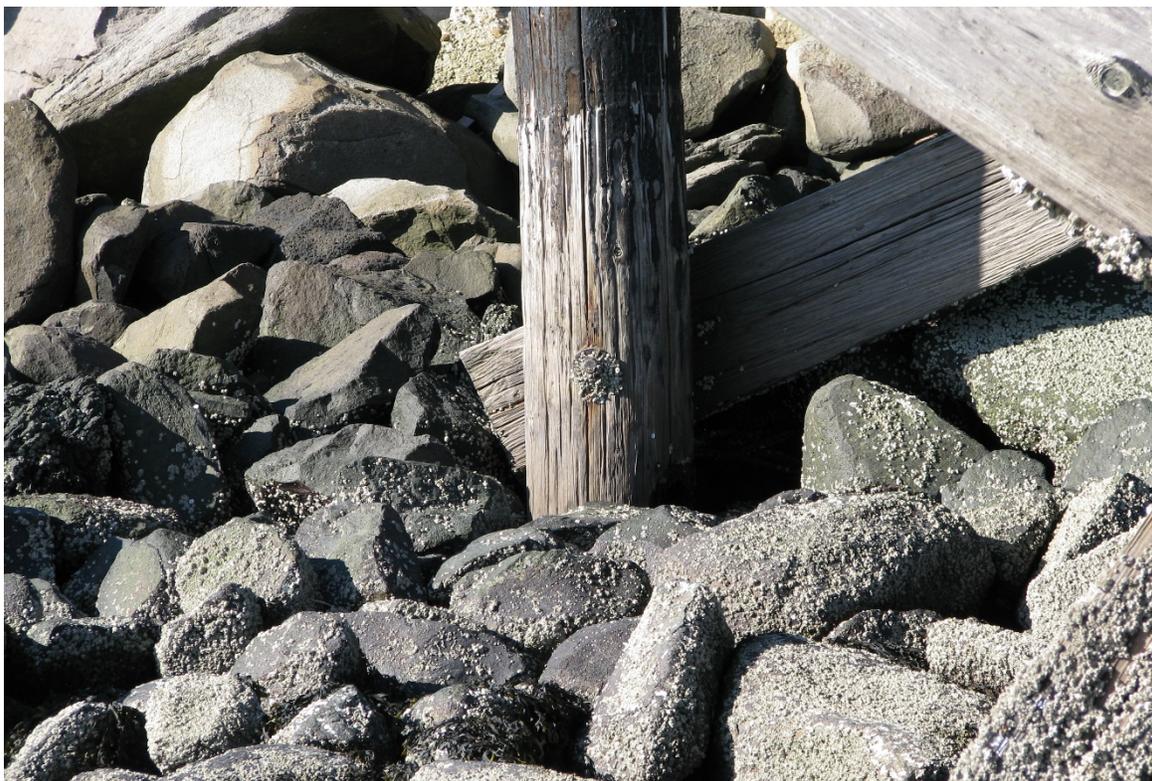
*Photo 6: North-West Pile at Dock Approach*

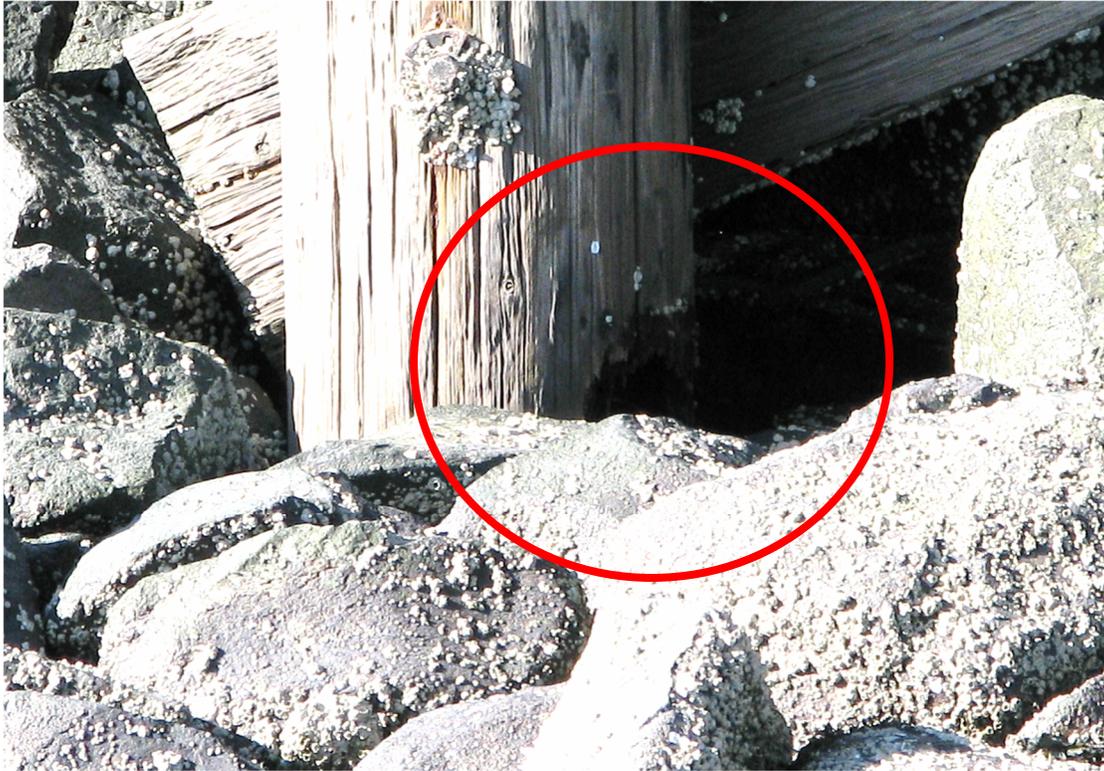
*Photo 7: Close-Up of Damage of Rip Rap at North-West Pile at Dock Approach*

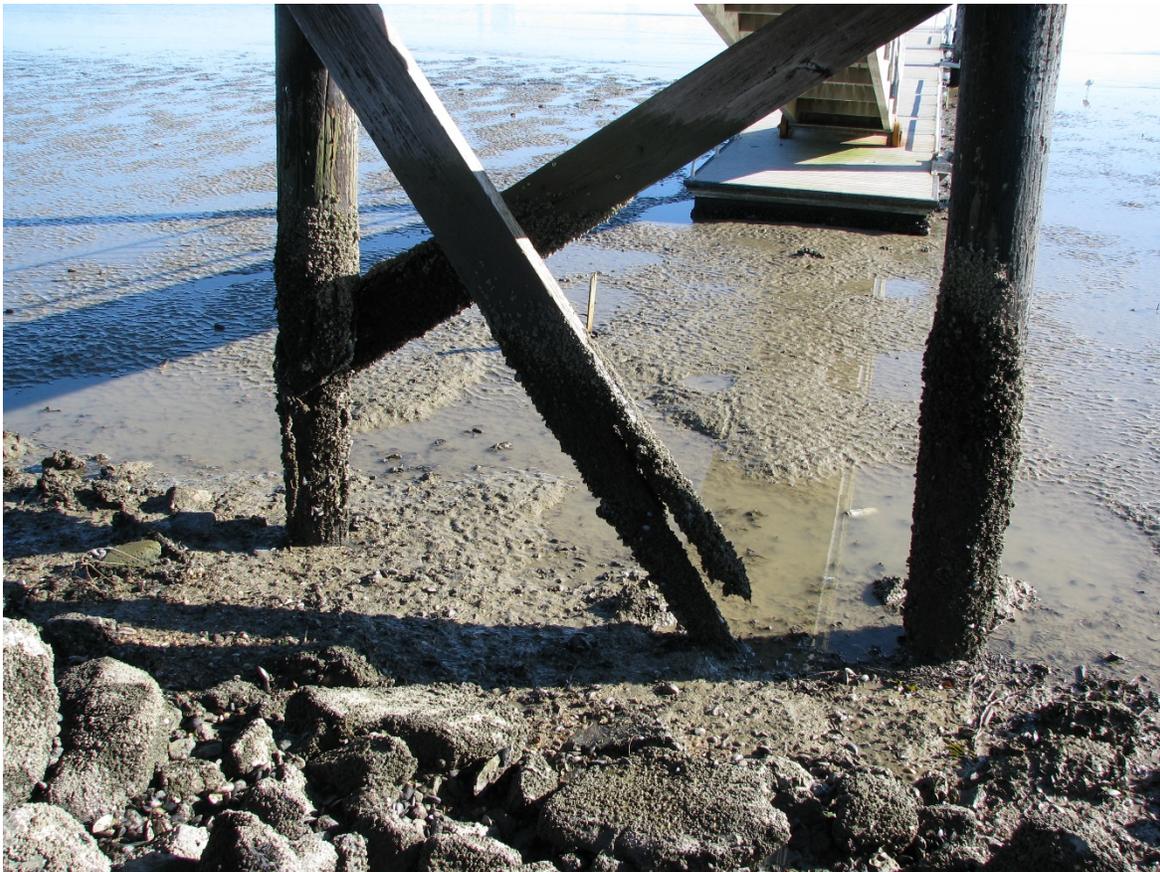
*Photo 8: Damaged Bracing at South Bent at Dock Approach*

Three of four braces at the dock approach are damaged and one is completely missing. We recommend replacement of all four diagonal timber braces once the sleeves are installed.

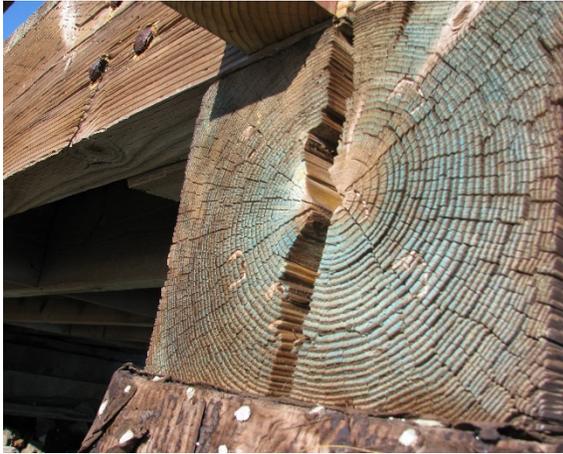
*Photo 9: North Cap West End*

All four ends of the pile caps have vertical splits that appear to run to the drift pins connecting the caps to the piles. These cracks do not extend for the full length of the caps, and do not reduce the vertical load-carrying capacity of the members. However, they do expose the interior, untreated portions of the members to the elements. We recommend installing horizontal bolts at each end, on each side of the drift pins, to pull the timber closed.

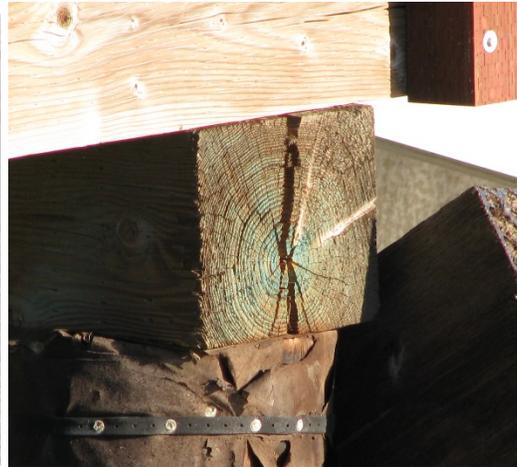
*Photo 10: South Cap West End*

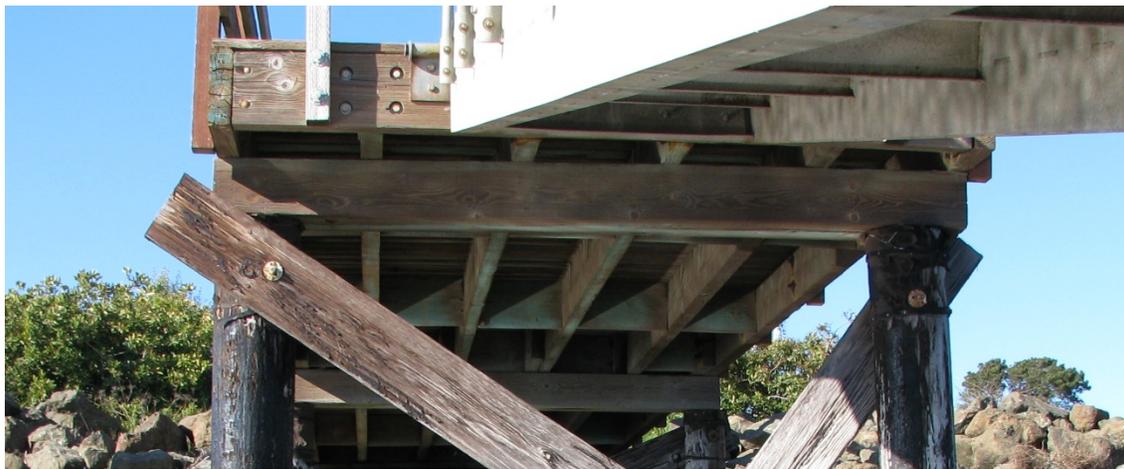
*Photo 11: Deck Framing*

The stringers, blocking and decking were all in sound condition without any defects noted higher than a moderate rating.
