**Asbestos and Lead Survey for Interior Improvements**

West Berkeley Service Center  
1900 Sixth Street  
Berkeley, CA

February 2024

Acumen Project No. COB 2440

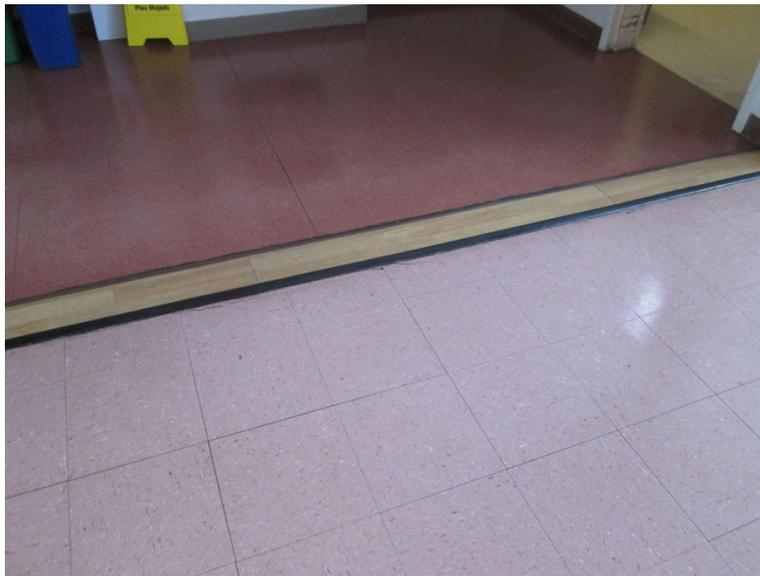
**Photo 2**

Floors are generally covered with carpet with yellow glue and the vinyl base boards have brown mastic neither contain asbestos. We did not sample the light pink, dark pink and beige 12x12-inch vinyl floor tiles (Photo 2). The brown 12x12-inch vinyl floor tiles in the electrical room (room 19) were found to contain 2% asbestos with 5% asbestos mastic under them (Photo 3).

- Main hall, light pink 12x12-inch vinyl floor tiles and mastics
- Main hall, dark pink 12x12-inch vinyl floor tiles and mastics
- West offices/clinic, beige 12x12-inch vinyl floor tiles and mastics
- Kitchen vinyl sheet flooring and mastic
- Duct insulation/ duct tape
- Fireplace flue

We did not sample the light pink, dark pink and beige 12x12-inch vinyl floor tiles. These are assumed to contain asbestos and should be sampled prior to disturbance.

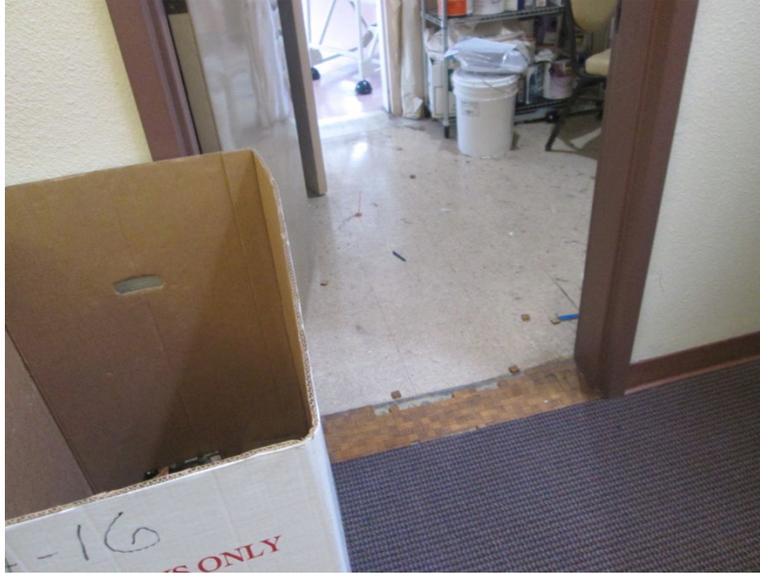
**Photo 3**

- Brown 12x12-inch vinyl floor tiles in the electrical room contain 2% chrysotile asbestos and the associated mastic contains 5% asbestos (Sample COB 2440-07A). Other VFT and mastics in the building are also suspect. The removal of the VFT and mastic is considered Cal/OSHA Class II asbestos abatement. If mechanical methods are used to abate this material, the BAAQMD would regulate this activity. This material must be removed prior disturbance during construction or demolition. It can be left in place and managed under an asbestos O&M program.

<b>Location</b>	<b>Material</b>	<b>Results<sup>1</sup></b>	<b>BAAQMD<sup>2</sup></b>	<b>EQ<sup>3</sup></b>	<b>Sample No.</b>
Electrical Closet	12x12" Brown Vinyl Floor Tile and Mastic	Vinyl Floor Tile: 2% CH Black Mastic: 5% CH	Cat I NF	Not Quantified	COB2440-07A

The brown 12x12-inch vinyl floor tiles in the electrical room (room 19) were found to contain 2% asbestos with an 5% asbestos mastic under them. The carpet mastics and base board mastics do not contain asbestos.

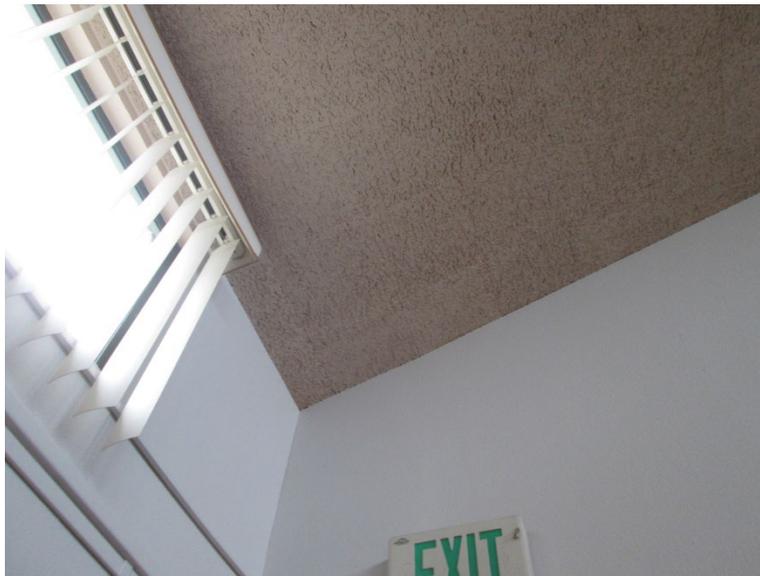
**Photo 4**

In the main areas, the 1x1-foot ceiling tiles were also not sampled (Photo 4). We were not able to access the ducting in soffits or above the ceilings or the flue above the fireplace. Acumen sampled the exterior stucco, which also does not contain asbestos. The windows do not have window putty. The paint on exterior window sills was found to contain 96 parts per million (ppm) lead in the courtyard (Photo 6). This yellow paint is deteriorated in some locations. The textured ceiling paint, drywall paint and exterior brown paint do not contain lead.

In the main areas, the 1x1-foot ceiling tiles were also not sampled. These are assumed to contain asbestos and should be sampled prior to disturbance.

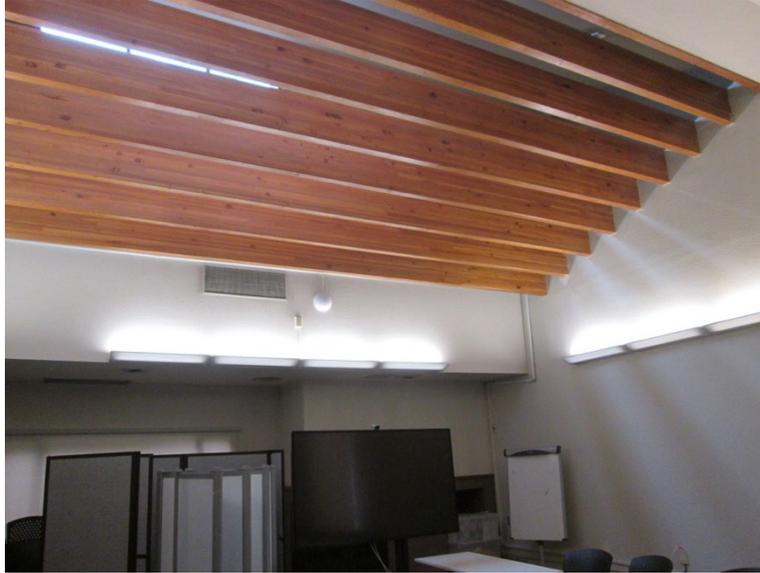
**Photo 5**

There were no friable asbestos containing materials found at the Site during our investigation based on bulk samples collected. The ducting above ceilings and inside soffits was not accessible.

We were not able to access the ducting in soffits or above the ceilings or the flue above the fireplace.

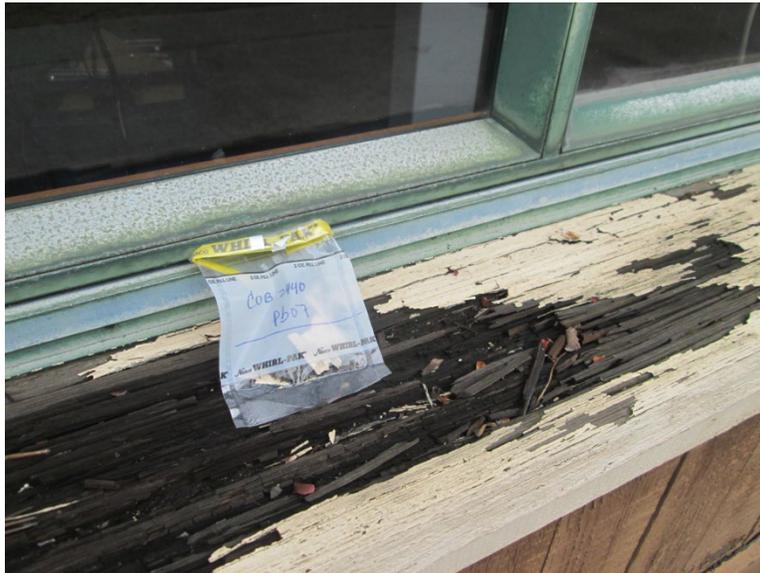
**Photo 6**

As shown on Table 3 and Table 4, we representatively sampled paints to comply with Cal/OSHA and waste disposal during construction. The result of this investigation determined that lead-containing paint is present on exterior window sills at 96 parts per million lead in the cage area (Photo 4). Deteriorated leaded paint must be stabilized prior to demolition or renovation.

The paint on exterior window sills was found to contain 96 parts per million lead in the courtyard.
