# West Berkeley Circulation Master Plan

Quiet Zone Study

Draft Existing Conditions Report

# TECH MEMO 1: EXISTING CONDITIONS

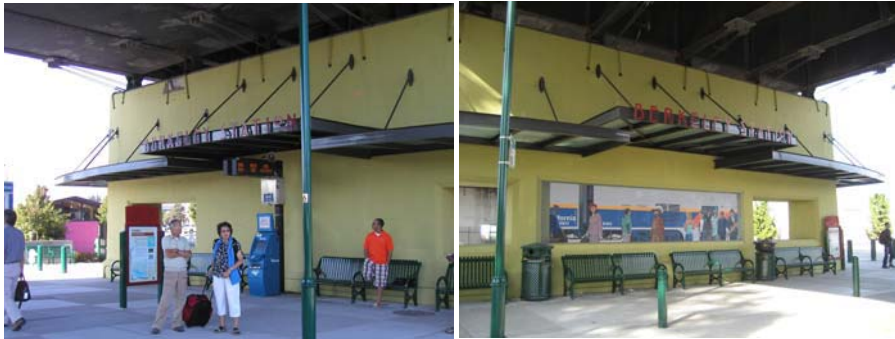
**Figure 2: Berkeley Amtrak Station**

The Berkeley Amtrak Station is located at University Avenue and 3rd Street, below the University Avenue overpass (**Figure 2**). The station is unstaffed but is equipped with two ticket vending machines that allow passengers to pre-purchase boarding passes. The University Avenue overpass provides shelter for passengers waiting on the platform below. The station is also equipped with a pay phone and wayfinding map for the City of Berkeley and waterfront areas. A \$2.4 million upgrade of the station was recently completed in September 2005 by the Berkeley Redevelopment Agency.

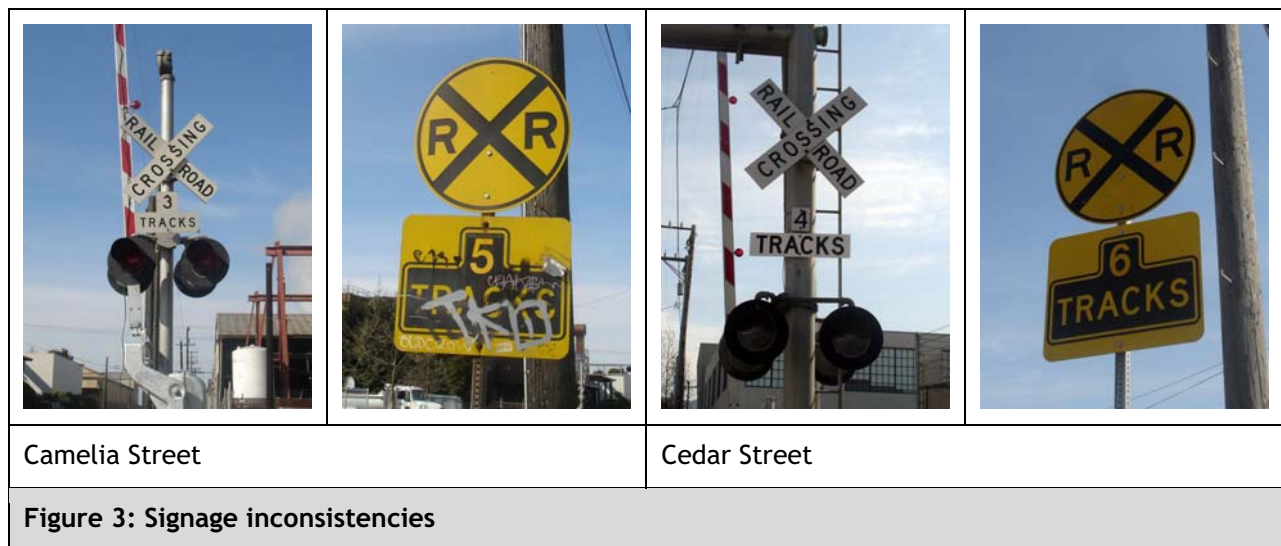
The number of tracks to be crossed is noted on both the advance warning signage and also on the warning gates themselves. At the grade crossings in Berkeley, this signage is not consistent as shown in **Figure 3**. There is confusion as to how many tracks are actually present since some are active and others are not. In fact, some of the trackage has been removed on either side of the crossing panel. In some cases, the warning devices have been placed within the easternmost track alignment (**Figure 4**).

The following safety issues were noted during site visits to the study area. It will be necessary to address these issues to establish a Quiet Zone in Berkeley either to satisfy the FRA's "pre-approved" sets of measures (termed Supplemental Safety Measures or SSMS) or non-engineering Alternative Safety Measures (ASMs).

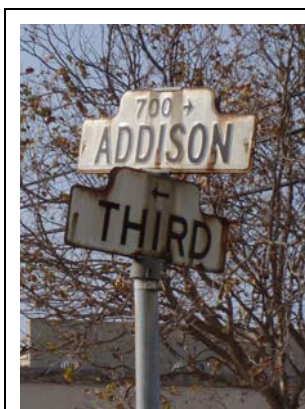
**Figure 5: 3rd Street Sign**

Although the rail corridor is referred to as 3rd Street (**Figure 5**), there is no publicly maintained street within the right-of-way. Concrete barriers and fences have been installed at most of the crossings to minimize trespassing by both vehicles and pedestrians. However, there are some parcels that do not have other access except for the '3rd Street. As shown in **Figure 6**, public access is available; sometimes the railroad right-of-way is fenced off but sometimes it is not.

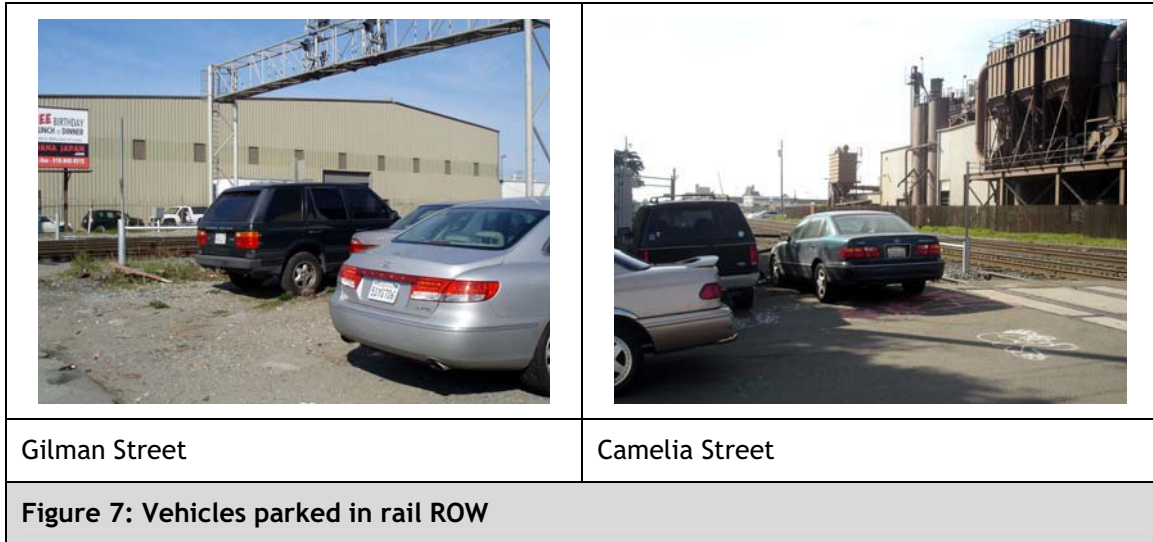
Parking in most of Berkeley is at a premium; the demand for parking is no different in the study area. Vehicles are often parked in the railroad right-of-way, directly on the out-of-service tracks and very close to the mainline tracks as shown in **Figure 7**.

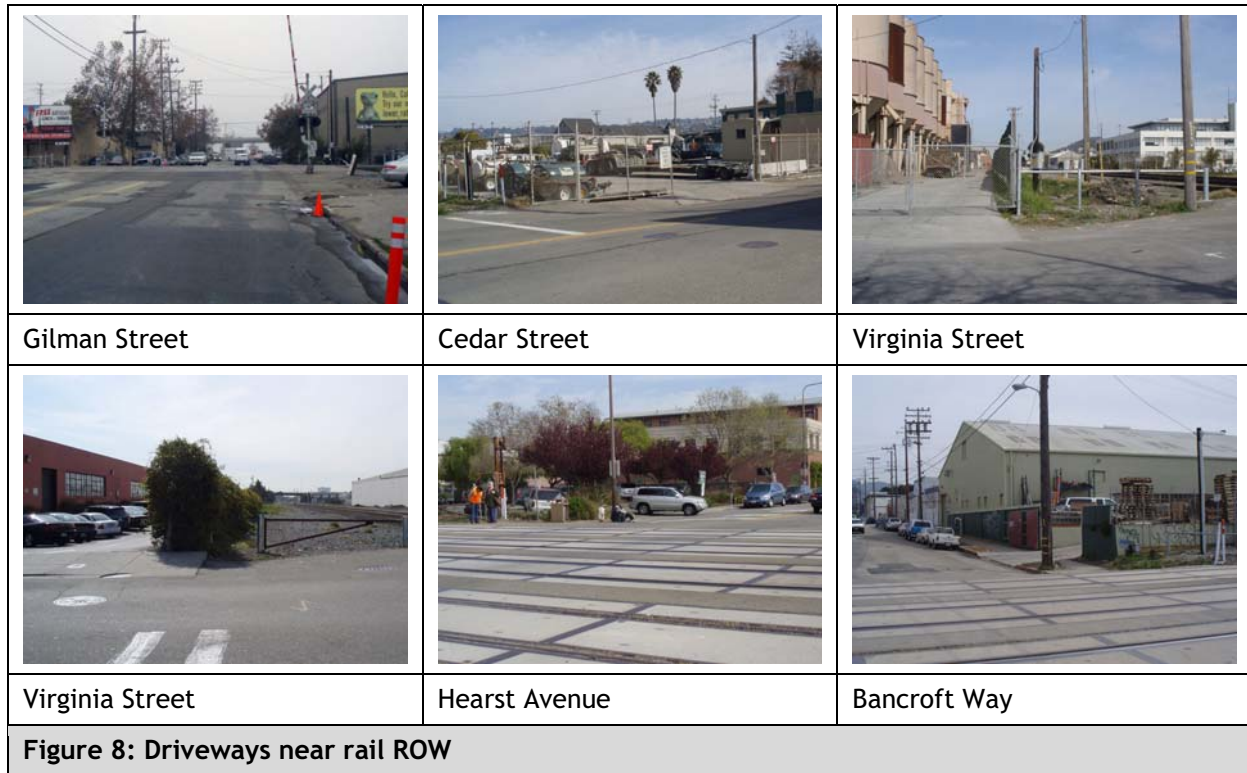
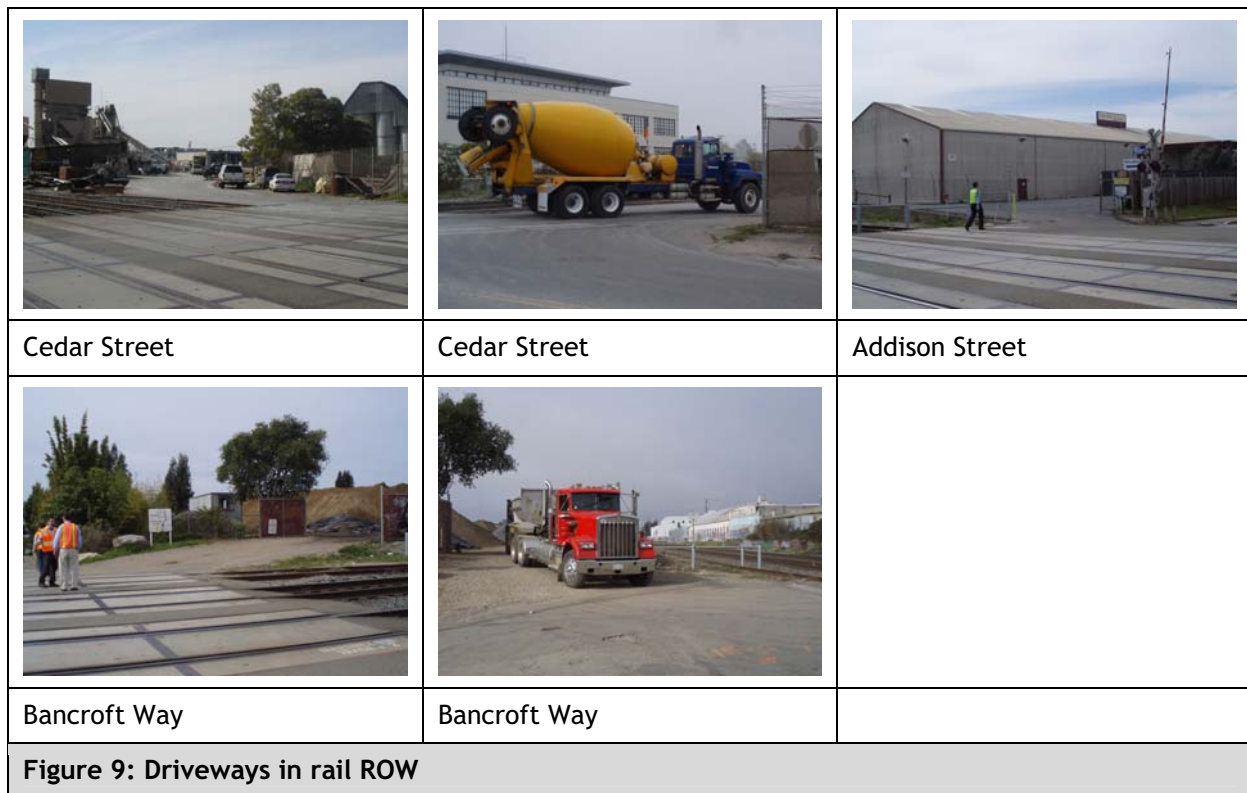
Many of the crossings have driveways or access roads that enter the roadway within 60 feet of the track as shown in **Figure 8**. In some cases, these driveways are within the quadrant protected by the warning devices with the result that an exiting vehicle would not be warned or required to stop in the case of an approaching train. Examples of this configuration are shown in **Figure 9**.

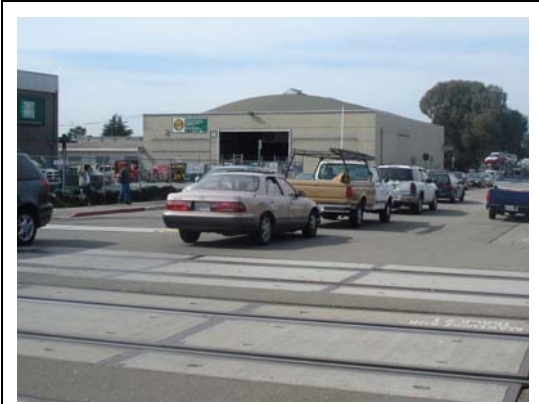
**Figure 10: Queuing at Hearst Ave driveway**

Driveways located within 60 feet of the track are also an issue for vehicles entering the driveways. Depending on the volume entering a particular driveway there may be a potential for vehicles to be stopped on the railroad right-of-way because of queuing at driveway entrance as shown in **Figure 10**.

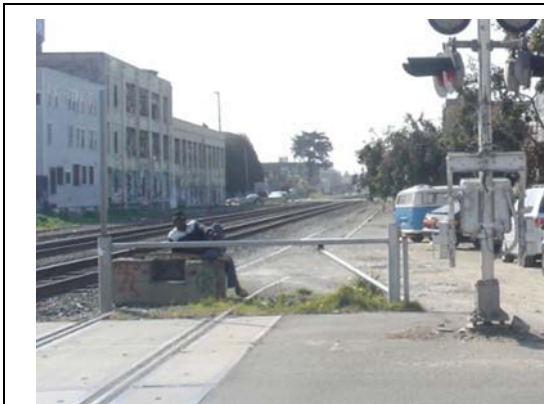
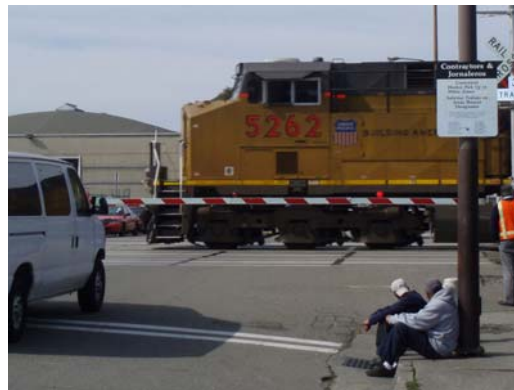
**Figure 11: Pedestrians in railroad right-of-way**

Loitering, trespassing and pedestrian crossings within the railroad right-of-way are a consideration for establishing a Quiet Zone as well as a general safety concern for the City (**Figure 11**). Pedestrian activity is especially high near the Amtrak Station and the 4th Street shopping area. In addition, Hearst Avenue is a designated pick-up location for day laborers within close proximity to the railroad corridor. Workers waiting in this area and vehicles stopping in the vicinity of the tracks should not be encouraged.

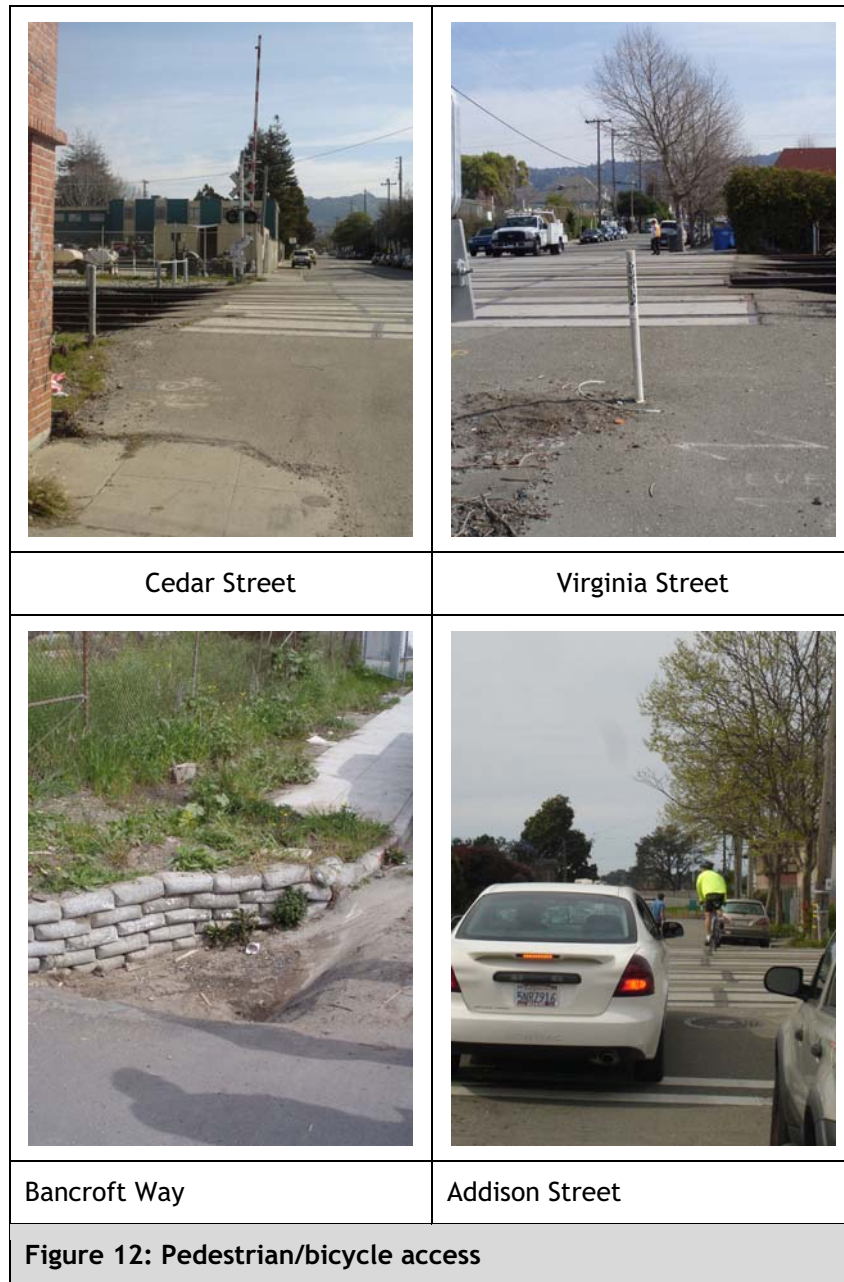
The pedestrian pathway across the tracks is generally not improved even at locations where sidewalks are provided on either side of the tracks as shown in **Figure 12**. Industrial land uses and high volumes of truck traffic are generally not conducive to walking; pedestrian facilities are usually limited and, when provided, in poor repair. In particular, improvements should be provided to Addison Street as the primary pedestrian and bicycle route to Aquatic Park and the pedestrian/bicycle overpass over Interstate 80.
