L A N D M A R K S
P R E S E R V A T I O N
C O M M I S S I O N
S T A F F R E P O R T

60 Panoramic Way – William J. Moore House

Mills Act Contract Application (#LMMA2023-0001) for a residential property and City of Berkeley Landmark.

**William J. Moore Residence
60 Panoramic Way, Berkeley CA
Historic Architectural Summary**

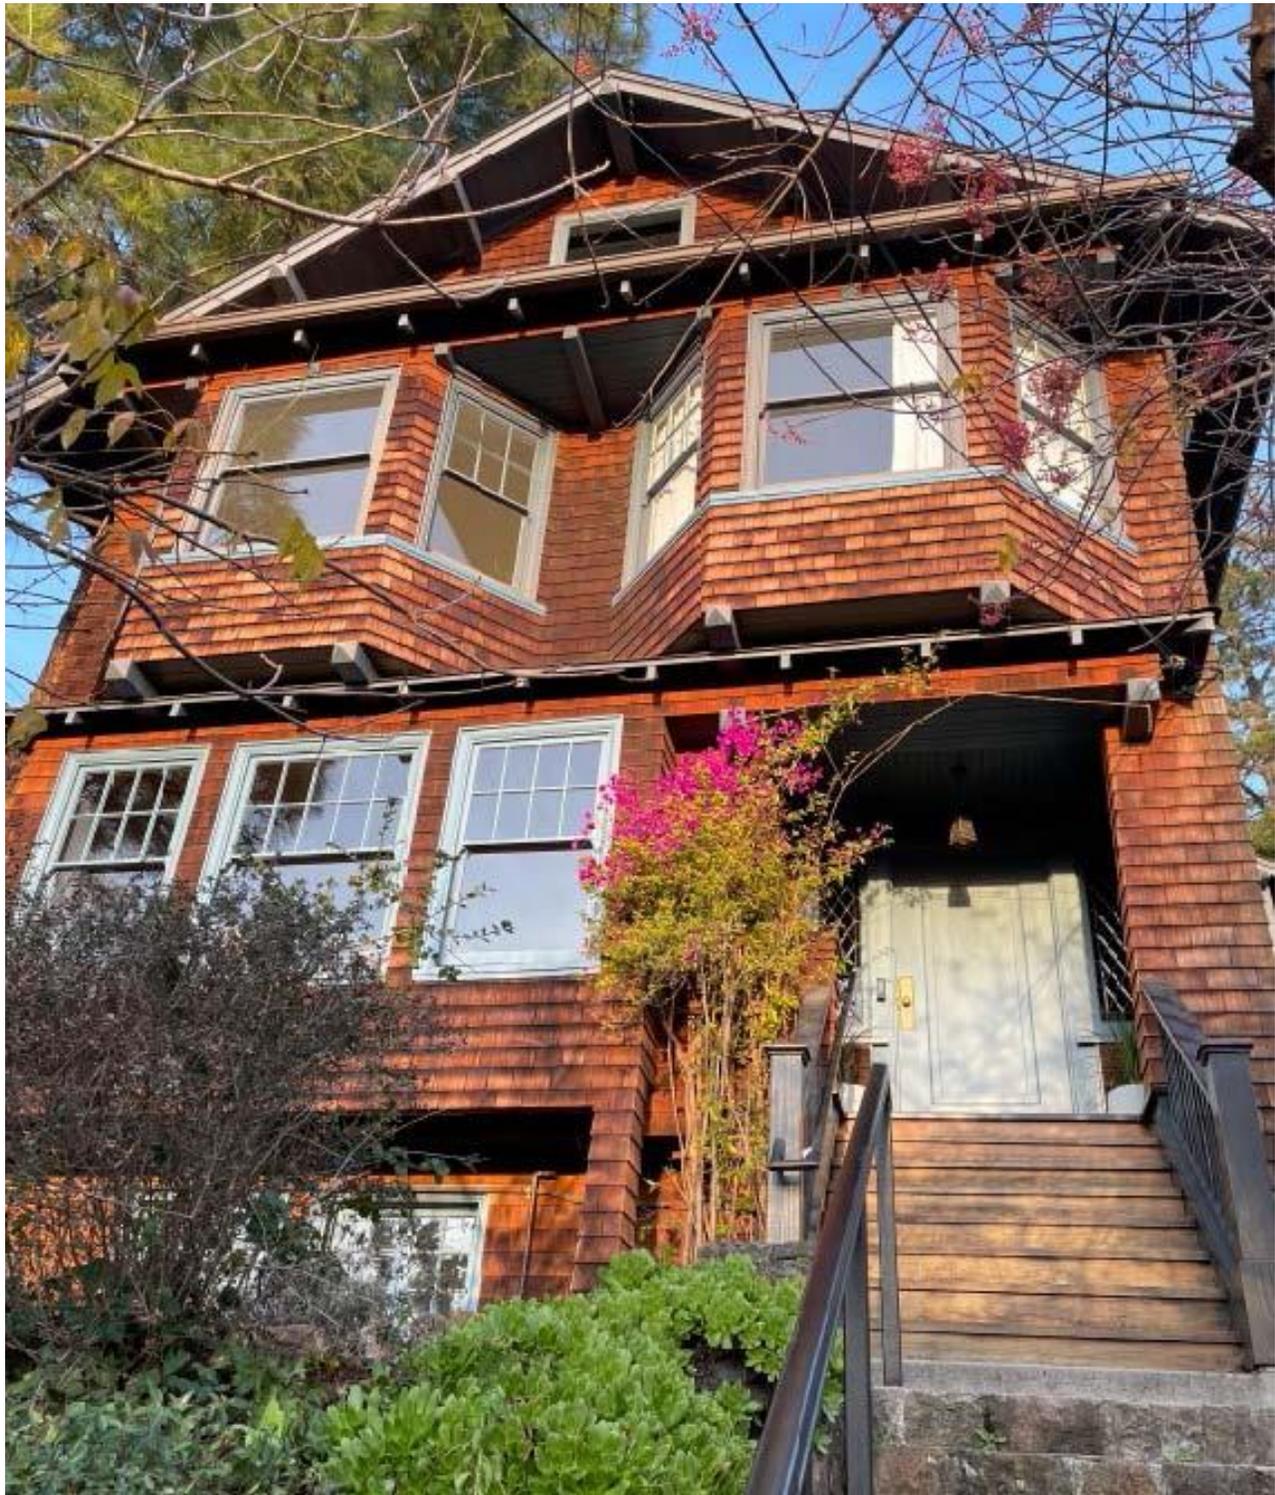
FIG 1: Front (west) bay windows, extended wood elements, entrance steps and recessed porch

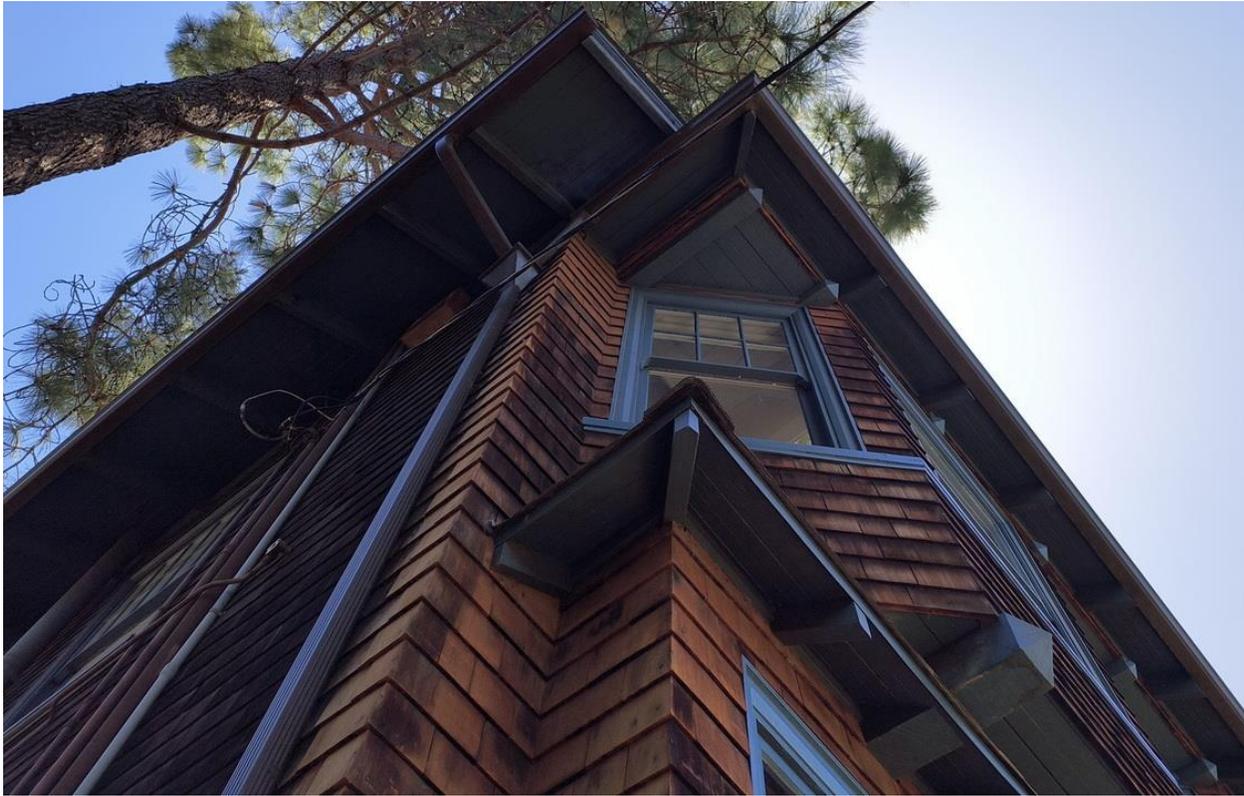
FIG 2: Overhanging roofs supported by wood rafters with tapered and pyramidal ends

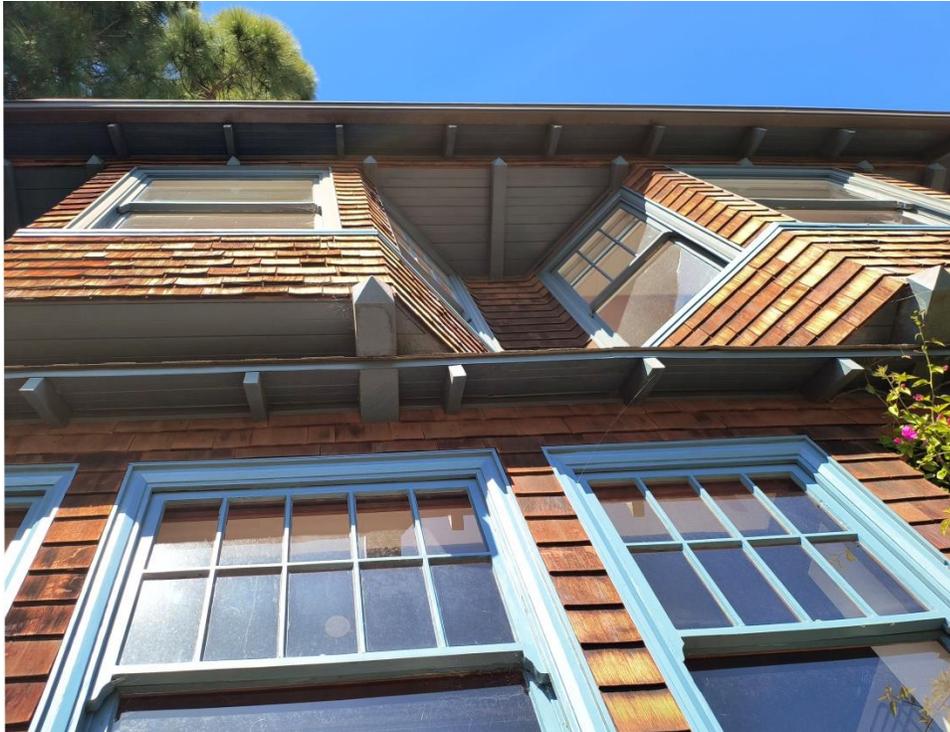
FIG 3: Hip roofs spanning first floor and second floor window bays

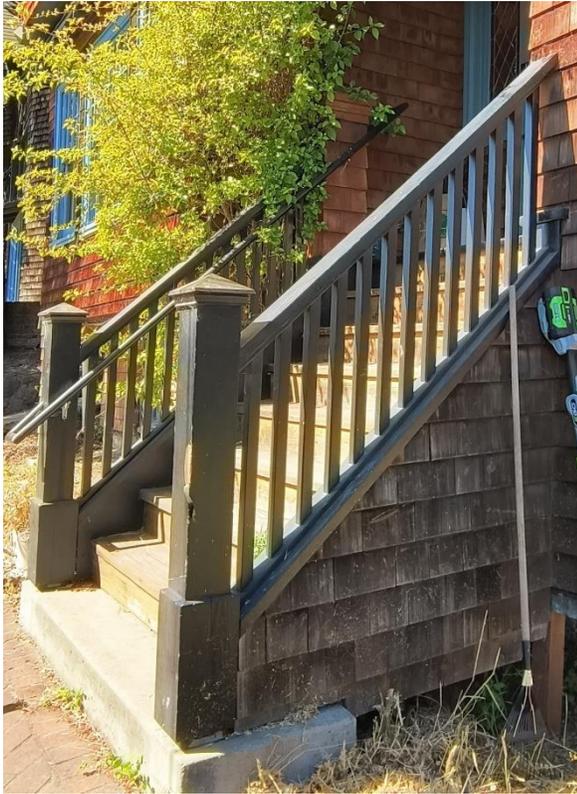
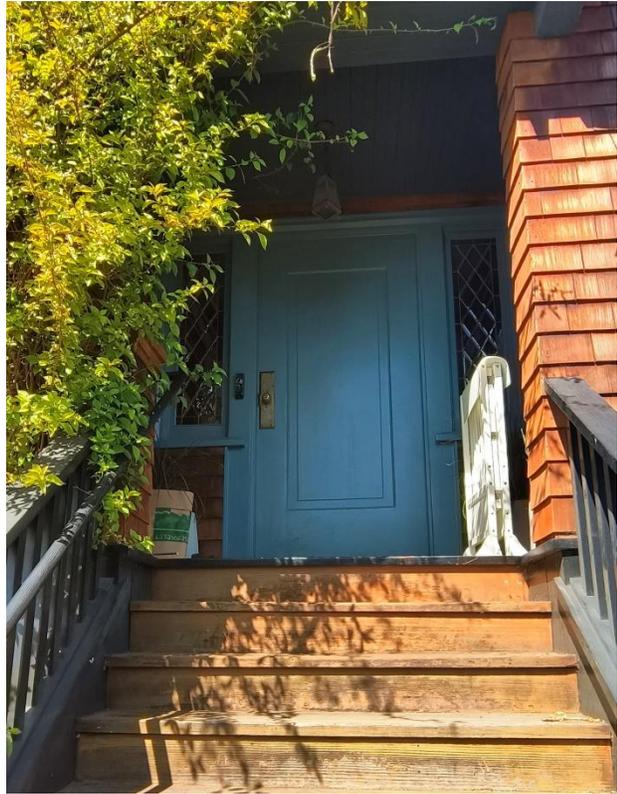
FIG 4, FIG 5: Entrance steps to porch with wood railing, balusters and posts with pyramidal caps

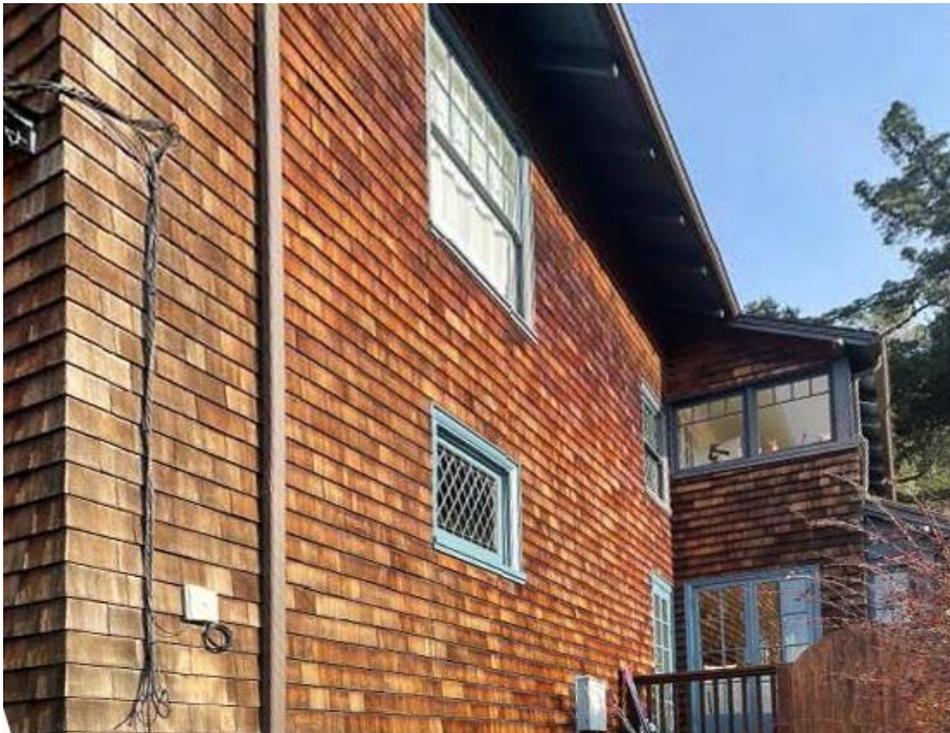
FIG 6: Side (south) showing the building's L- shape clad in unpainted wood shingles

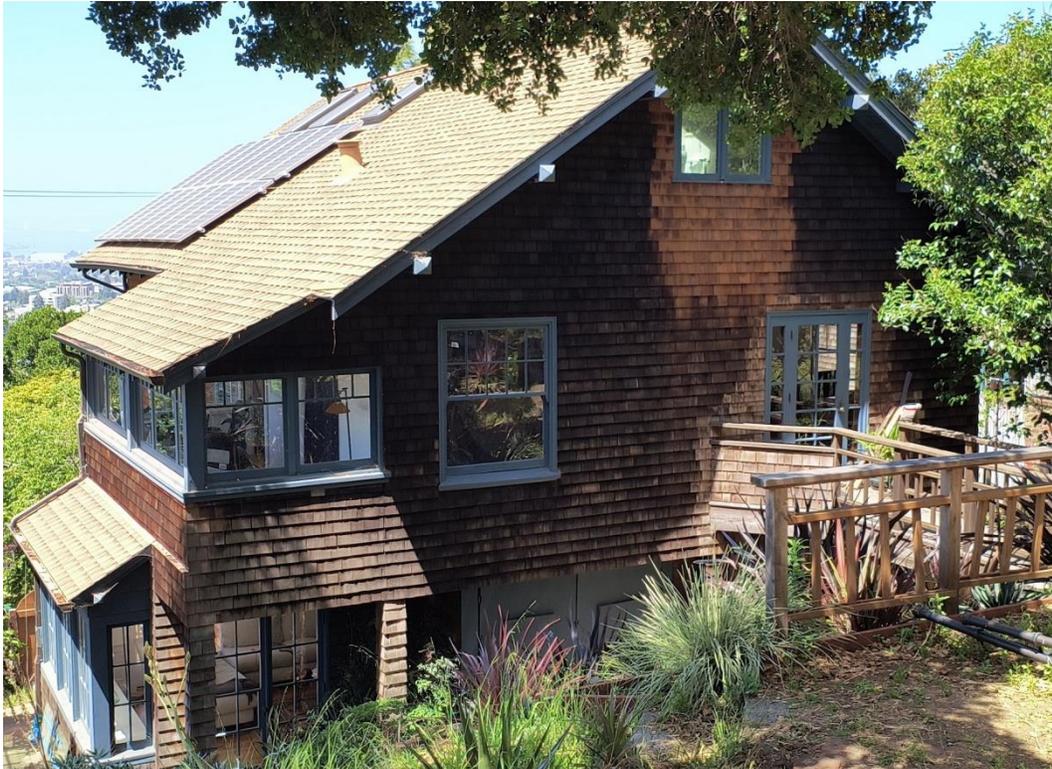
FIGURE 7: Rear (east) side shows fixed, casement and double hung wood windows

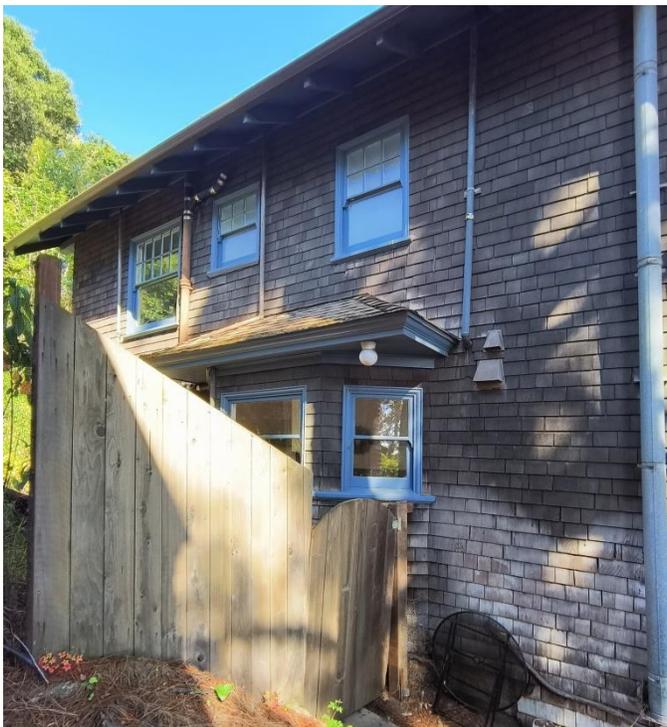
FIG 8: Side (north) façade features a three part bay window topped with a hip roof

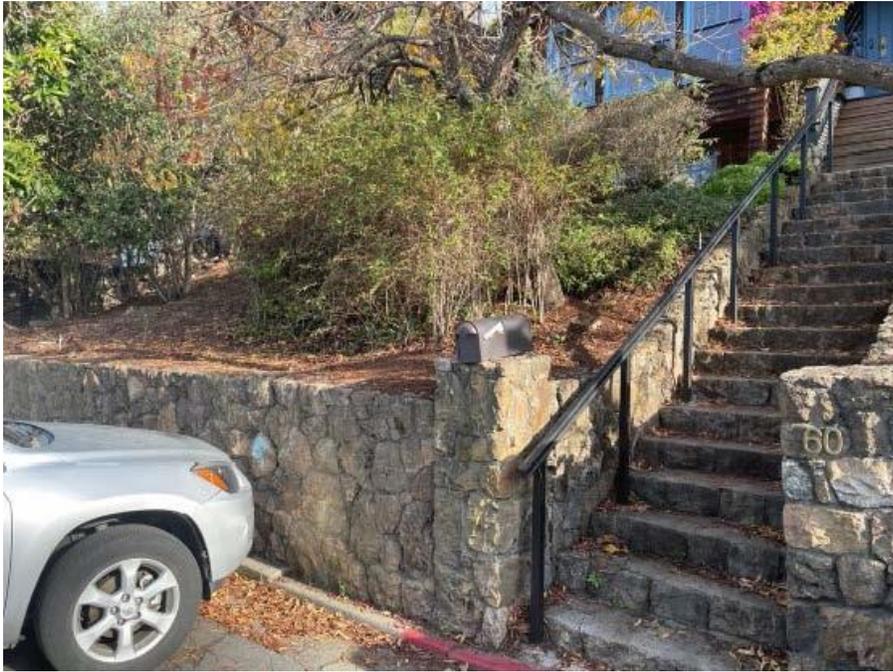
FIG 9: Rhyolite stone retaining walls at the front (west) of the property

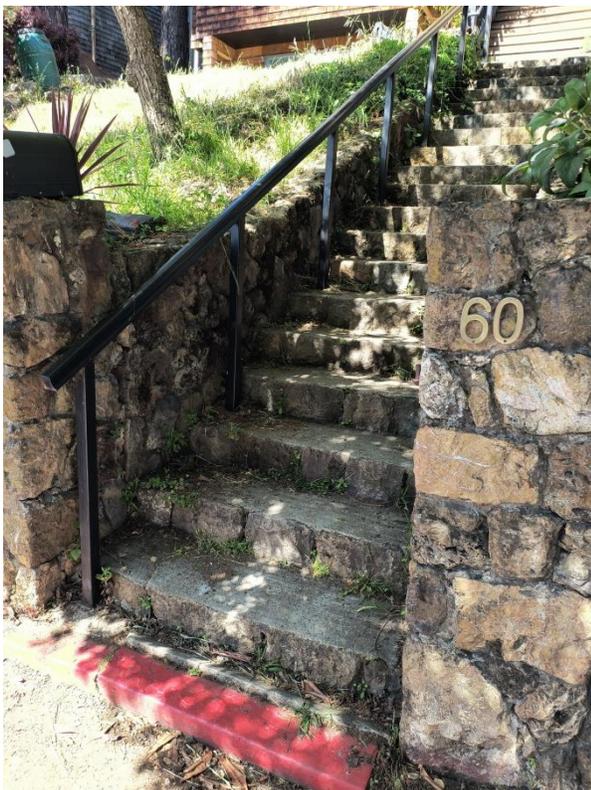
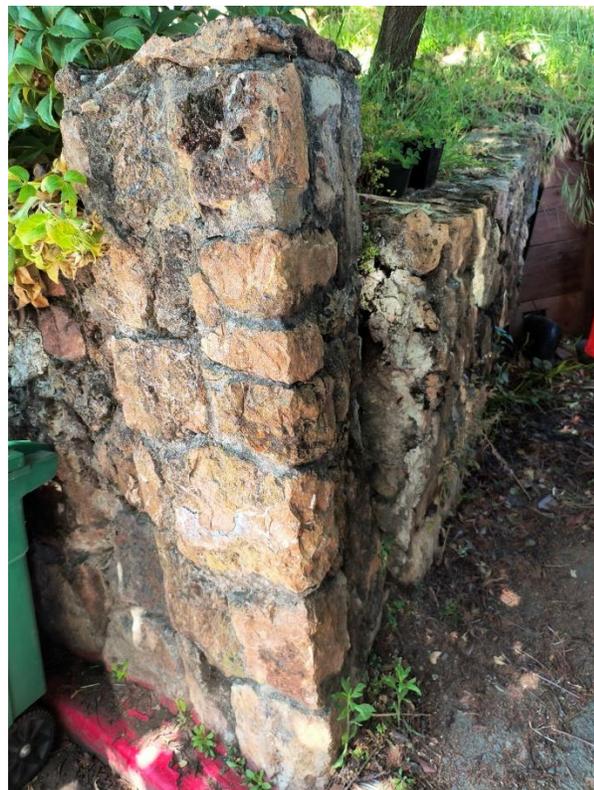
FIG 10: Square stone pilasters FIG 11: Stone wall along Panoramic Way as it wraps south

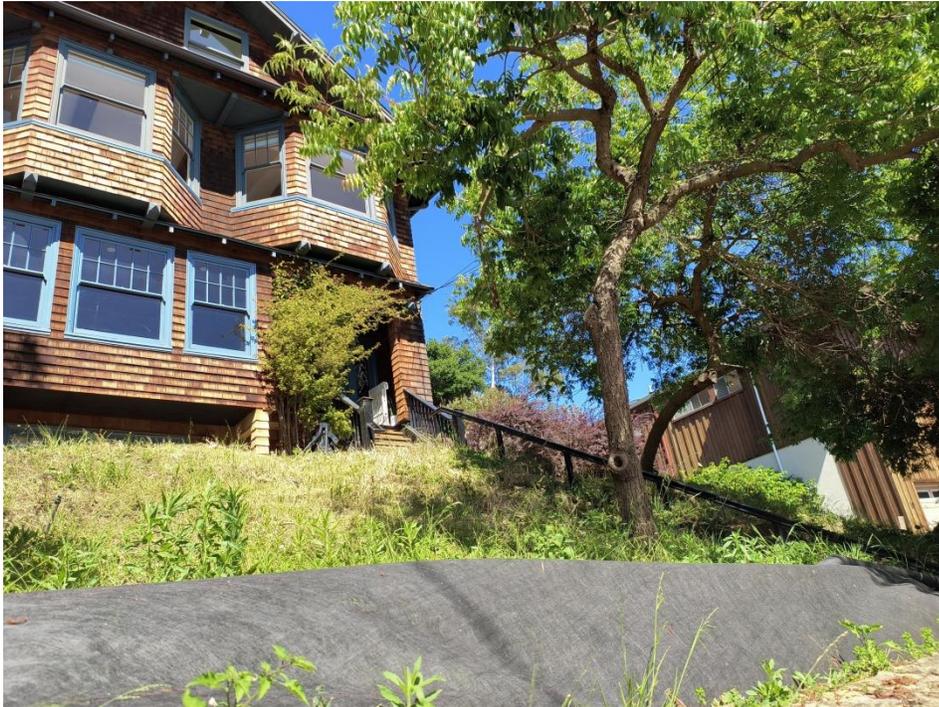
FIG 12: Building sits on an upslope site elevated from Panoramic Way

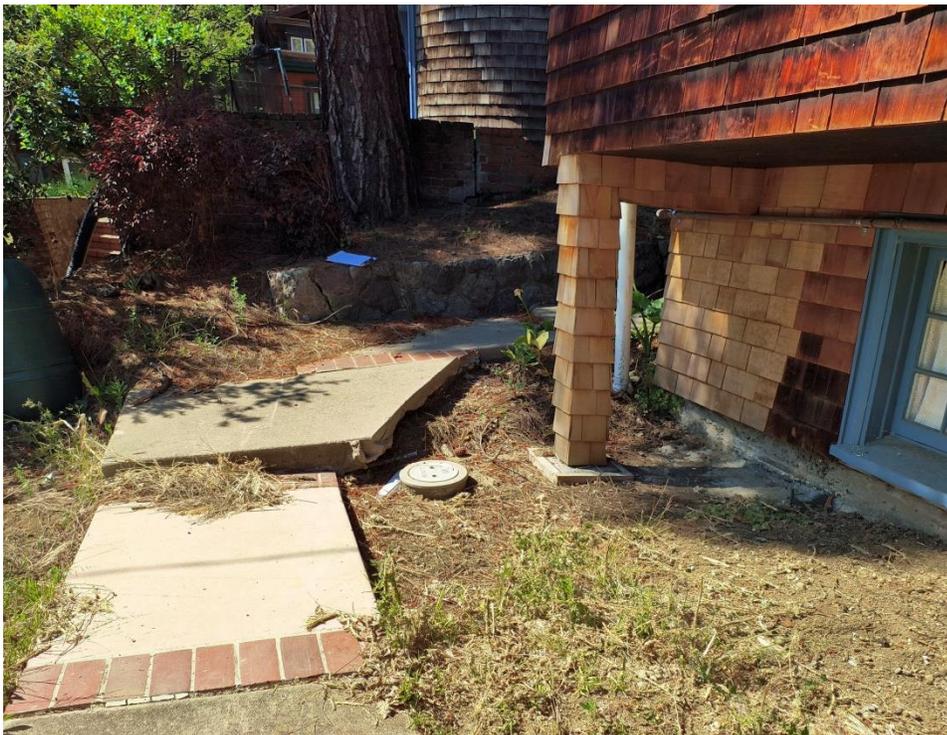
Fig 13: Walkway around building connects to stone entrance steps

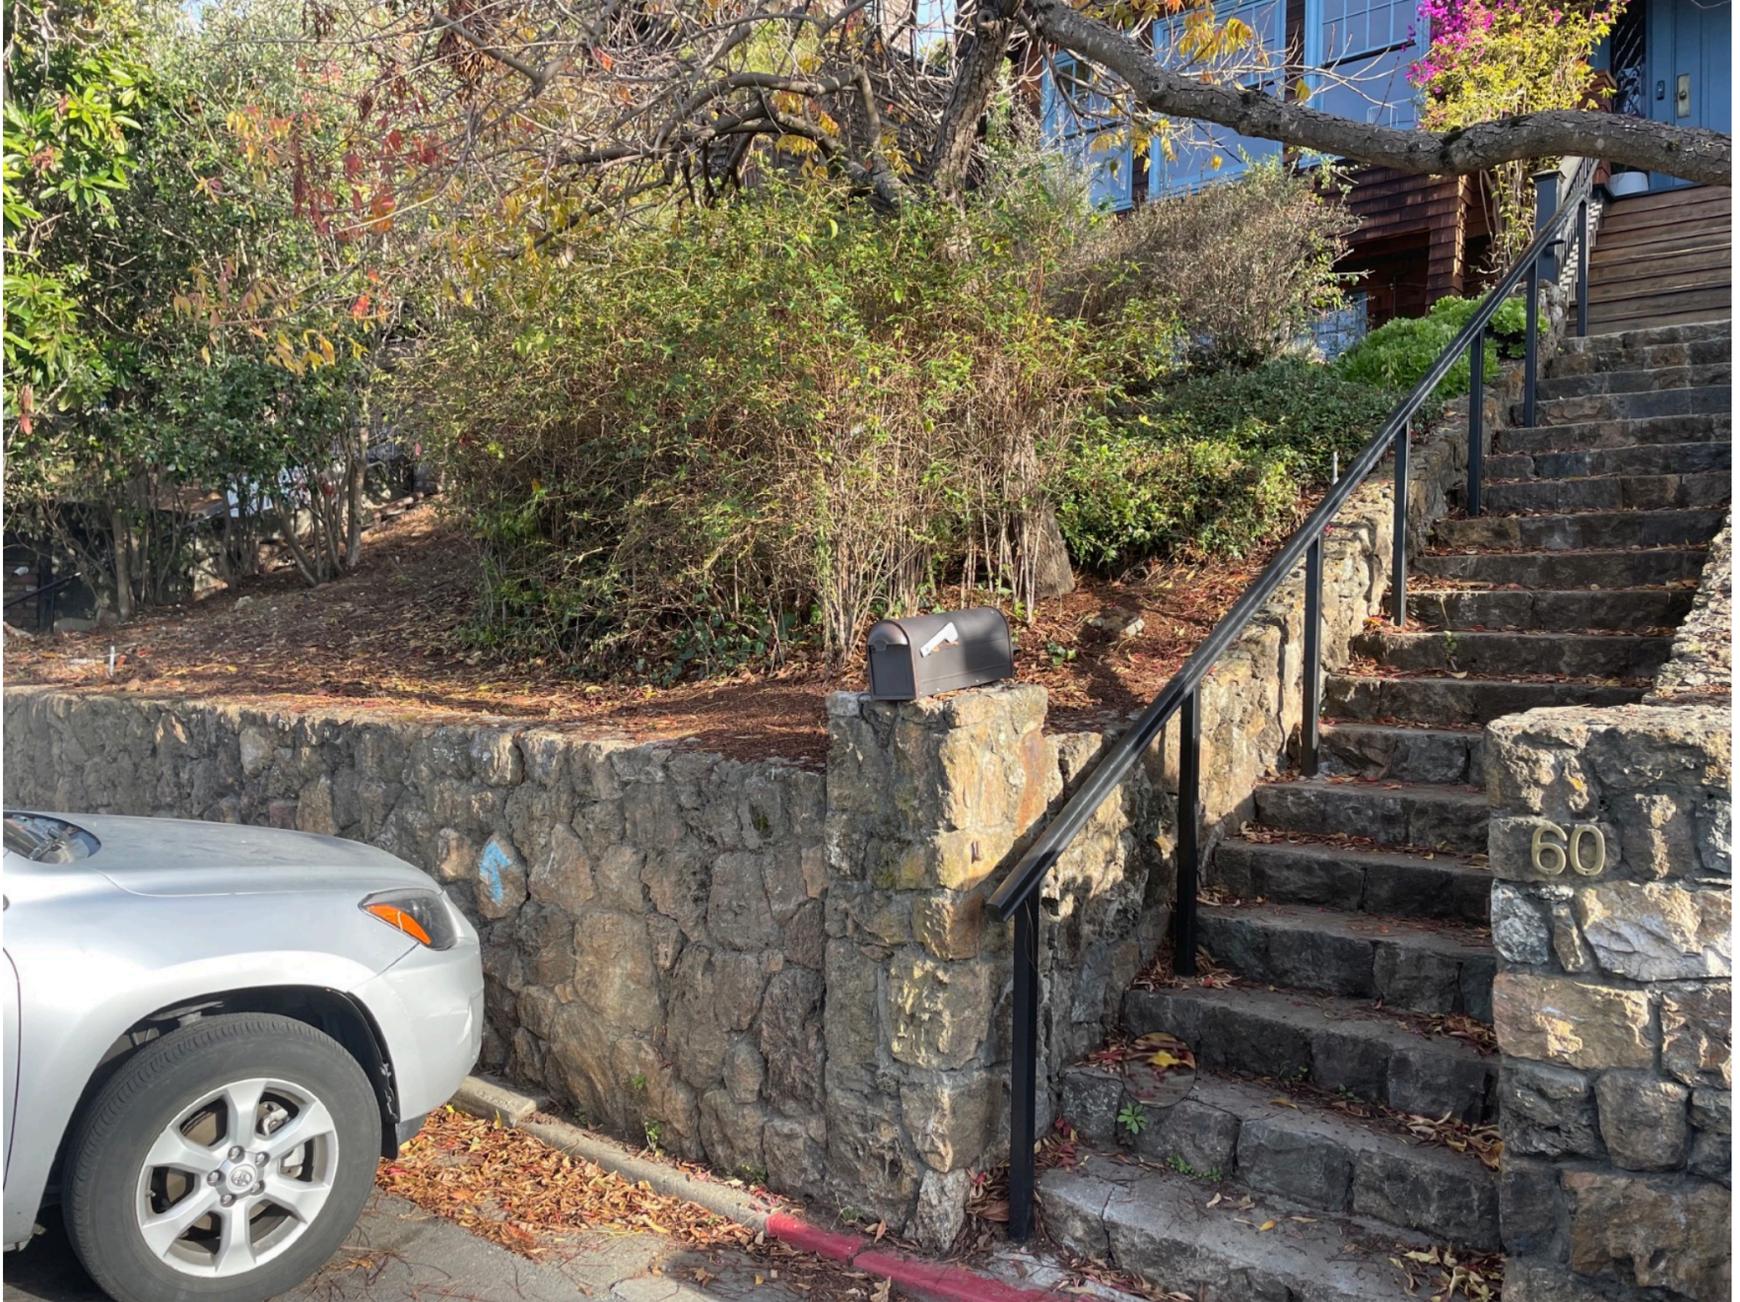
Stone retaining wall at the front of 60 Panoramic Way.

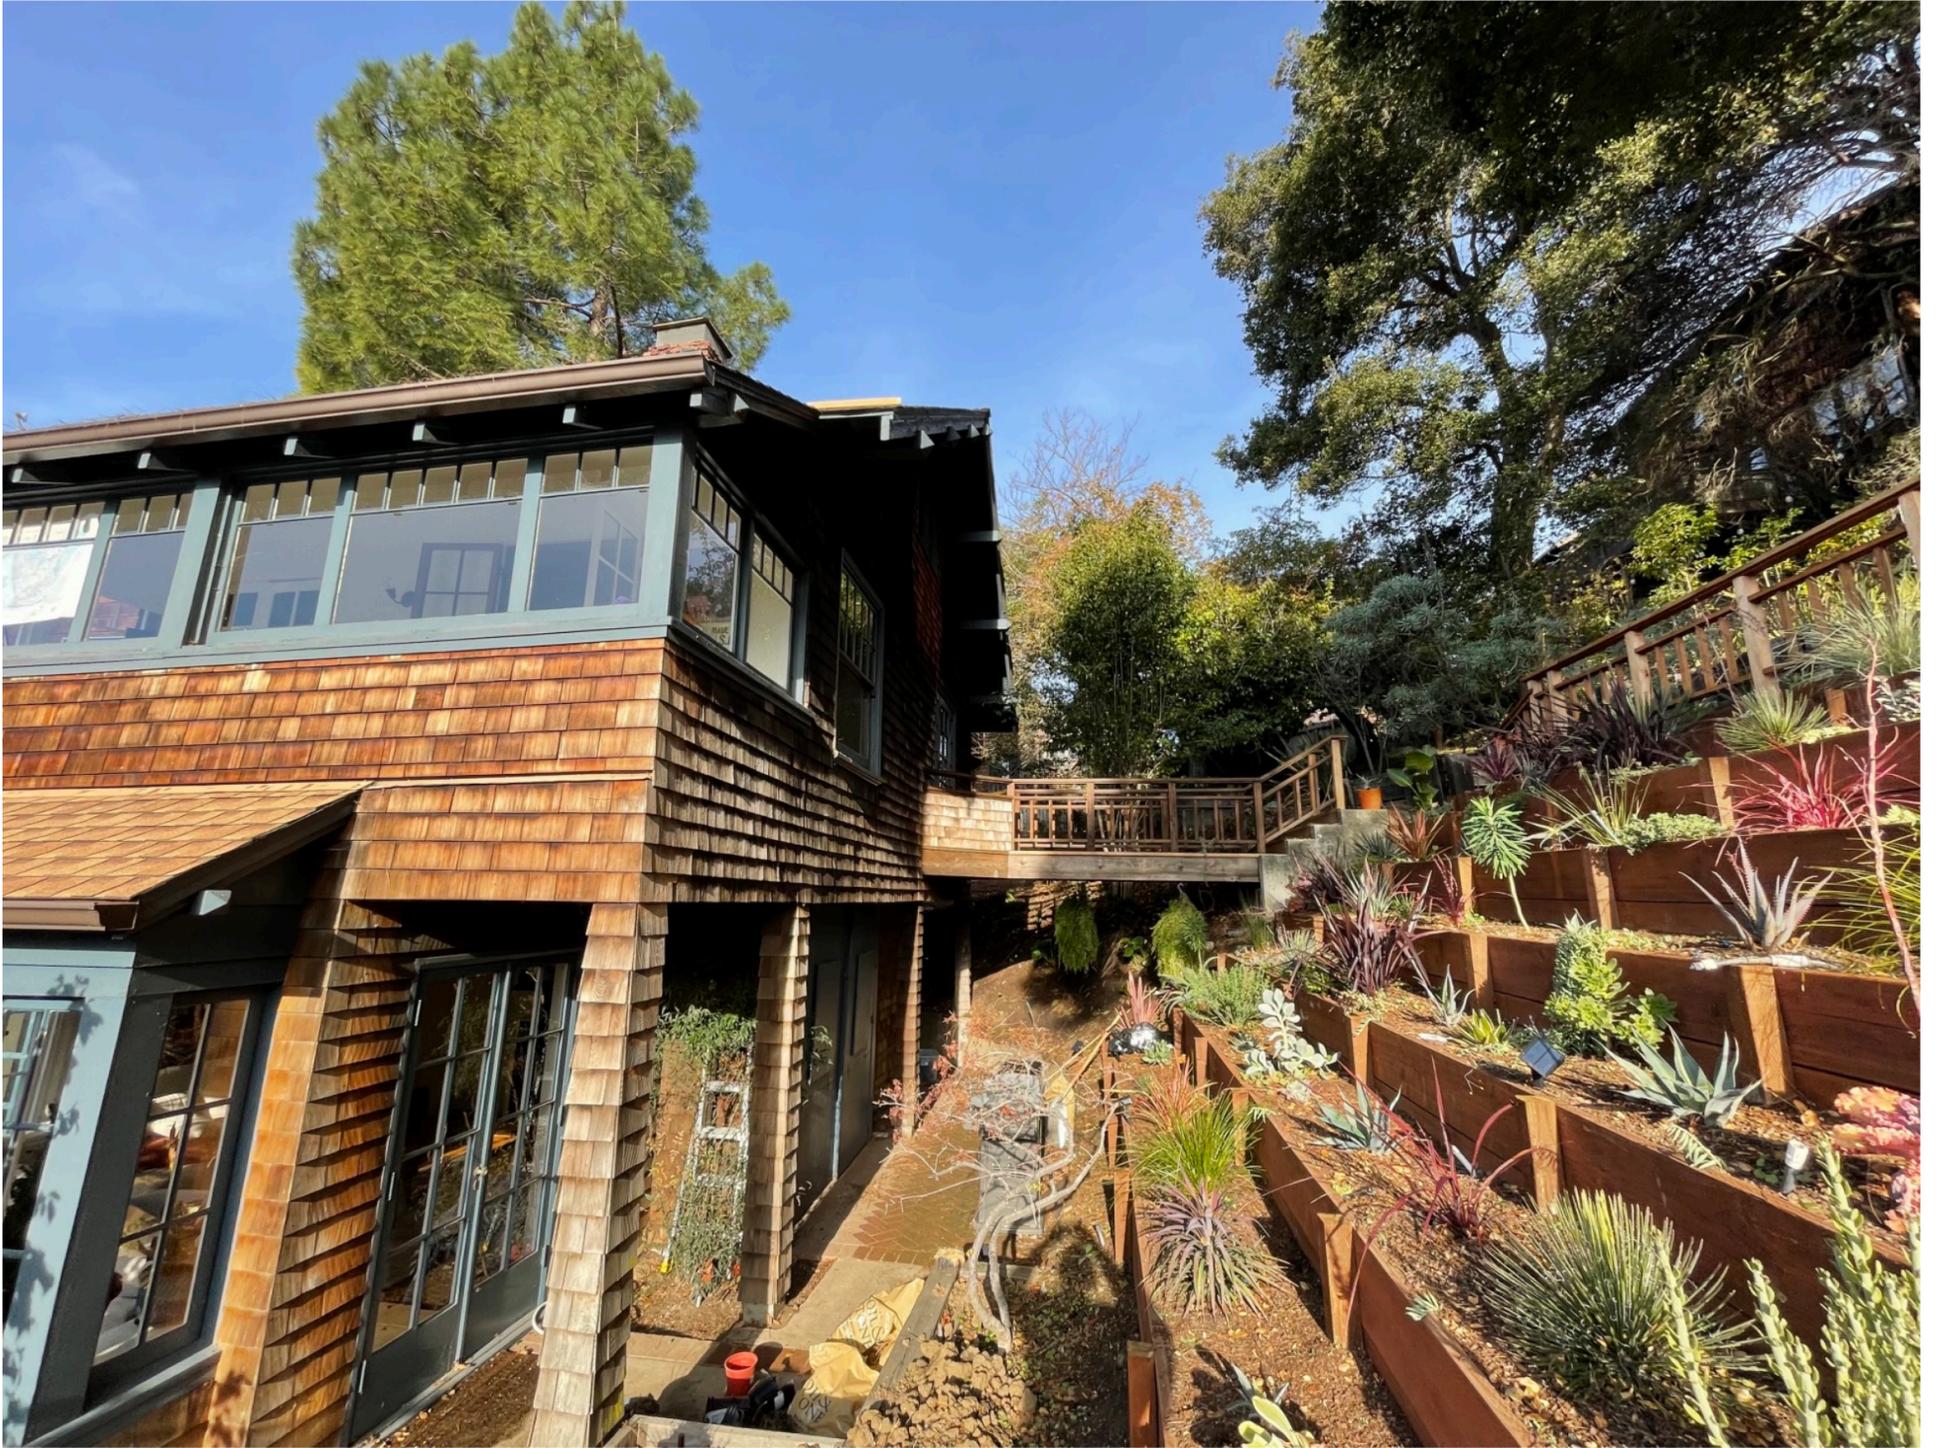
South west corner, including bridge to patio.

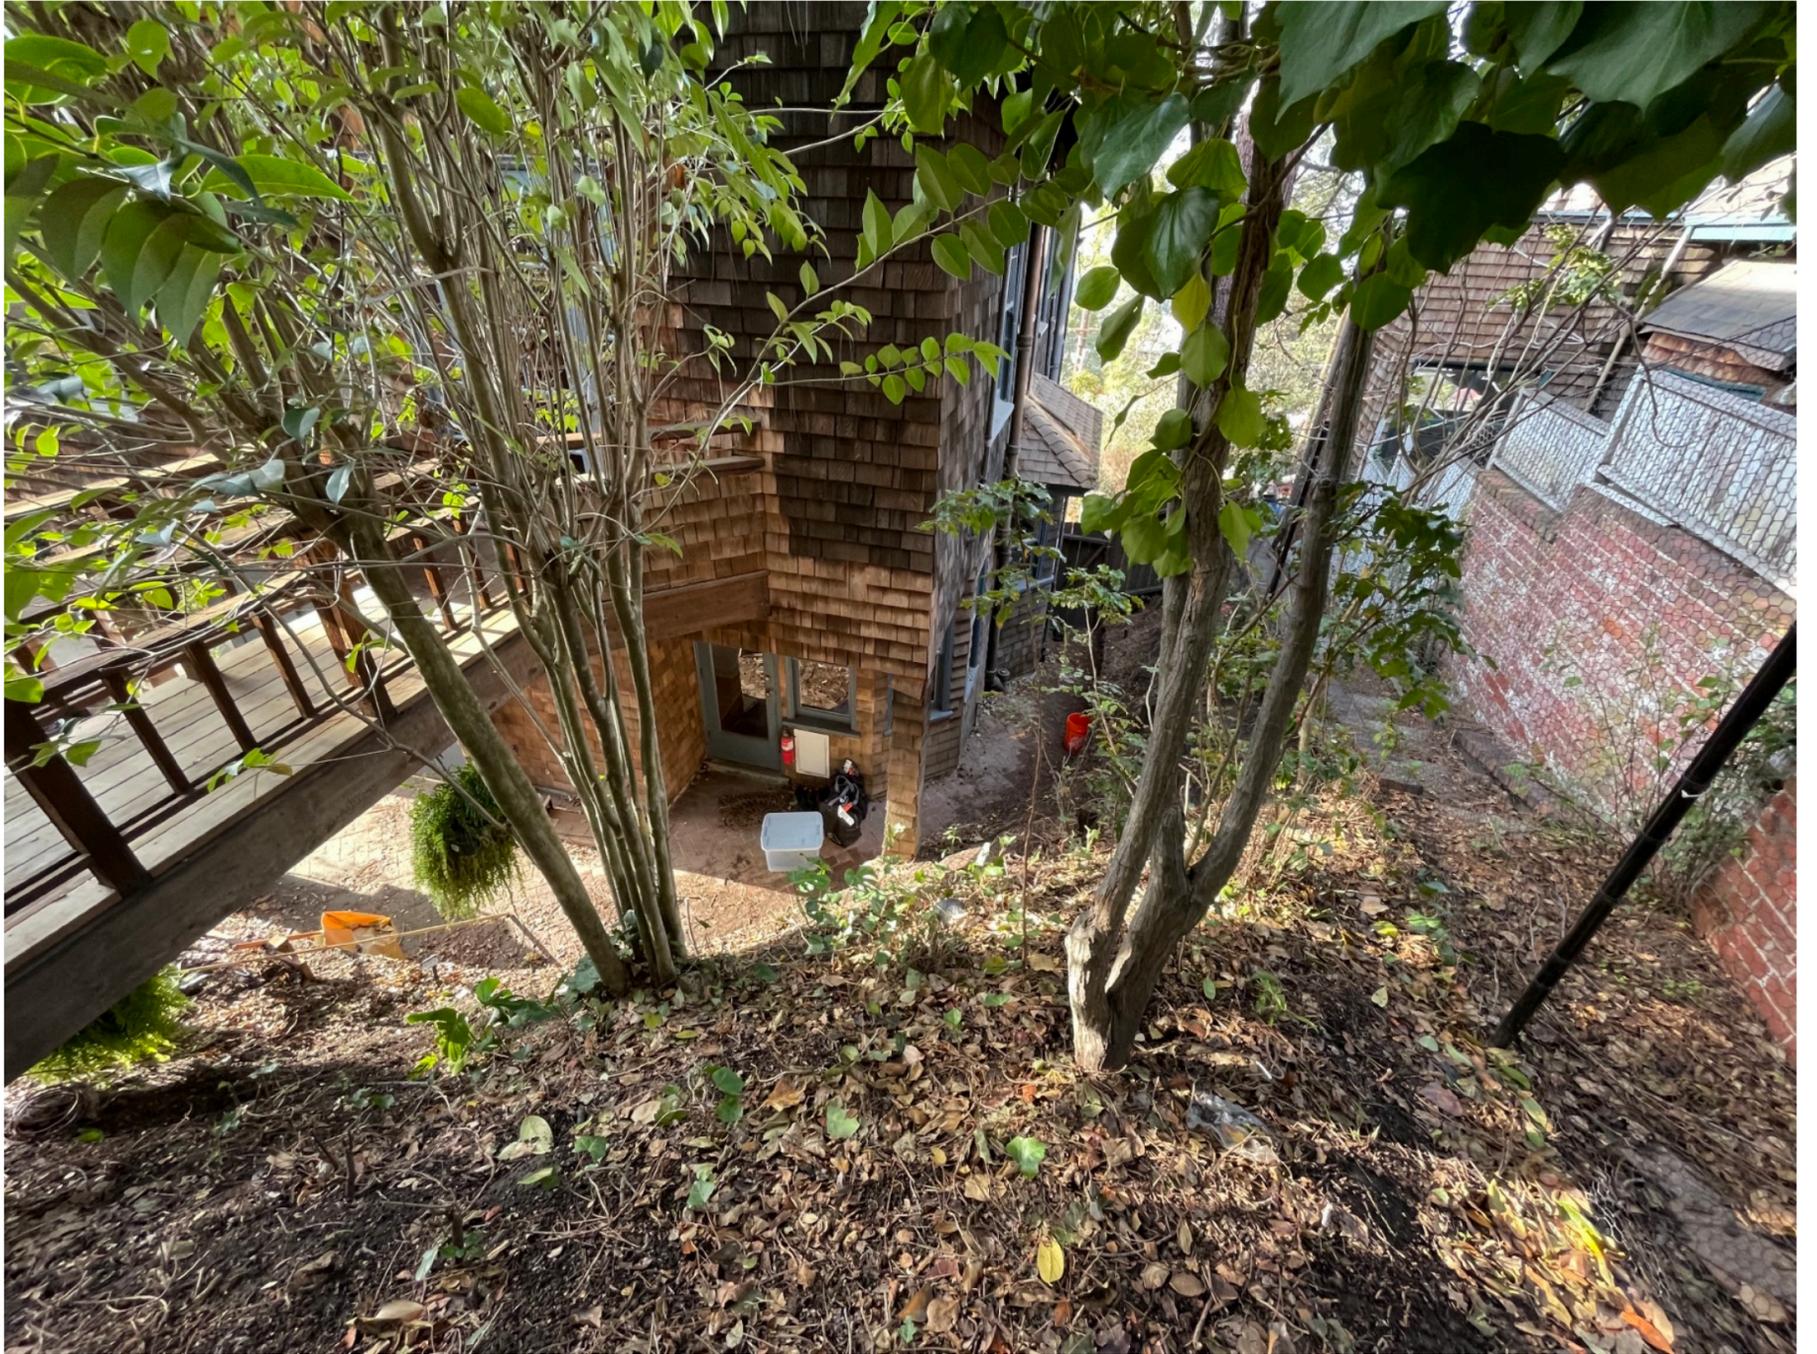
North west corner, including bridge to patio.
