L A N D M A R K S  
P R E S E R V A T I O N  
C O M M I S S I O N  
S T A F F R E P O R T

## 2100-2108 Milvia Street

**Demolition Referral: Use Permit (#ZP2023-0163) to demolish a three-story commercial building completed in 1960, and altered in 1997 (APN: 057-2022-017-01).**

**2100-2108 Milvia St., Berkeley  
Historic Resource Considerations**

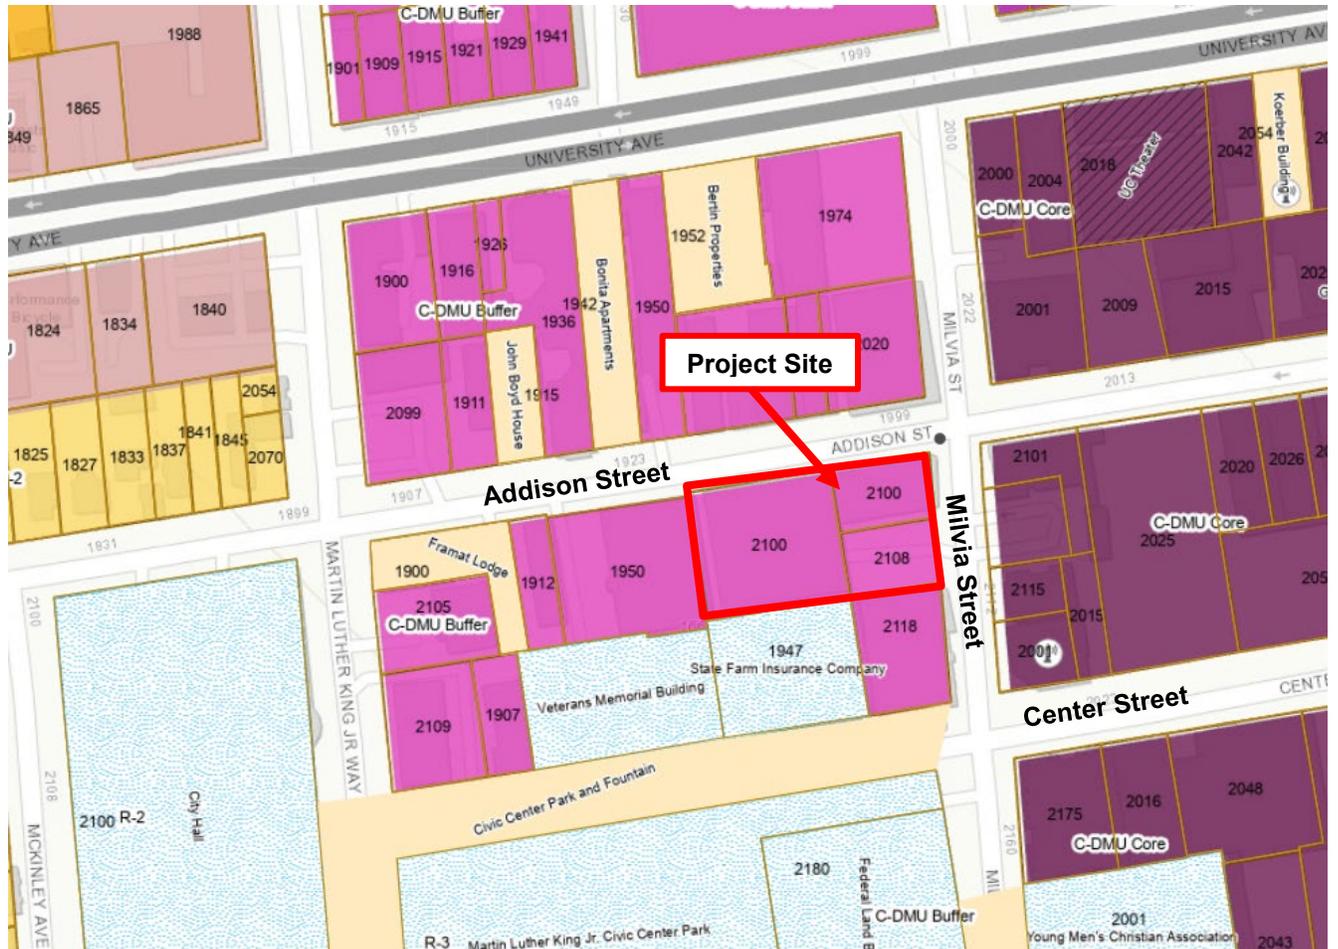
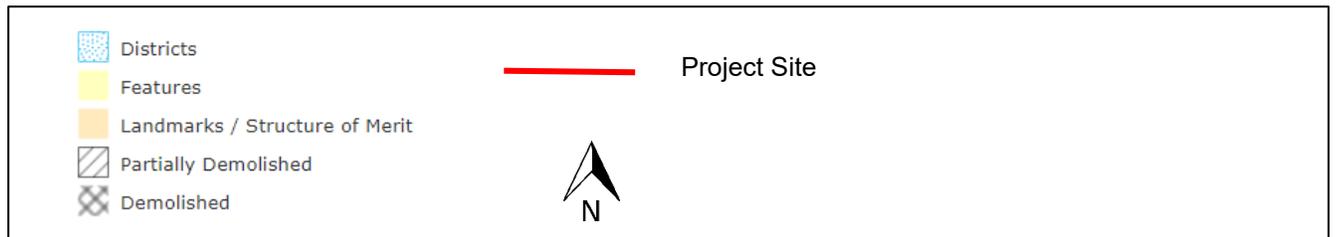
**Figure 1: Vicinity Map showing historic resources** (City of Berkeley GIS, 2023)

The subject property is directly adjacent to the State Farm Insurance Company building (1948) of the Civic Center Historic District. Other nearby City of Berkeley Landmarks/Structures of Merit include the Framat Lodge (1927), and the Bonita Apartments (1905) (see Figure 1).

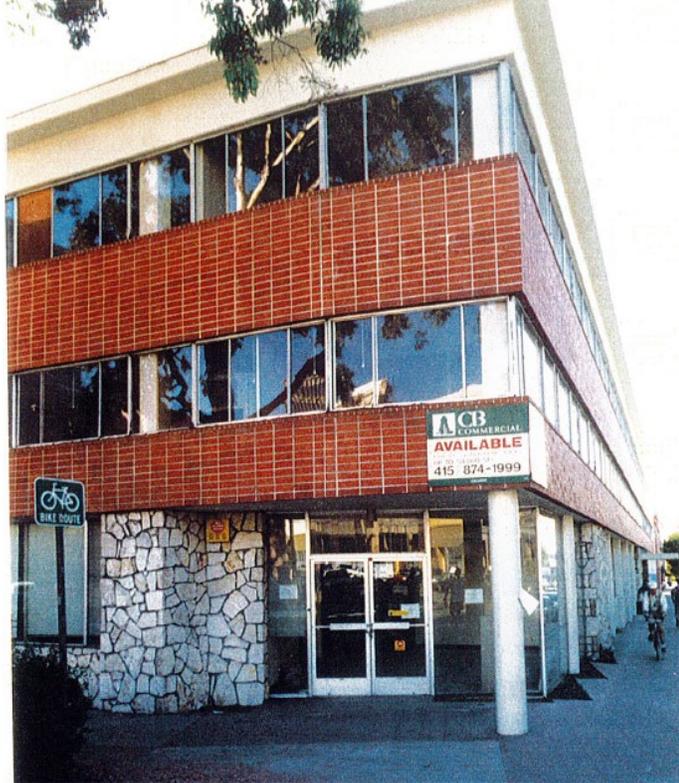
**Figure 2: Subject Property, entrance on Milvia Street, at the corner of Milvia and Addison Street, looking southwest, 1996 (Burns and Nettle Architects, 1996)**

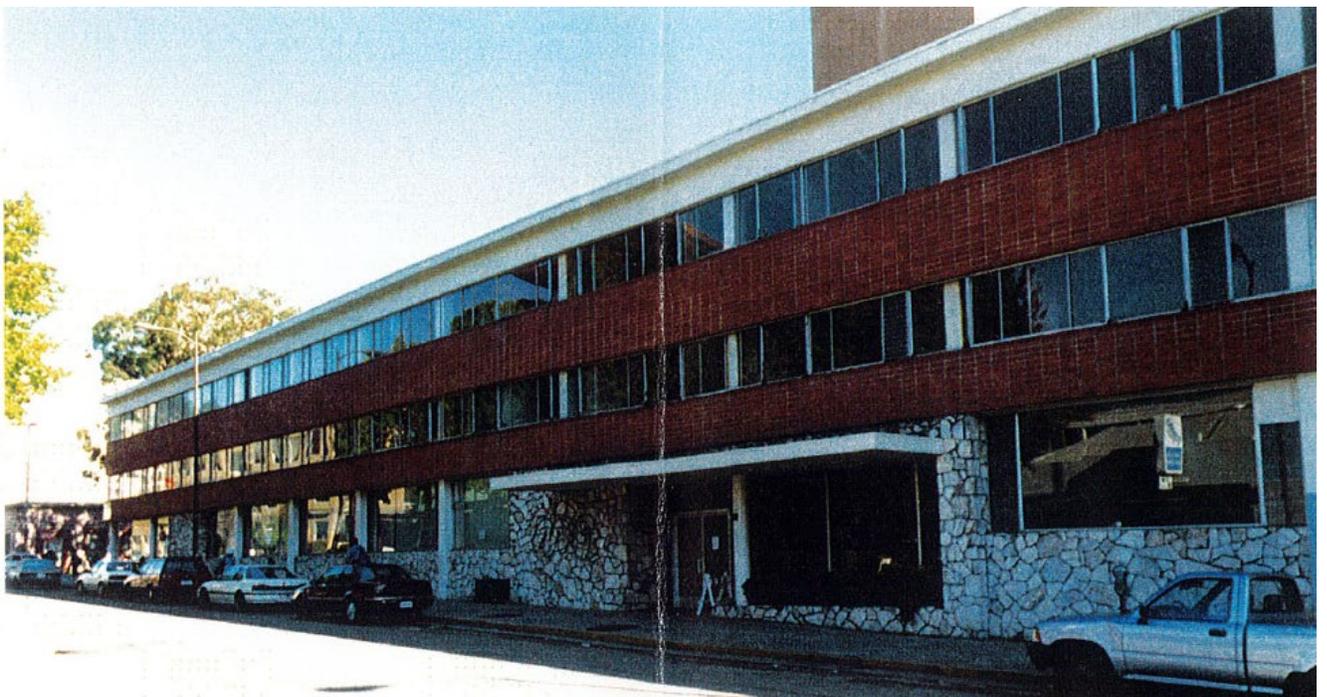
**Figure 3: Subject Property, Addison Street entrance/street-side frontage, looking east, 1996 (Burns and Nettle Architects, 1996)**

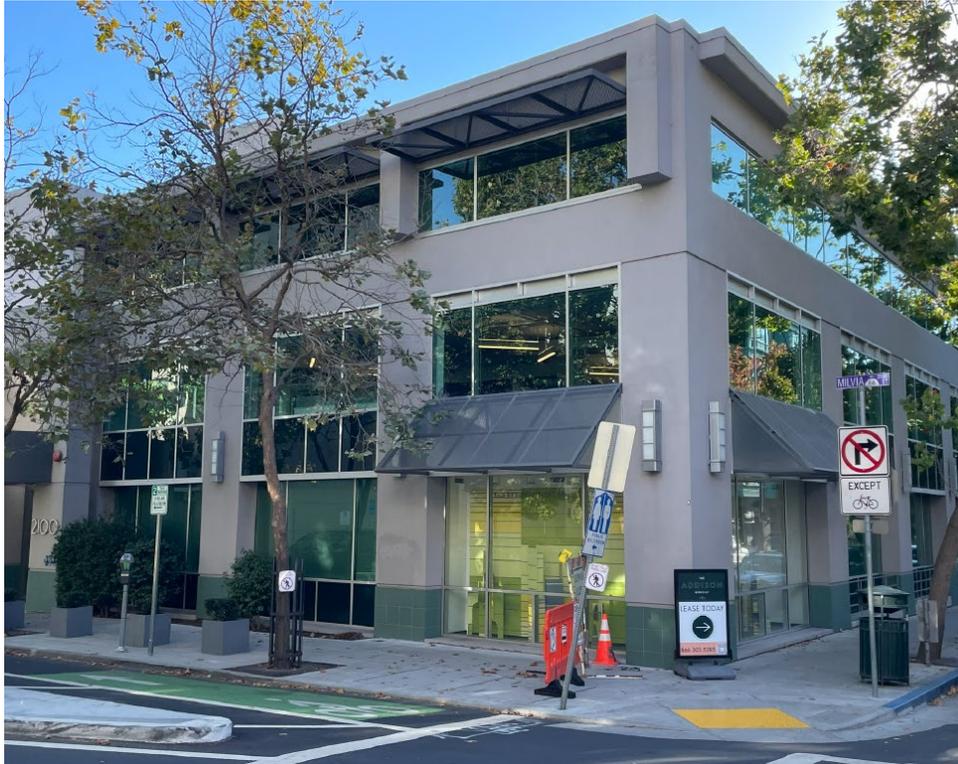
**Figure 4: Subject Property, current site conditions, corner of Milvia Street and Addison Street, looking southwest (staff, 2024)**

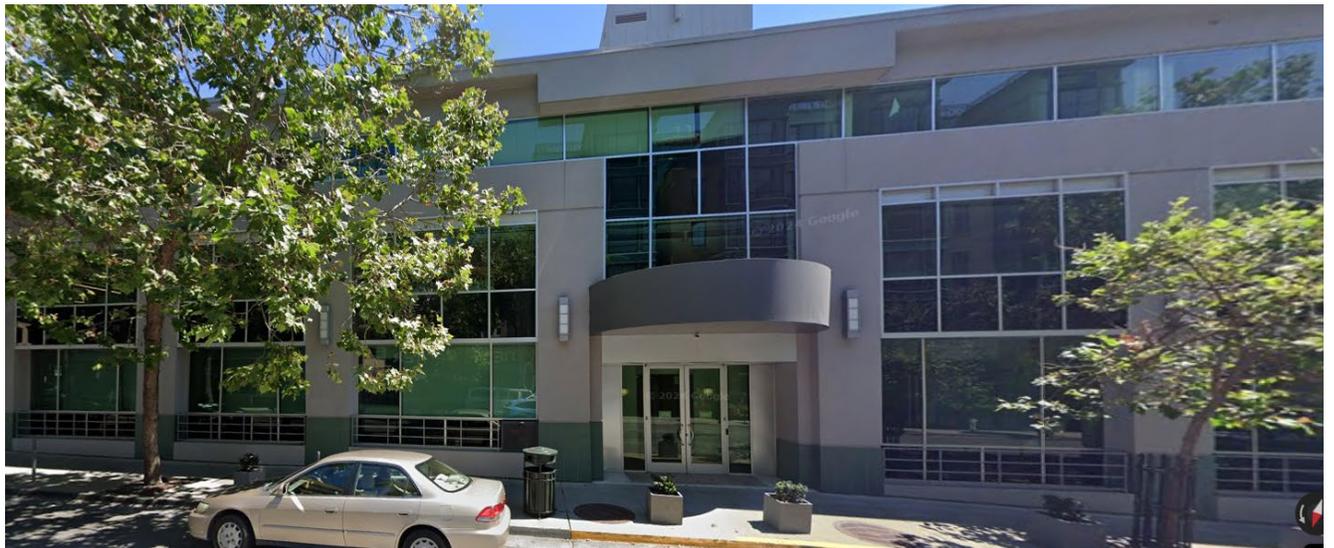
**Figure 5: Subject Property, current site conditions, entrance on Addison Street, north elevation (Google Street View, 2024)**

There is a rounded entry canopy over the entrance on the north elevation (Addison Street). At the northeast corner of the building, metal awnings are located above windows on the first floor of the north and east elevations. At the third floor of the east and south elevations, metal awnings are located above the windows.

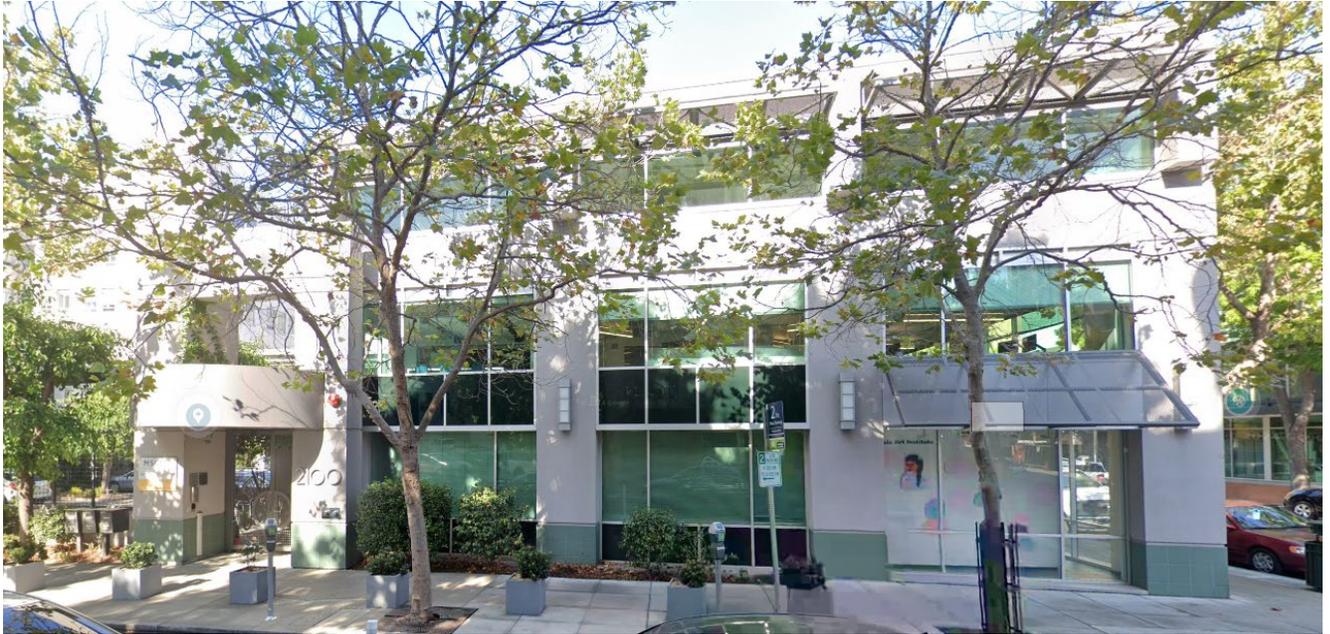
**Figure 6: Subject Property, current site conditions, primary façade on Milvia Street, east elevation**  
(Google Street View, 2022)

**Building Description:** The three-story flat-roofed concrete-frame commercial building is situated along the north (street side) and east (front) lot lines, with an L-shaped plan. Broad two-story pilasters frame aluminum-clad windows. On floors one and two dark green spandrel panels are located below rows of windows. The base of the pilasters is clad in green ceramic tile. The façade is clad in an Exterior Insulation and Finish System (EIFS) that resembles plaster. At the third floor, the EIFS cladding connects the pilasters, with a row of aluminum-clad windows above.

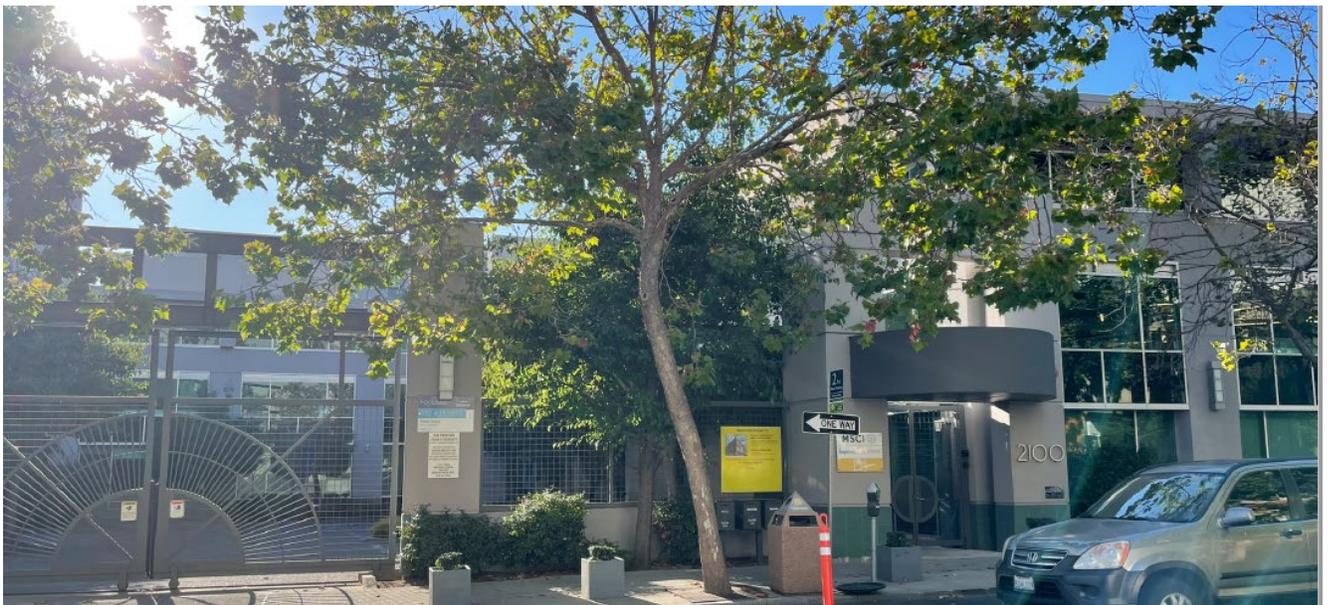
**Figure 7: Subject Property, current site conditions, gated parking lot and primary façade on Milvia Street, east elevation**  
(staff, 2024)

**Parcel Description:** The Use Permit project site is located in Downtown Berkeley, and consists of an approximately 27,000 square-foot L-shaped parcel with frontage on Milvia Street (primary) and Addison Street (secondary), and an adjacent approximately 7,000 square-foot rectangular parcel with frontage on Milvia Street. The subject building (2100 Milvia Street) is located on the L-shaped parcel, and the parking lot (2108 Milvia Street), is on the rectangular parcel. The entrance to the parking lot is gated (see Figure 7).

An additional entrance is located on the east elevation near the gated parking lot. A rounded entry canopy is above the pedestrian entrance that leads to the building entrance. The gate at the parking lot is metal, and supported by three columns that match the columns on the building. Landscaping consisting of low plants and medium-sized trees is in front of the gate, and in an alcove to the right of the pedestrian entrance on Milvia Street. There is a series of square pots on the sidewalk containing landscaping along the Milvia Street and Addison Street frontages. The style of the building could be described as contemporary commercial.

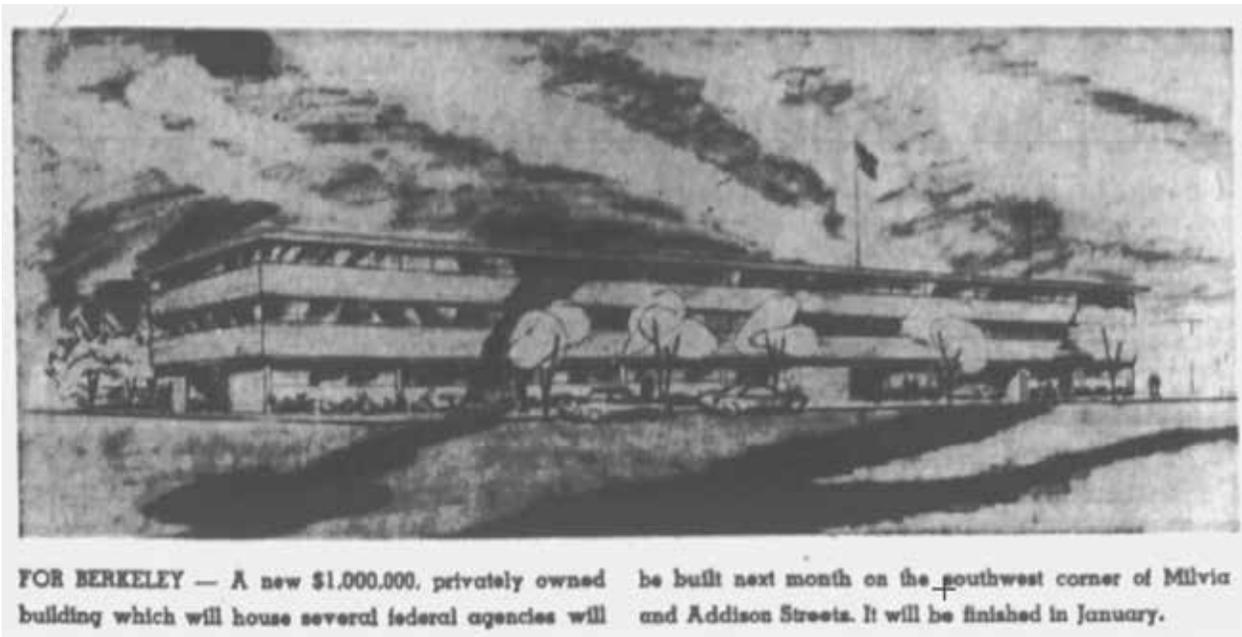
Fig.3 – 1960 Addison St. – from 1959 news article

The pre-1996 building exterior had an exposed concrete frame with concrete columns and cultured stone walls at the ground floor, continuous red (Roman) brick spandrels, clear aluminum ribbon windows and continuous concrete fascia and roof eaves. In other words, it was architecturally a Mid-Century Modern building design.

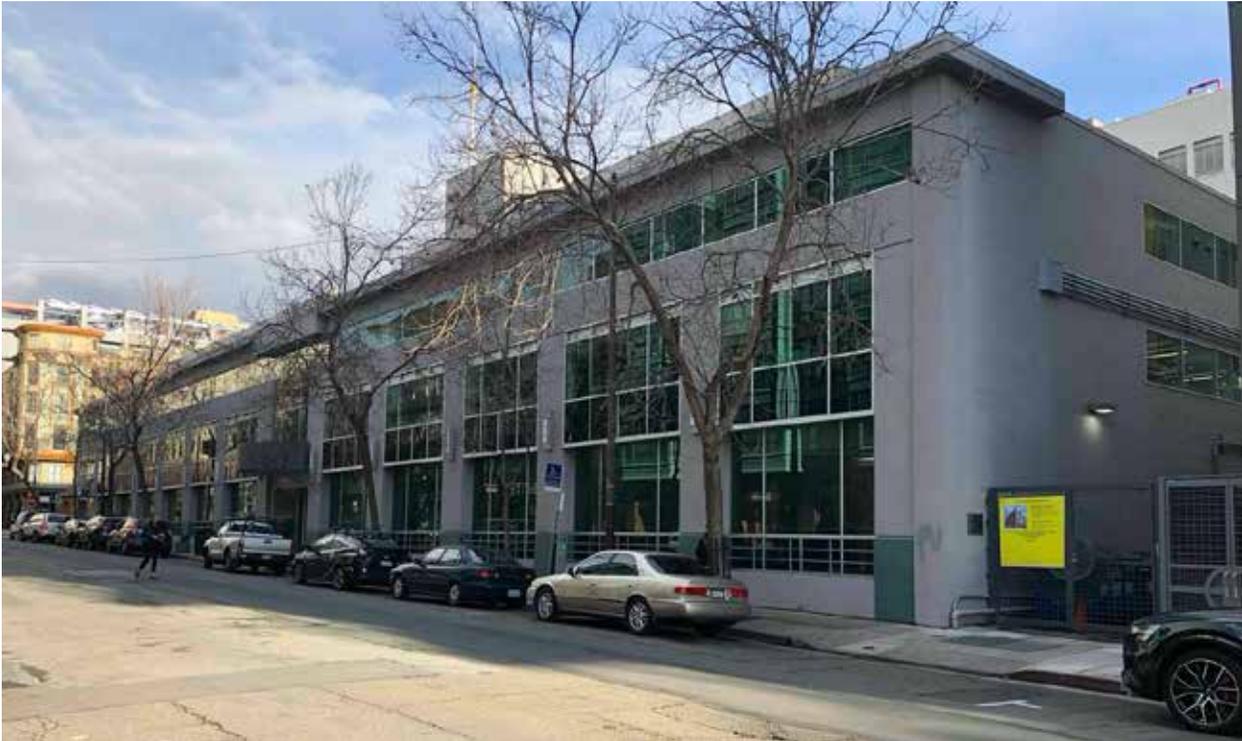
Fig.4– 2100 Milvia St. – North front

The 1996 building exterior (figs.4-7) has scored plaster-like (“EIFS”) cladding with broad piers and spandrels that enframe window bays, including 2-story high windows at floors 1 and 2, its doors and windows anodized aluminum with green glass and dark green apron and spandrel panels. Vertical piers all land on ceramic tile bases. No structure is exposed while there are a range of projecting architectural embellishments such as portal-like elements at the upper story and metal canopies – including a rounded entry canopy on Addison. Within the open lot, its open-end monumentally gated, a trellised-arcade ends at a vertical aedicule within the reentrant corner.

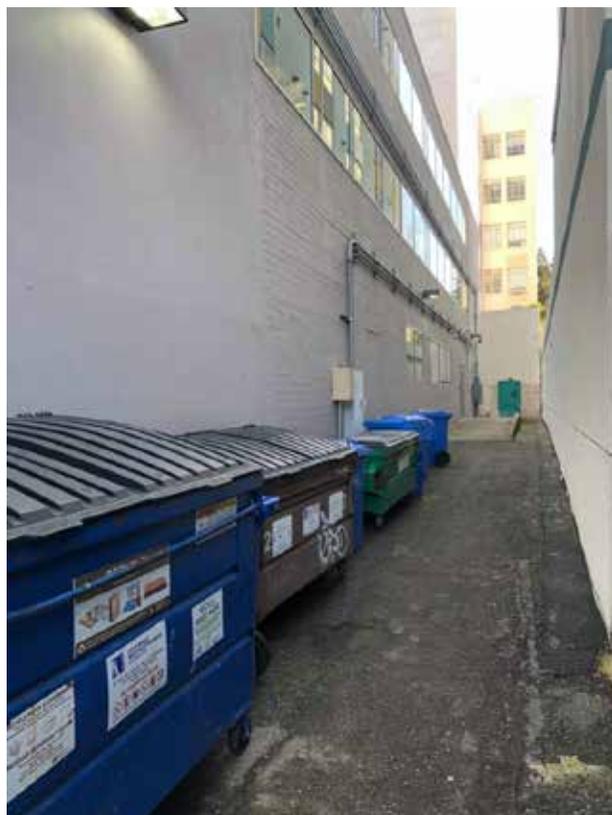
Fig.7 – 2100 Milvia St. – Rear (west)

As noted, in 1996 the overall building was renovated, the existing exterior design replacing the original to the extent that the only visibly surviving exterior elements are the brick clad penthouse atop the building and brick cladding at the rear (west) wall.

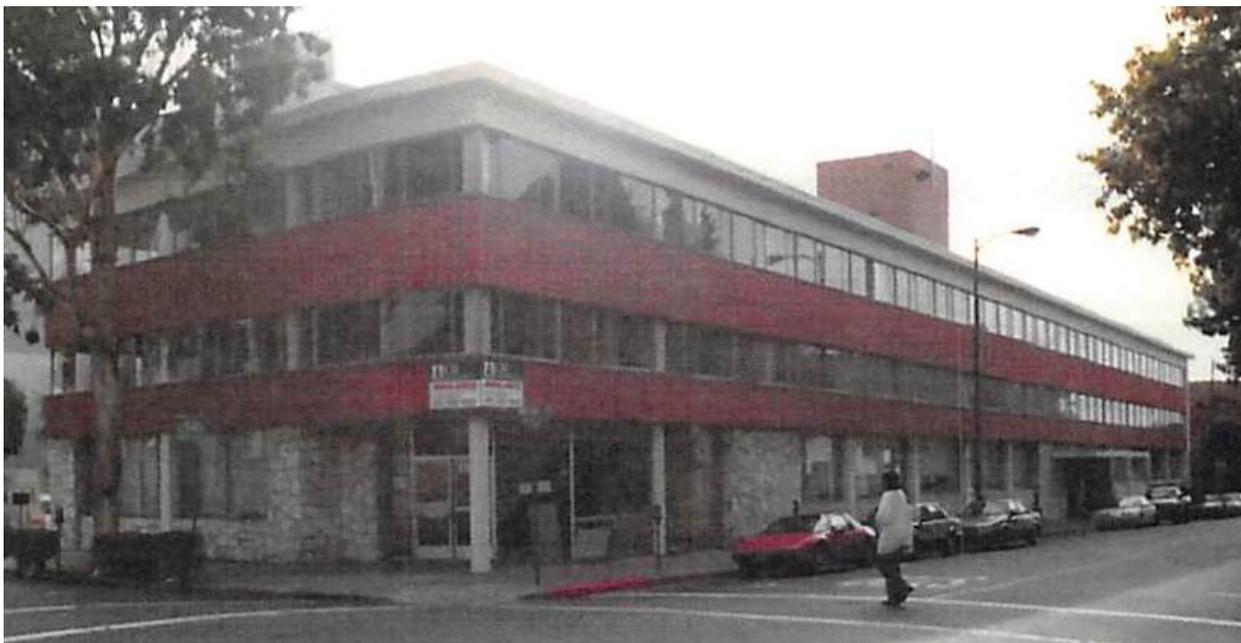
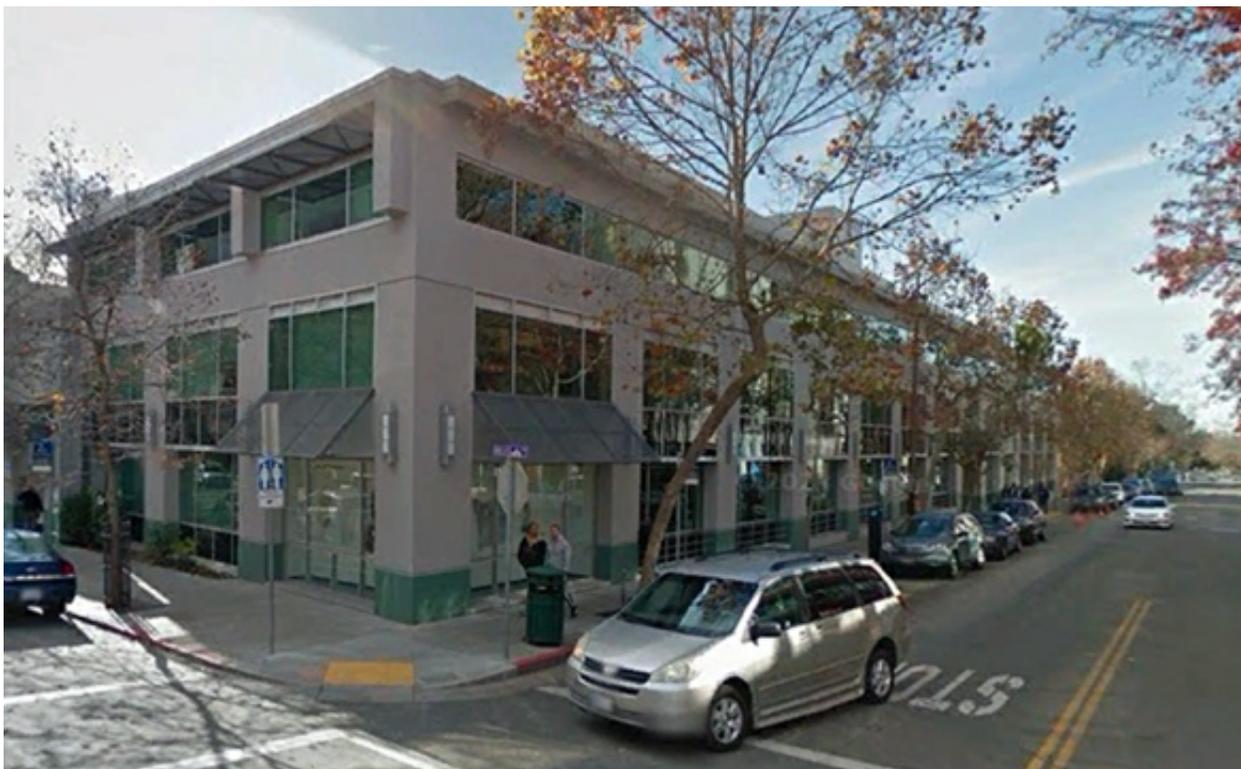
A comparison of pre-1996 views of the building versus the extant building illustrates how the contemporary commercial design eliminated the original minimal and horizontal mid-century architectural character and materials (figs.8-11).

Figs.8-9 – 1960 Addison/2100 Milvia St. – c1996 (above) and 2024 (below)

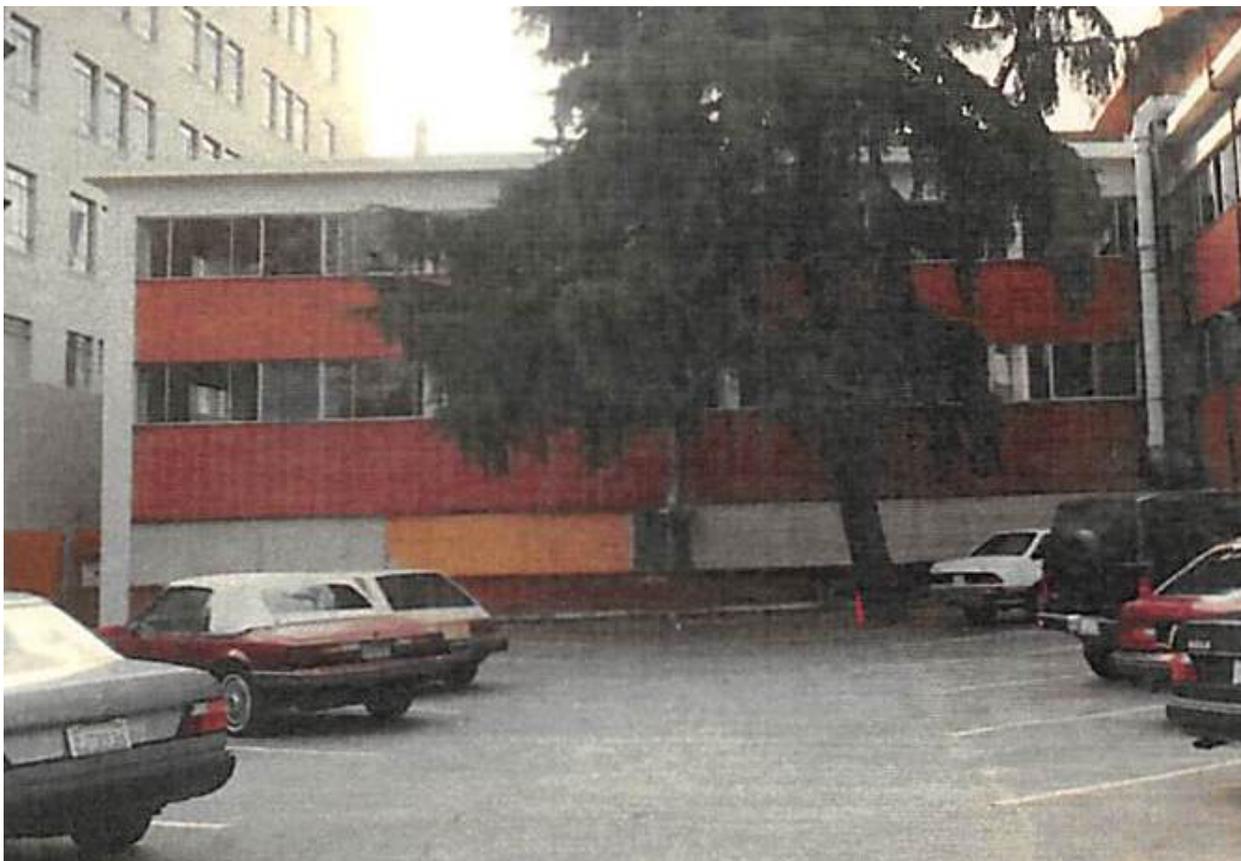
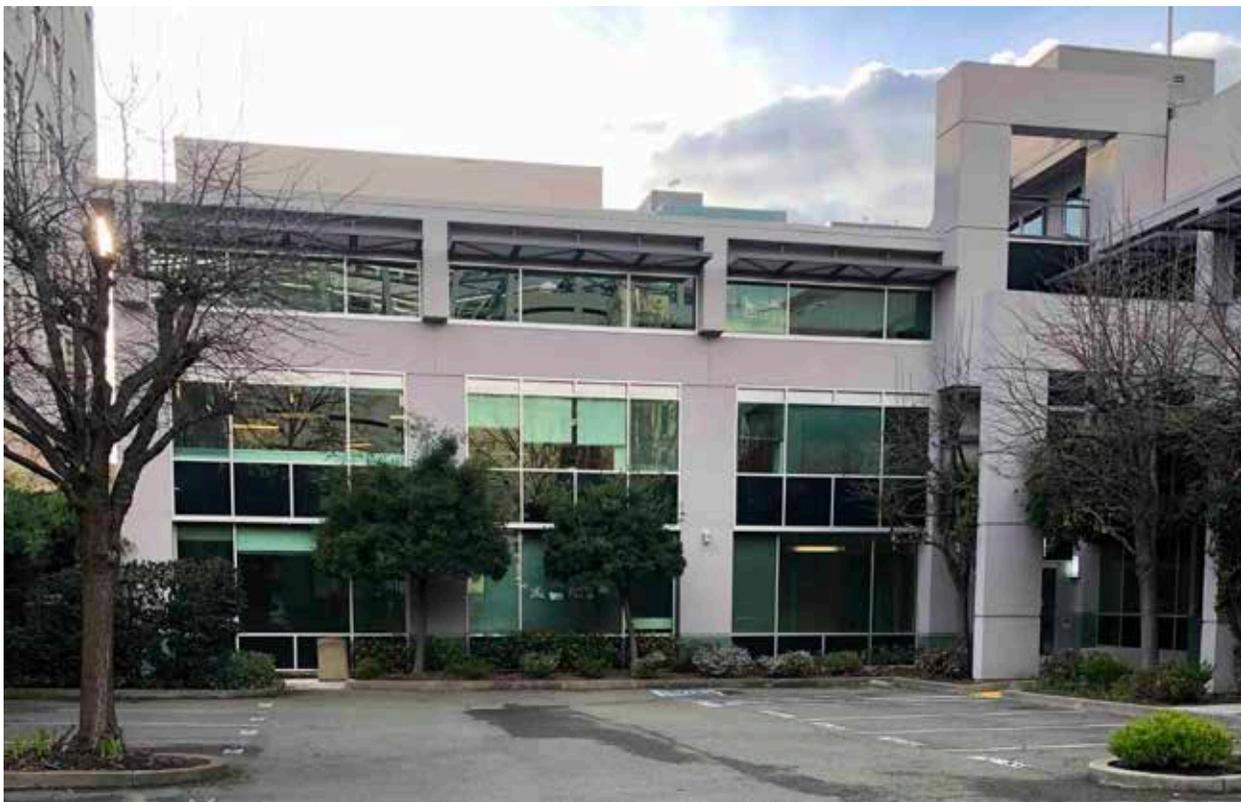
Figs.10-11 – 1960 Addison/2100 Milvia St. – c1996 (above) and 2024 (below)
