L A N D M A R K S  
P R E S E R V A T I O N  
C O M M I S S I O N  
S T A F F R E P O R T

## 1663-1687 Shattuck Avenue/2109 Virginia Street

**Demolition Referral: Use Permit (#ZP2024-0066) to demolish an existing two-story commercial building, originally constructed in 1906, substantially altered, and rebuilt in 1983 (APN: 058-2178-18).**

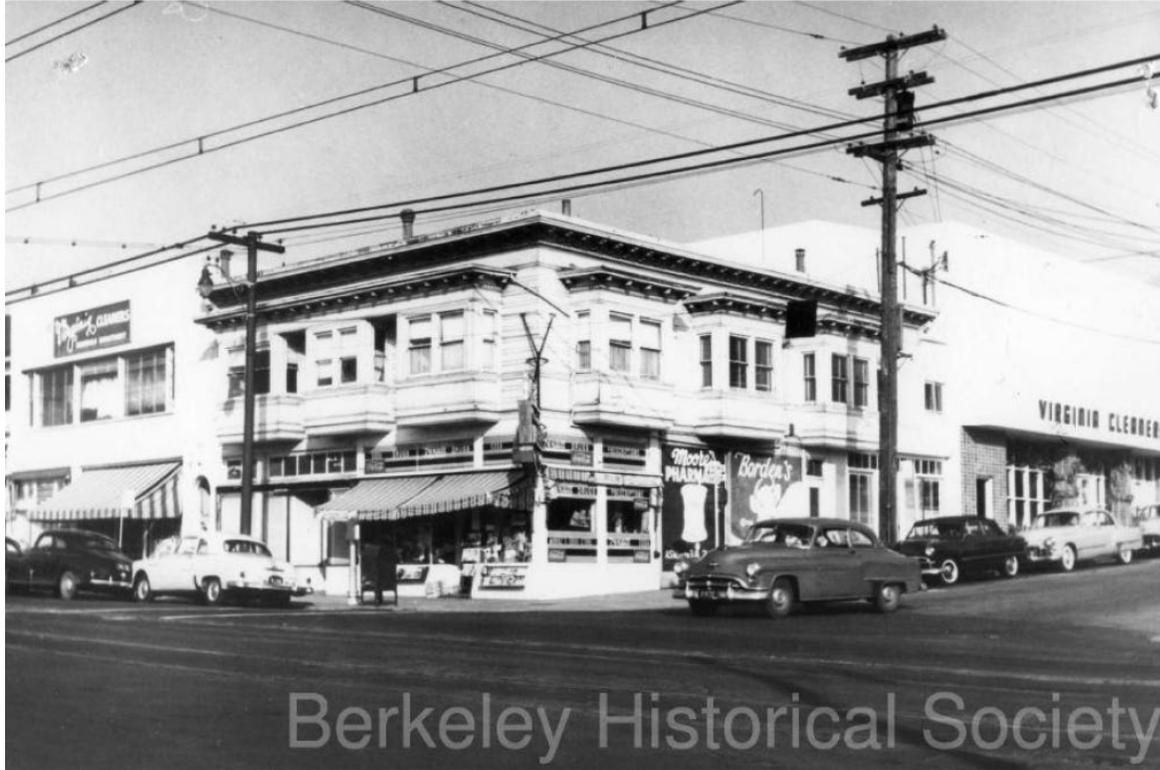
**Figure 2: Subject Property, historic photograph, ca.1952** (Berkeley Historical Society, via Left Coast Architectural History, 2024)

The 1950 Sanborn Fire Insurance map shows the conditions of 1929 still largely the same, although a 1952 photograph shows that the northern half of the building and the Virginia Street additions had been stylistically remodeled in the Art Moderne style, including boxy forms, flat stucco wall planes, large multi-part windows with thick steel-sash frames, stack bond brick veneer, flat projecting canopies, and unadorned flat rooflines. These Modernistic sections of facade bracketed the original portion of the building, which still exhibited its original Edwardian style. The aesthetic improvements were made on behalf of Virginia Cleaners, which had also come to occupy the northernmost shop space fronting on Shattuck, where "ironing" was performed, and the second floor of the northern half of the building, which was used for "spotting and ironing." Shop spaces along Virginia Street were more specifically labeled as "office" and "pressing." A drug store, then Moore's Pharmacy, was still located in the corner storefront and may have extended into the space to the north, while the Ideal Market still occupied the right-hand shop space in the northern half of the building.

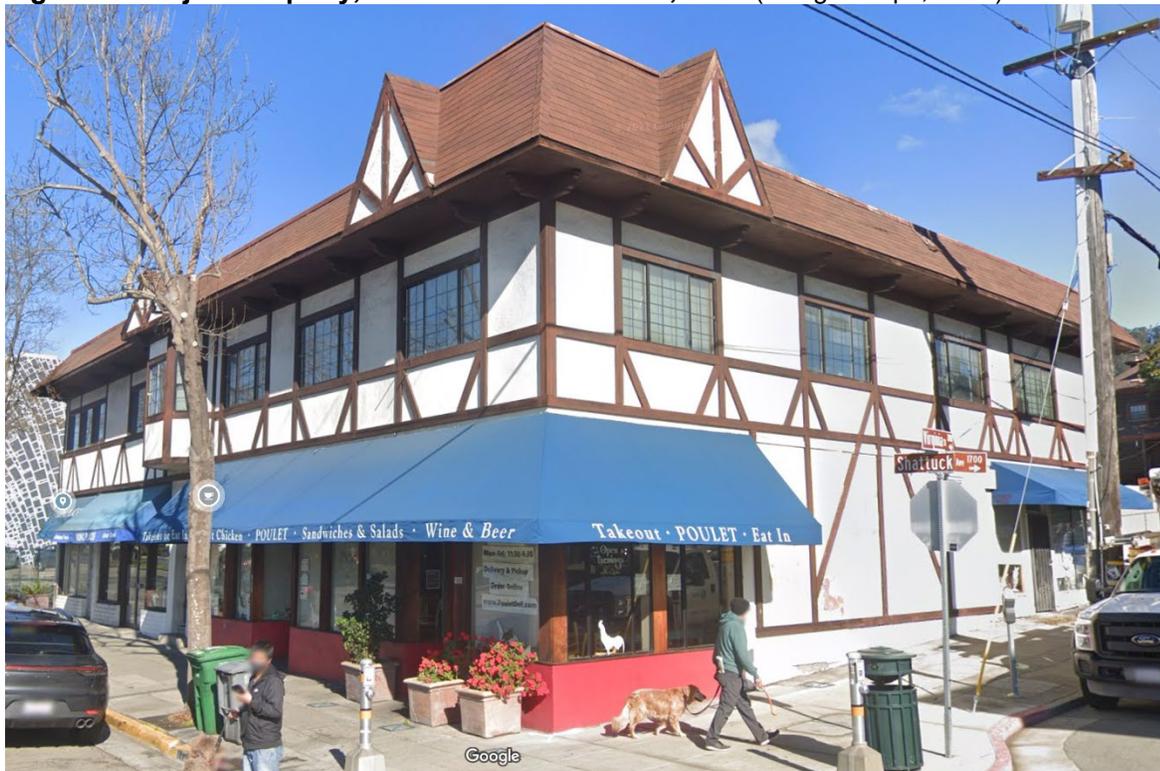
**Figure 3: Subject Property, current site conditions, 2024** (Google Maps, 2024)

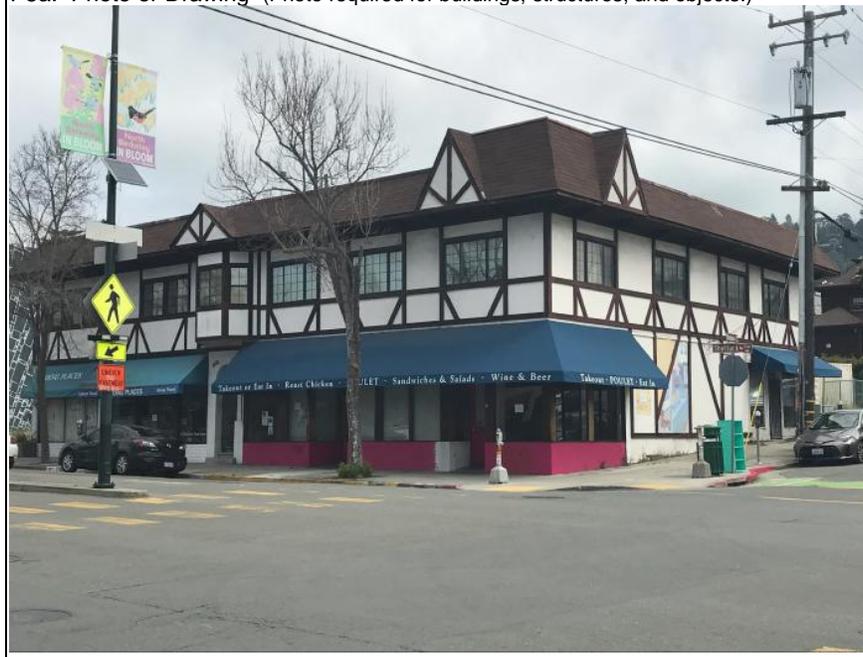
P5a. Photo or Drawing (Photo required for buildings, structures, and objects.)

Primary (west) and south facades, looking northeast; April 2024

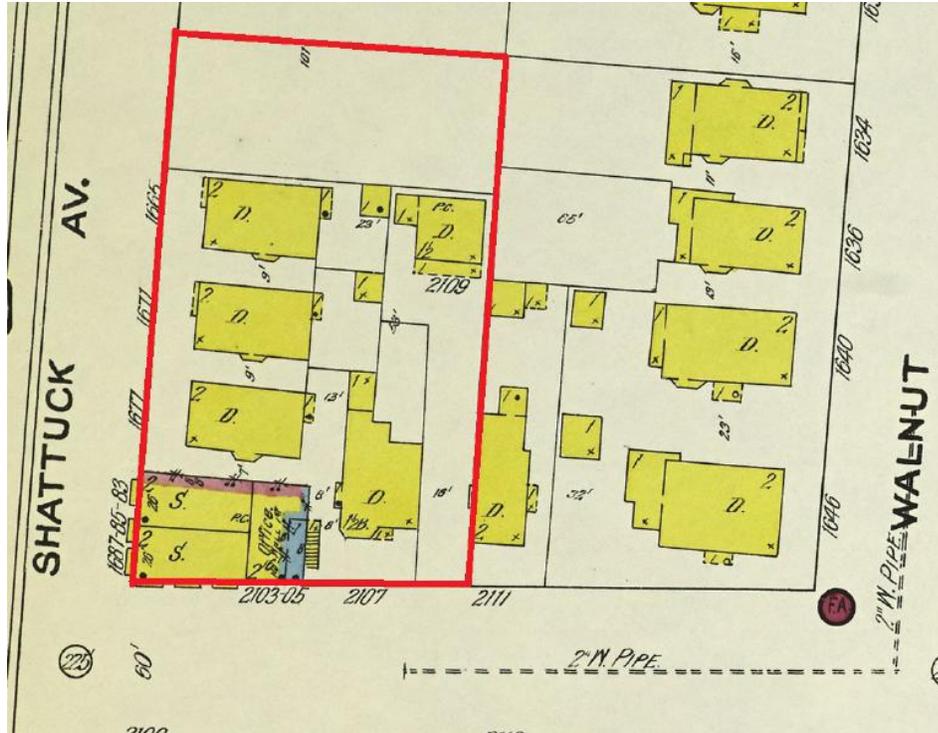
1911 Sanborn Fire Insurance map, showing original extent of building at corner. Current subject parcel outlined. (Historical Information Gatherers)

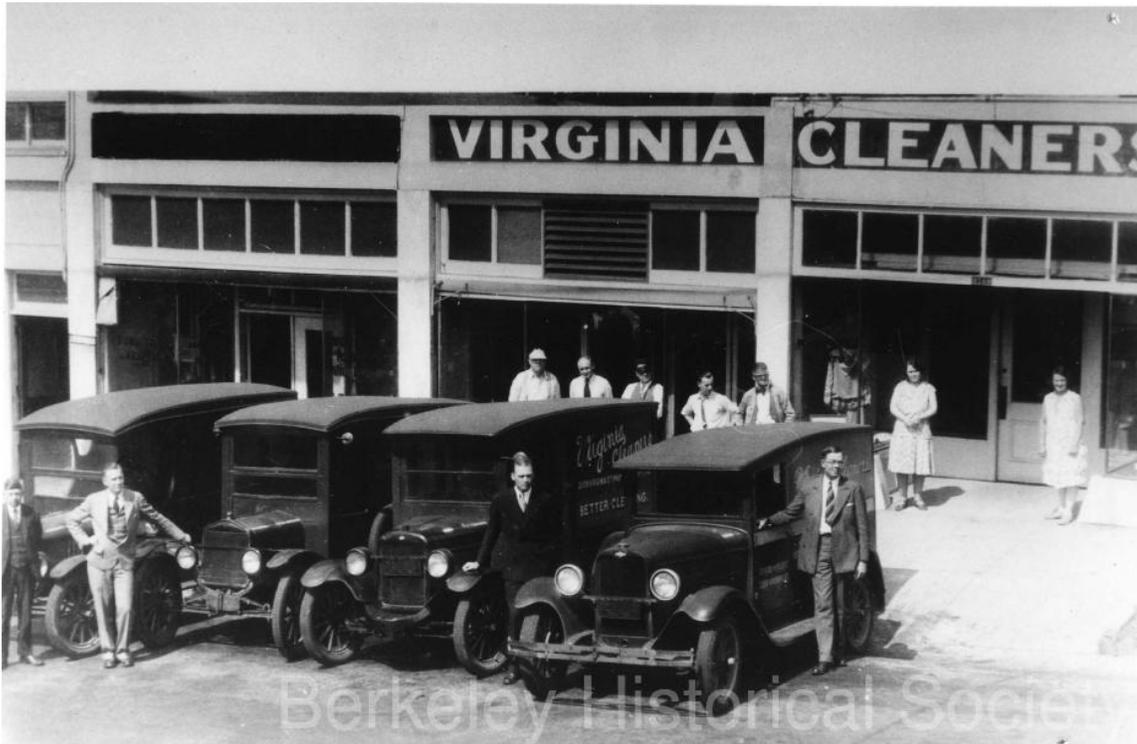
1928 photo of Virginia Street facade, storefronts of eastern addition (no longer extant). (Berkeley Historical Society)

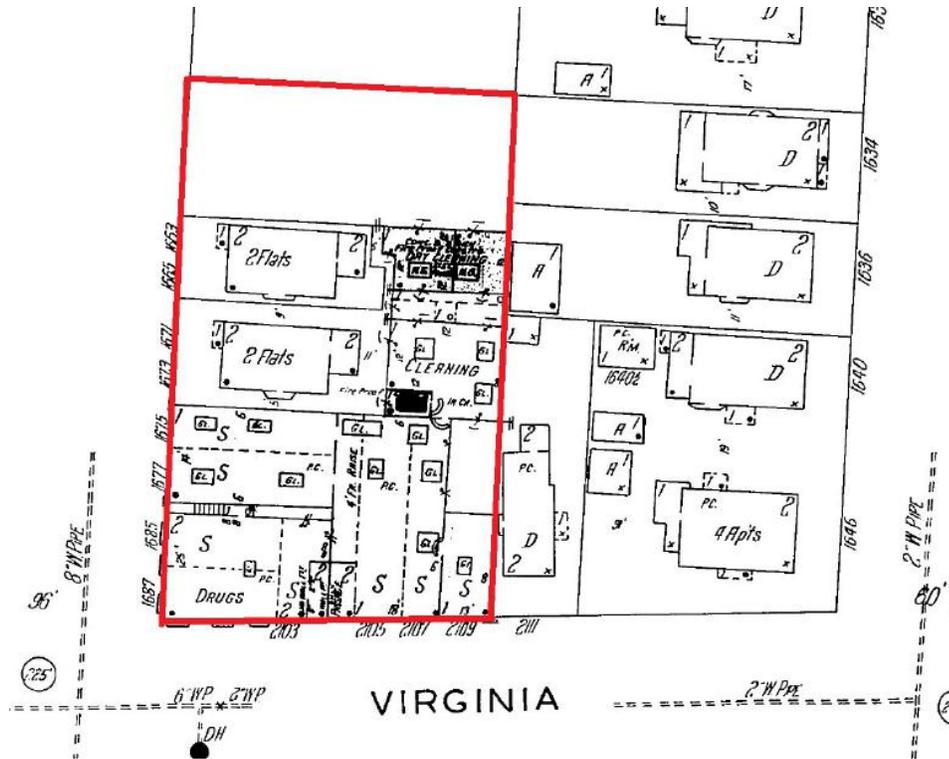
1929 Sanborn Fire Insurance map, showing additions to north and east of original building at corner. Current subject parcel outlined. (ProQuest)

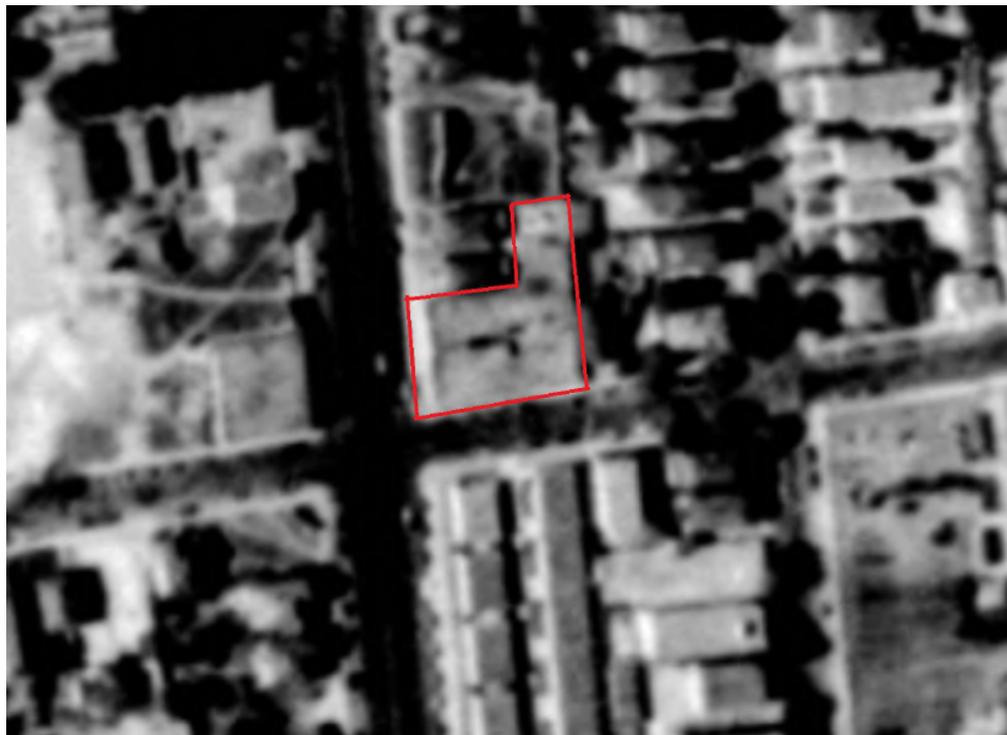
1939 aerial photo, extent of building at the time outlined. (UC Santa Barbara Library)

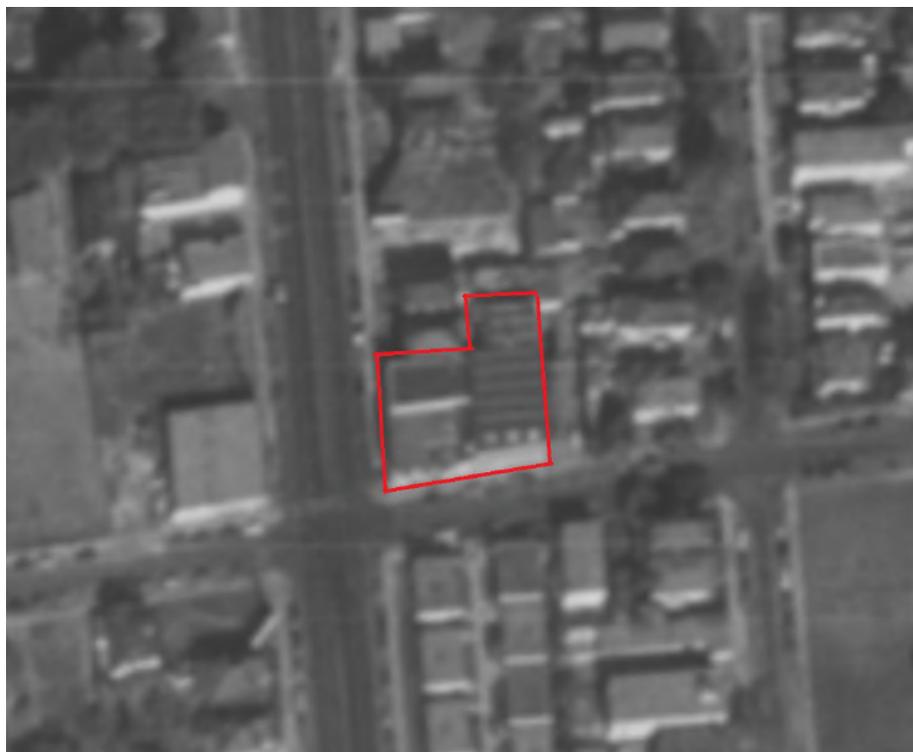
1947 aerial photo, extent of building at the time outlined. (UC Santa Barbara Library)

- 1950 Sanborn map:  
Map indicates the eastern extension had gained a second story. A sawtooth roof is noted over this portion of the building, reproducing the roof that was present when the building was one story (as seen in a 1947 aerial photo).

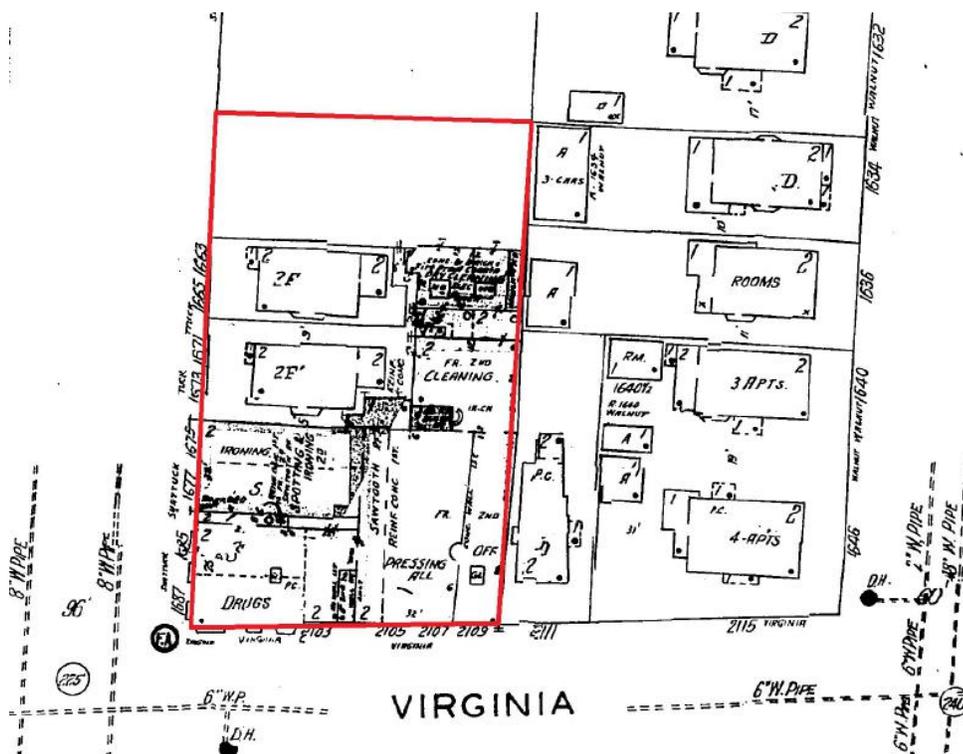
1950 Sanborn Fire Insurance map, showing full extent of building at the time. Current subject parcel outlined. (ProQuest)

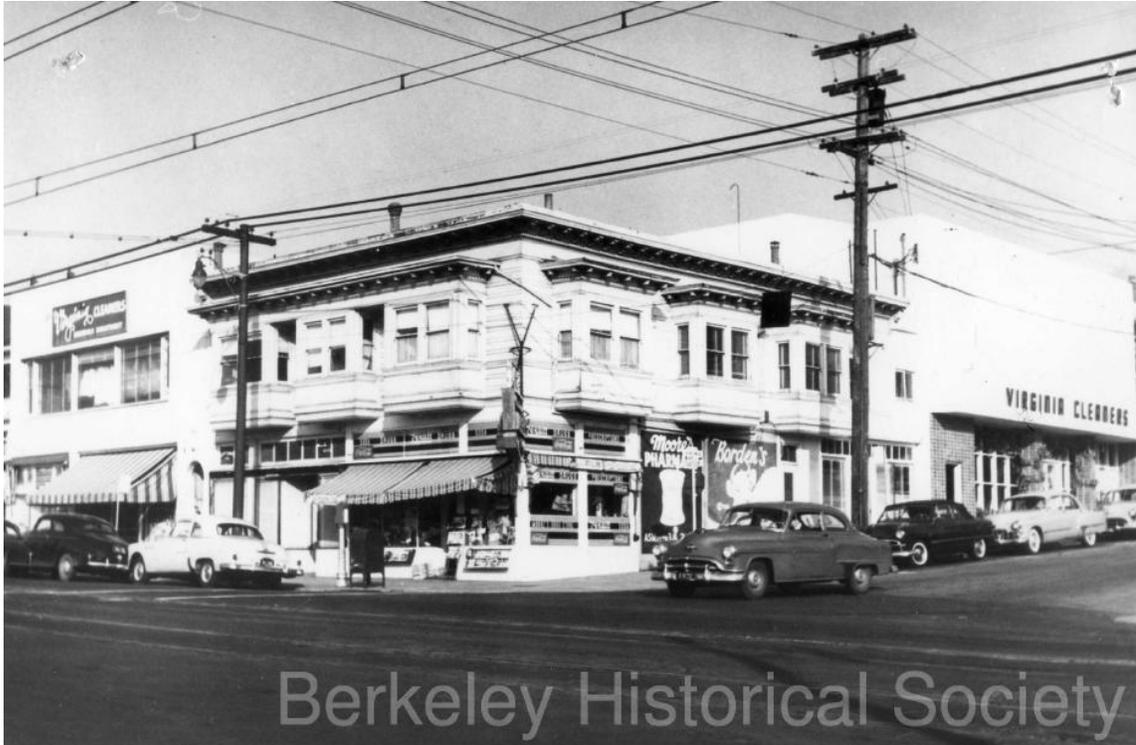
1952 photo looking northeast at subject property; includes Edwardian corner building, two story mass to left, and two story mass to right, both with "Virginia Cleaners" signs visible. (Berkeley Historical Society)

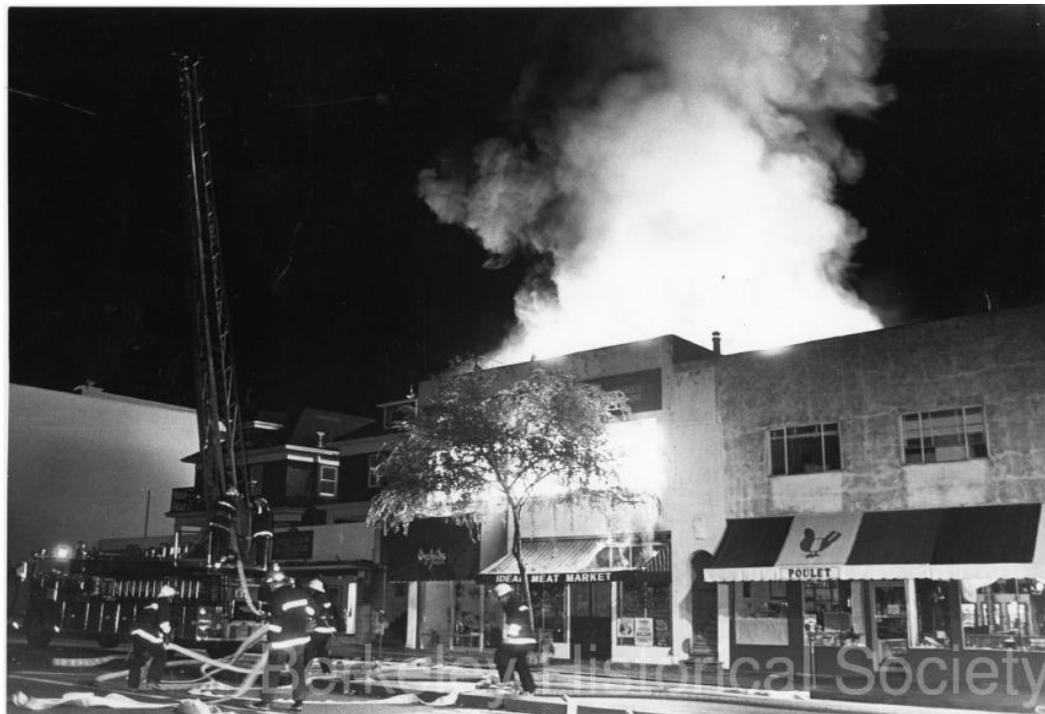
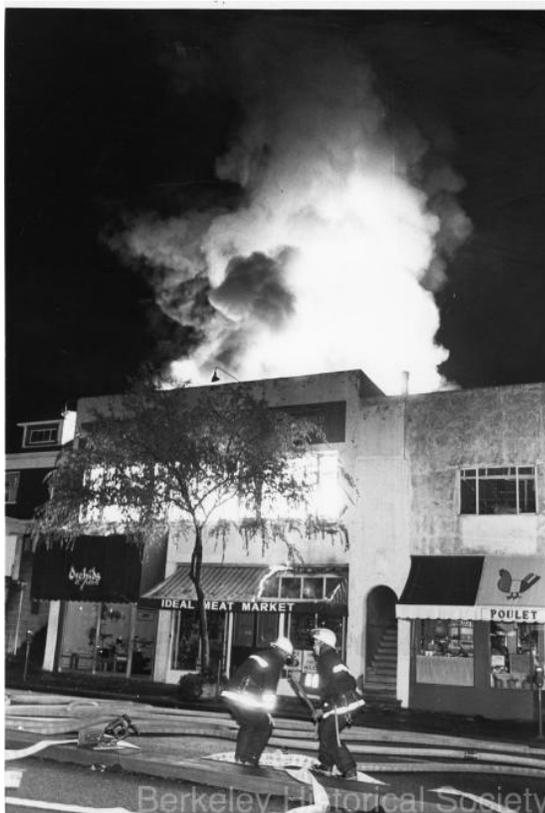
1981 photographs of fire at property, looking east from Shattuck Ave. (Berkeley Historical Society)

In the early morning hours of 17 November 1981, an electrical problem sparked a three-alarm blaze in the eastern portion of the building, occupied by Virginia Cleaners. Flames spread into the western portion of the building where the Ideal Meat Market, a flower shop, and Poulet restaurant were storefront tenants. The fire burned for over two hours before being extinguished. A firefighter fell down the central stairwell and was injured during the emergency, which caused an estimated \$1.2 million in damages. After the fire, the deputy fire marshal stated that "the building look[ed] like a Hollywood false front... all the walls and floors fell into the center." (BDG, 27 Nov. 1981)

- 1981 Photograph, Newspaper Articles, and Property Records:  
The building was damaged by a major fire, which destroyed the entire eastern extension and second floor of the current building, while heavily damaging the northern half of the first floor. The shop spaces on the southern half of the first floor were relatively unharmed, but damage resulted in the demolition of most of the existing structure. The building was rebuilt by 1983 in its current extent and architectural character (Neo-Tudor style), which is entirely different from its original appearance and the appearance it had taken on over time with subsequent alterations, additions, and remodeling efforts.

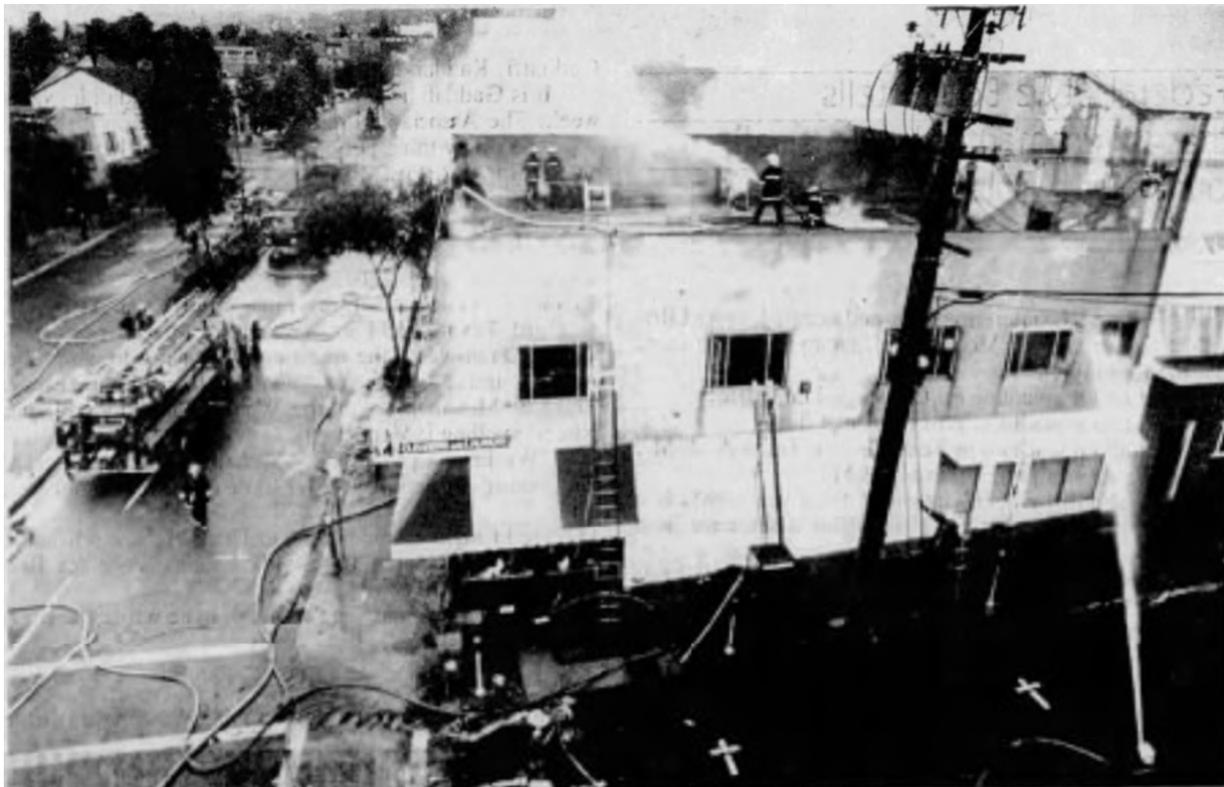
1981 photograph from *Berkeley Daily Gazette* (17 Nov. 1981 edition) showing post-fire clean-up.

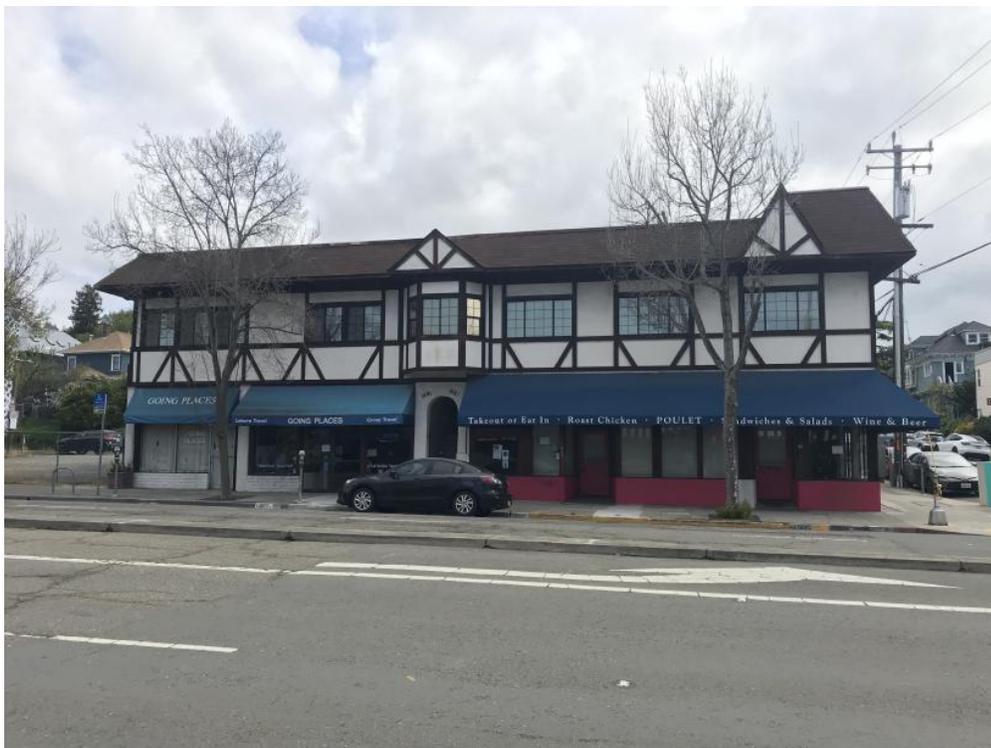
Primary (west) facade, looking east from Shattuck Avenue.

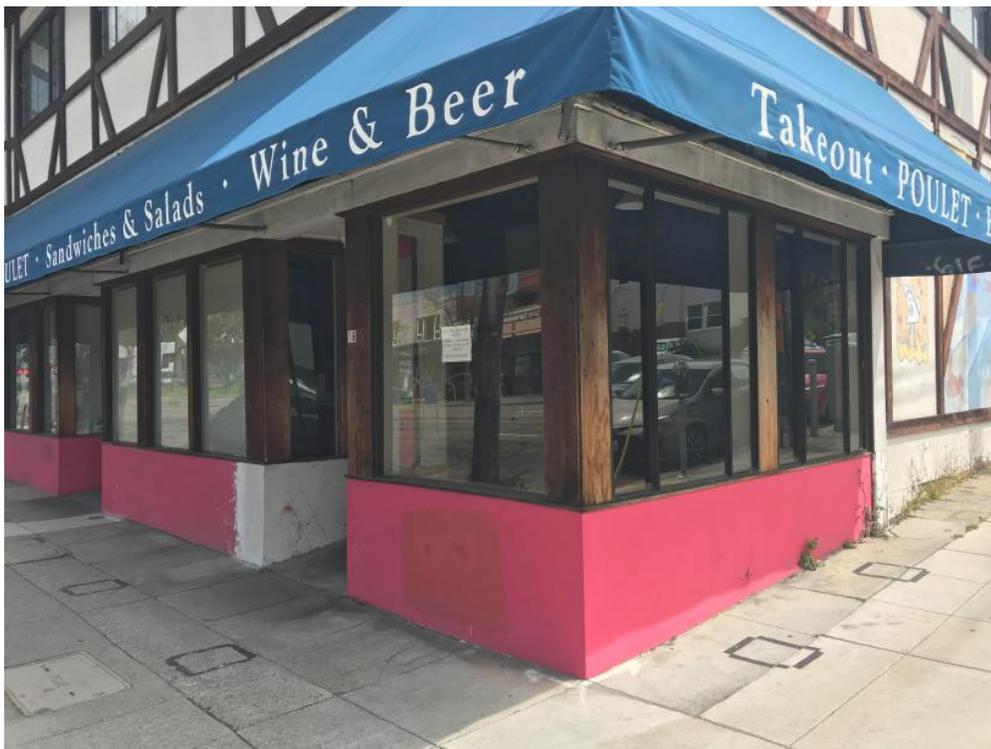
Southwest corner of building, looking northeast at 1685 Shattuck Ave. storefronts.

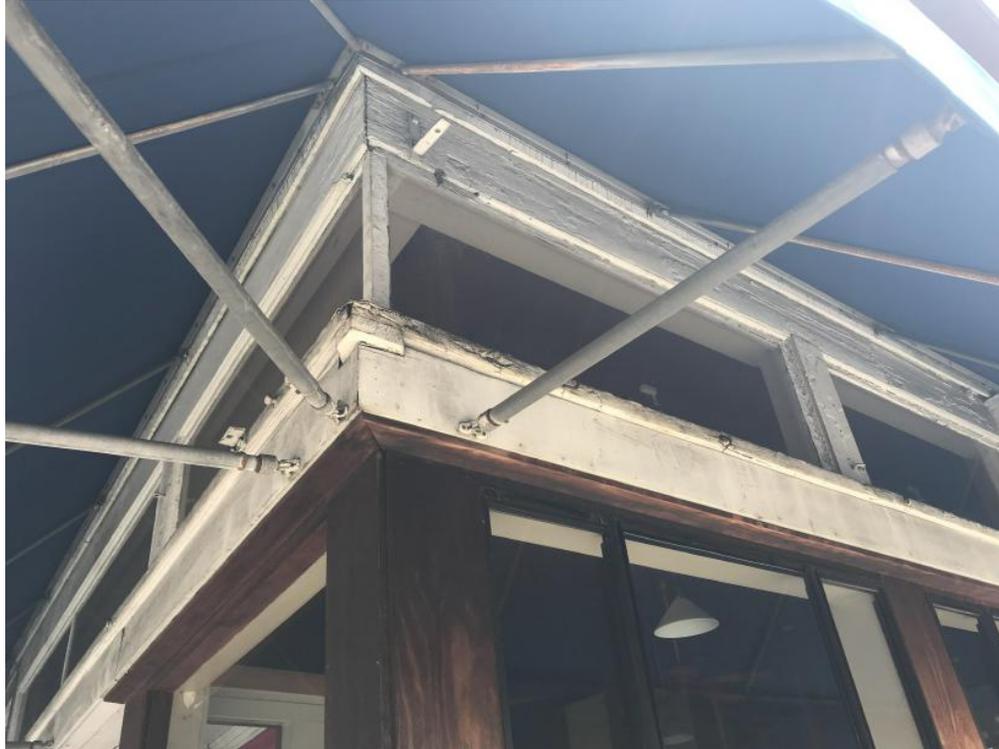
Detail of clerestory windows above storefronts at southwest corner of building, only original feature of building that remains.

The extant building at 1677-1685 Shattuck Avenue possesses very little historic fabric from the original 1906 building that was developed on site. The HRE in Attachment 1 identifies the only remaining original feature from the original 1906 construction as being the clerestory windows about the storefronts at the southwest corner of the building.

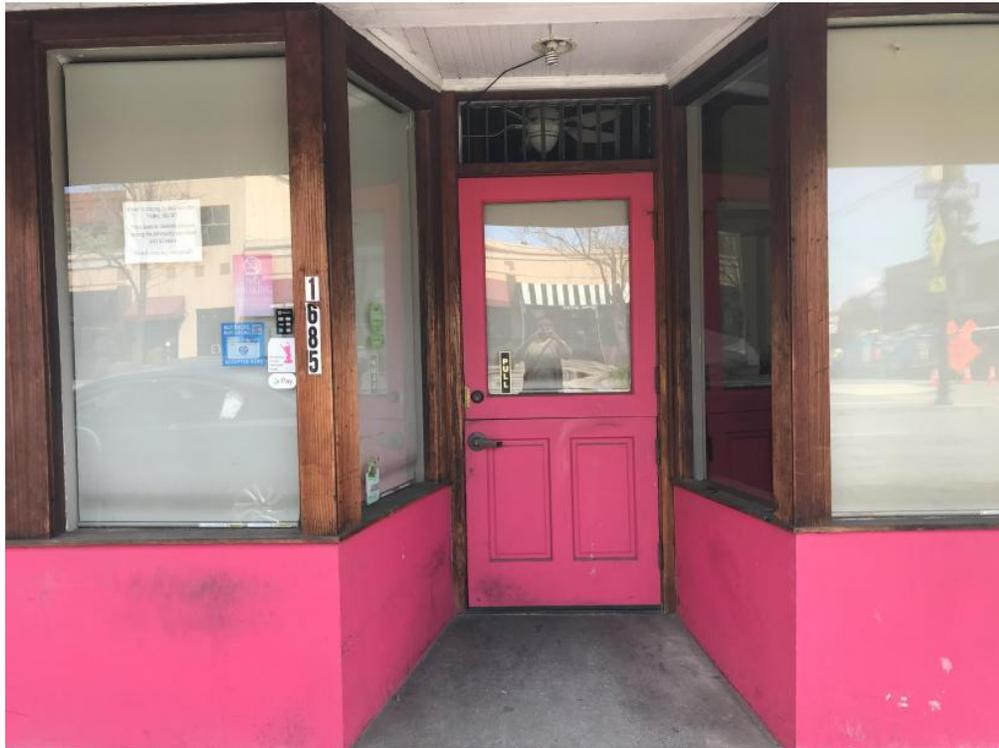
Example of recessed storefront entry on south side of primary (west) facade (one of two similar).

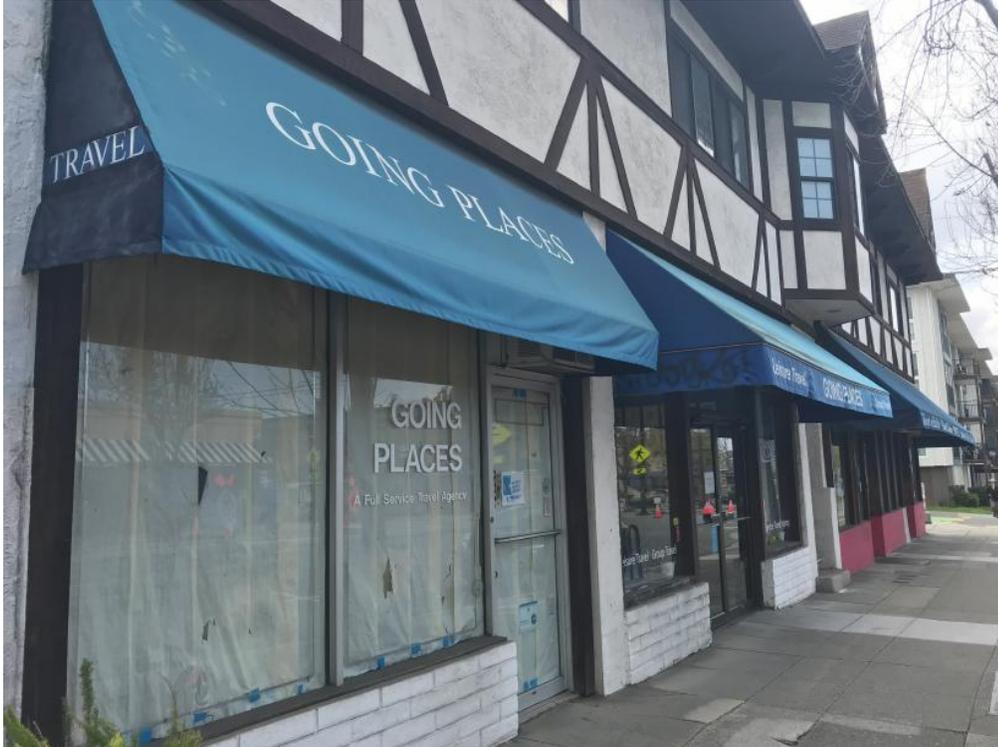
Primary (west) facade, looking southeast from building's northwest corner. 1677 Shattuck storefronts nearest.

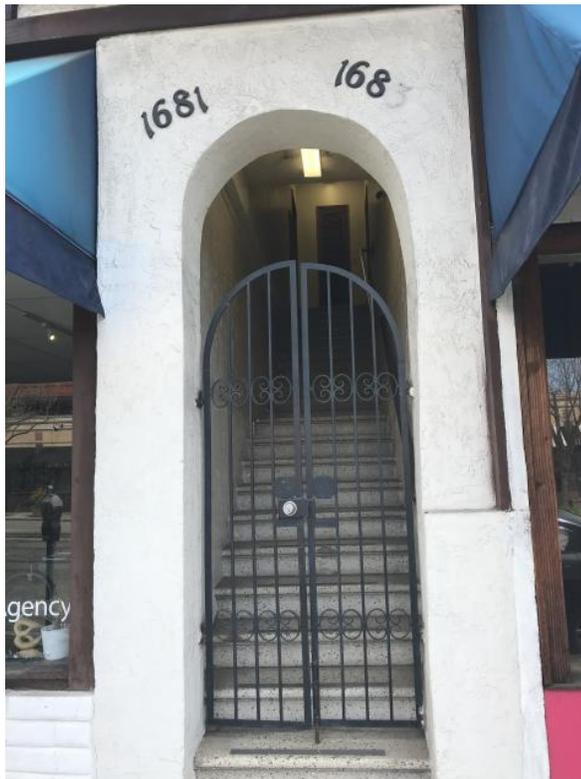
Centered entry to second floor on primary (west) facade.

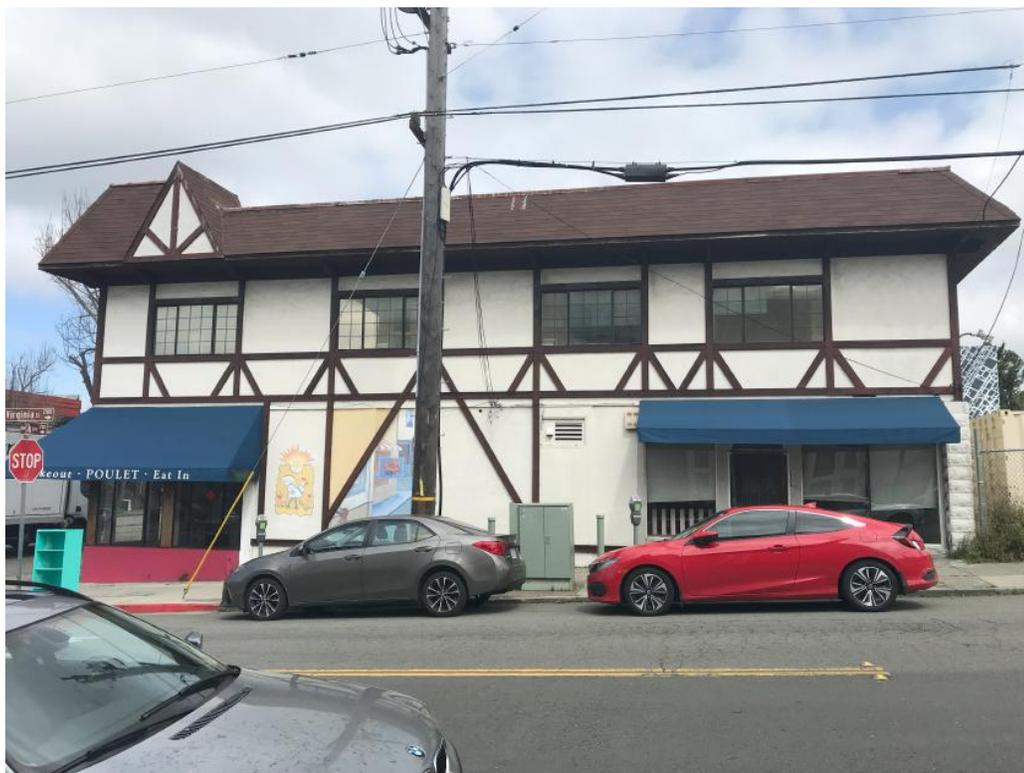
South facade, looking north from Virginia Street.

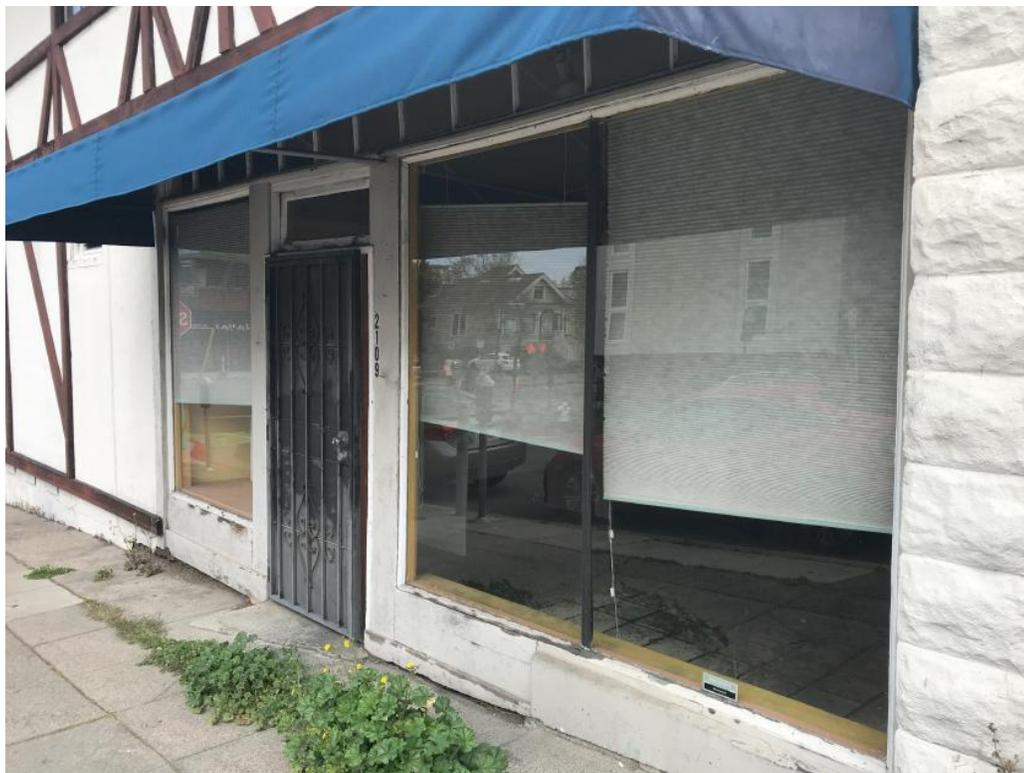
Storefront of 2109 Virginia Street at east side of south facade.

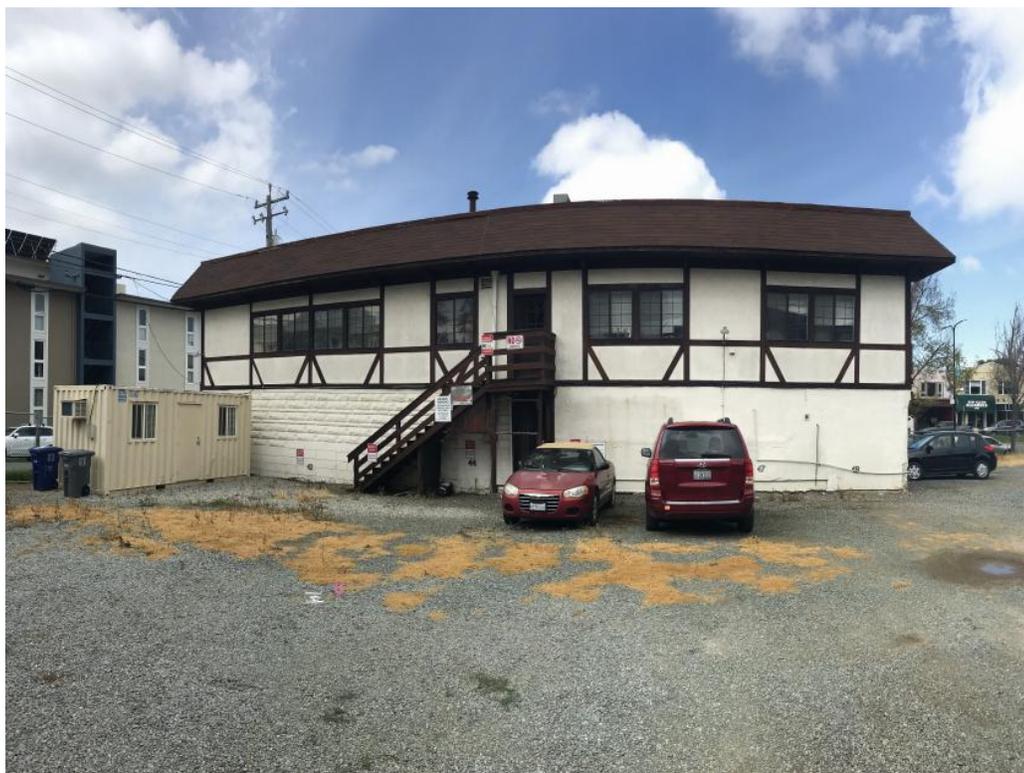
Rear (east) facade, looking west from parking area.

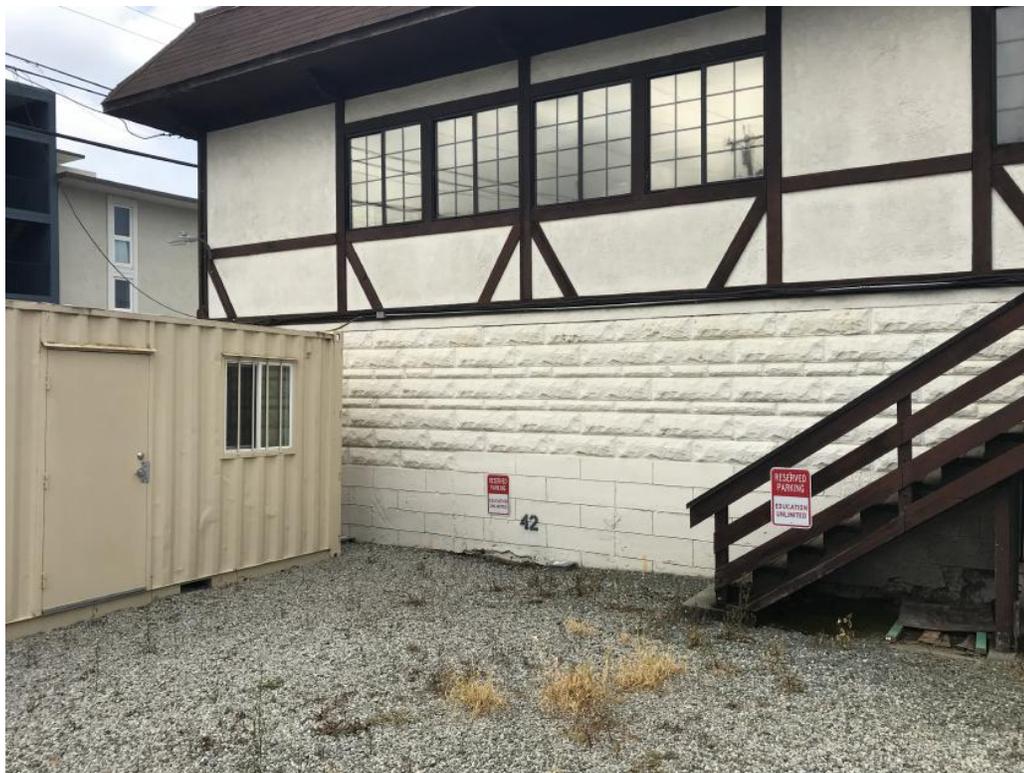
Detail of cast stone section of wall at south side of rear (east) facade.

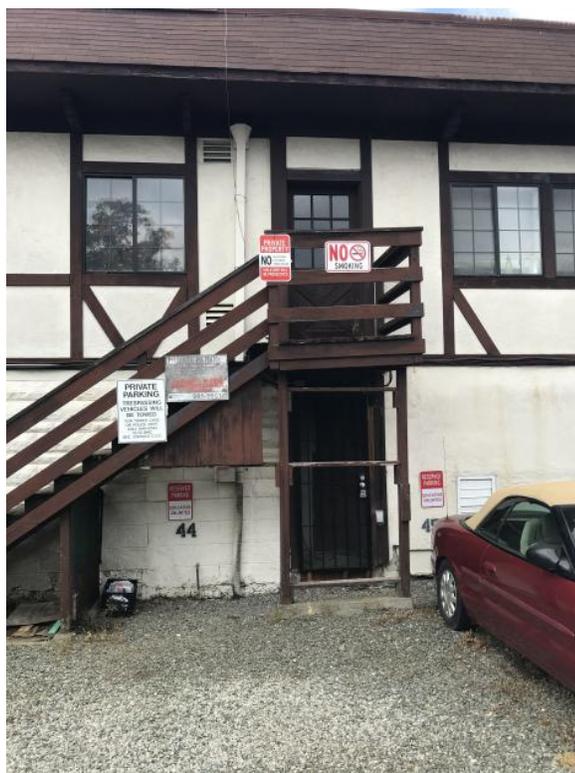
Detail of secondary entrances on rear facade related to central stairwell.

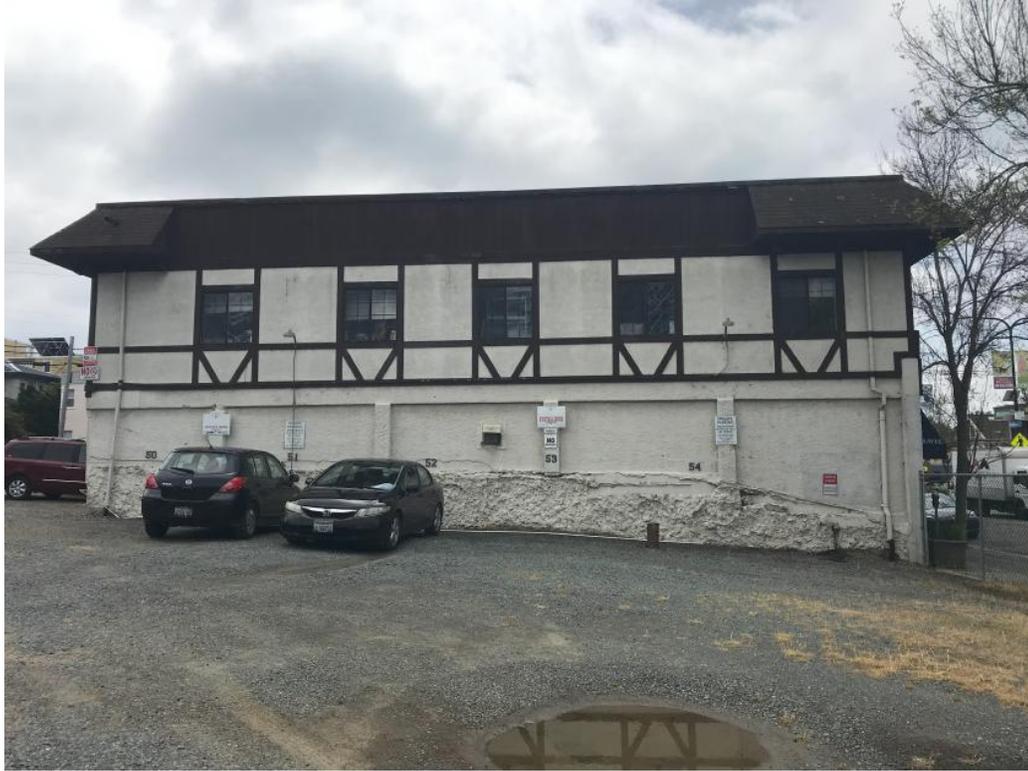
North facade, looking south from parking area.

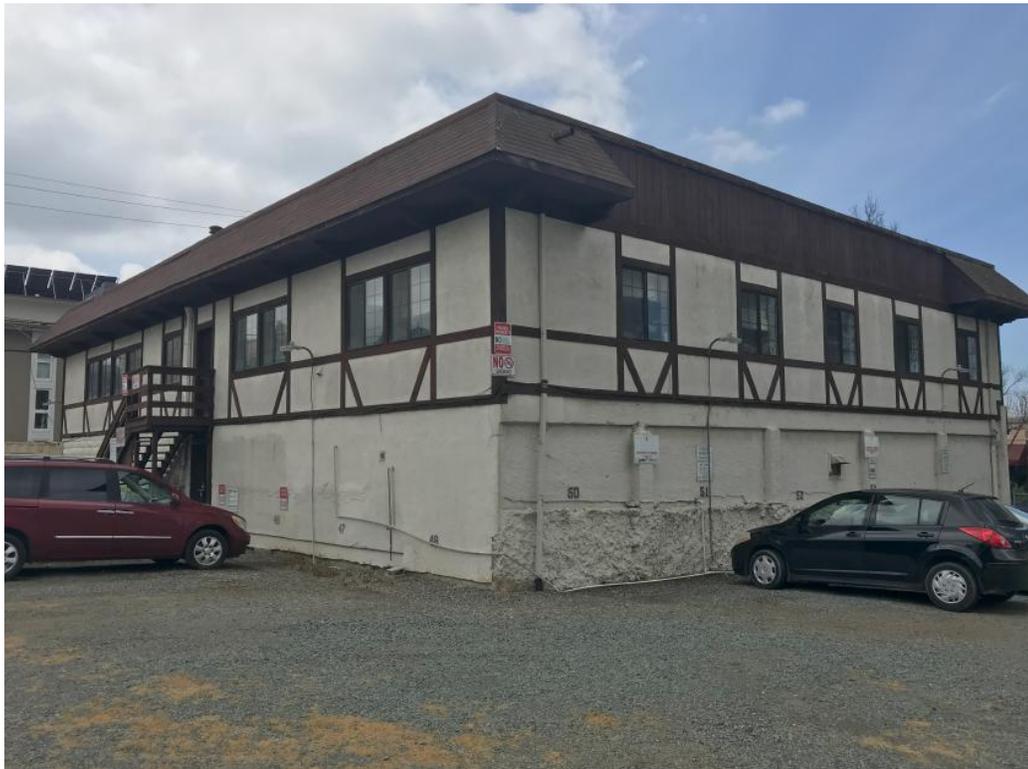
Northeast corner of building, looking southwest from parking area.
