DATE April 7, 2025 PROJECT 24021.1
NUMBER
TO Allison Reimer, Associate Planner PROJECT 214 Hillcrest Road, Berkeley,
California Register Nomination
OF Planning and Development FROM Stacy Kozakavich, Page & Turnbull
Land Use Division
City of Berkeley
1947 Center St., 2nd Floor
Berkeley, CA 94704
CC VIA USPS Certified Mail

State of California — The Resources Agency DEPARTMENT OF PARKS AND RECREATION PRIMARY RECORD	Primary # _____		
	HRI # _____		
	Trinomial _____		
	NRHP Status Code <u>3CS</u>		
Other Listings _____	Review Code _____	Reviewer _____	Date _____

Page 1 of 38 Resource name(s) or number (assigned by recorder) 214 Hillcrest Road

P1. Other Identifier: Claremont Club Building

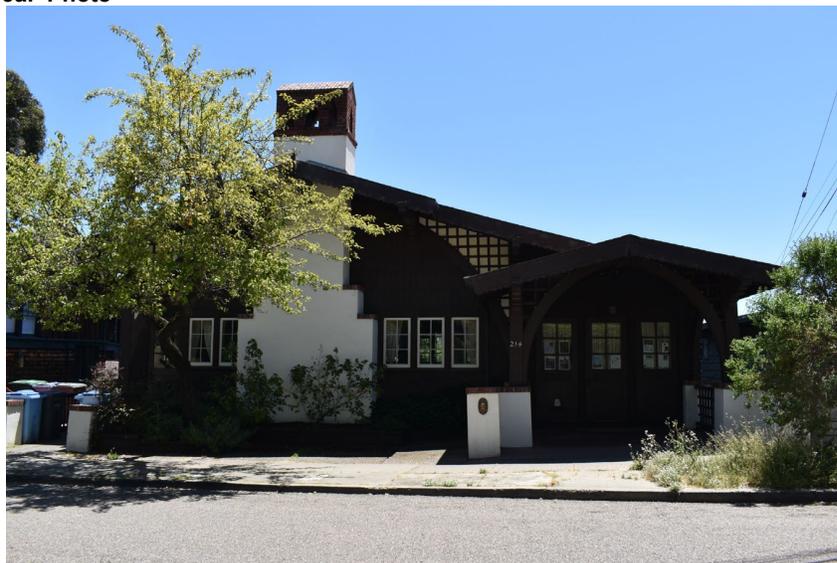
P5a. Photo

P5b. Photo: (view and date)
 Primary façade, view southeast. Taken March 6, 2025.

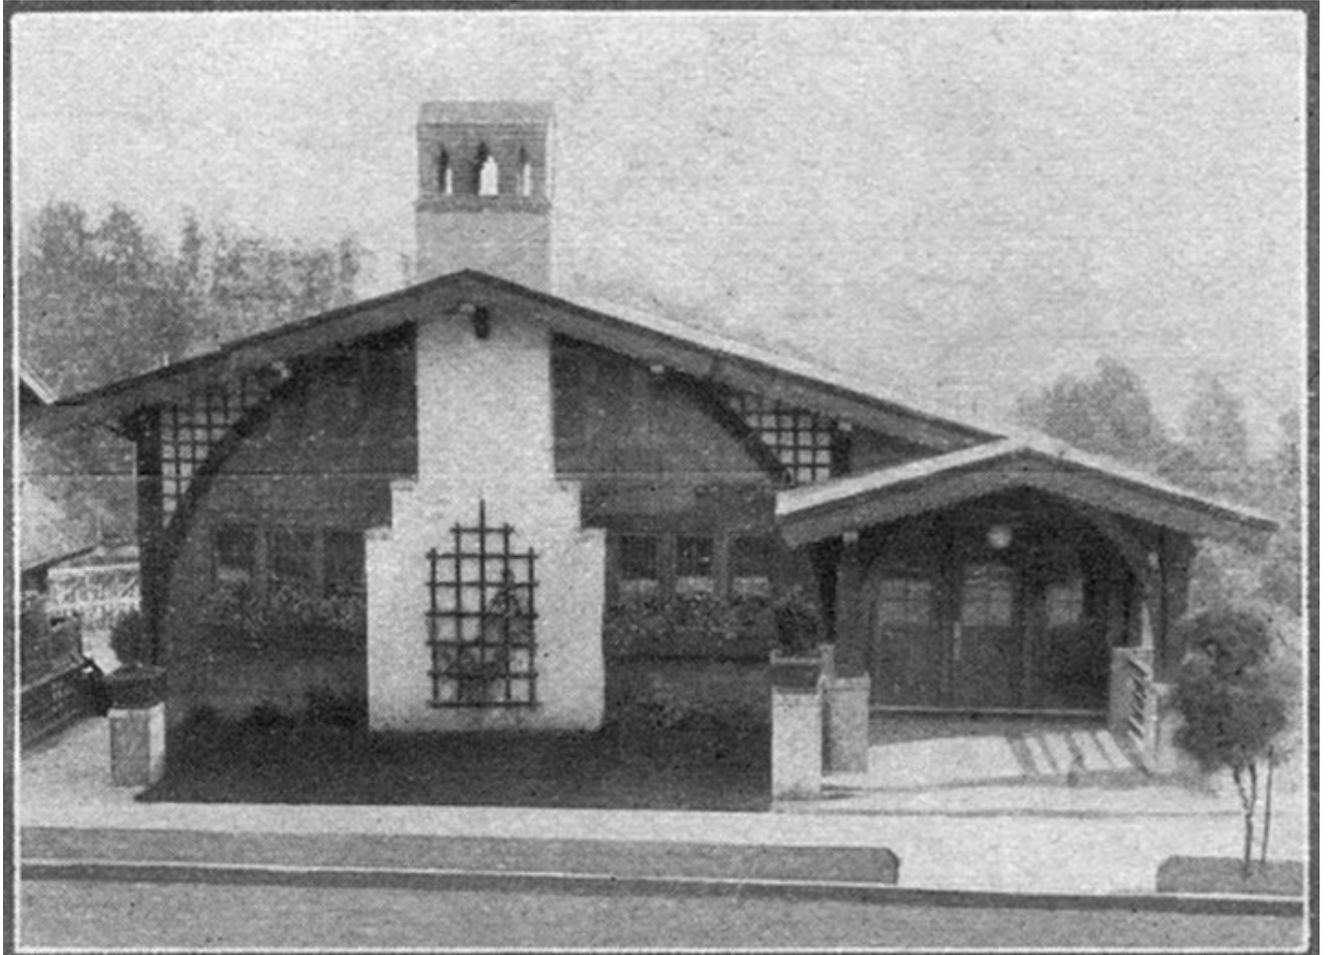
Figure 1: Early photograph of the Claremont Club, likely from a club bulletin advertising the completion of the new building, undated. Source: archival collection of the Claremont Club.

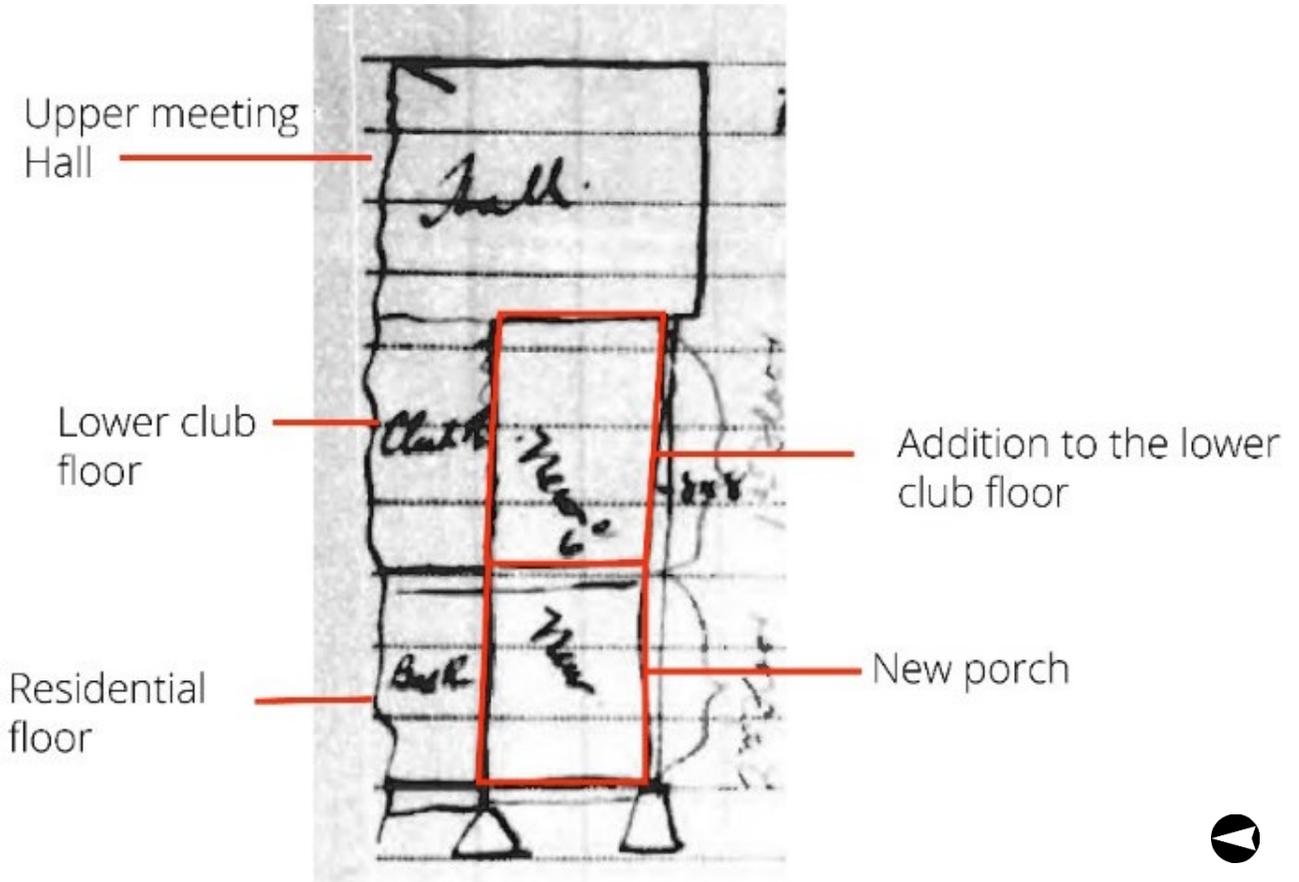
Figure 2: Section drawing detailing alterations to the south façade, including an addition to lower clubroom spaces on the second floor and construction of a new porch at the exterior of the residential unit, 1924. Source: Permit #17927. Edited by Page & Turnbull.

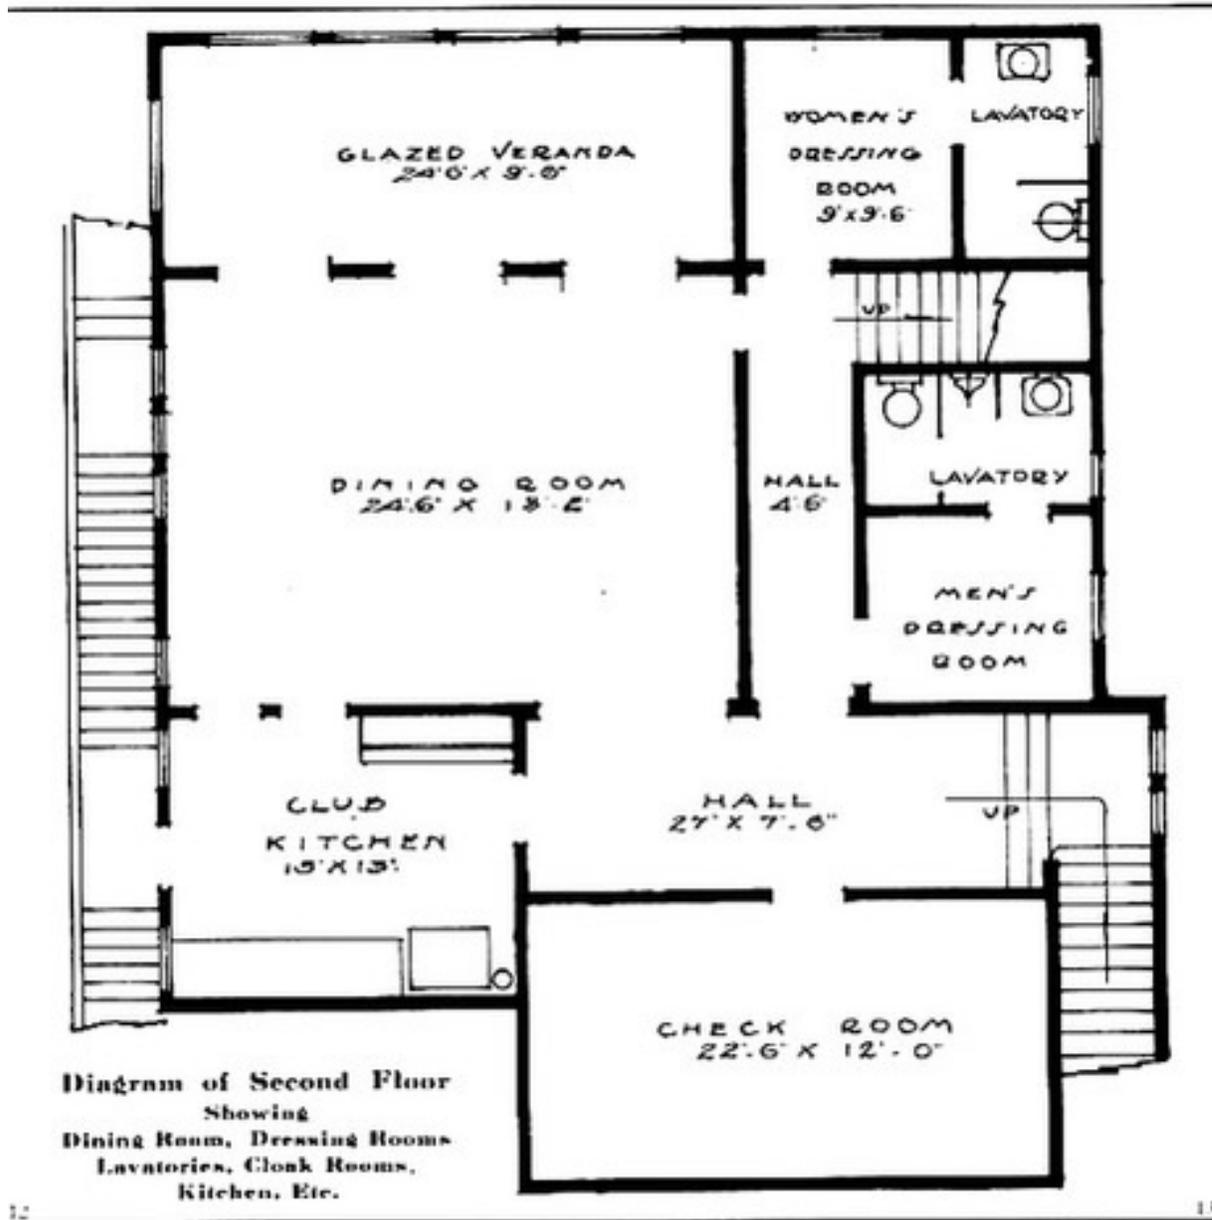
Figure 3: Early plan of the second floor of the Claremont Club, likely from a club bulletin advertising the completion of the new building (undated). Source: archival collection of the Claremont Club.

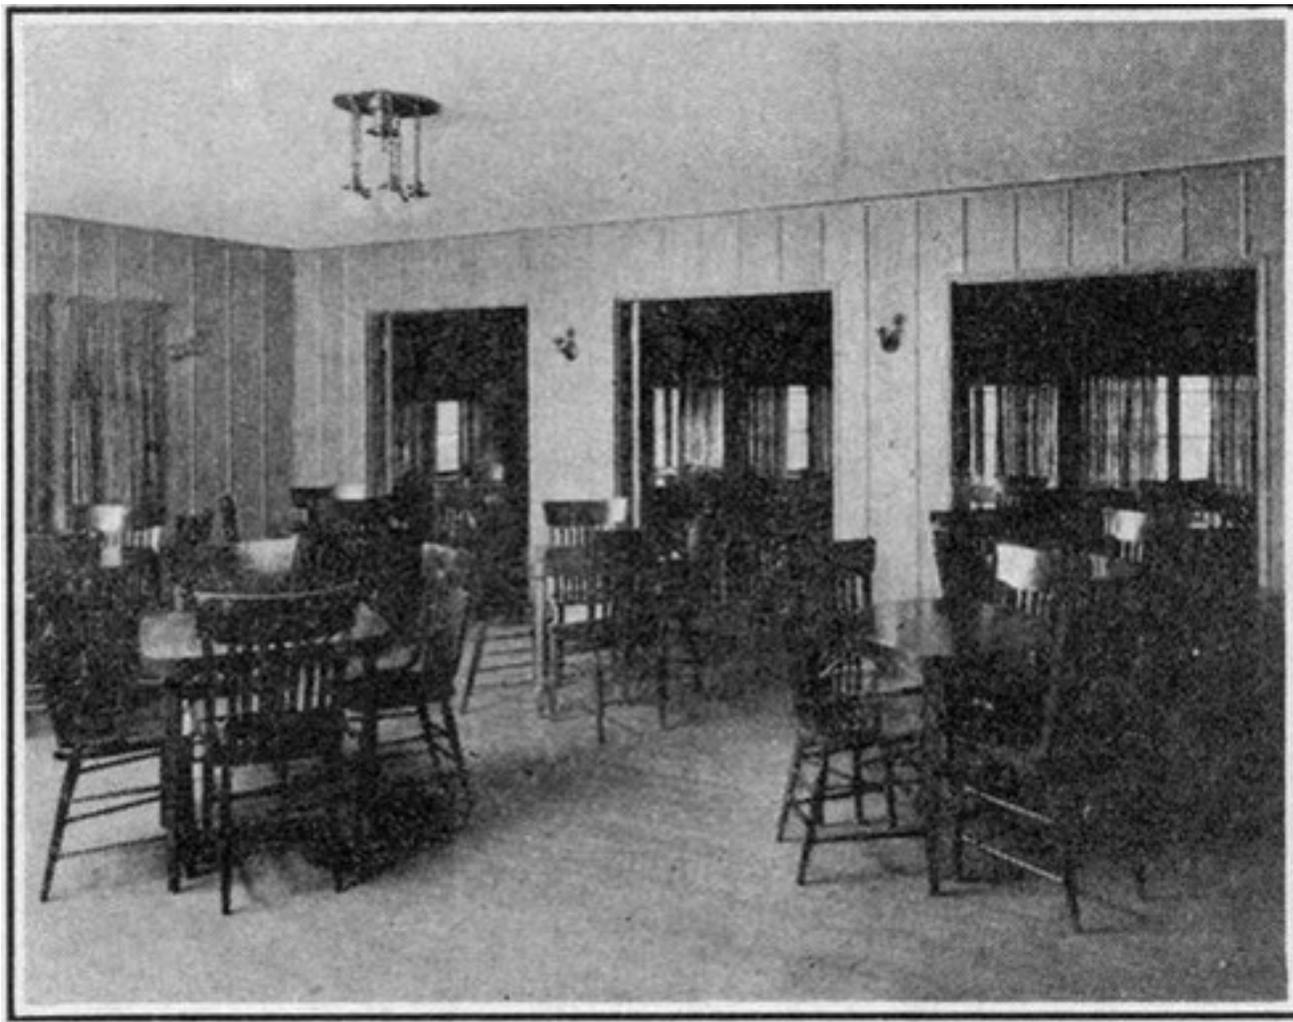
Figure 4: Early photograph of the Claremont Club "Dining Room" on the second floor, likely from a club bulletin advertising the completion of the new building (undated). Source: archival collection of the Claremont Club.

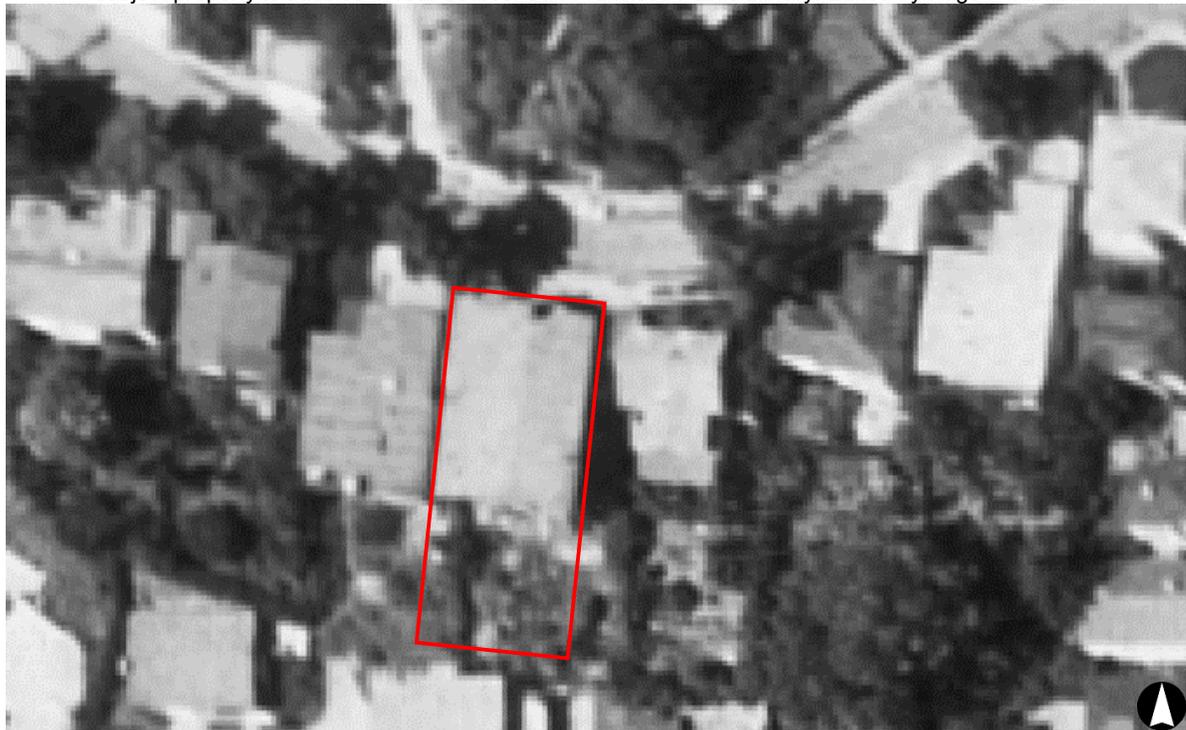
Figure 6: Aerial photograph of the Claremont Club, 1965. Cartwright Aerial Surveys Flight CAS_65_130, Frame 6-116. The location of the subject property is outlined in red. Source: University of California, Santa Barbara Special Collections. Edited by Page & Turnbull.

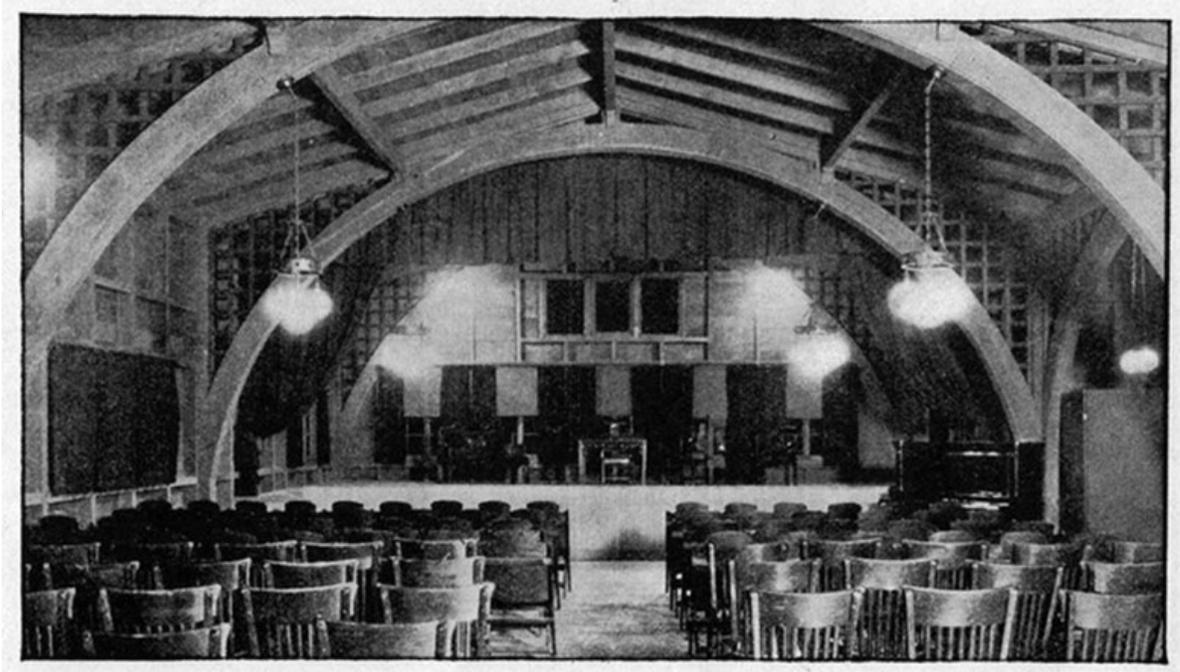
Figure 7: Early photograph of the southern facade of the upper meeting hall, likely from a club bulletin advertising the completion of the new building (undated). Source: archival collection of the Claremont Club.

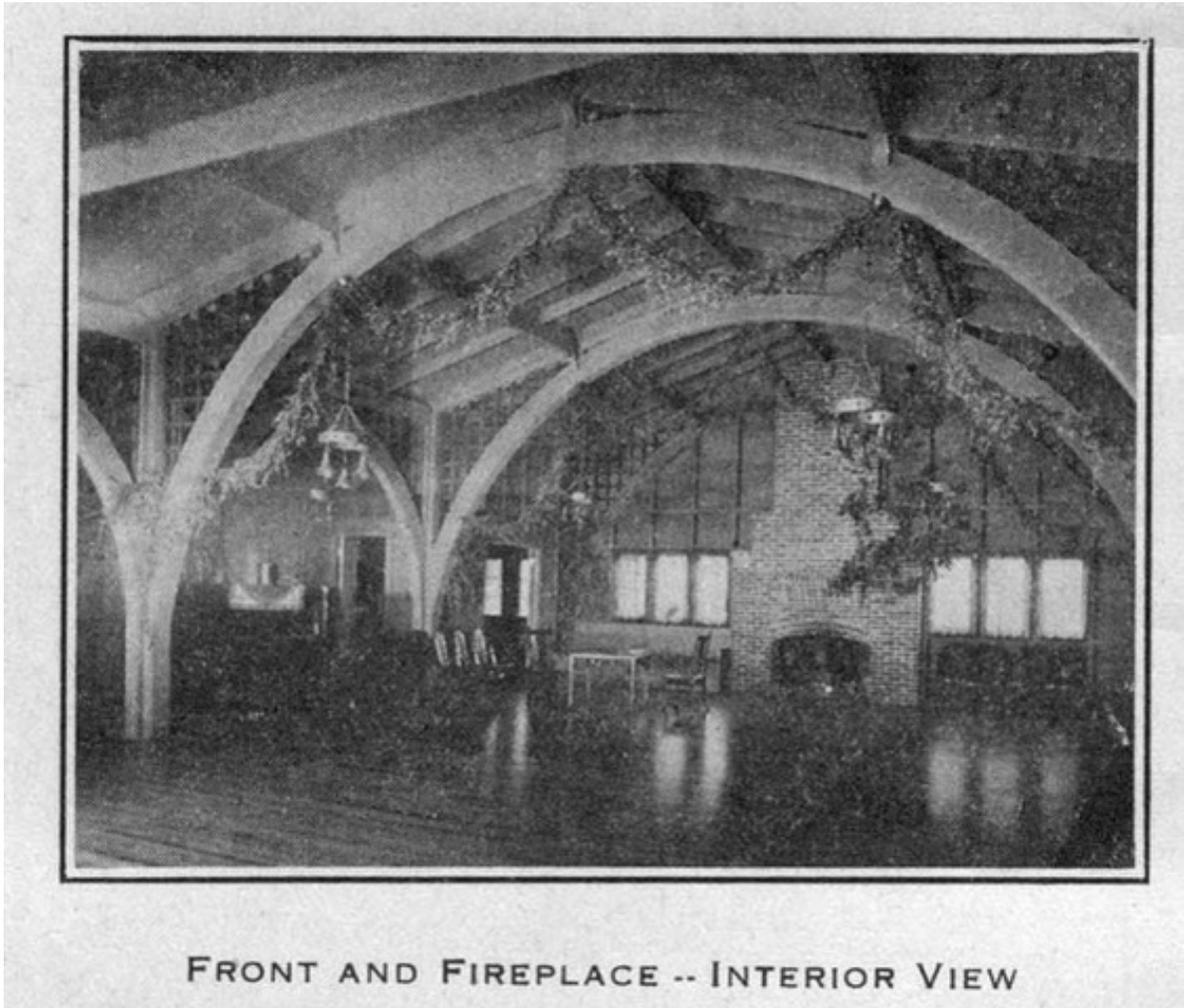
Figure 8: Early photograph of the northern facade of the upper meeting hall, likely from a club bulletin advertising the completion of the new building (undated). Source: archival collection of the Claremont Club.

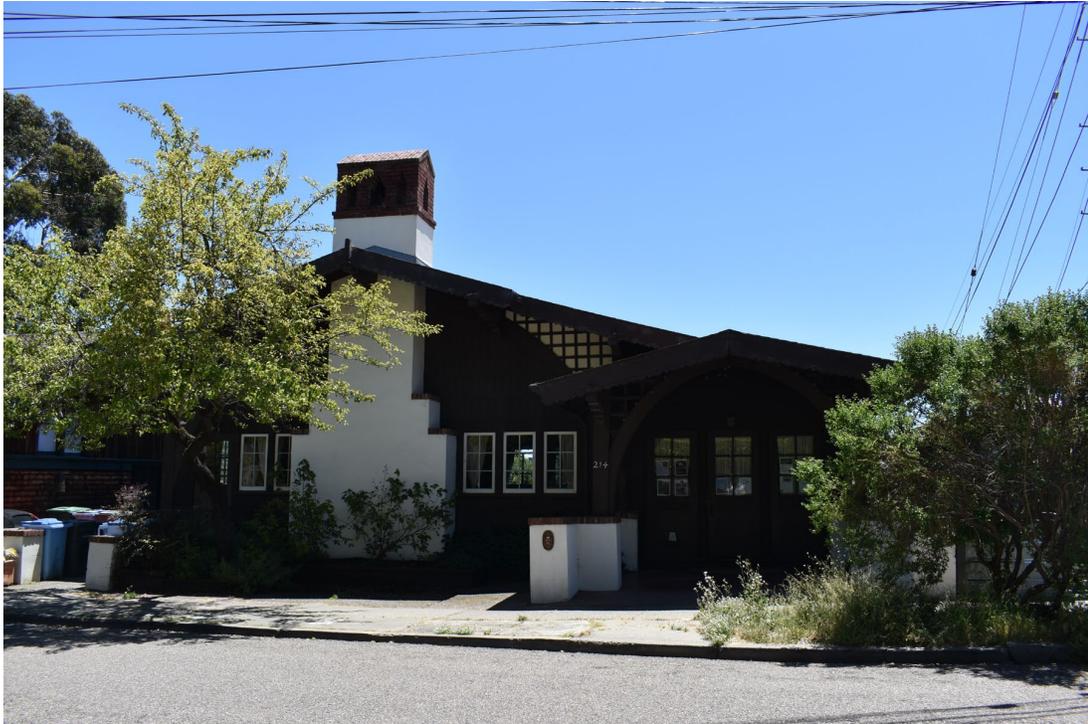
Photo 1. CA_Berkeley_Alameda County_Claremont Club_0001. SITE VIEW: Primary north façade, view southeast.

The primary north façade of the Claremont Club fronts Hillside Drive and is one story in height with asymmetrical massing and fenestration (**Photo 1**). From the street level, the building's low-pitched gable rooflines and one-story massing provide continuity with its residential surroundings (**Photo 2**). The primary entryway to the club consists of three identical wood doors aligned to the right (west) side of the building, each glazed with six lites (**Photo 3**). The entryway is covered by a wood frame portico with a low-pitched gable roof, redwood elliptical truss beams, and concrete piers clad with stucco and brick. Redwood lattice is used as spandrel panels beneath the portico and as a railing between the westernmost stucco piers (**Photo 4**). The gable ends of the roof and portico are deeply overhanging and feature a paneled soffit with a scalloped bargeboard and exposed decorative rafters carved with an undulating form. The primary façade is centered by a stepped stucco chimney with brick trim and a brick flue opening (**Photo 5**). The flue cap is gabled and features small lancet openings (**Photo 6**). The central chimney is flanked on either side by three multi-lite casement windows (**Photo 7**). At the gable end of the roof, the eave projects forward slightly and features a scalloped bargeboard, lattice spandrel panels, and decorative rafters (**Photo 8**). At the furthest east (left) side of the primary façade, there is a wood secondary entrance door that is glazed with six lites. The door is accessed from a concrete platform with metal railing (**Photo 9**).

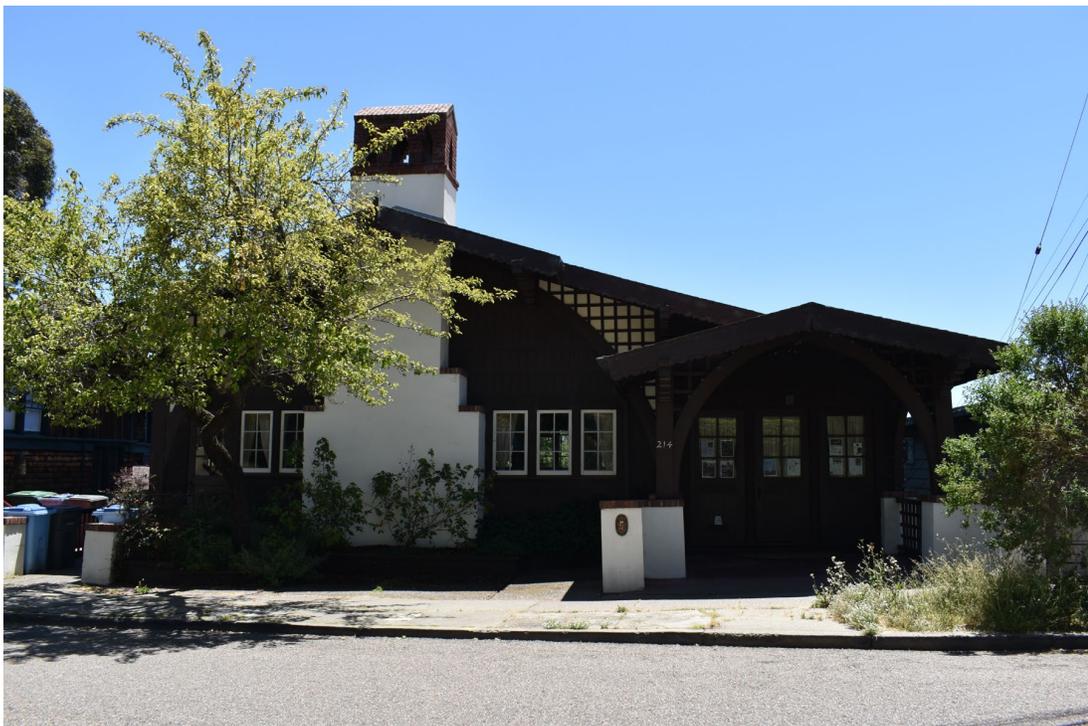
Photo 2. CA_Berkeley_Alameda County_Claremont Club_0002. SITE VIEW: Primary north façade, view south.

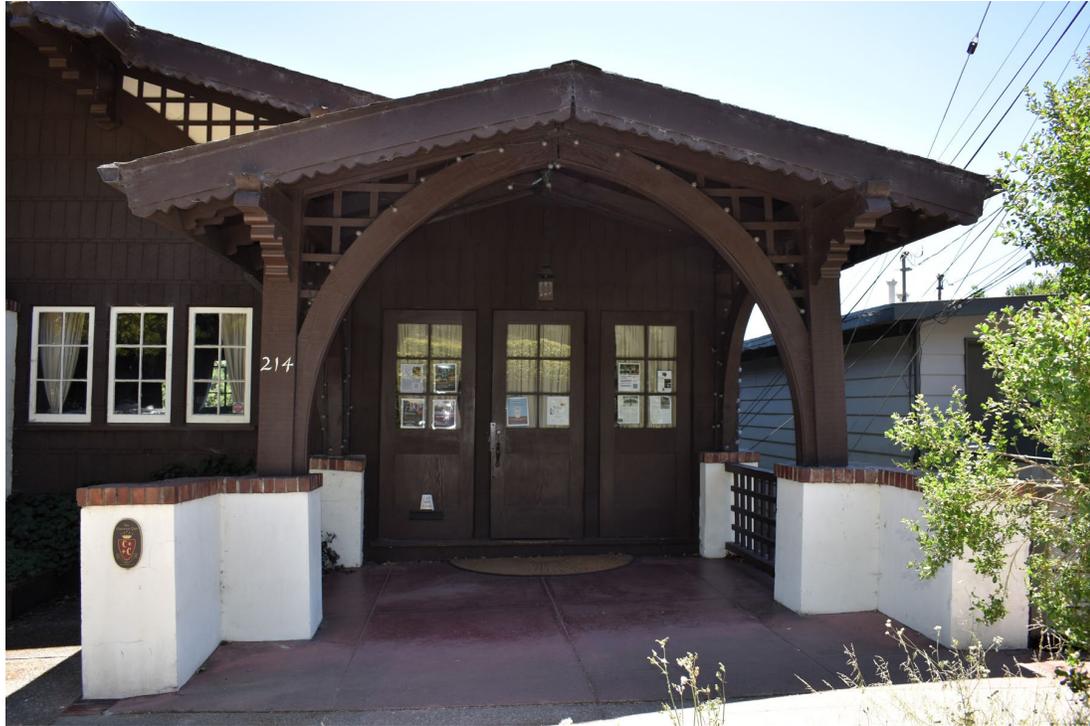
Photo 3. CA_Berkeley_Alameda County_Claremont Club_0003. SITE VIEW: Detail view south of the primary entry portico.

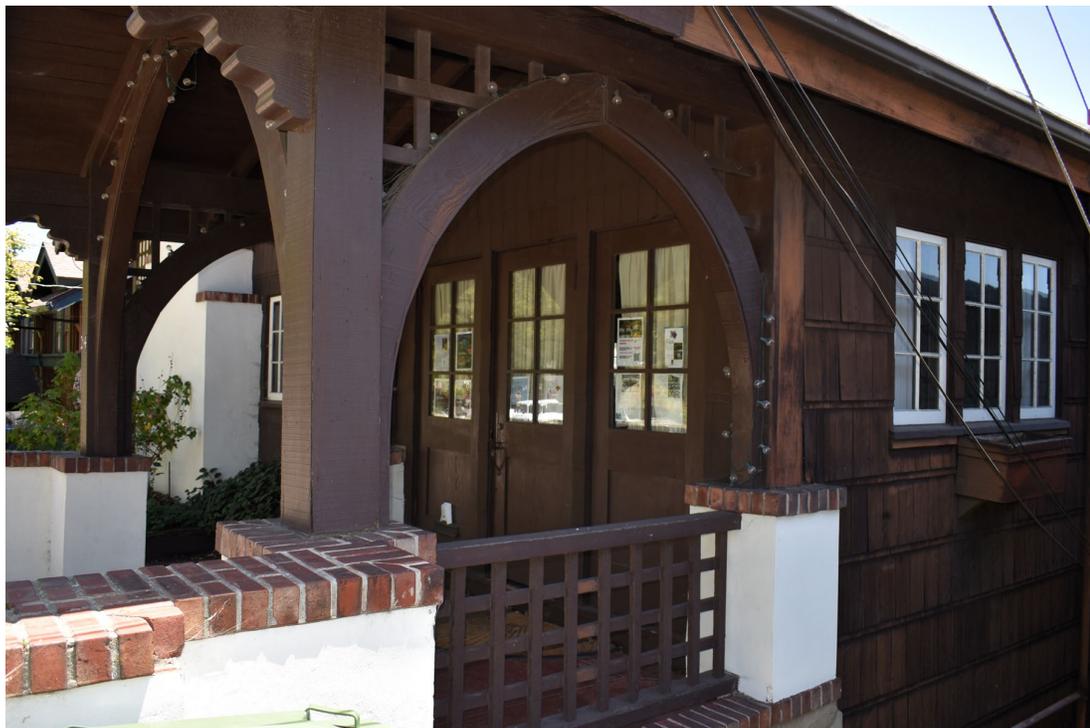
Photo 4. CA_Berkeley_Alameda County_Claremont Club_0004. SITE VIEW: Oblique view to the southeast of lattice spandrels and banister along the entry portico.

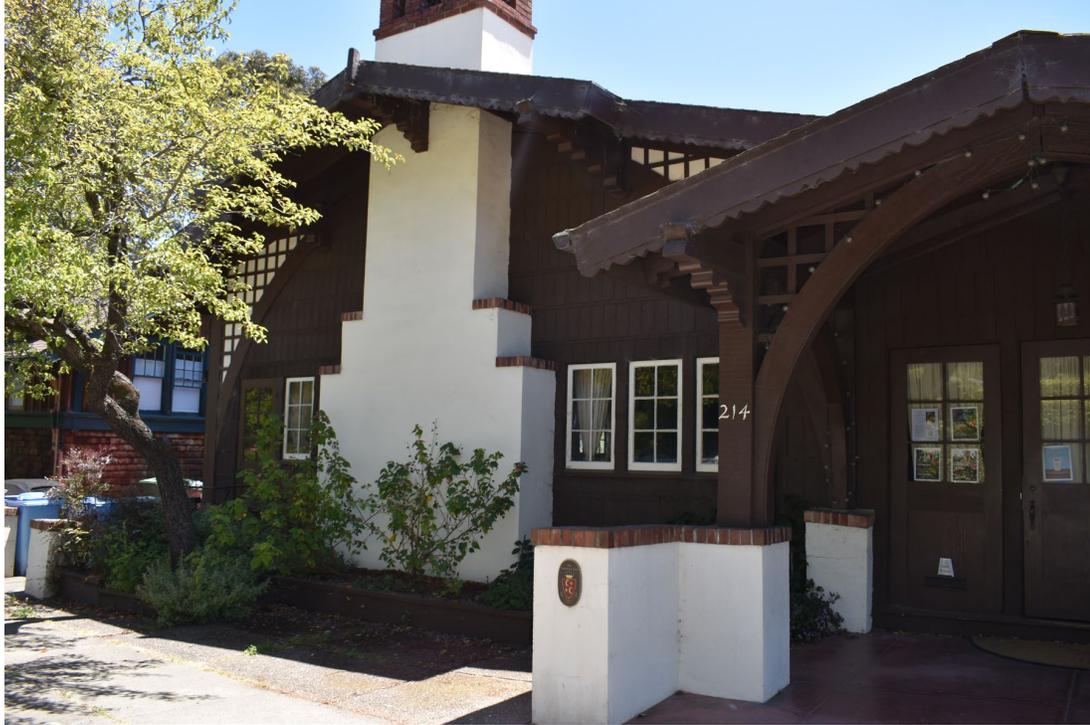
Photo 5. CA_Berkeley_Alameda County_Claremont Club_0005. SITE VIEW: Oblique view southeast of the central chimney.

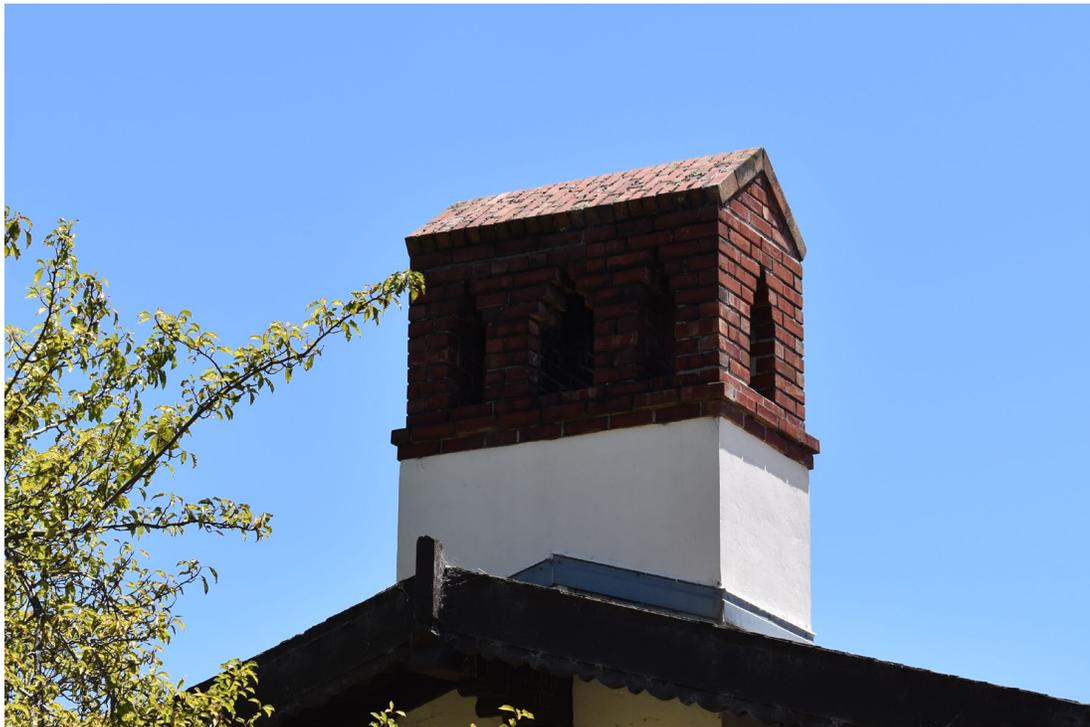
Photo 6. CA_Berkeley_Alameda County_Claremont Club_0006. SITE VIEW: Detail view southeast of the chimney flue opening.

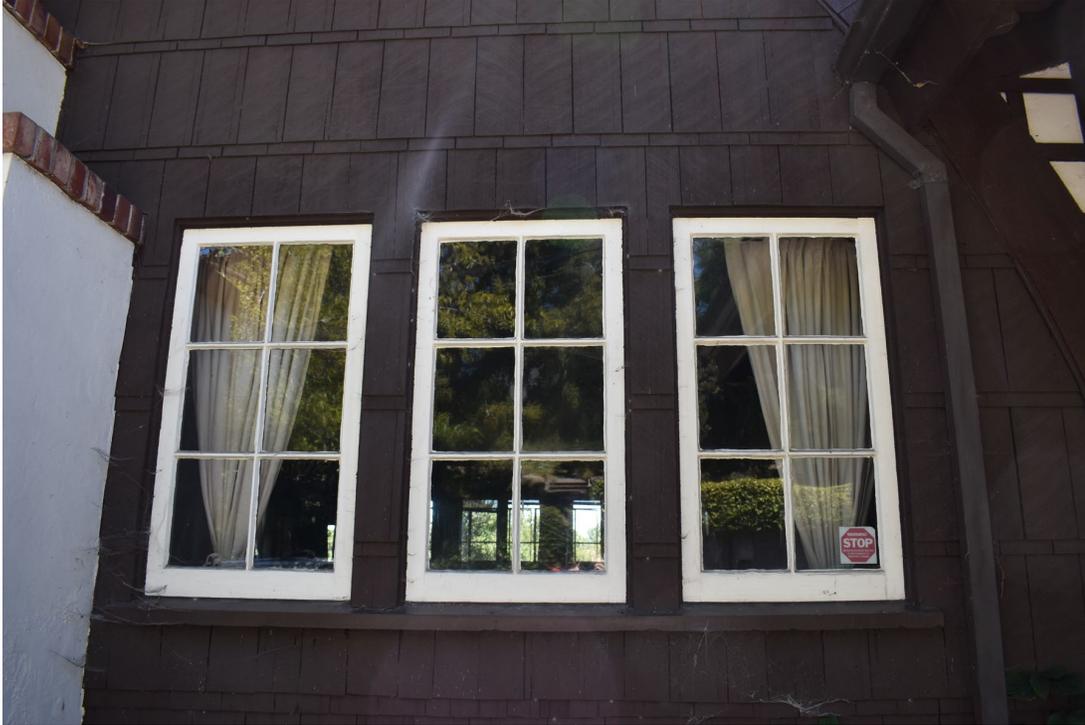
Photo 7. CA_Berkeley_Alameda County_Claremont Club_0007. SITE VIEW: Detail view south of wood sash casement windows on the primary façade.

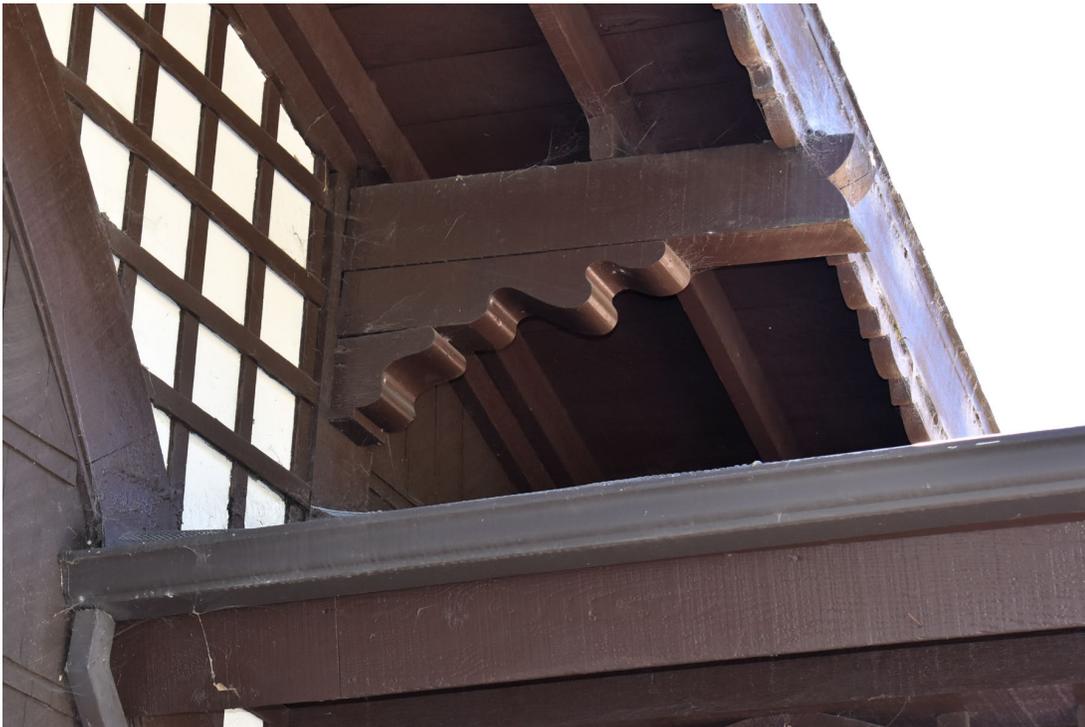
Photo 8. CA_Berkeley_Alameda County_Claremont Club_0008. SITE VIEW: Detail view to the southwest of spandrels, paneled soffit, and decorative rafters at the primary gable end.

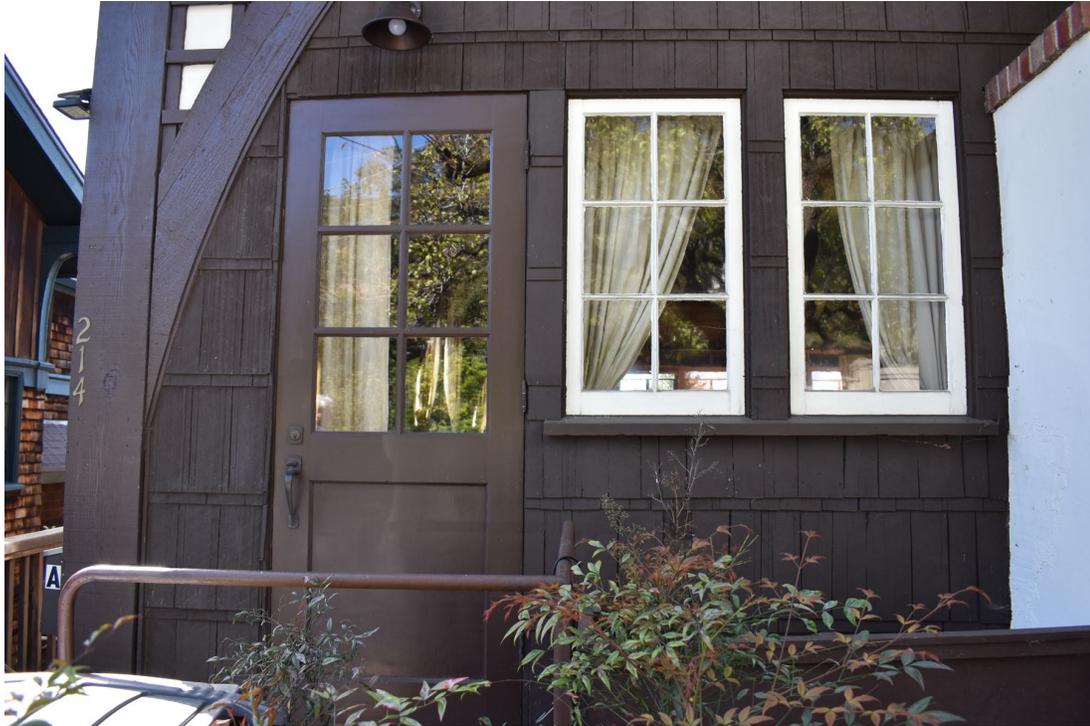
Photo 9. CA_Berkeley_Alameda County_Claremont Club_0009. SITE VIEW: Detail view south of non-historic side entry door at the primary façade.

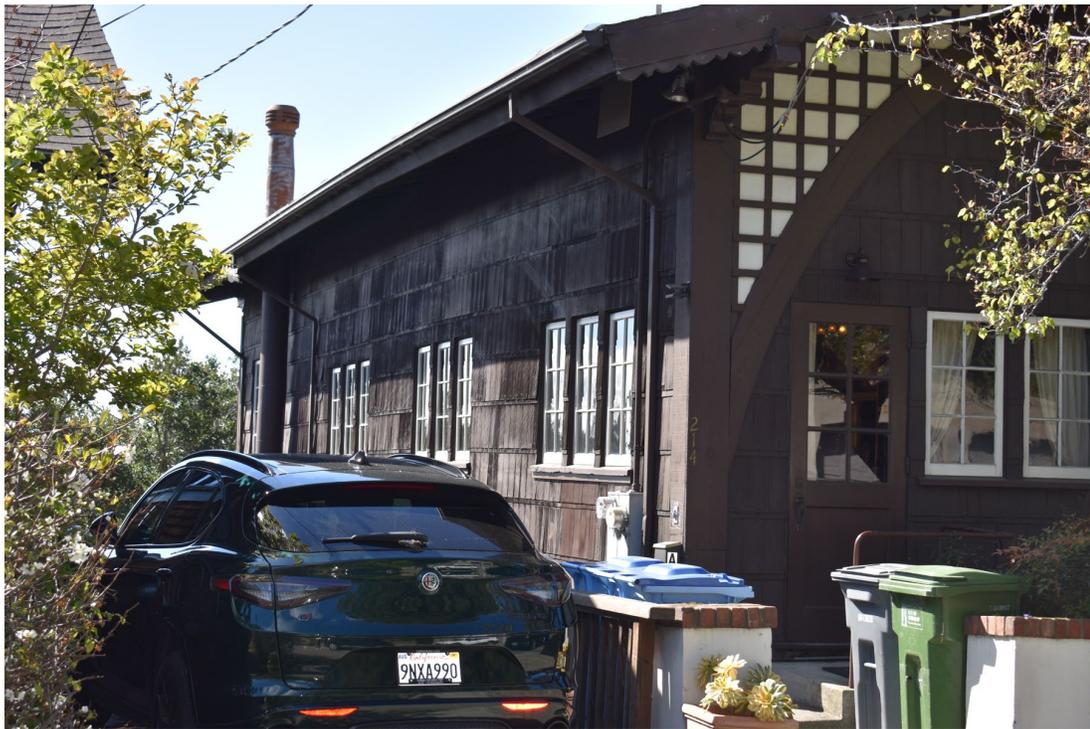
Photo 10. CA_Berkeley_Alameda County_Claremont Club_0010. SITE VIEW: Oblique view south of the northern side of the east façade

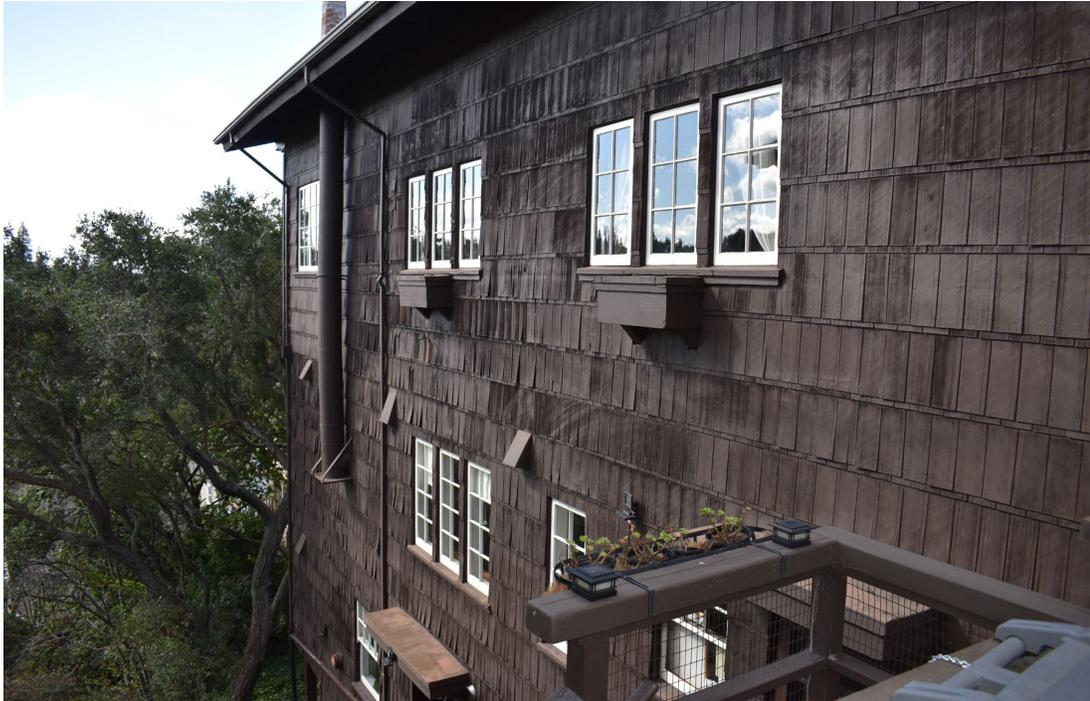
Photo 11. CA_Berkeley_Alameda County_Claremont Club_0011. SITE VIEW: Oblique view of the east façade, looking south.

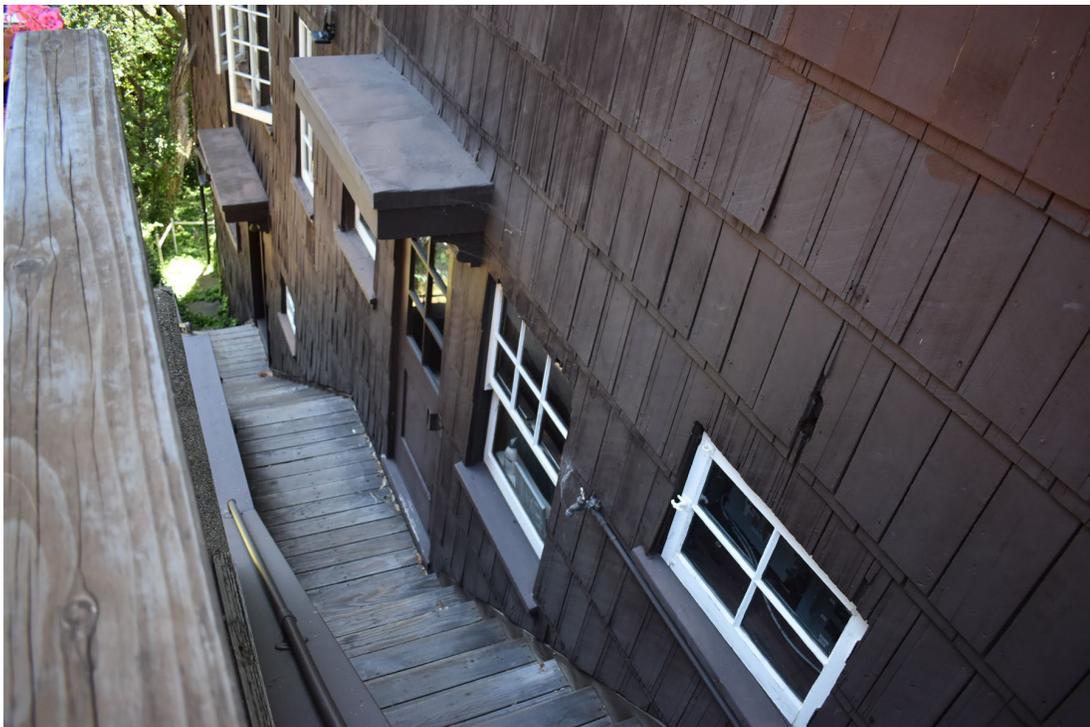
Photo 12. CA_Berkeley_Alameda County_Claremont Club_0012. SITE VIEW: Oblique view of the lower two floors of the east façade, looking south.

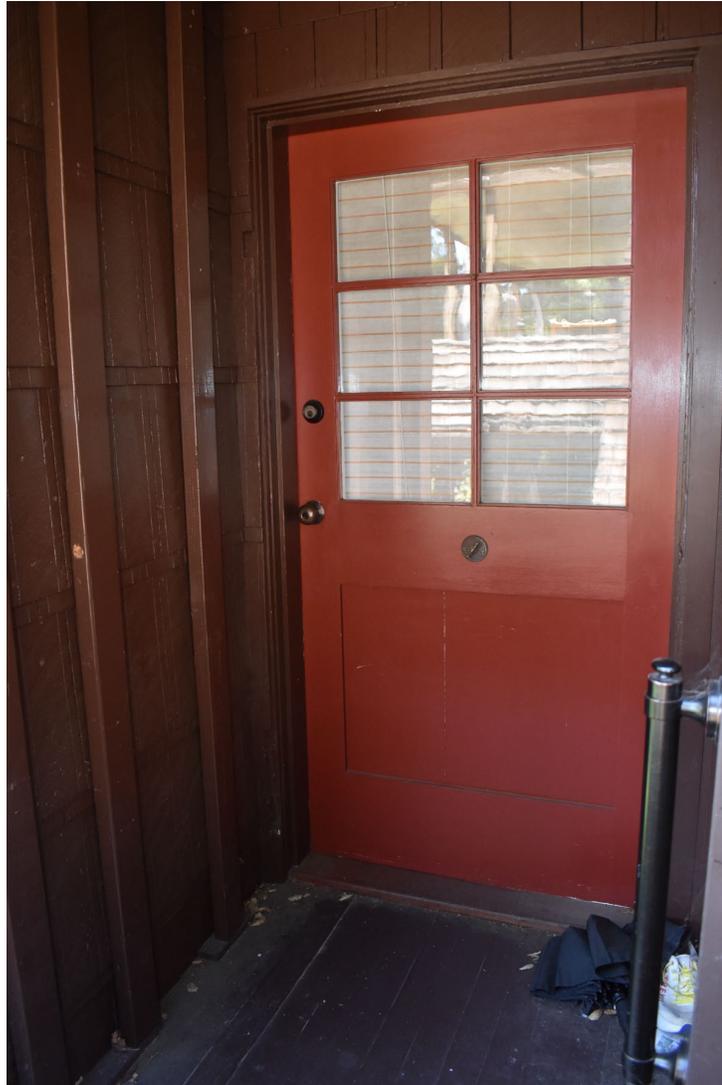
Photo 13. CA_Berkeley_Alameda County_Claremont Club_0013. SITE VIEW: Detail view of the recessed entryway to the residential unit at the lowest level of the east façade, view west.

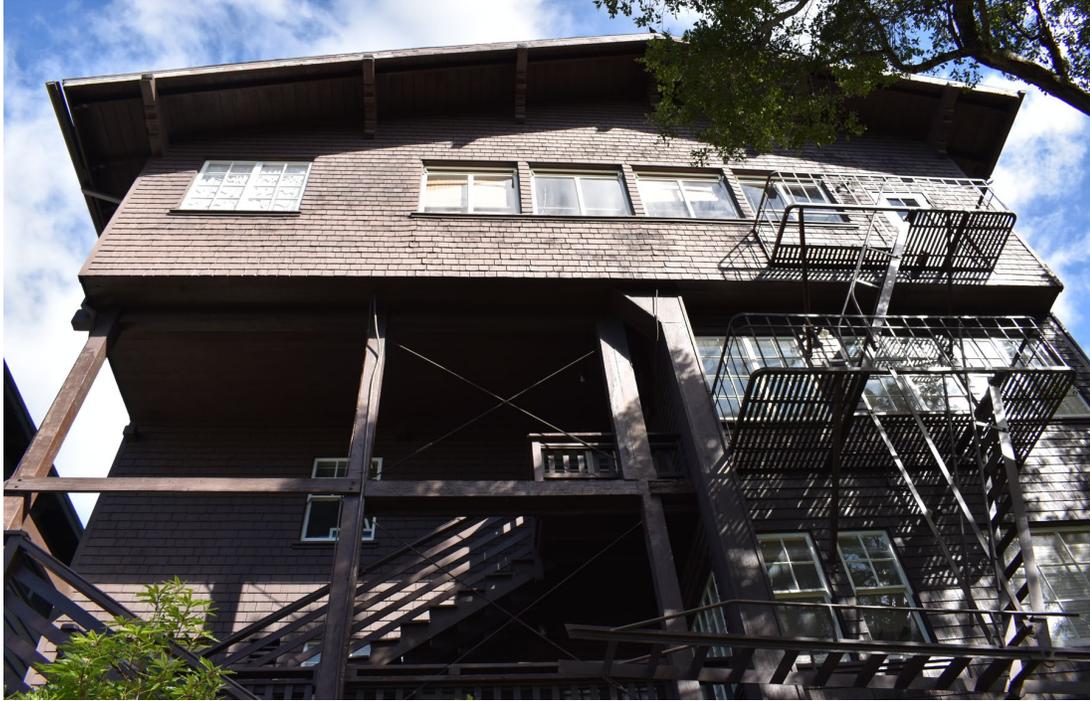
Photo 14. CA_Berkeley_Alameda County_Claremont Club_0014. SITE VIEW: Rear façade, view north.

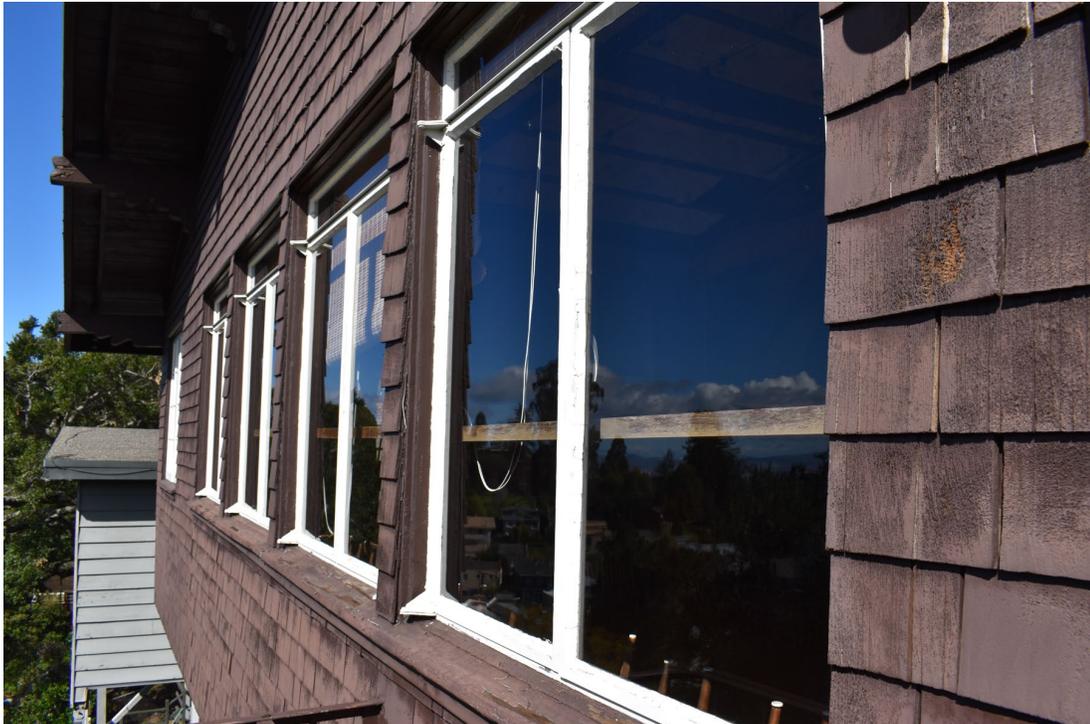
Photo 15. CA_Berkeley_Alameda County_Claremont Club_0015. SITE VIEW: Oblique view of the uppermost floor of the rear south façade, looking east.

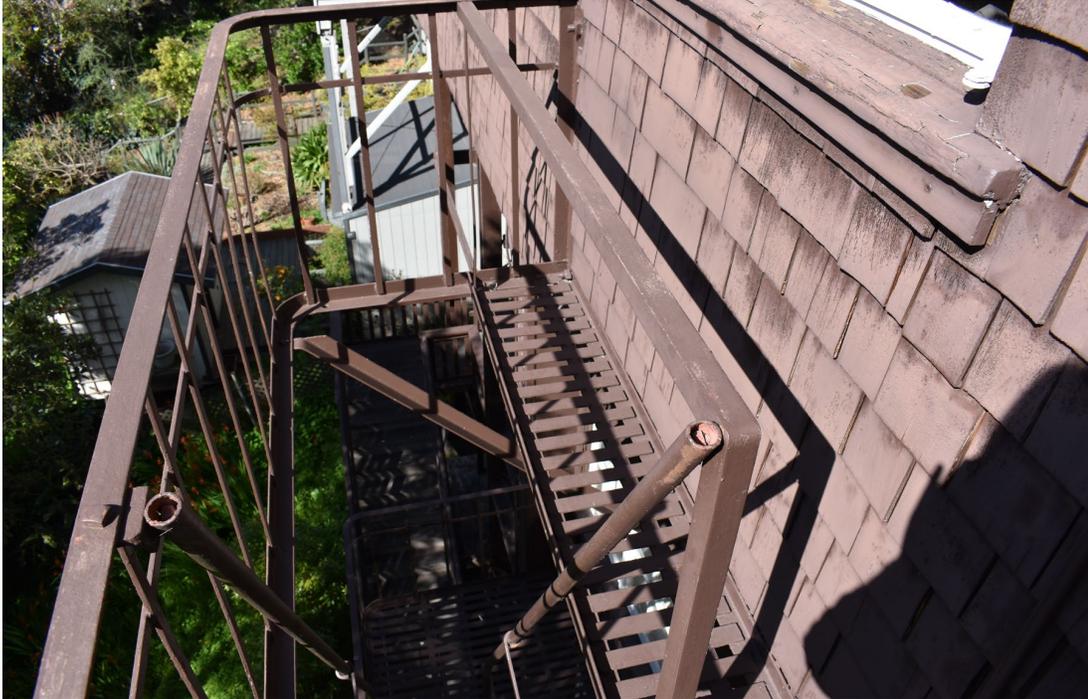
Photo 16. CA_Berkeley_Alameda County_Claremont Club_0016. SITE VIEW: Oblique view of the fire escape accessed from the upper floor of the rear façade, view west.
