DATE April 7, 2025 PROJECT 24021.1
NUMBER
TO Allison Reimer, Associate Planner PROJECT 214 Hillcrest Road, Berkeley,
California Register Nomination
OF Planning and Development FROM Stacy Kozakavich, Page & Turnbull
Land Use Division
City of Berkeley
1947 Center St., 2nd Floor
Berkeley, CA 94704
CC VIA USPS Certified Mail

State of California — The Resources Agency DEPARTMENT OF PARKS AND RECREATION PRIMARY RECORD	Primary # _____		
	HRI # _____		
	Trinomial _____		
	NRHP Status Code <u>3CS</u>		
Other Listings _____	Review Code _____	Reviewer _____	Date _____

Page 1 of 38 Resource name(s) or number (assigned by recorder) 214 Hillcrest Road

P1. Other Identifier: Claremont Club Building

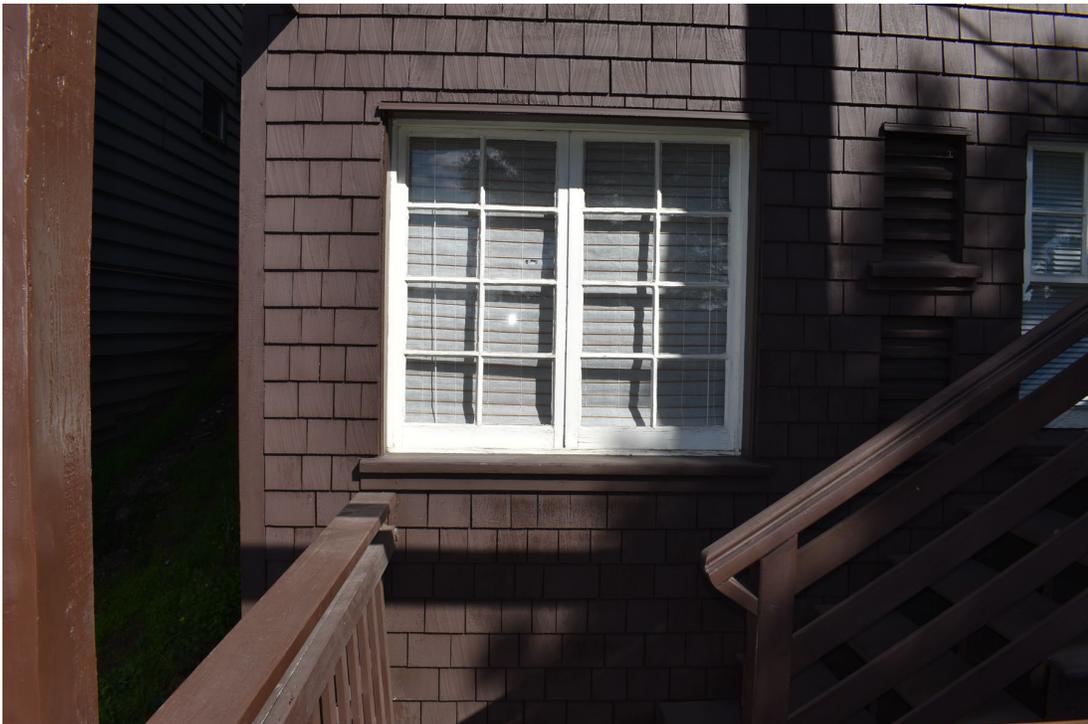
Photo 17. CA_Berkeley_Alameda County_Claremont Club_0017. SITE VIEW: View of the (residential) third floor on the rear south façade, looking north.

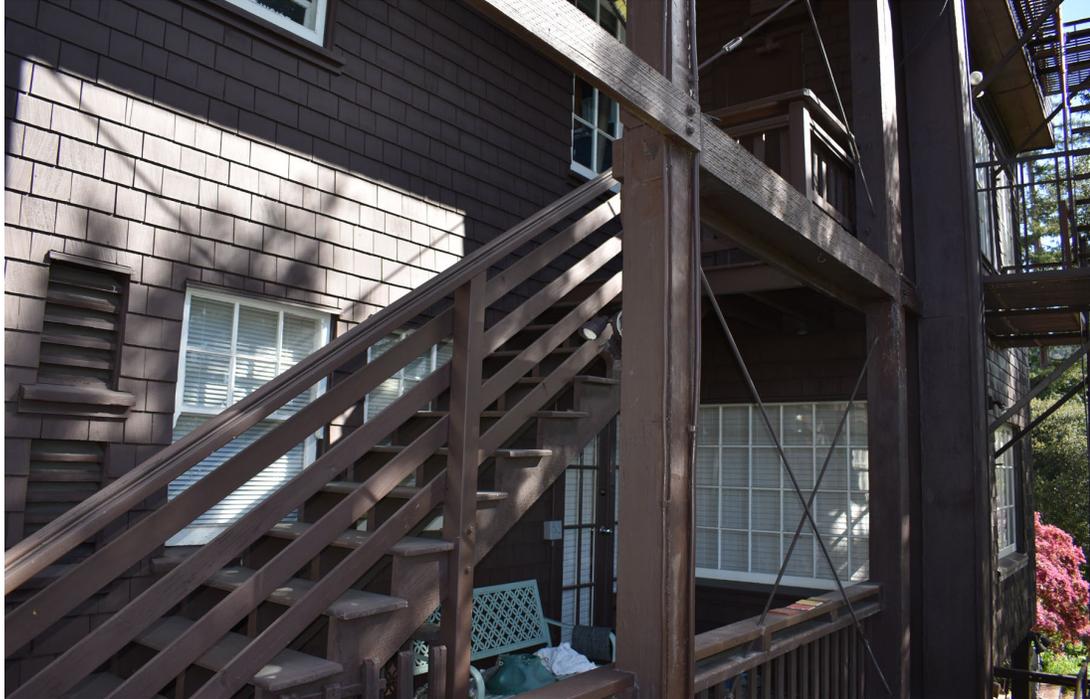
Photo 18. CA_Berkeley_Alameda County_Claremont Club_0018. SITE VIEW: View of the external staircase and (residential) third floor on the rear south façade, looking west.

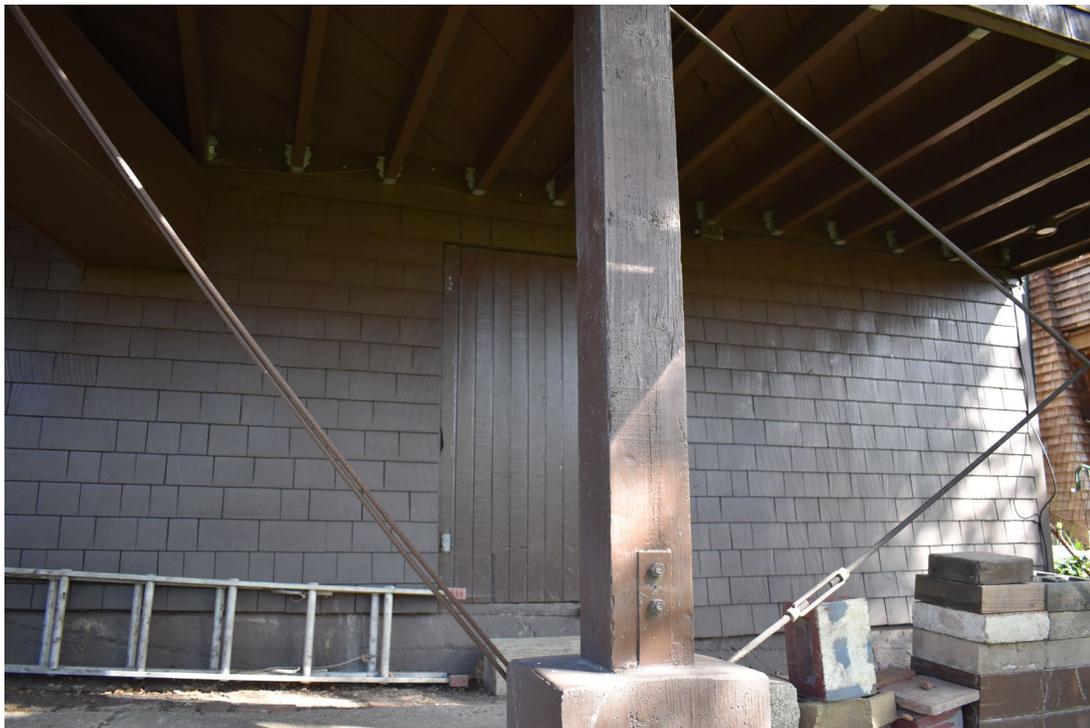
Photo 19. CA_Berkeley_Alameda County_Claremont Club_0019. SITE VIEW: View of the basement level of the rear south façade, looking north

The rear (south) façade is three stories in height over a basement, with portions that recess beneath the uppermost floor and are accessed through a wood-frame porch and staircase (**Photo 14**). At the uppermost level of the rear façade, there are four pairs of non-historic aluminum casement windows, each with a single lite beneath a connecting transom (**Photo 15**). At the furthest west (left) side of the rear façade, there is a pair of casement windows, each with eight lites. At the furthest east (right) side of the façade, a wood door opens to a shallow fire escape (door is not visible in the photograph) (**Photo 16**). The west (left) side of the second floor is recessed behind a wood-frame staircase and partial-width porch. There is a six-over-one double-hung, and series of non-historic multi-lite casement windows that continue to the eastern (right) side of the façade. At the third (residential) floor, viewing from west to east (left to right): there are a pair of casement windows with six lites each, two six-over-one double-hung windows, a French door with eight lites, a multi-lite fixed window, a pair of four-over-one double hung windows, and a multi-lite fixed window (**Photo 17 and Photo 18**). The basement level has one wood-paneled door and an attached potting bench (**Photo 19 and Photo 20**).

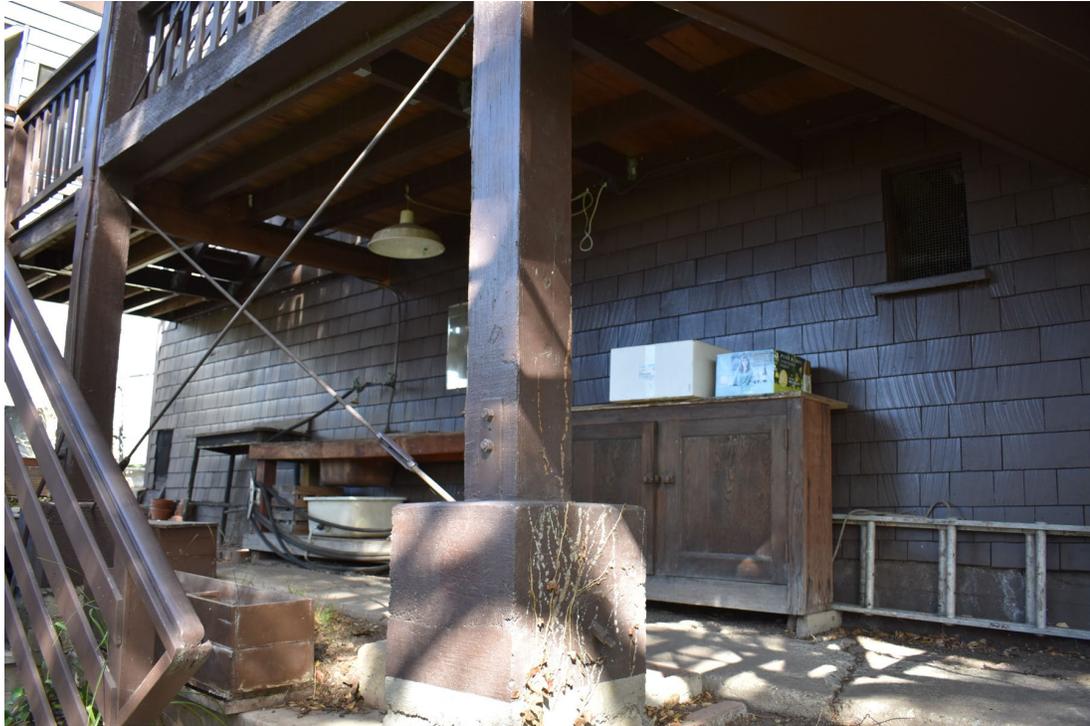
Photo 20. CA_Berkeley_Alameda County_Claremont Club_0020. SITE VIEW: View of the basement level of the rear south façade, looking northwest.

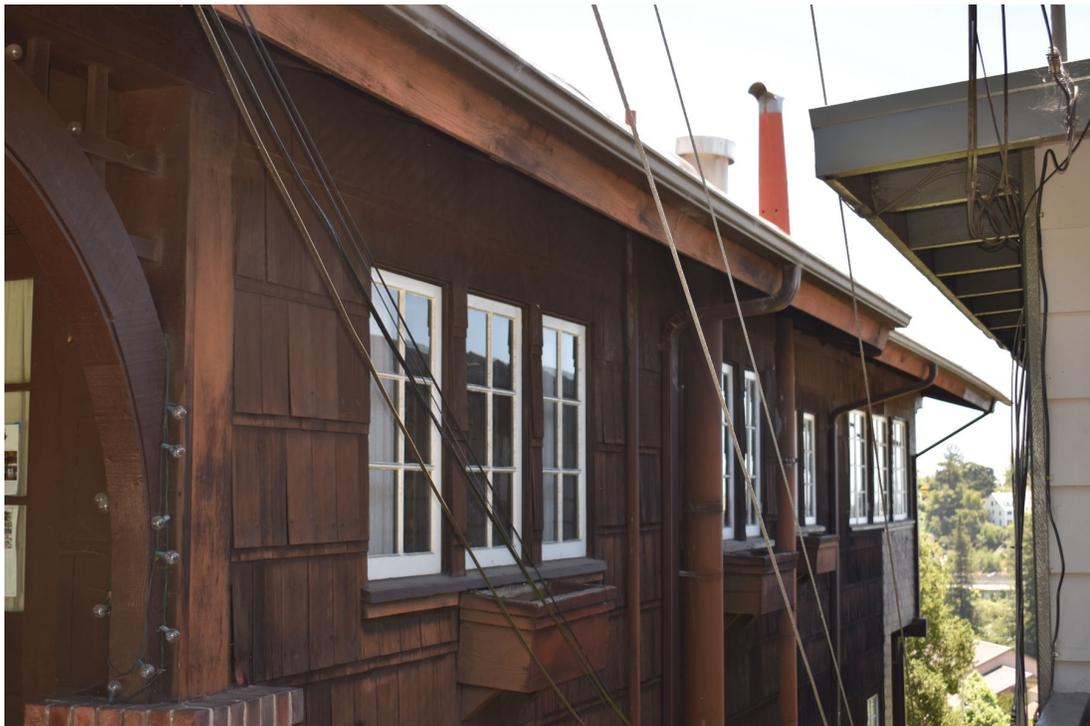
Photo 21. CA_Berkeley_Alameda County_Claremont Club_0021. SITE VIEW: Oblique view of the west façade, looking southeast.

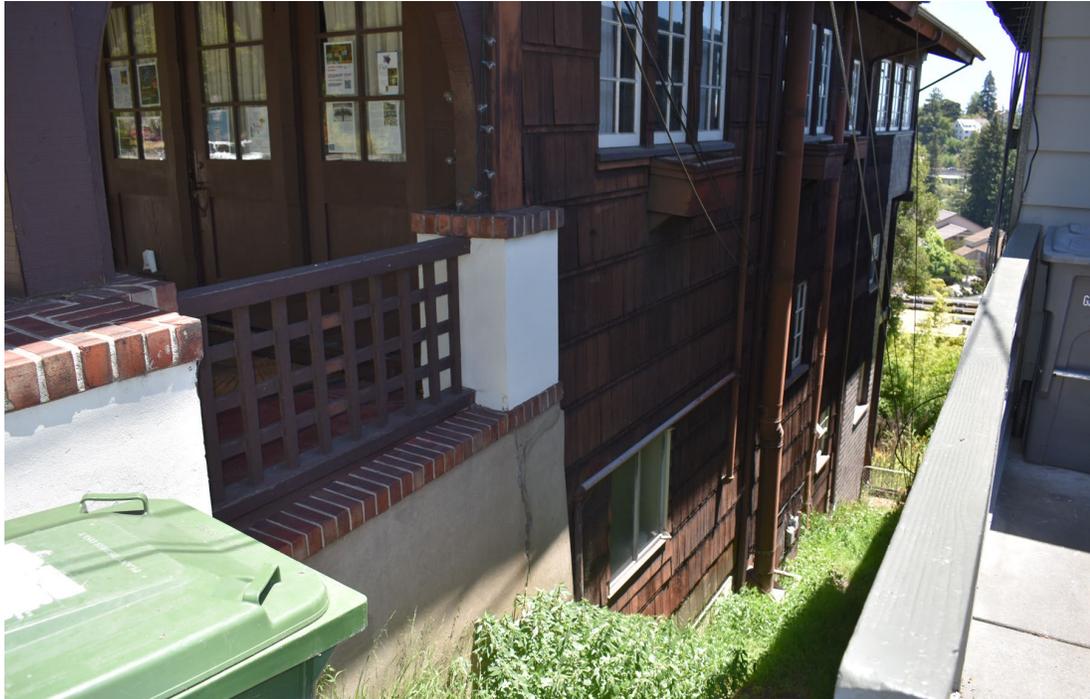
Photo 22. CA_Berkeley_Alameda County_Claremont Club_0022. SITE VIEW: Oblique view of the west façade, looking southeast.

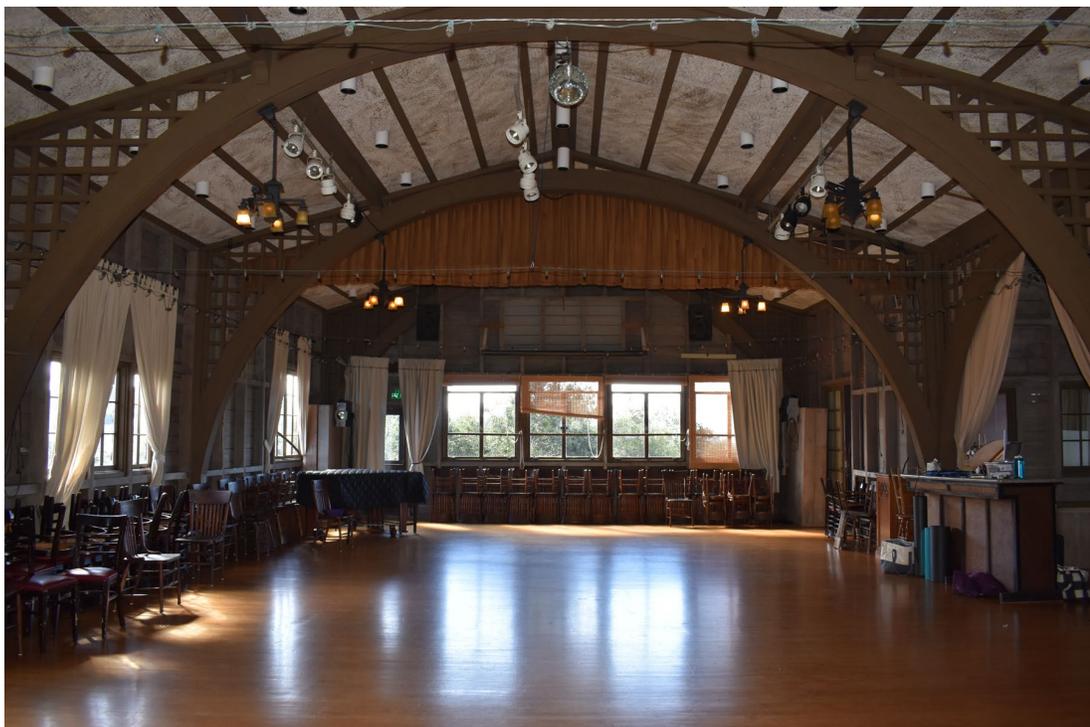
Photo 23. CA_Berkeley_Alameda County_Claremont Club_0023. SITE VIEW: Interior view of the main meeting hall space, looking south

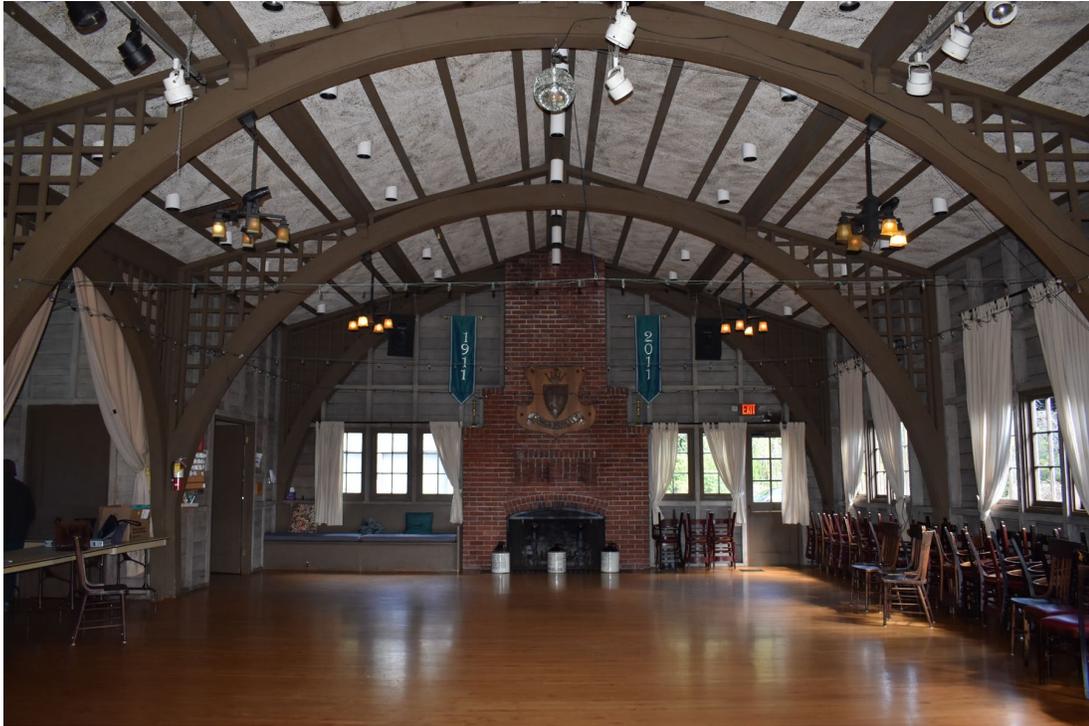
Photo 24. CA_Berkeley_Alameda County_Claremont Club_0024. SITE VIEW: Interior view of the main meeting hall space, looking north.

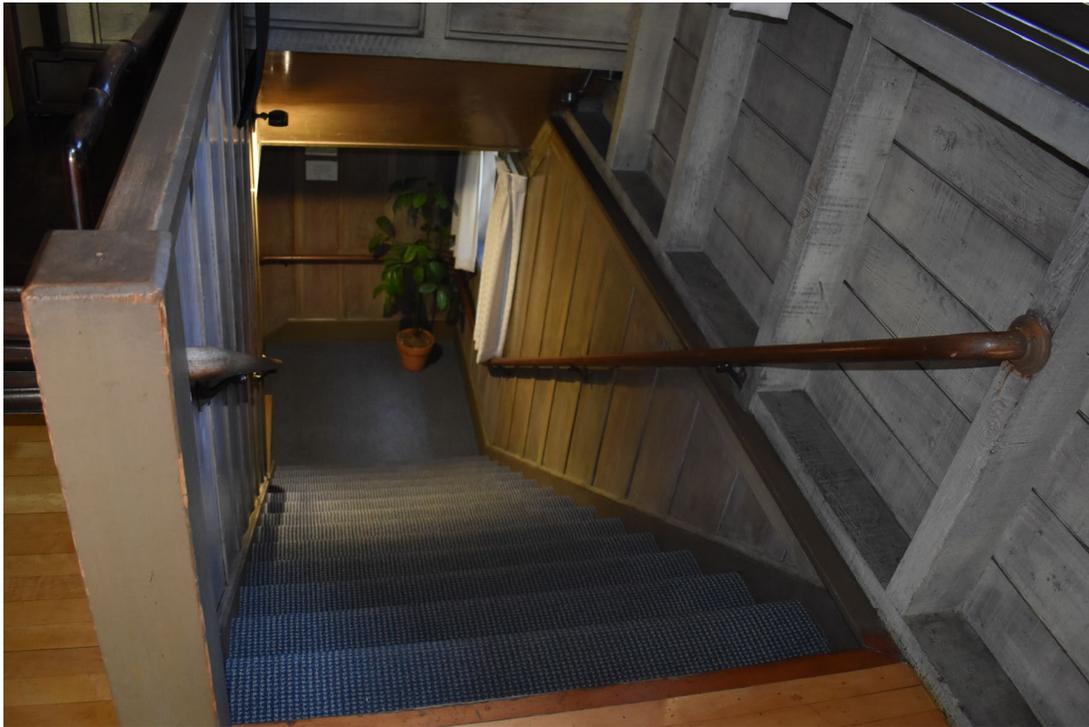
Photo 25. CA_Berkeley_Alameda County_Claremont Club_0025. SITE VIEW: Interior view of the staircase leading from the foyer to the lower clubhouse floor, view south.

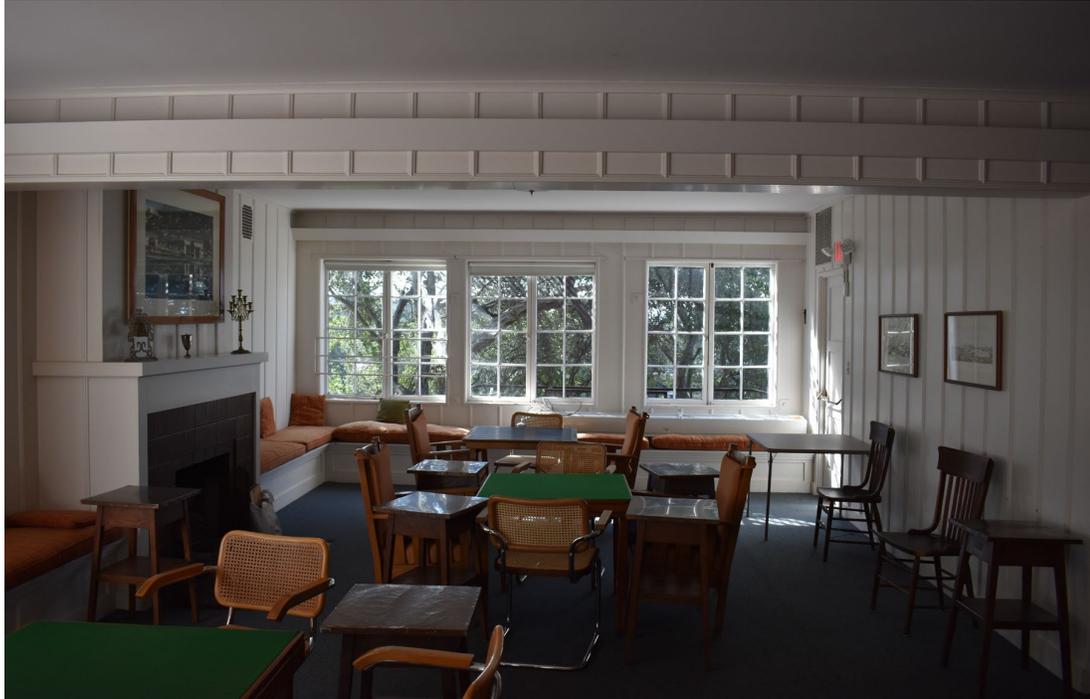
Photo 26. CA_Berkeley_Alameda County_Claremont Club_0026. SITE VIEW: Interior view of the main meeting space on the lower clubhouse floor, view south.

The publicly accessible spaces of the Claremont Club's interior include a large meeting hall space on the upper floor and club rooms on the second floor. The meeting hall features large arched redwood trusses with lattice spandrel panels, wood-paneled open-stud walls, and a brick chimney with the club's insignia. The light fixtures and ceiling panels are not original (**Photo 23 and Photo 24**). The lower club rooms are accessed through a wood-paneled staircase that descends from the club's foyer (**Photo 25**). The lower club floor has been remodeled more extensively, but appears to have retained much of the original wall cladding in the primary gathering space (**Photo 26**).

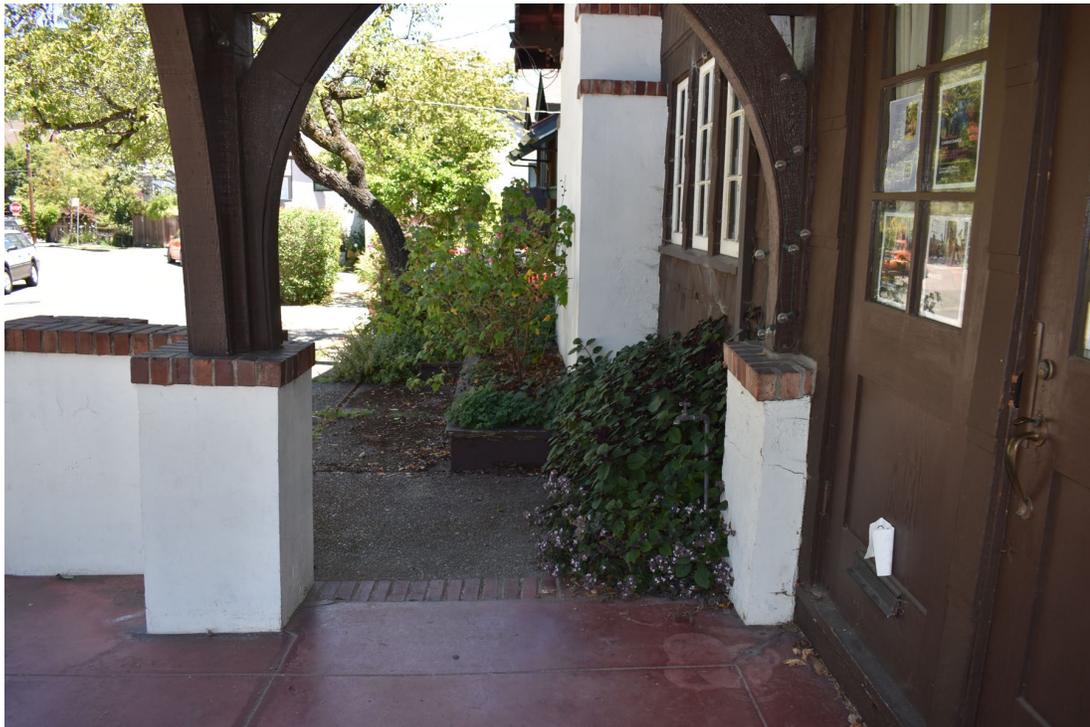
Photo 27. CA_Berkeley_Alameda County_Claremont Club_0027. SITE VIEW: Planter box along the primary façade, view east.

Site and landscape features include a wood frame planter box along a portion of the primary façade, and a non-historic wood frame staircase along the east façade (**Photo 27 and Photo 28**).

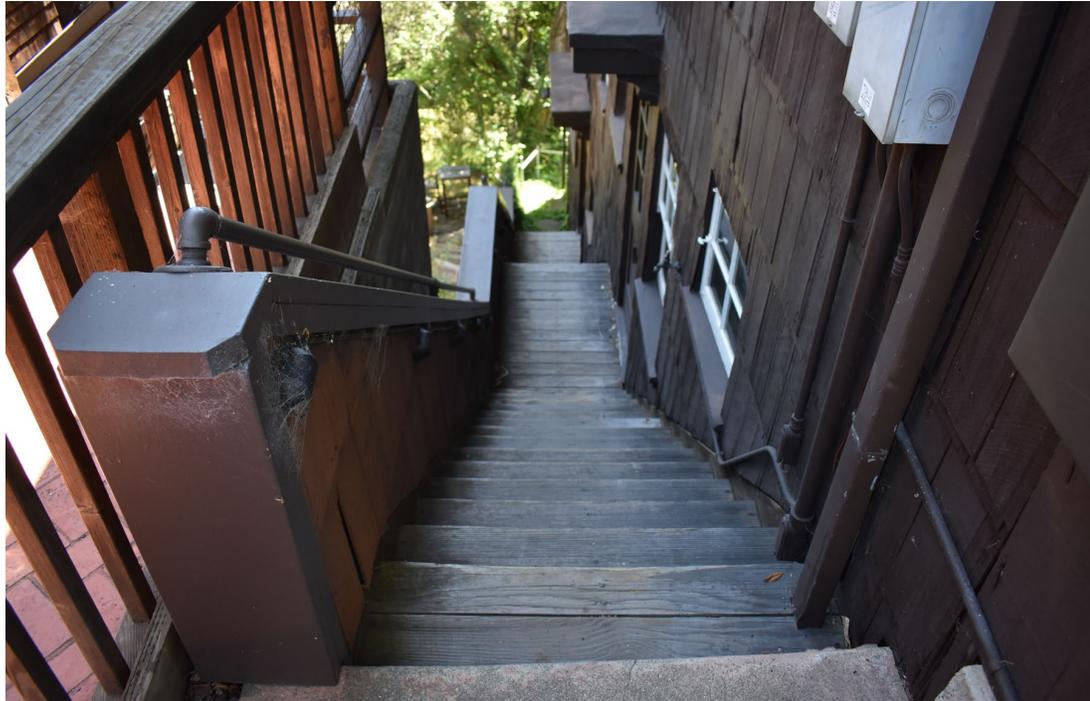
Photo 28. CA_Berkeley_Alameda County_Claremont Club_0028. SITE VIEW: Wood-frame staircase along the eastern façade, view south.
