# Strawberry Creek Culvert Maintenance Project

January 7, 2025  
Community Meeting

## Project Description

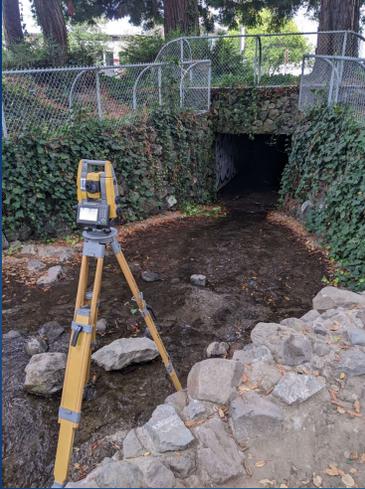
Culvert entrance east of Oxford

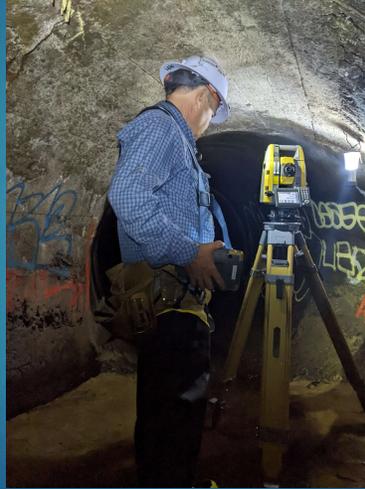
Survey work inside culvert

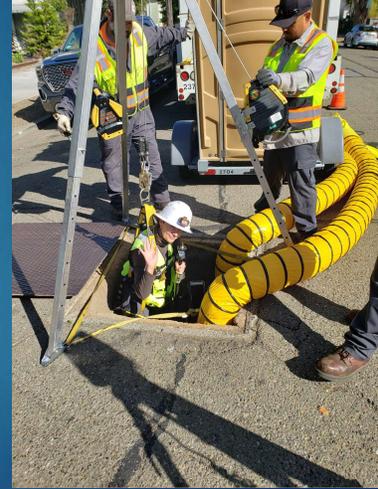
Confined space entry at Roosevelt Ave

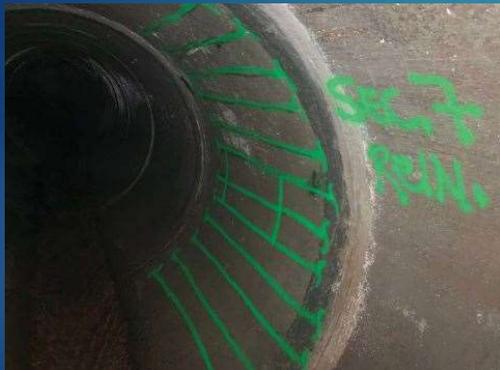
Rebar markings on culvert wall

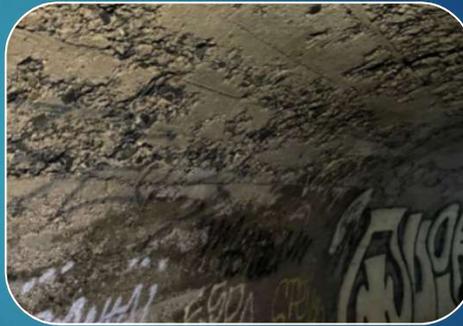
Concrete Spalling

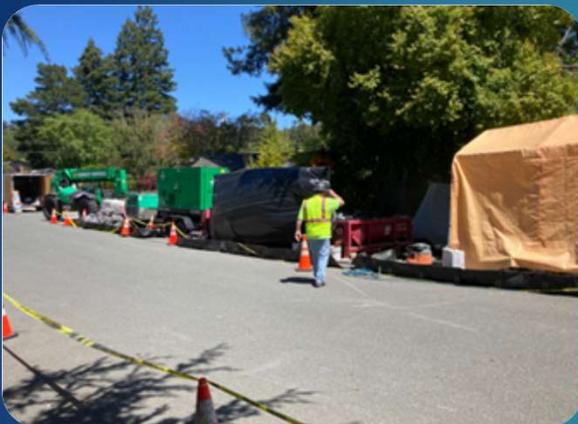
Typical geopolymer lining operation

- ▶ **Passive flow diversion w/ cofferdams and bypass pipe**
- ▶ **Structural repairs**
  - ▶ Floor repairs
  - ▶ Crack filling
- ▶ **Geopolymer mortar lining**
  - ▶ Provides structural rehabilitation
  - ▶ Mixed on-site
  - ▶ Spray applied
  - ▶ Approx. 1.75 inches thick
  - ▶ High strength, fast cure material

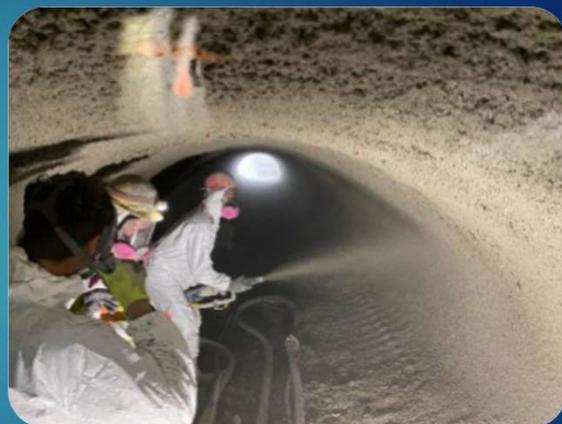
Typical liner application in confined environment

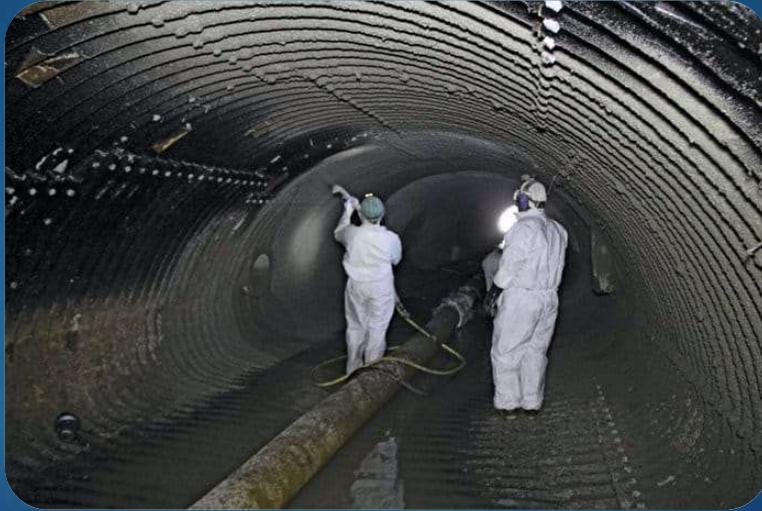
Liner application w/ bypass visible

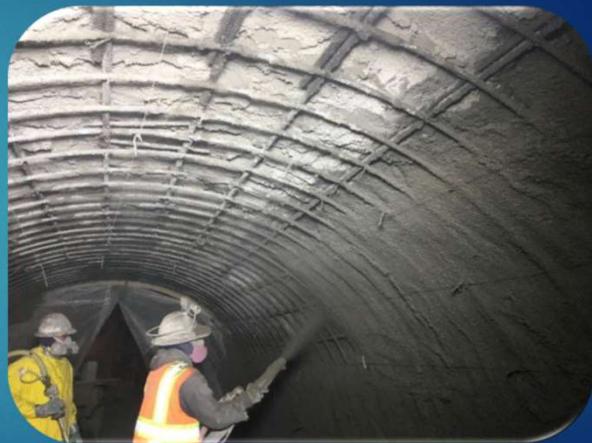
- ▶ **Shotcrete lining**
  - ▶ Spray applied concrete mortar
  - ▶ Well-established technology that's been used for over 100 years
- ▶ **Disadvantages in creek culvert application**
  - ▶ Requires steel reinforcement for structural applications
  - ▶ Thicker section required would significantly reduce hydraulic capacity of culvert
  - ▶ Longer cure time required before finished surface can be exposed to creek flows
