EXECUTIVE SUMMARY

QUESTION #14: ARCHITECTURAL DESCRIPTION

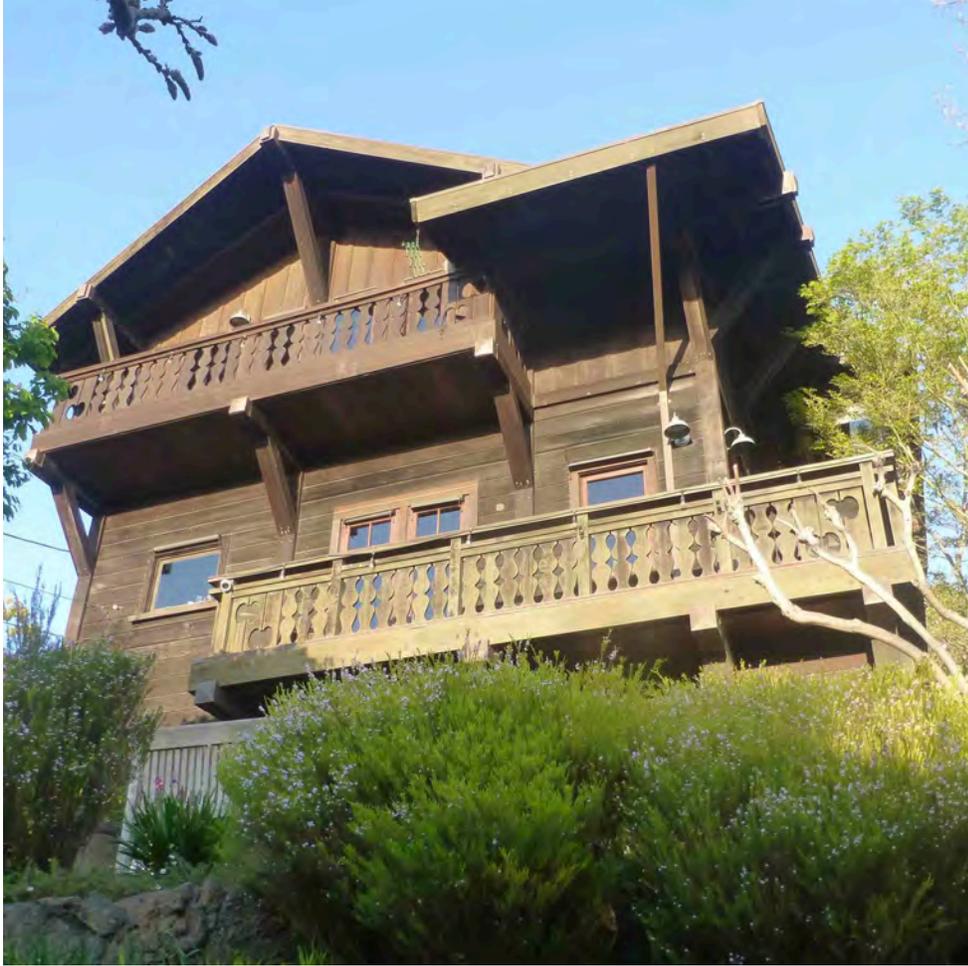
(At left, west elevation showing upper two floors and roof form.

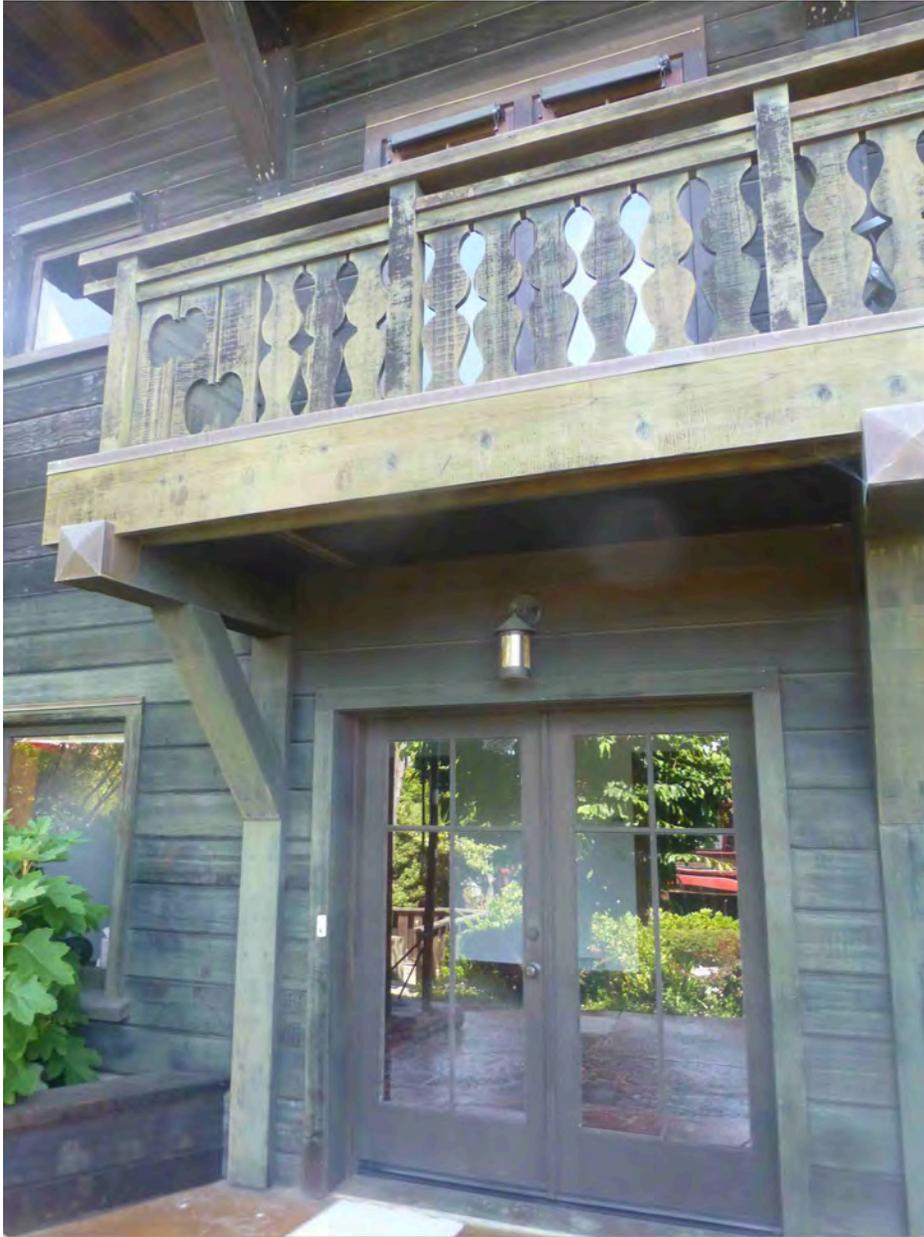
(At left, detail of basement level with newer French doors. Photo S. Finacom, 2021)

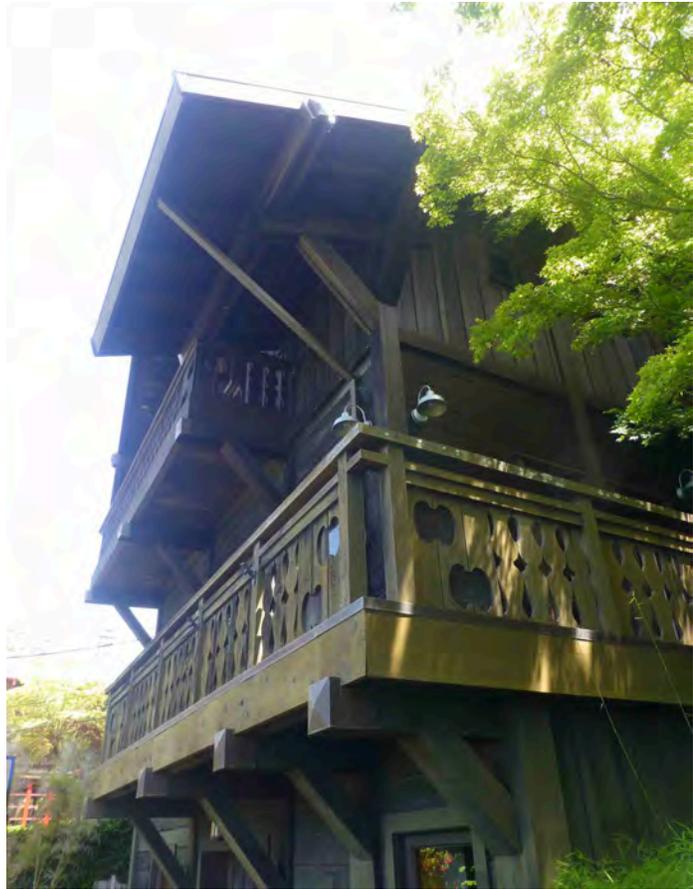
(At right, southwest corner of house showing upper two floors, balconies, and corner roof form. Photo S. Finacom, 2021.)

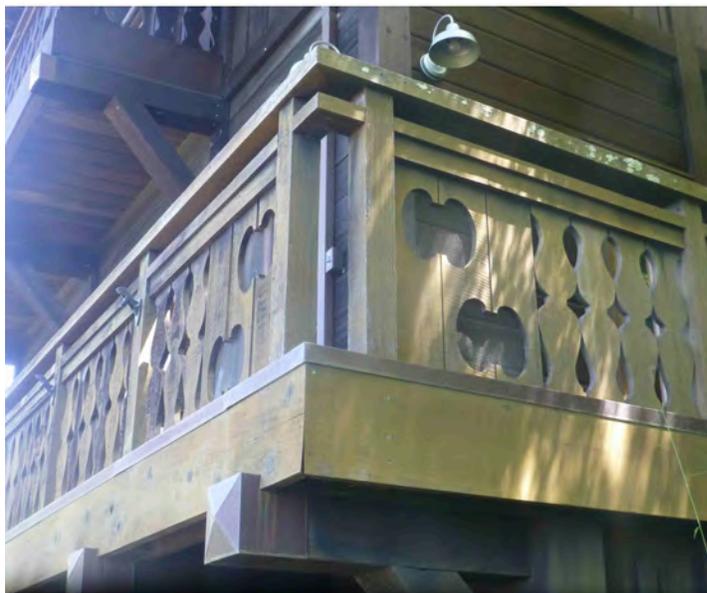
(At left, detail of lower balcony, southwest corner of house. Note ‘butterfly’ cutouts, classical balustrade form, and metal caps over balcony supports, lower left. Photo S. Finacom, 2021.)

south and two at the north. The balcony “turns the corner” of the building on the southwest and extends onto the south facade. The balcony is lit by contemporary metal fixtures, with downward facing hoods. The balcony railing has a board to which the balusters below are attached; then there is a narrow gap, and a wider railing cap mounted above that. Since parts of the balcony are known to have been reconstructed after deterioration / storm damage, it is likely that the top board was added during a

reconstruction to raise the overall height of the balcony, perhaps to comply with modern codes, or simply to accommodate the generally taller height of humans today. Either way, it was done in a manner sympathetic to the original design of the house.

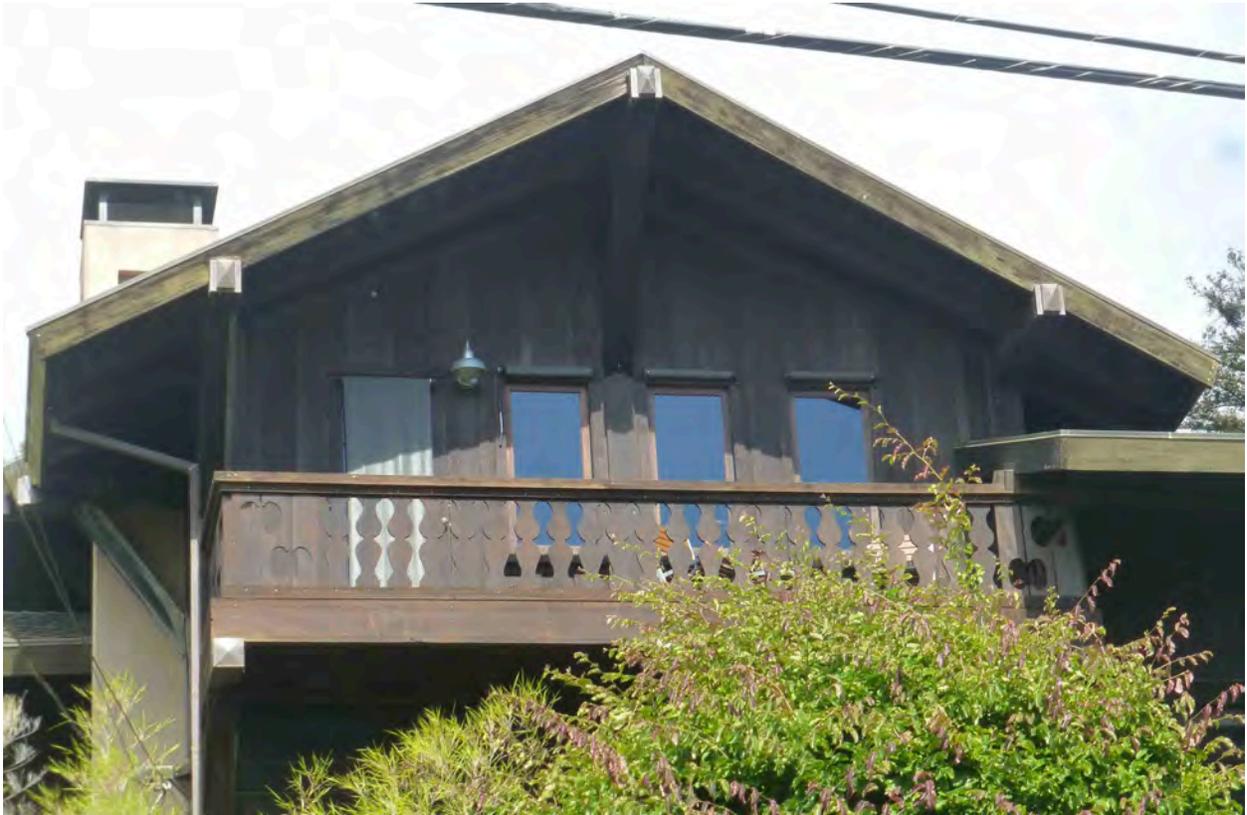
(Above. Top floor of west facade, top floor balcony under gable. Note metal caps on ends of roof supports, Venturi form chimney top at left, and canted southwest corner roof form at right. Below, detail of southwest roof corner. At left. View of basement level of west elevation, looking southeast towards entry path. New patio outside basement in foreground. (Photo S. Finacom, 2021.)

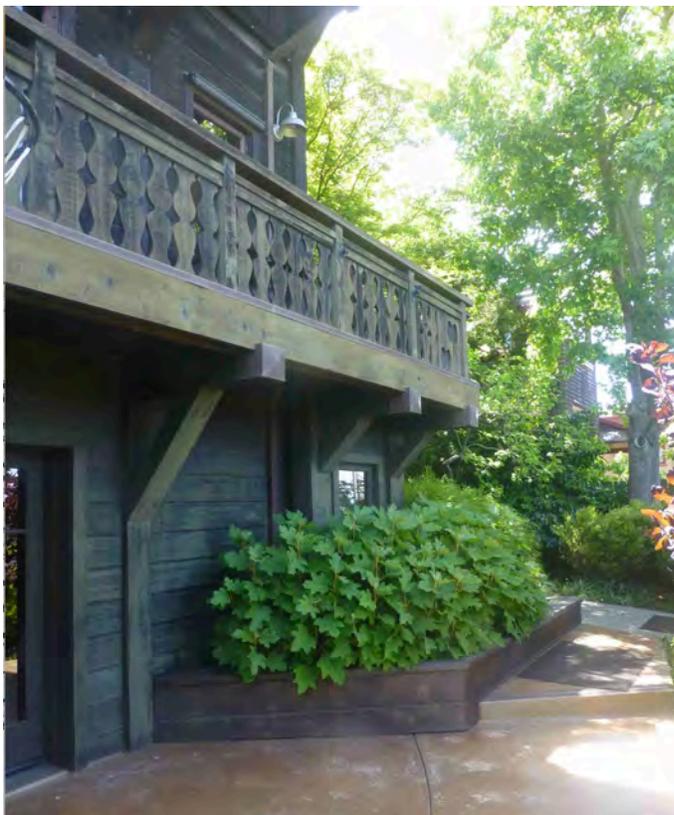
(At right. South elevation, looking west. Vestibule bay is at right. Basement windows at bottom are modifications of original openings, not original. Photo S. Finacom 2021.)

The siding of the basement level is vertical board and batten, rough sawn. There are now three square windows, single lites, in a band slightly above the concrete foundation. Because of the rising grade, from the inside of the basement space these are essentially transom windows.

The original drawings show two windows in this location, slightly divided by a section of wall. Further east on the wall there is a horizontal, single-lite, window with obscure glass. This appears to be an addition, since the original working drawings show only a small opening in this area, perhaps a ventilation grate or hatch.

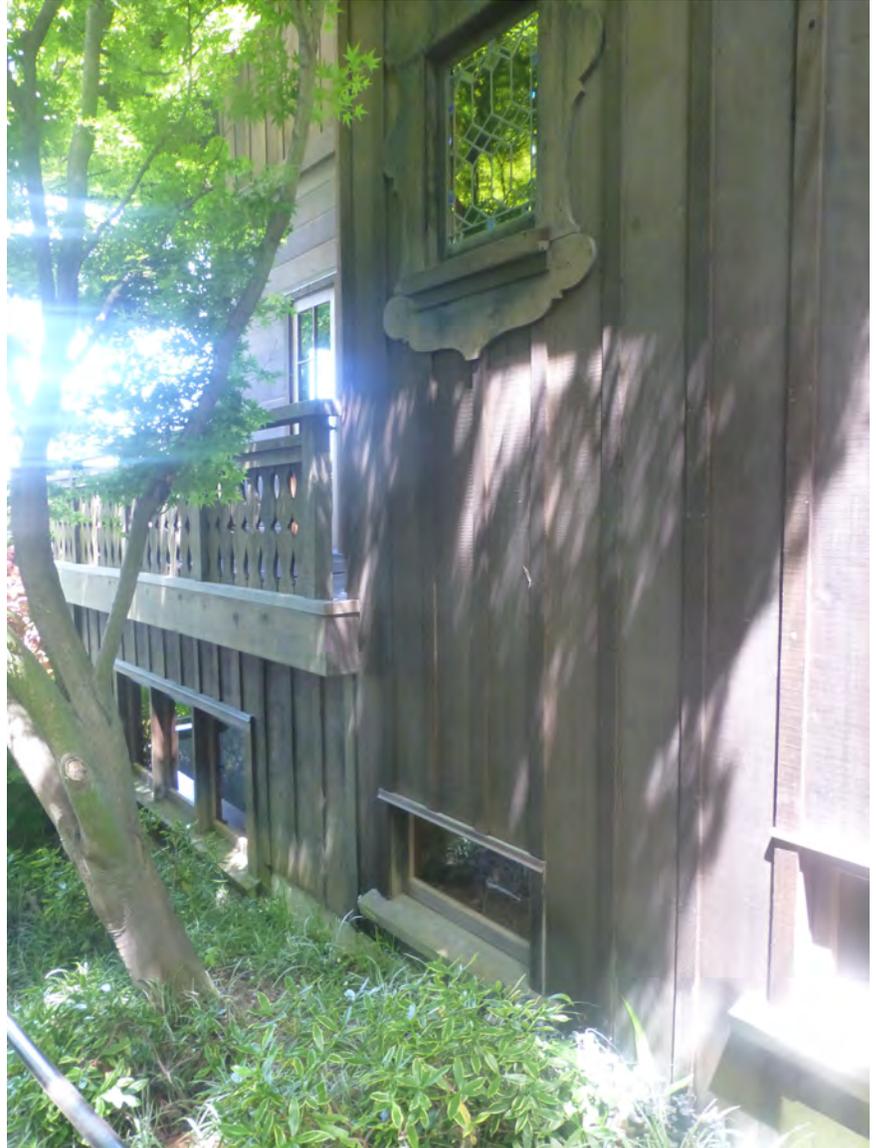
(At left. View of south wall, showing lower balcony and how it dead-ends into vestibule wall; one of the French doors to balcony from living room; change in siding from horizontal boards to vertical boards and battens at main level. Photo S. Finacom, 2021.)

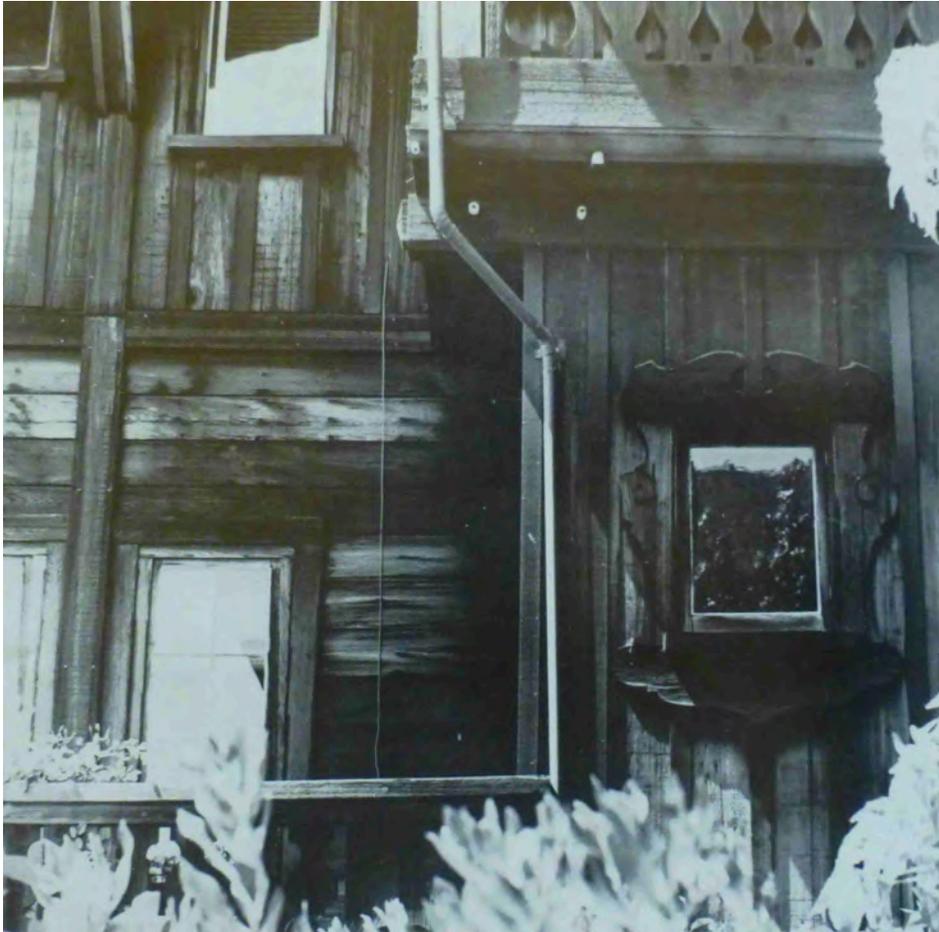
(At left. 1970s photograph of south facade, showing deteriorated horizontal board siding at first floor level, original French doors from living room to balcony at left, and original scroll-sawn wooden surround for vestibule window, at right. Source: Freudenheim.)

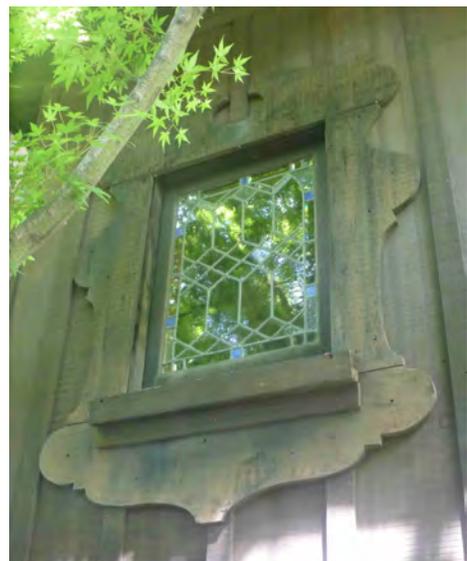
Below, left. Detail of vestibule window today. Surround has been replaced and the side and top details are slightly modified / simplified from the original. (Photo S. Finacom, 2021.)

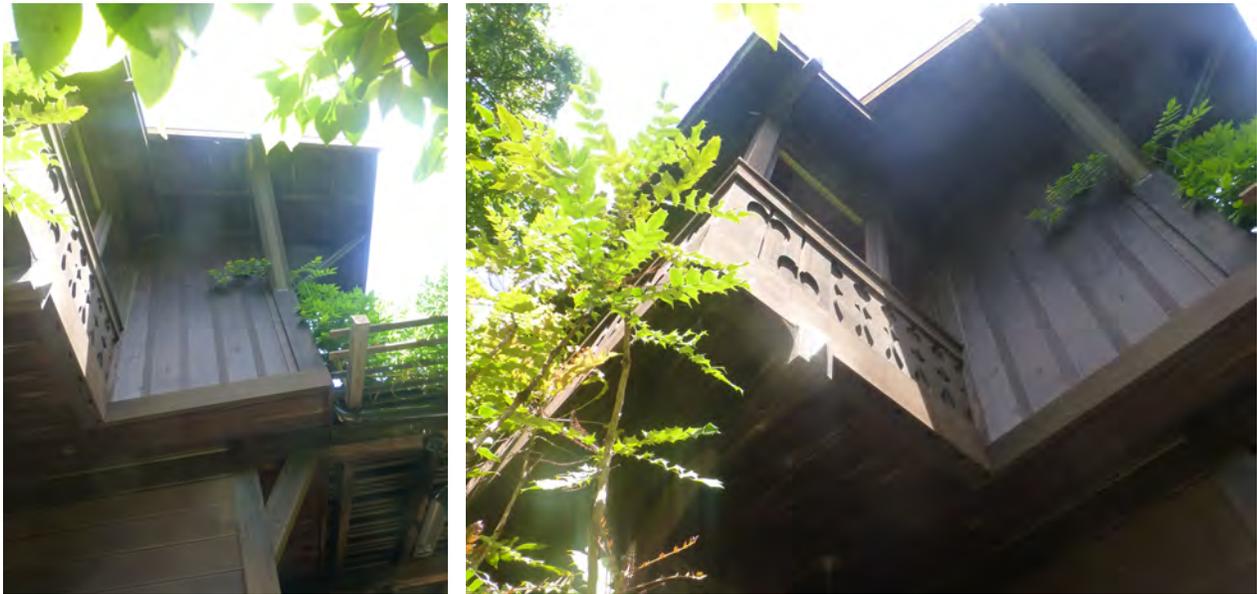
(Above, left and right. Two views of the east end of the sunroom porch and south wall of the house, above the main entry porch / door. Photos S. Finacom, 2021)

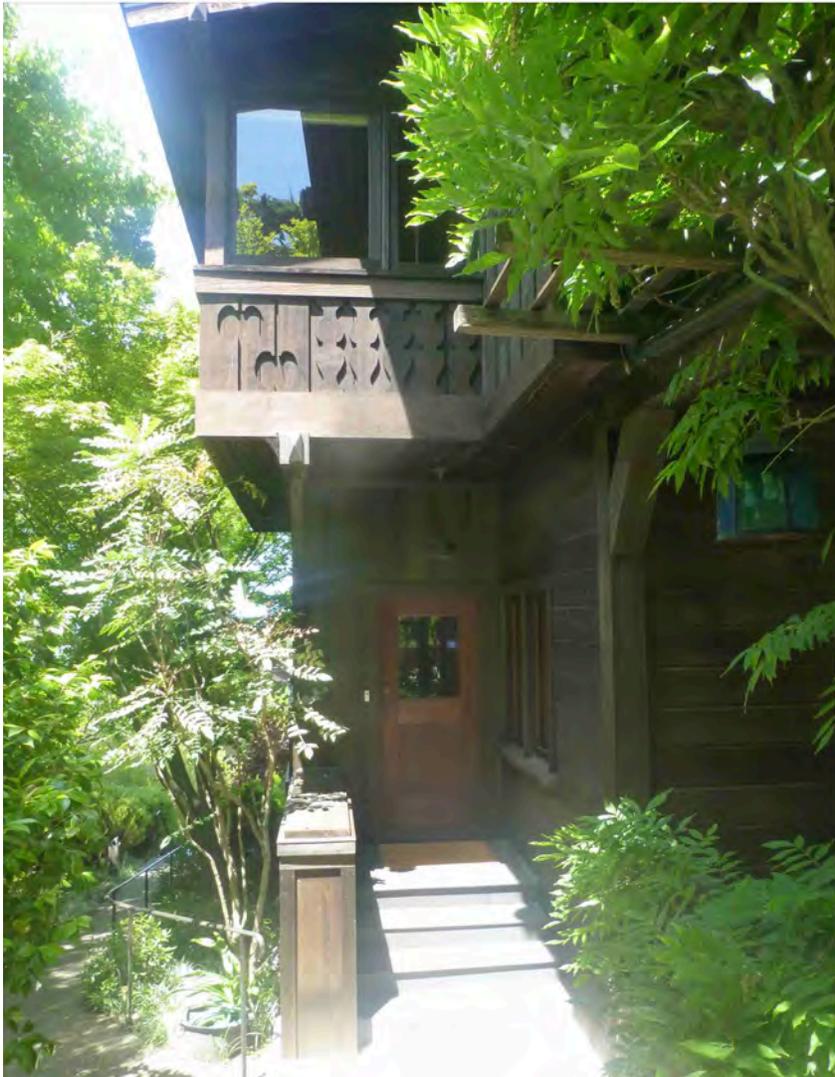
*(At left. Looking west towards the the house and the main entry. Path from street approaches on the left. Four wooden steps with low cheek wall on outer side, rising to small porch which is beneath overhang of sunporch above. Windows to dining room facing porch at right. Front door at center. At right, portion of replacement arbor / pergola over dining room terrace. The sun porch on the second floor was originally an open air balcony under awning, later enclosed. Balcony always formed “roof” over front porch. **Below**, front door of house with Dutch Door configuration, dining room windows at right.*

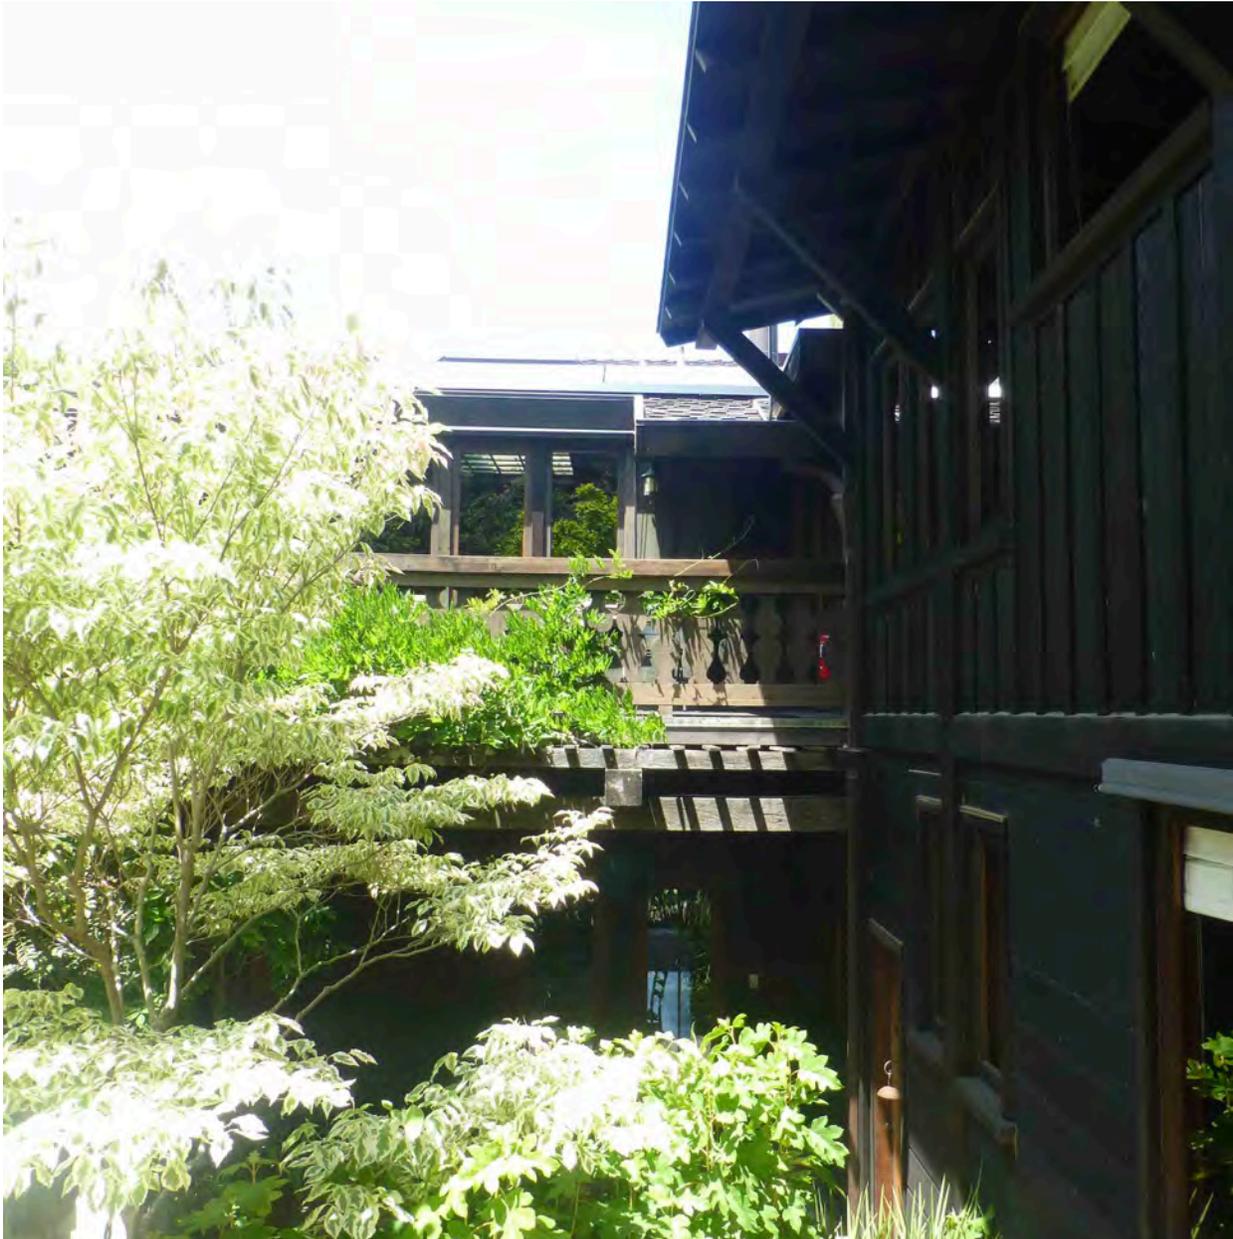
(Above: view of the eastern elevation, with dining room at center bottom, second floor at the top center, and 1930s addition to house at the right. The kitchen is at the lower level, in the angle where the addition meets the original house. The front door of the original house faces this way but is out of sight behind the foliage at the lower left of the image. Photo S. Finacom, 2021)

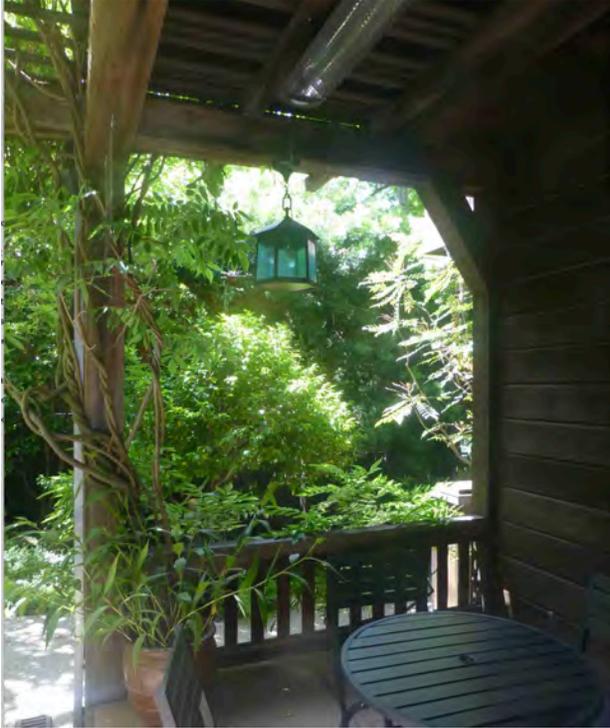
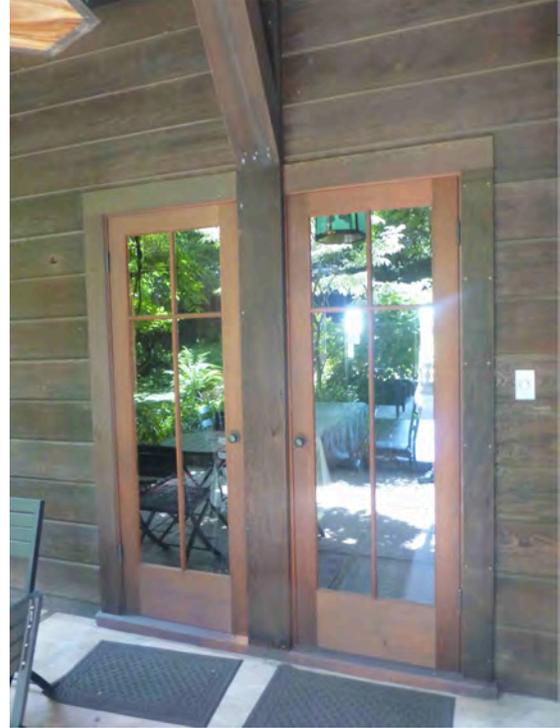
(Above, right. Doors from dining room onto terrace, under pergola / arbor.

Above left. South end of terrace under pergola / arbor and second floor balcony. The front porch of the house is just out of sight around the corner of the wall.

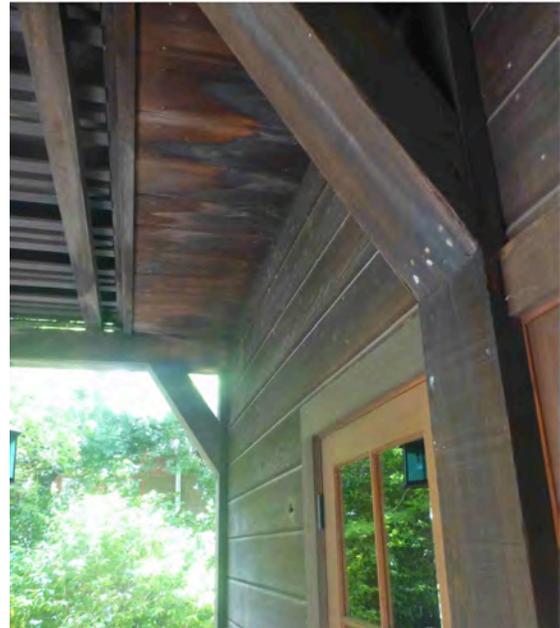
At right. A view of the house overhang from the dining terrace. One can see the way the second floor cantilevered out from the first floor, then the new pergola / arbor structure at left, topped by second floor balcony. Photos S. Finacom, 2021).

The ground level terrace in the exterior angle of the dining room and kitchen is now overhung by a pergola of heavy timbers, supporting both a wisteria vine and a second floor balcony. The pergola is not original but is designed in the general character of the original house, and includes an arrangement of small, square, wooden poles grouped in threes that form the “ceiling” of the open air terrace below. Two large, hexagonal, metal and colored glass lamps hang on chains from the pergola, over the terrace; the six vertical glass panels have a sea-green color. These fixtures are not original, but were apparently added by Ken Rasmussen after 2012.

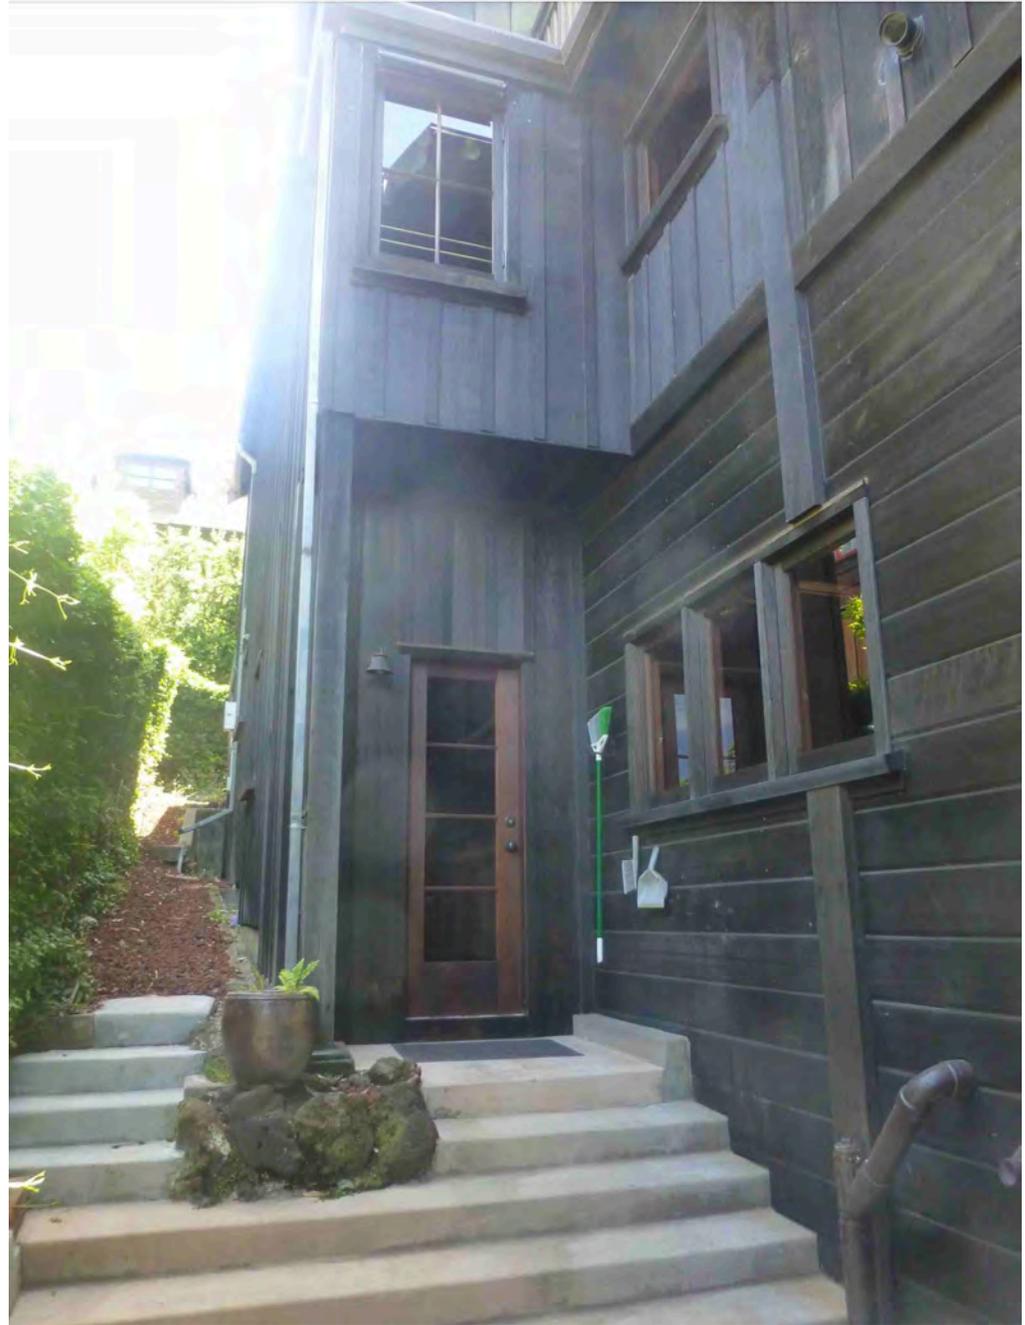
(At right, the rear addition of the house as seen from the north, looking east. The original kitchen area and second floor of the main house are to the right; the addition projects to the left. Photo S. Finacom, 2021)

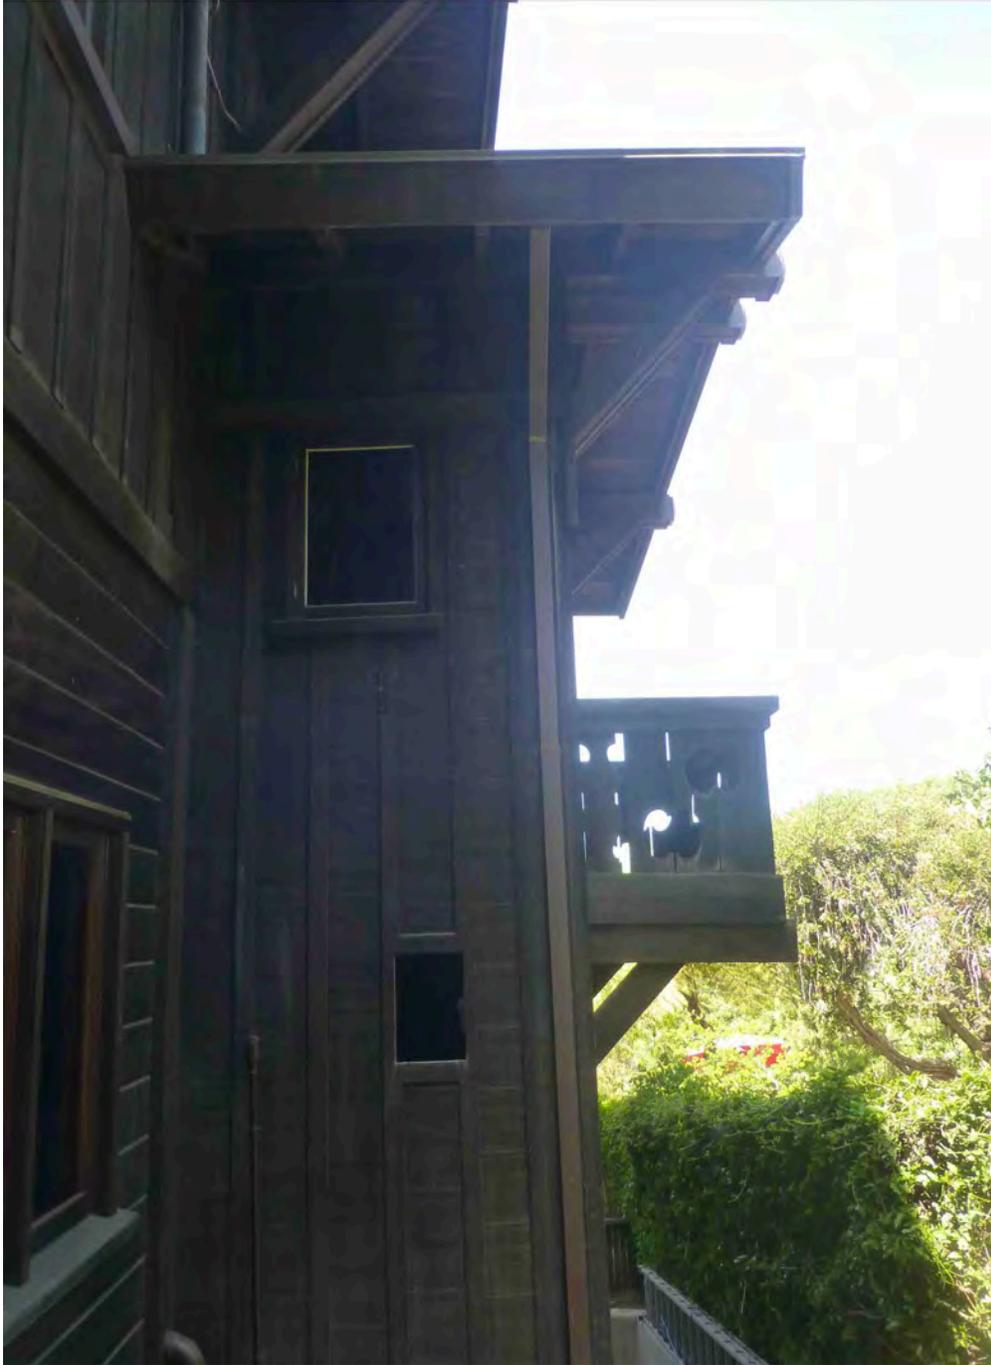
(At left, looking west, along the north wall of the original house, showing the one and a half story board and batten bay that contains the stairwell. The “Juliet” balcony is on the right, and there is a small hipped roof over the projecting bay. Photo S. Finacom, 2021.)

The north elevation includes an exterior chimney and a projecting bay that encloses the staircase landing. A small “Juliet” balcony further projects from the bay at the level of the landing. The balcony also has the “butterfly” cutout and classical baluster motif.

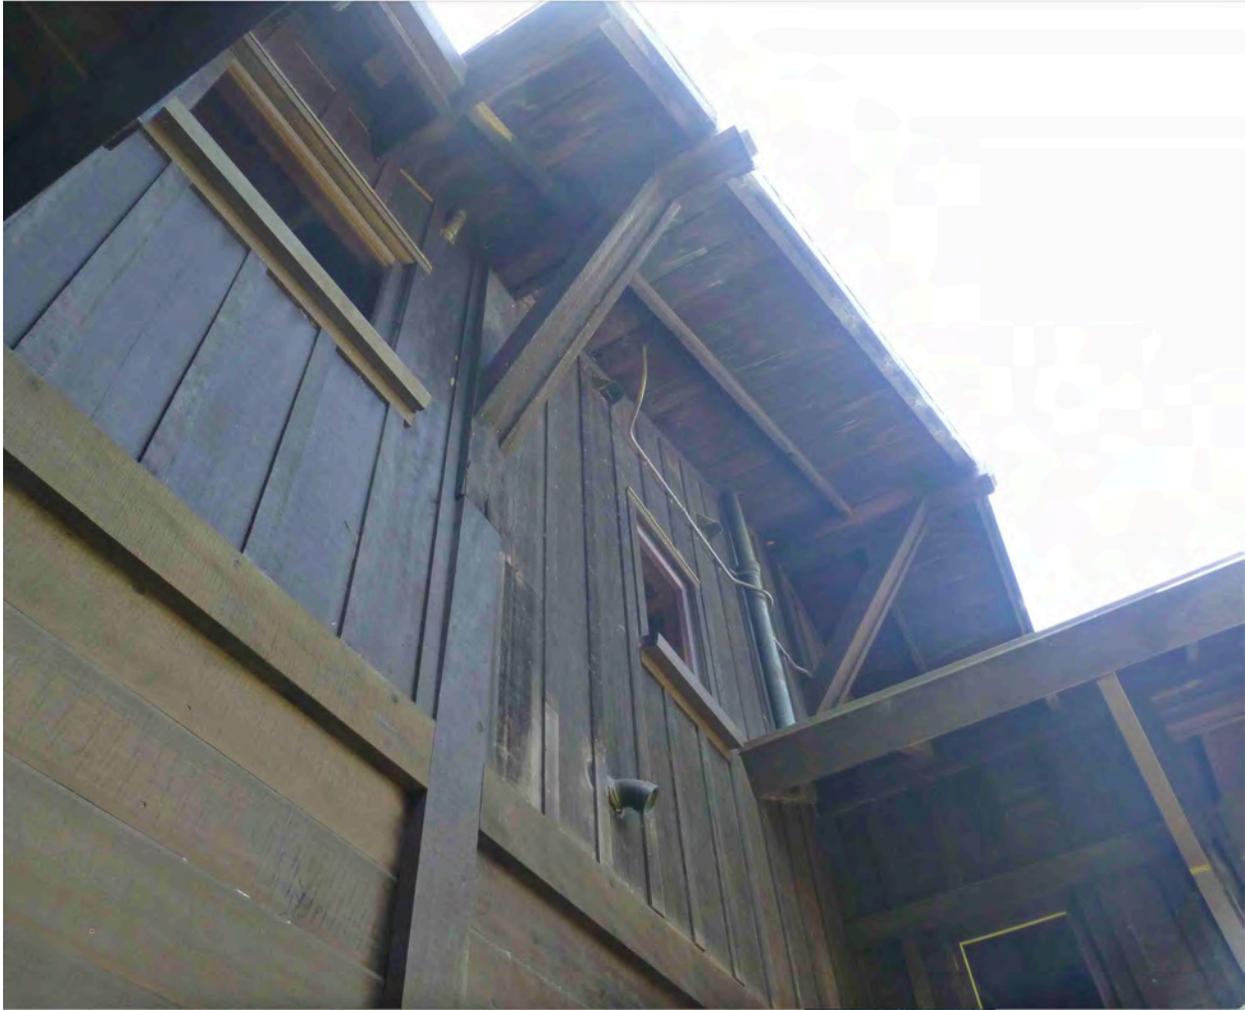
(Above, upper exterior wall and roof detail of north elevation of main house. Note the wide eaves, brackets, board and batten on upper floor, horizontal board siding on main floor, and wooden “posts” expressed on the exterior. This is looking southwest, towards the upper portion of the second floor, with the stairwell bay at right. Photo S. Finacom, 2021)

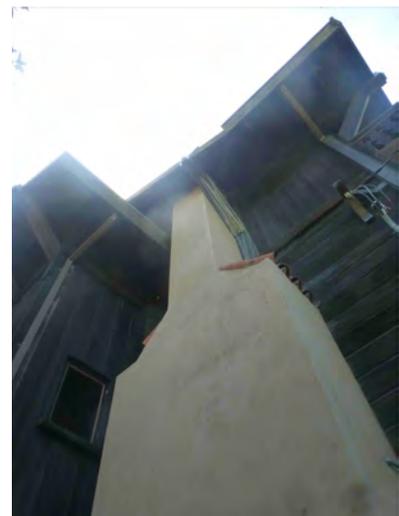
(Right, chimney for main living room fireplace looking up from ground level. Photo S. Finacom, 2021.)

It is unclear whether the top of the chimney has been modified. Maybeck’s original drawings for the house show a Venturi cap on the chimney, with two square cutout gaps on each side in the masonry or terra cotta top. Venturi caps were a feature Maybeck often incorporated in houses of his design in this era. However, the current chimney shows only one square cutout on each side, and it does not fully penetrate the chimney to facilitate the air exchange function but, rather, serves as an external decorative motif. There is also a metal top to the chimney that does not appear old enough to be original. Was the chimney top rebuilt at some point? And was it built to Maybeck’s original design, in the working drawings, or initially constructed (and/or later reconstructed) in a modified form? Research to date has not provided an answer.

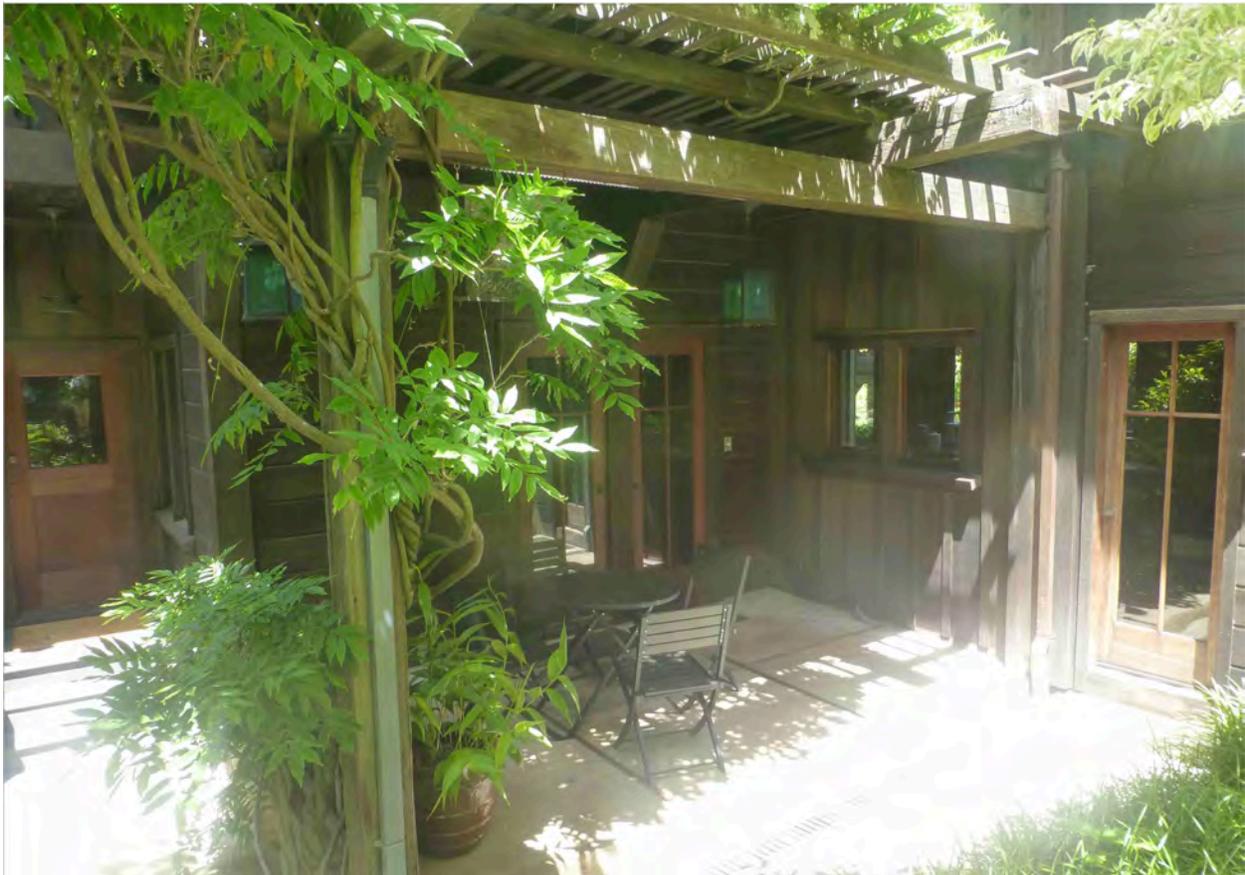
(Above, dining terrace looking northwest from garden. At left, front door of house. At center, dining room and pergola. At right, kitchen. Photo S. Finacom, 2021.)

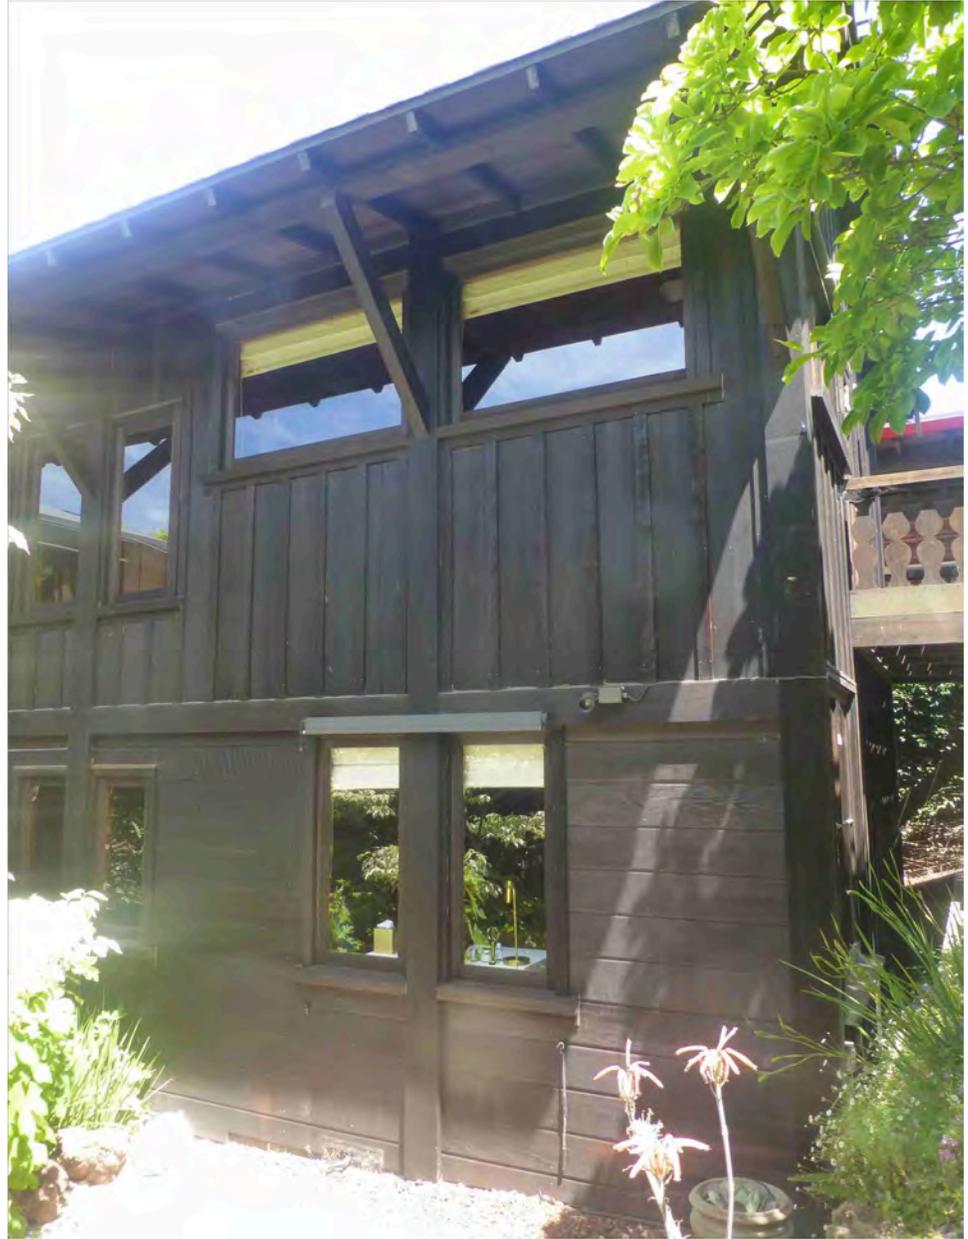
(At right, the east end of the 1930s addition, looking north from the garden. The lower windows at right open to Alfred Kroeber's second home office. Note the horizontal board siding on the ground level, the board and batten siding on the upper floor, and the overhanging eaves with brackets, all corresponding to the character of the original house. Photo S. Finacom, 2021.)

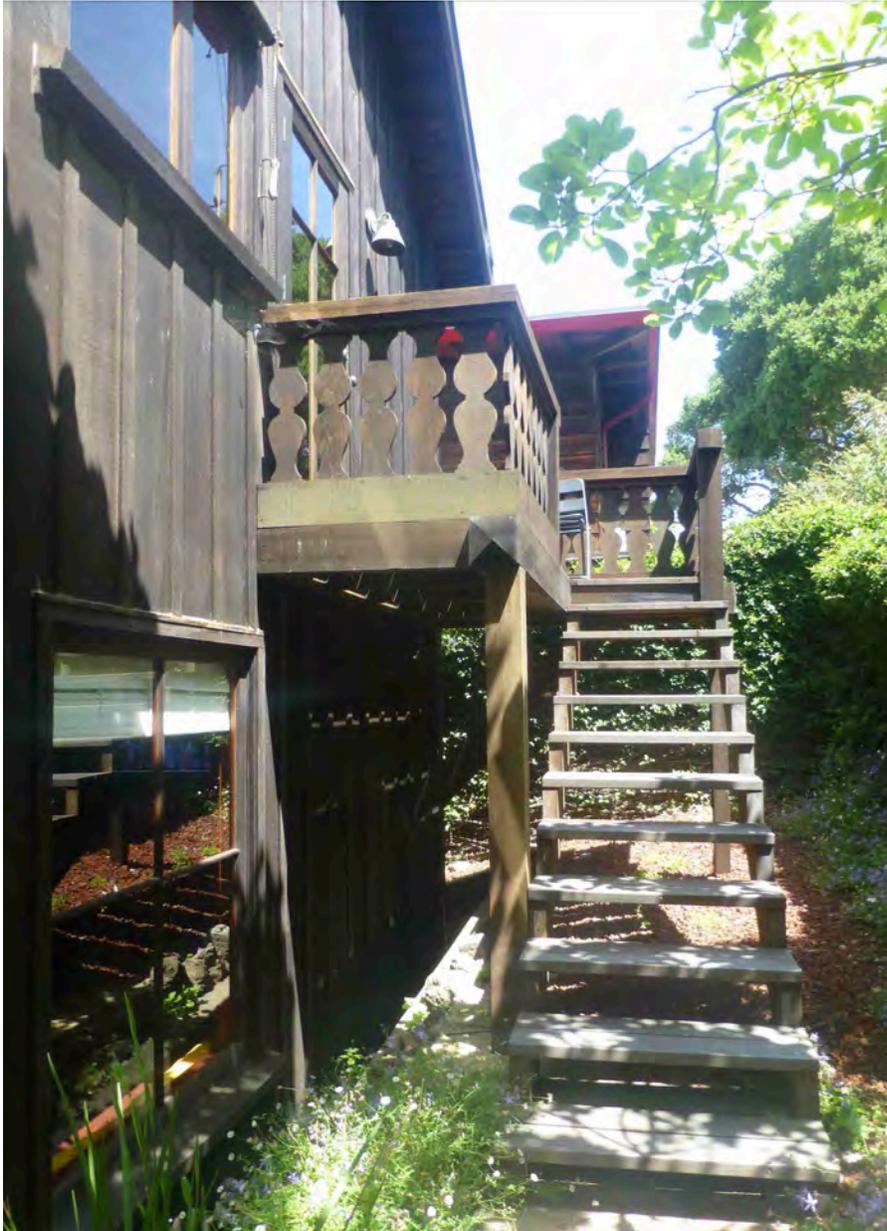
(At left, east end of addition showing balcony and staircase that altered the original “Juliet” balcony in this location. Kroeber study is lower left. Photo S. Finacom, 2021.)

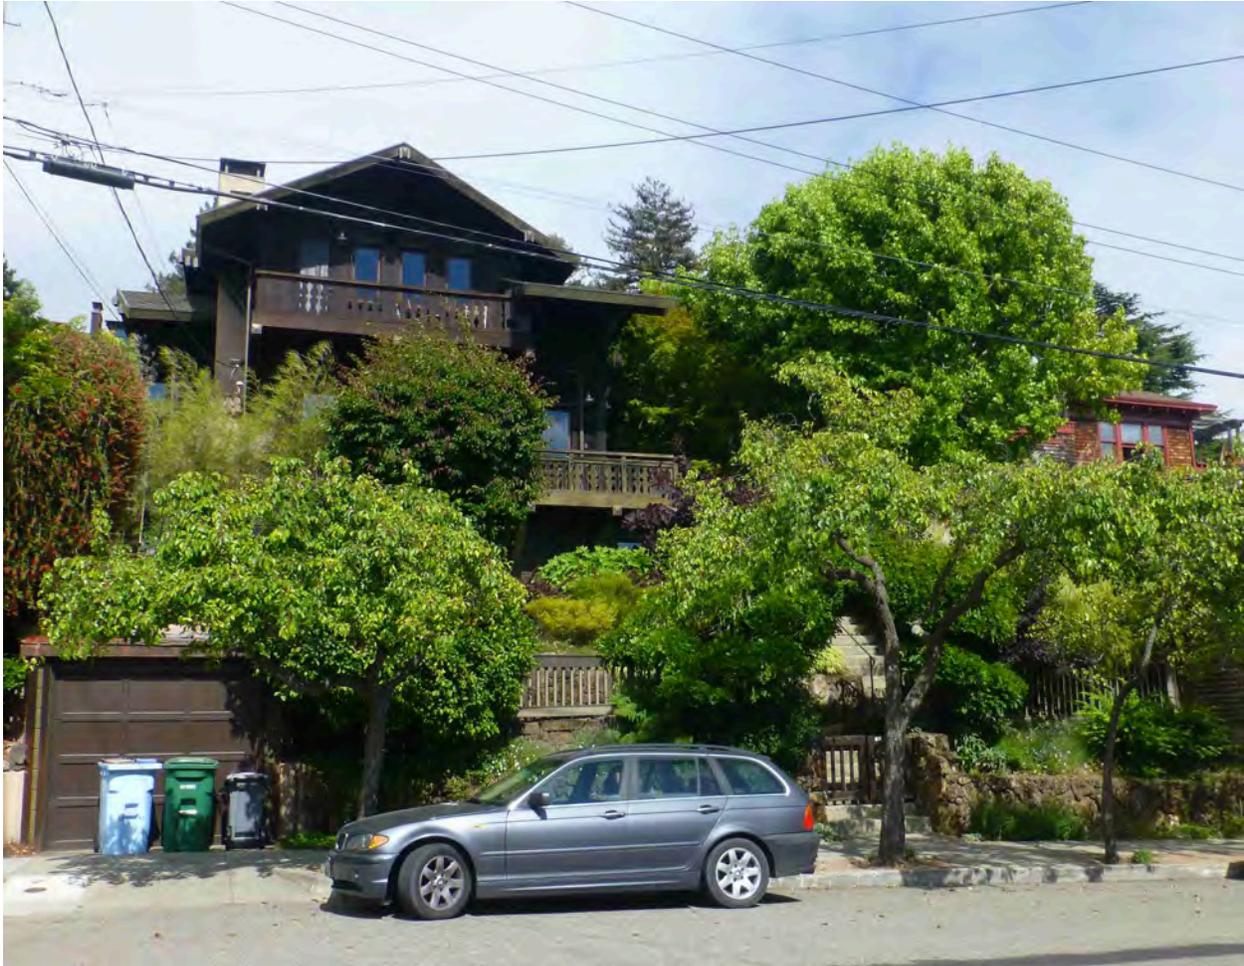
(Above, overall view of street frontage of property showing garage at lower left (in northwest corner of property), and rise of garden levels to house. The larger trees at the upper right are the liquid ambers mentioned by Theodora Kroeber in her description of the garden. Photo S. Finacom, 2021.)
