EXECUTIVE SUMMARY

QUESTION #14: ARCHITECTURAL DESCRIPTION

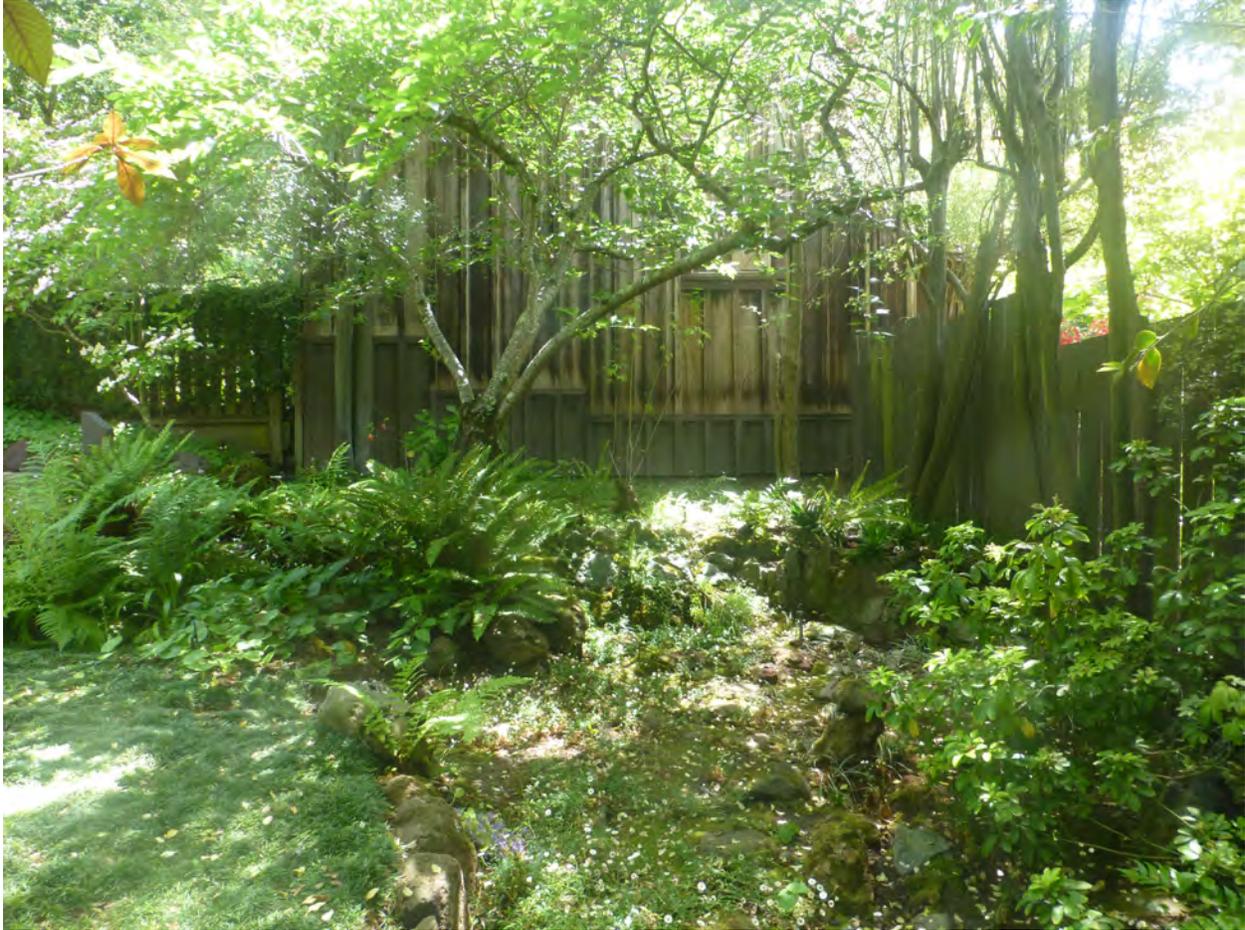
(Above, southeast, uphill, corner of garden. The property line follows the fences at left at right. At upper center there is the west wall of the small “1325 1/2 Arch” structure built on an adjacent property and owned separately. This is likely the building that the neighbors to the south offered to sell to the Kroeber’s as an office in the 1930s; the Kroebers chose instead to build the two story addition to the main house. Photo S. Finacom, 2021.)

Adjacent to the upper, southeast, corner of the 1325 Arch property there is a small structure, essentially a one room studio or cottage with board and batten siding on the downhill side, built on the property line, overlooking the 1325 Arch garden. This is currently part of the adjacent property to the south, 1329 Arch Street.

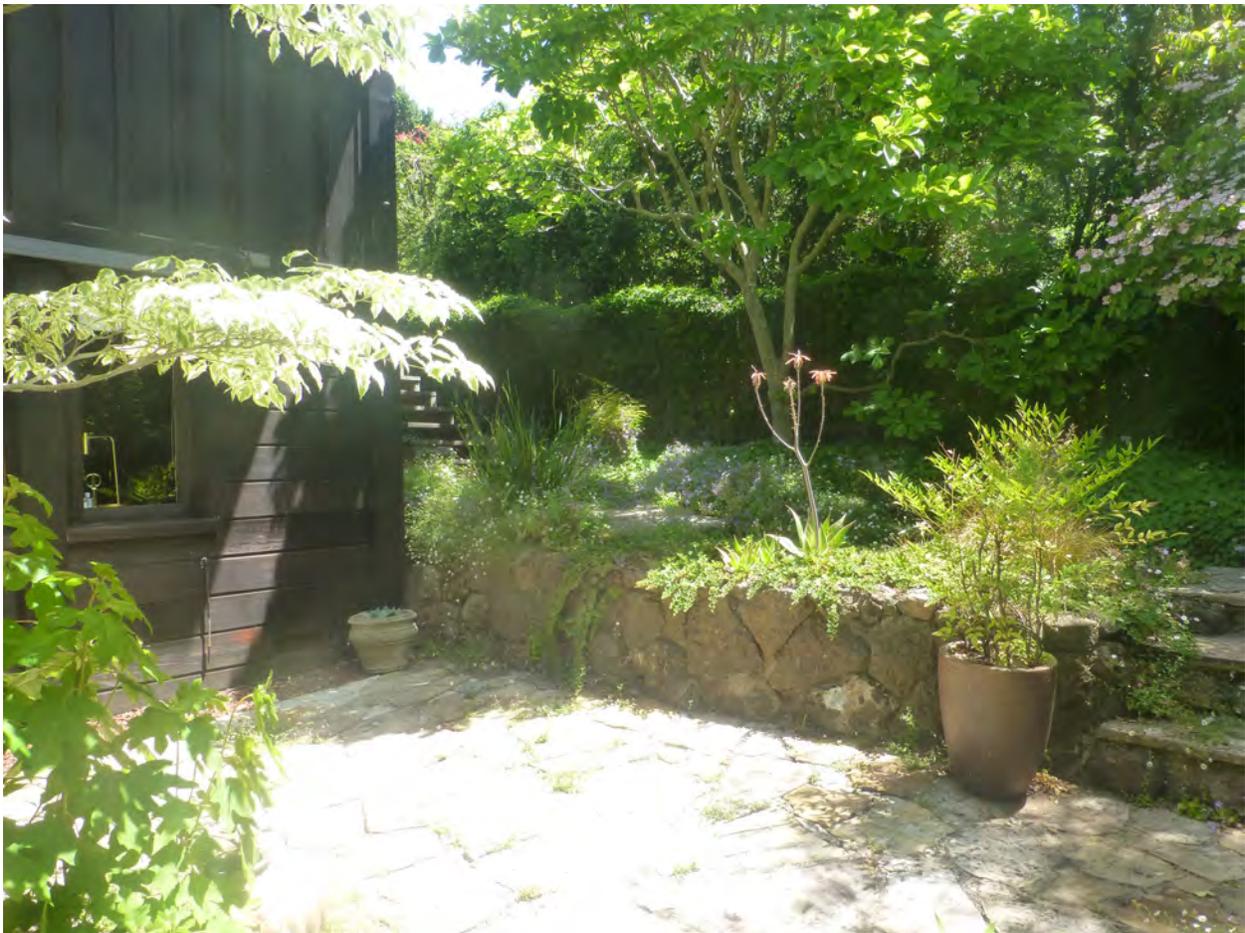
(Above, eastern end of the garden, showing flagstone terrace and stone walls south of the house addition, at left. Photo S. Finacom, 2021.)

In addition to the removal of the northern portion of the gardened area, the eastern portion was reduced by the construction of the addition to the house in the 1930s that extends along the north property line nearly to the east property line.

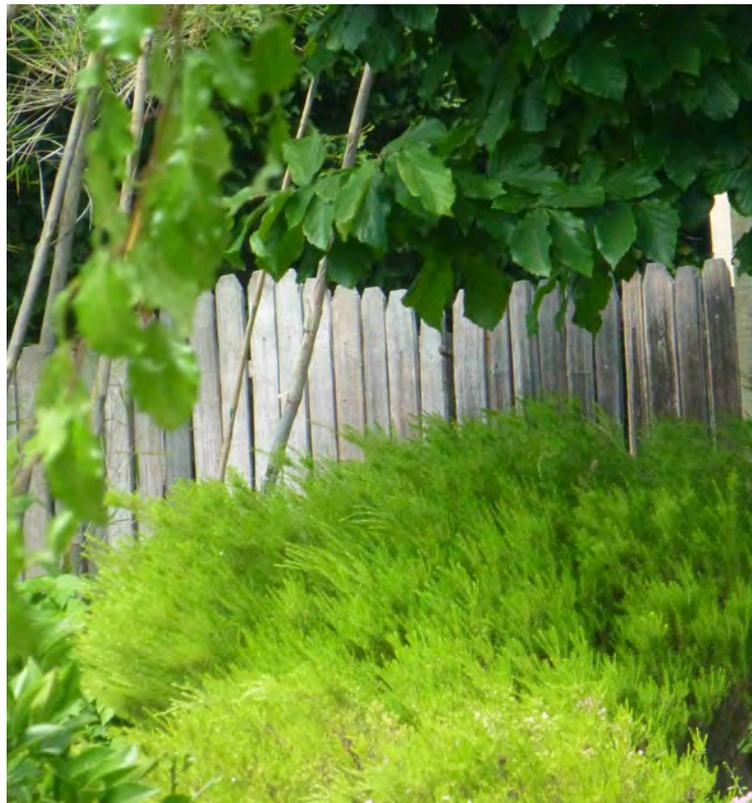
(At right, grapestake fence along north property line. Either the original installed by Lisa Stadelhofer, or a replacement, in kind. Photo S. Finacom, 2021).

Lisa (Stadelhofer) put in a grapestake fence along the north property line, so the lot is now completely fenced, and the north side of the house is an enclosed dog run. She has done extensive planting, including the street trees, and she put in the railroad-tie wall along the south edge of the lawn."

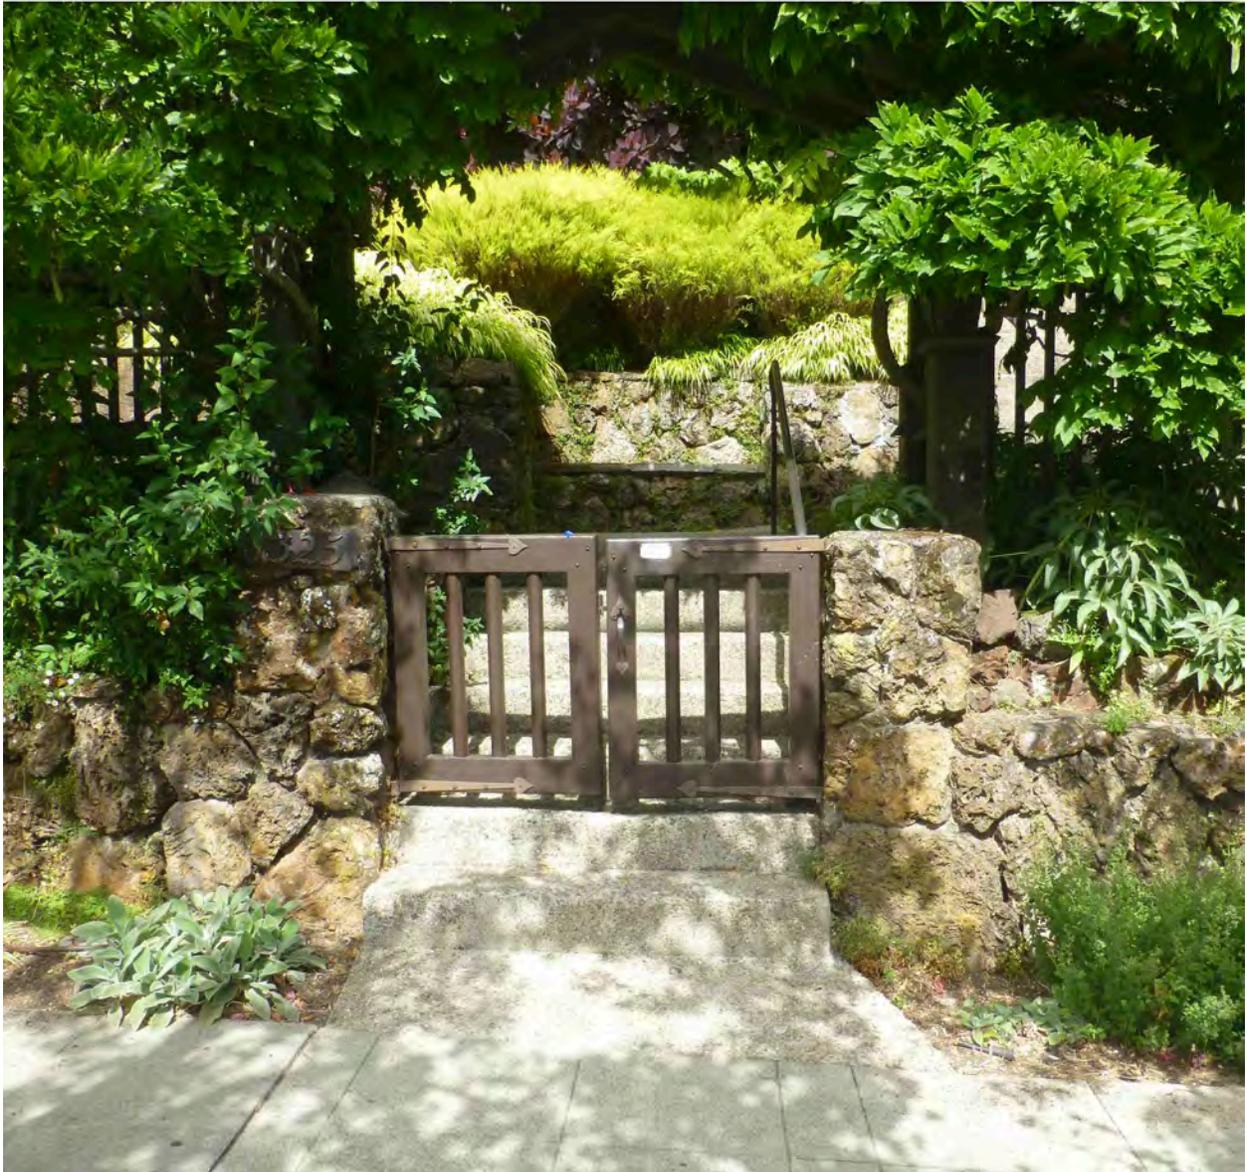
(At right. Entry gate from the street. Stone columns and rhyolite stone walls are from the Period of Significance. Gate and arbor above it are more recent additions, as are concrete stairs. Photo S. Finacom, 2021)

The garden contains a variety of stone walls. The oldest stones along the sidewalk, south of the entry gate, appear to be of Berkeley Rhyolite, a native volcanic stone picked up on Berkeley hillsides in weathered condition in the 19th and early 20th centuries and used throughout the eastern portion of the city to construct rustic garden walls that were seen as especially compatible with Arts and Crafts and Berkeley brown shingle houses. The stone walls to the steps ascending to the main door of the house are from early in the history of the house, but other areas of stone walls were apparently added in later periods.

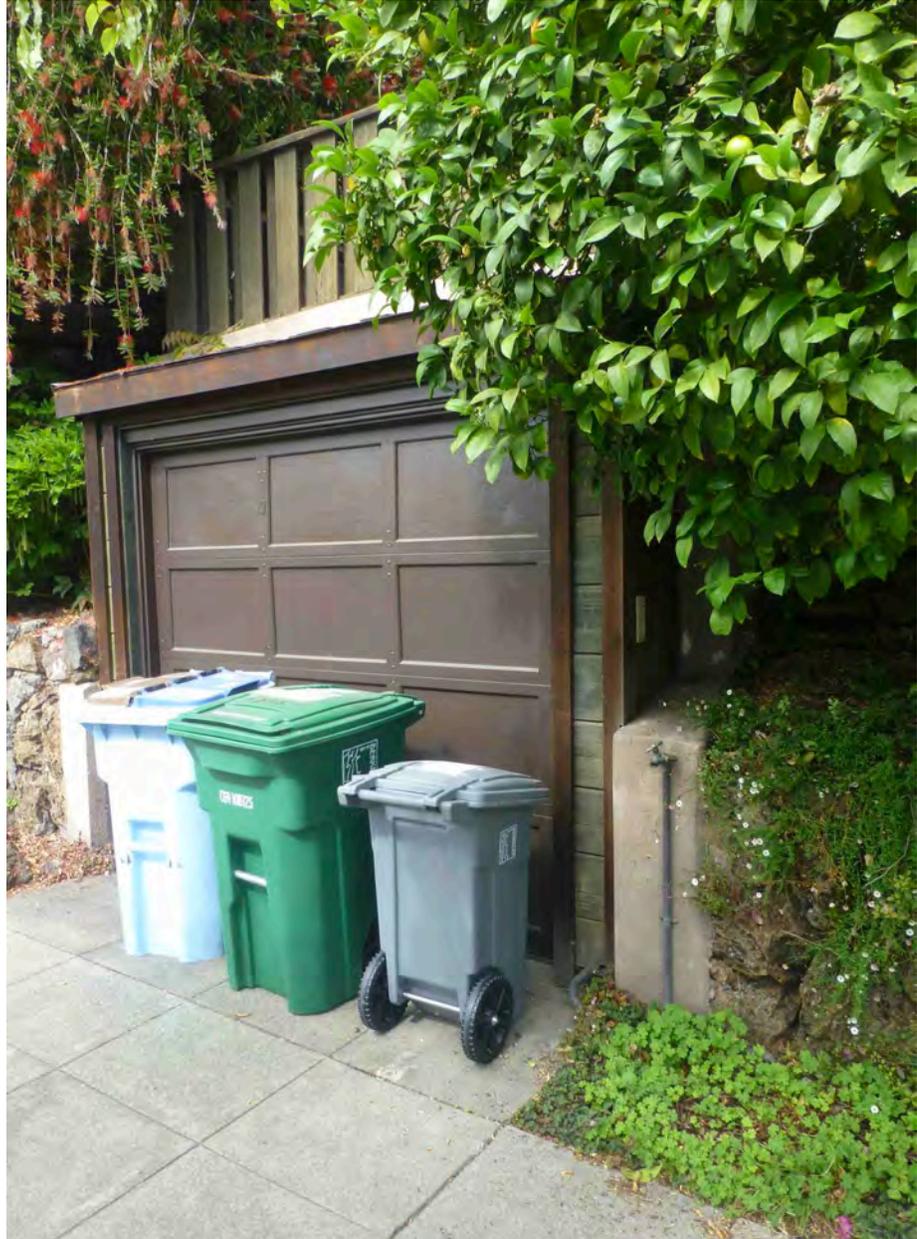
The one car garage at the lower northwest corner of the property was added to the grounds in 1933, so is from the Period of Significance, but has been altered in subsequent decades. The wood siding and garage door itself are not significant. No early photographs of the garage have been found, so it is not known whether there was originally a garage door or whether, as was sometimes the case in Berkeley, a roofed structure was built into the hillside but left open to the street.
