Waterfront Specific Plan for the City of Berkeley Public Tidelands Area

BERKELEY MARINA AREA specific plan

INFRASTRUCTURE ASSESSMENT

may 14, 2021

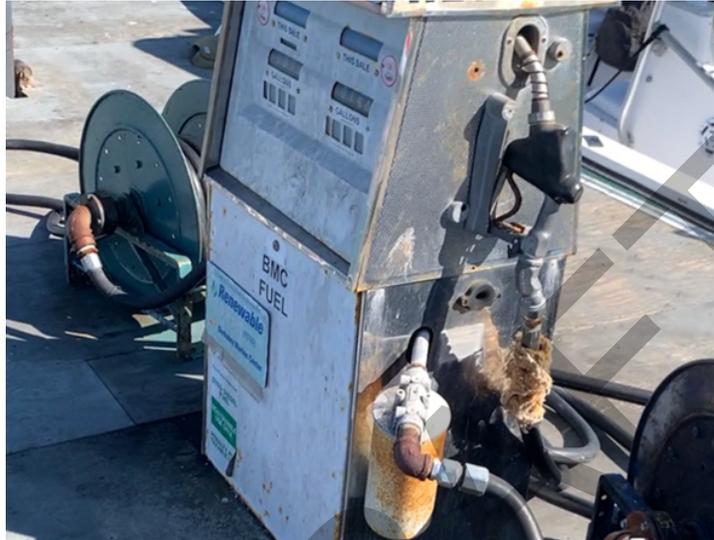
Fuel dispenser

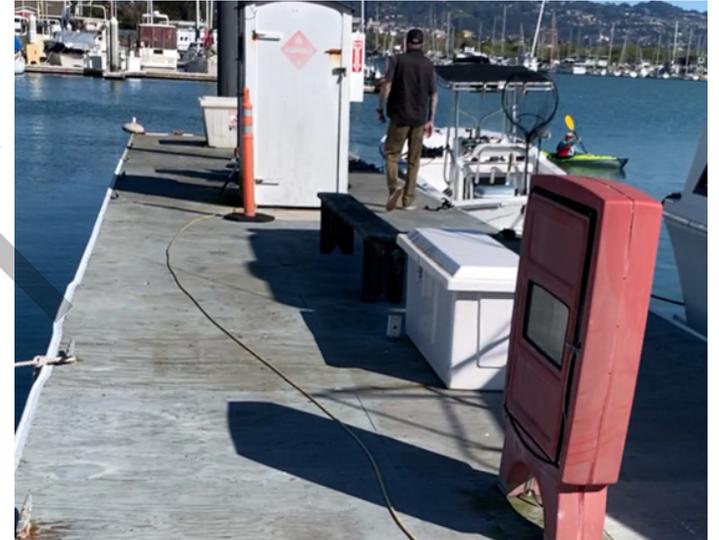
the docks adjacent to the fuel station consists of plywood boards so that the fuel line can be easily accessed underneath the deck, if need be. Some other fingers at this dock had plywood boards replace the original timber plank deck surface as well. A few of the fingers at A Dock are slightly warped, but most fingers are in excellent condition. One finger at the East Walk had missing deck panels which should be replaced.

Plywood cover deck at fueling station

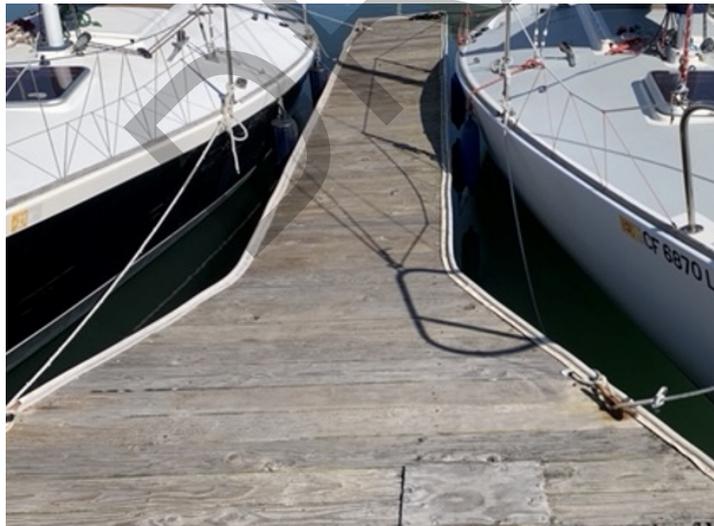
Twisted finger at west walk

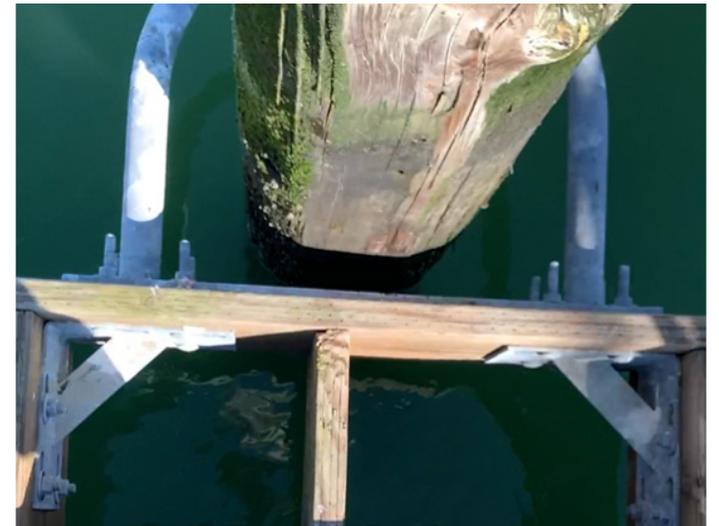
Exposed finger end revealing construction method for the docks

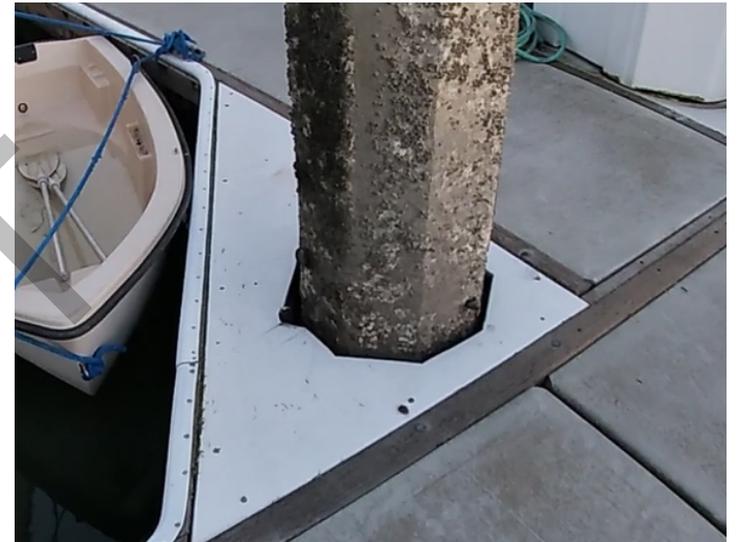
The pile guides at these two docks are steel pile guides with HDPE (high density polyethylene) rub strips hidden beneath polymer cover boards. A hole is cut into the cover board to fit the pile. The design of the guides creates a clean, flattering appearance and is similar to that seen at H and I Docks, which were constructed two years after the B and C Docks. Cleats, corner bumpers, and rub strips were all found to be in excellent condition.

Pile guide hidden beneath polymer cover board

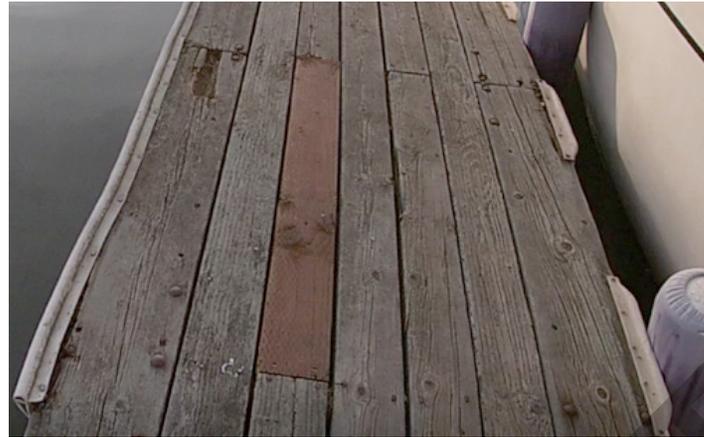
D and E Docks are comprised of timber framing and decking. The deck is comprised of staggered 2" x 6" timber planks, which run parallel to the dock's long axis rather than perpendicular (as seen in the other timber docks at the marina). The decking is showing signs of heavy wear and deterioration, often having holes and checks in the timber planks and a rough texture. Individual planks have been replaced at various locations along the dock and these can be identified by their noticeable color difference compared to the original planks. These repairs work well and highlight one of the advantages of having a timber deck in comparison to concrete. The southern end of E Dock is blocked off to the public. Despite the various issues with these two docks, they remain stable during use.

Typical timber deck at D and E Docks. Notice the replaced plank with a redder hue

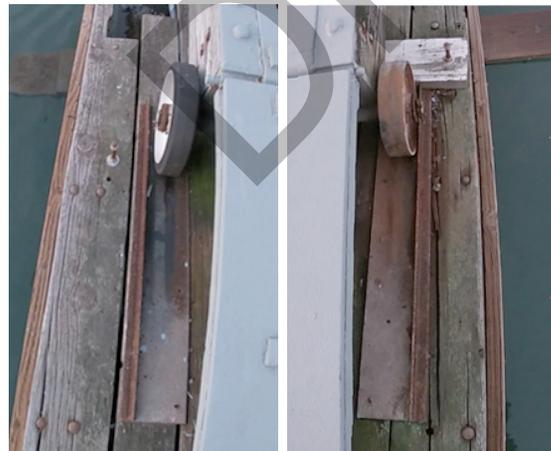
The timber gangway is in good condition and the timber access pier is in excellent condition. The gangway has notches on its west side which act as steps to assist with its steep slope. At the bottom of the gangway, the steel wheel and wheel guide on the gangway's east side are beginning to corrode but show no signs of further damage. On the west side, the steel wheel has been replaced with a rubberized wheel. The original wheel guide still sits beneath the new wheel and is also starting to rust.

Gangway wheels. Note the difference in wheel material between the west and east side of the gangway

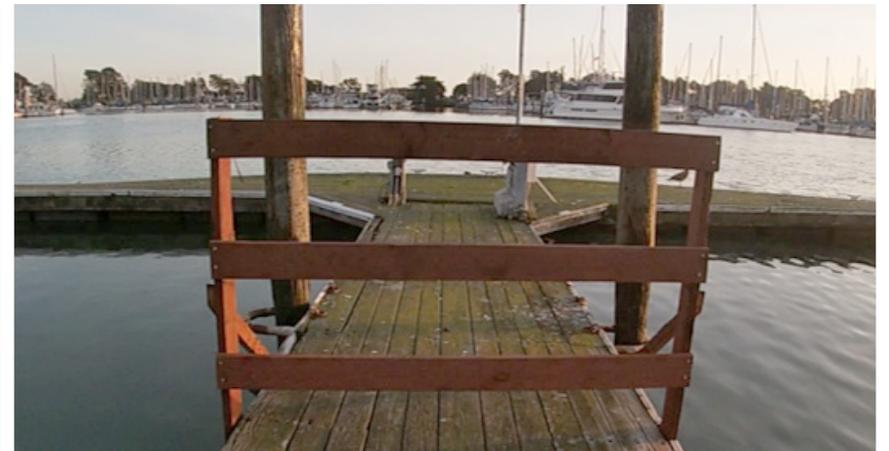
Closed off fingers and end of main walkway at E Dock

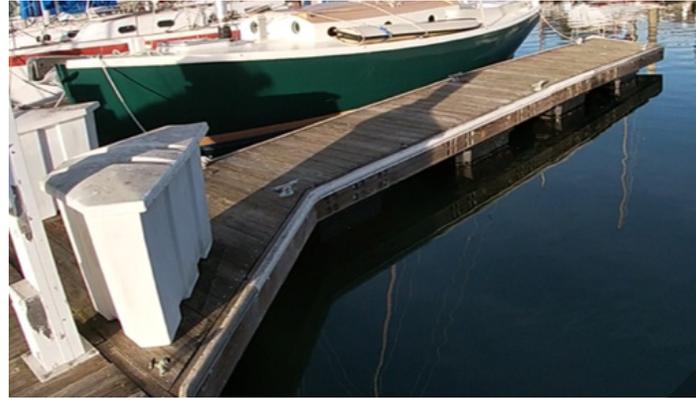
The decking for F and G Docks is made of timber which runs perpendicular to the long axis of the dock. The frames for the docks are made of timber. The majority of the decking is in excellent condition, but there are a few locations at the end of fingers where the wood is starting to show signs of decay. The decaying wood is found at fingers which are exposed to waves generated by vessels traversing the harbor's interior channel. When the waves splash water onto the docks and it is allowed to pond, the water slowly rots the timber deck. While the damage observed from this is minor, this should be monitored to see if the condition of the timber worsens over time. Some fingers at F and G Docks have begun to exhibit twisting and deformation; however, it is minimal, and the fingers remain stable to walk on.

Twisted finger at F Dock. Note the middle section of the finger is slightly raised in comparison to the ends

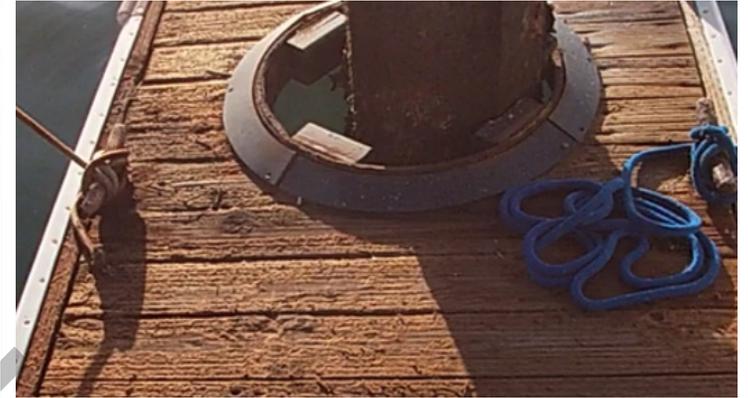
The piles at F and G Docks are all precast concrete and are in excellent condition. The pile guides are made of galvanized steel rings with HDPE rub block attachments to prevent direct contact between the concrete pile and steel ring. Similar to the decaying wood of the decks exposed to wave action, the pile guides at the exposed locations are showing signs of corrosion damage. While no significant section loss was observed at the guides, the corrosion should be monitored for changes to the condition of the rings.

Deteriorated wood and corroded guide at F Dock. This finger is exposed to the interior channel of the harbor

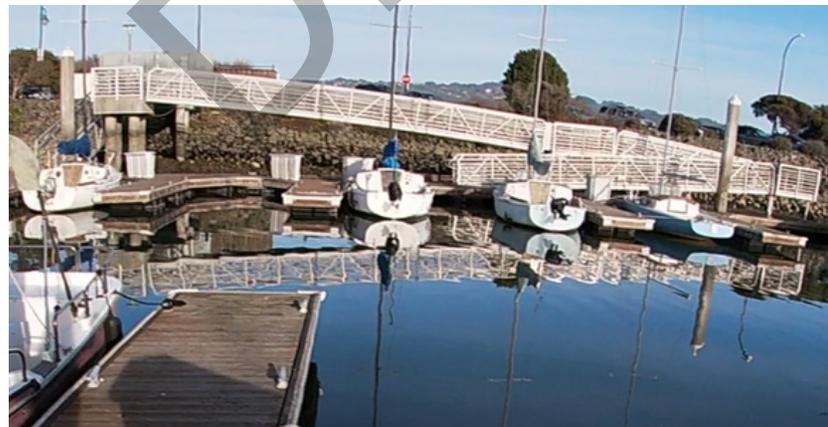
There are two gangways connecting F and G Docks to the shore. The north gangway is 35' long with a steep slope providing direct access to the docks. The gangway connects to the dock using HDPE skid pads on skid plates. The plate on the south side of the gangway needs to be reattached to the dock. The other gangway is ADA accessible with a switchback ramp on the dock. The ADA gangway has a steel frame with timber deck, which is uncommon. The total length of this gangway is approximately 160'. Both gangways are in excellent condition with no observable defects.

Gangways at F and G Docks. Note the shorter gangway on the left side of the photo

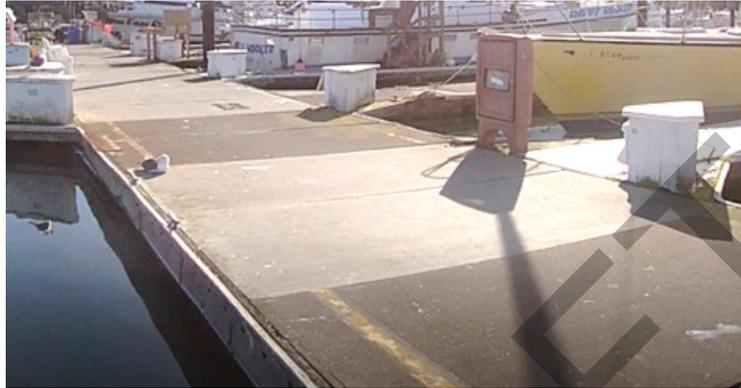
The dock modules at K Dock are in moderate condition. Most of the modules are precast concrete floats made by Bellingham Marine, Inc., but some of the most damaged fingers have been replaced with aluminum framed, composite timber deck docks. The older concrete dock modules, especially at the northern end of the dock, are cracking at their edges. There are color differences between adjacent dock modules, suggesting that replacements have been made over time.

Main walkway of K Dock. Note the width of the dock as well as the different color of the float modules. Floats lighter in color are likely replacements

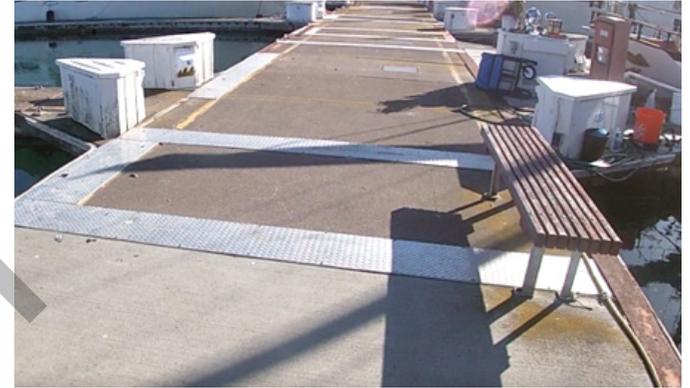
Diamond plate covers at the edges of the floats. Covers hide cracks and tripping hazards

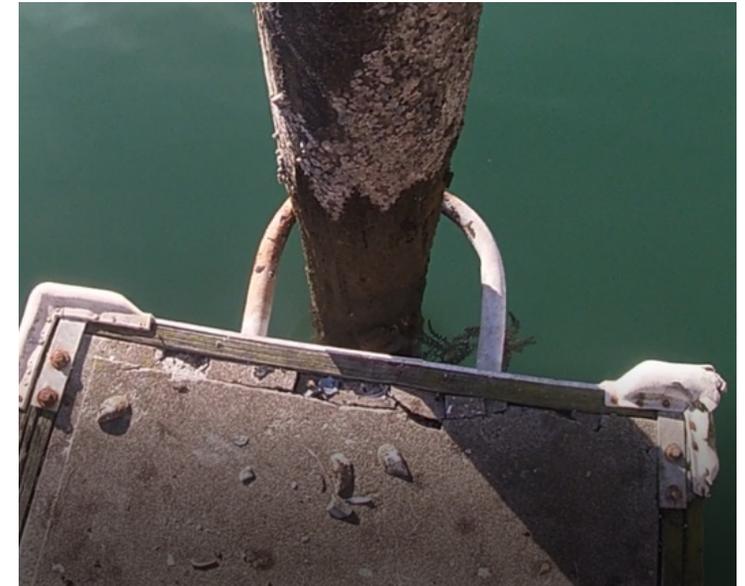
Cracking concrete and finger end

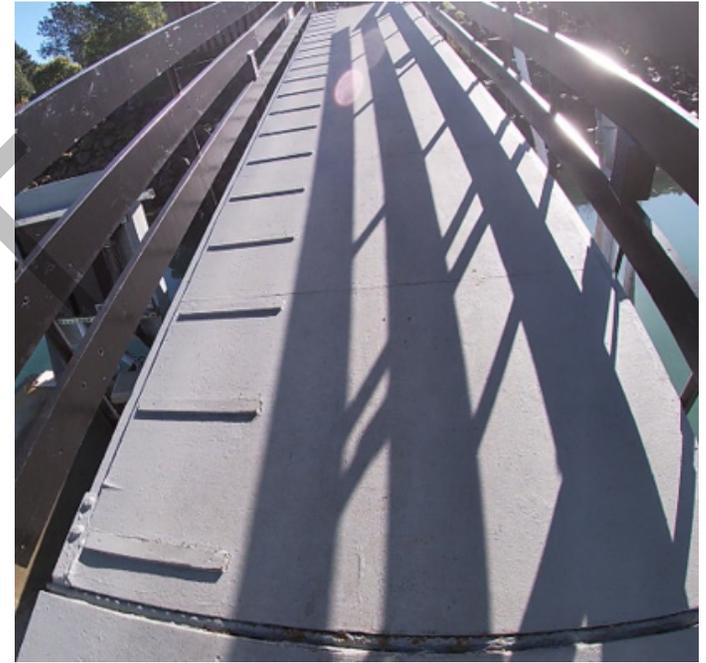
The gangway and access pier are in good condition. The gangway is 35' long and is built similar to the gangway at J Dock. The gangway rolls on the dock using steel wheels in wheel guides. The steel wheels and guides are discolored from rusting and the texture of the steel is beginning to show signs of corrosion. The wheel guides rest on two concrete float modules with different finished surface elevations, causing the wheel guides to bend.

Gangway with notches. This gangway design is typical of the older docks at the marina.

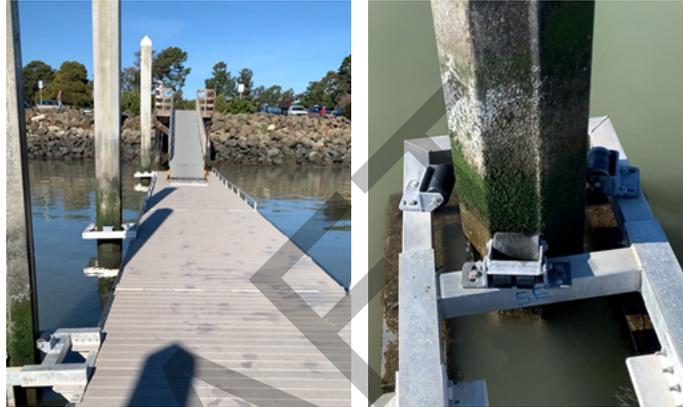
Skewed roller assemblies at southern end of East Dock

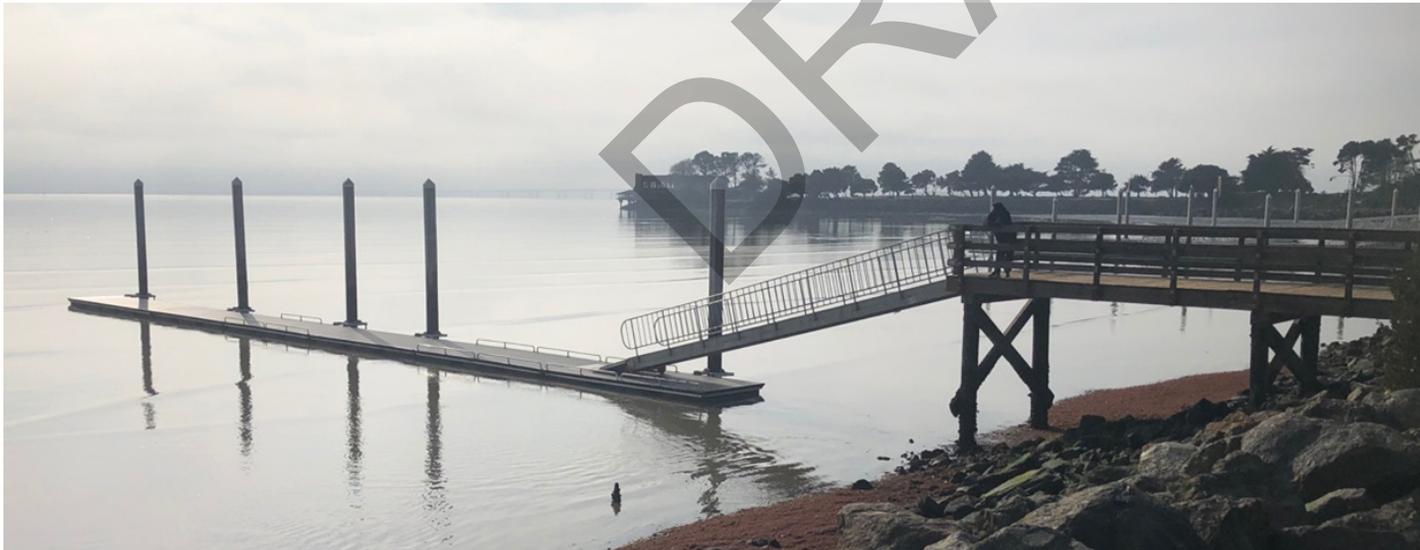
East Dock as seen from the shore

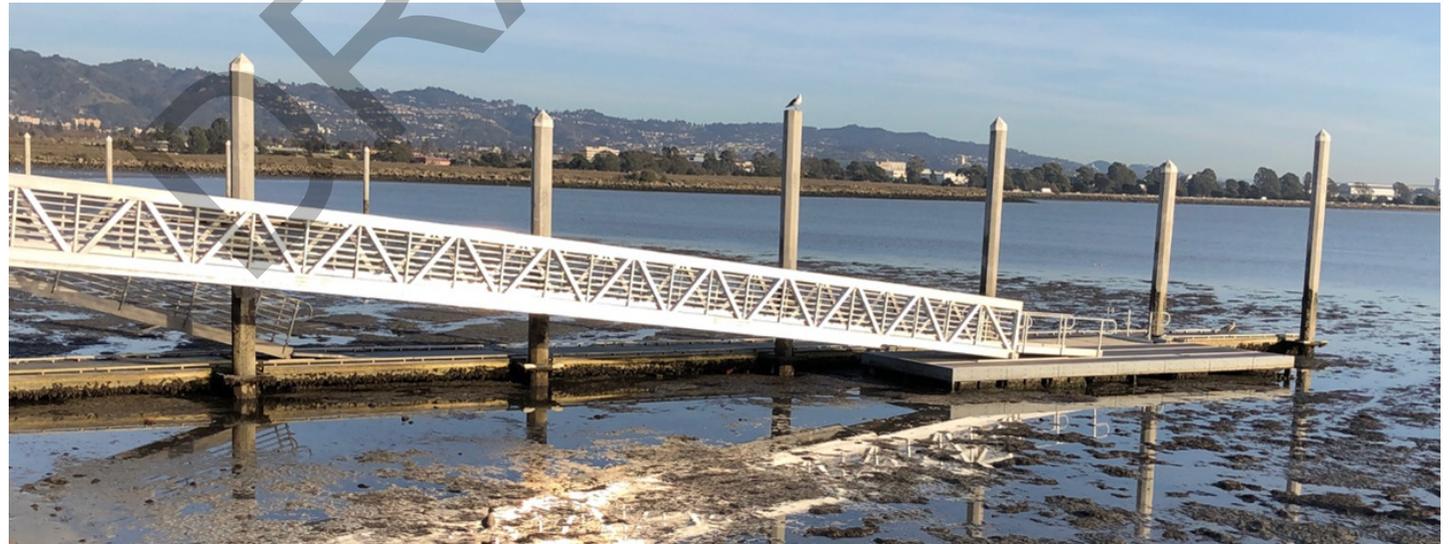
The Middle Dock is located at the South Sailing Basin Seawall's east side and was replaced in 2010. An ADA accessible gangway and associated landing attachment were added to the dock in 2020. The Middle Dock is in excellent condition.

Middle Dock as seen from the South Sailing Basin Seawall.

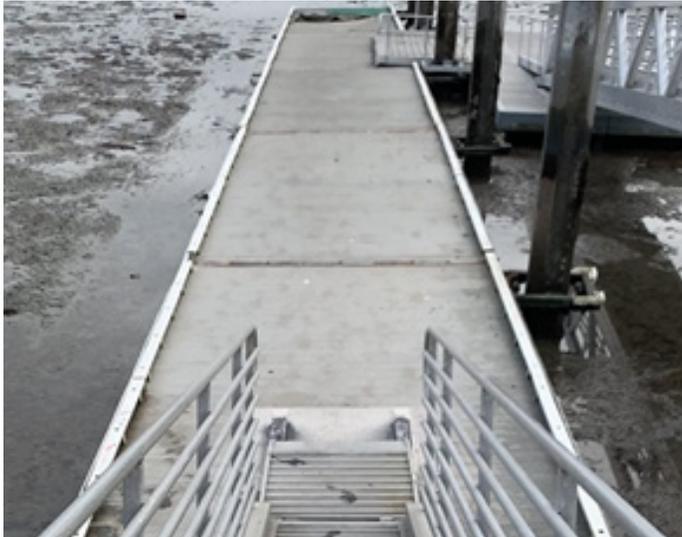
The Middle Dock modules are made with aluminum frames, with flotation tubs attached to the bottom of the frames. The deck surface appears to be made of aluminum sheets. The deck, frame, and flotation tubs are in excellent condition. The piles are all precast concrete and are in excellent condition with no observable defects. The steel members at this dock, specifically the pile guides and hinges between floats, are corroding and the texture of the steel is rough and chipping away. Dock appurtenances were found to be in excellent condition.

View of the deck surface from the gangway

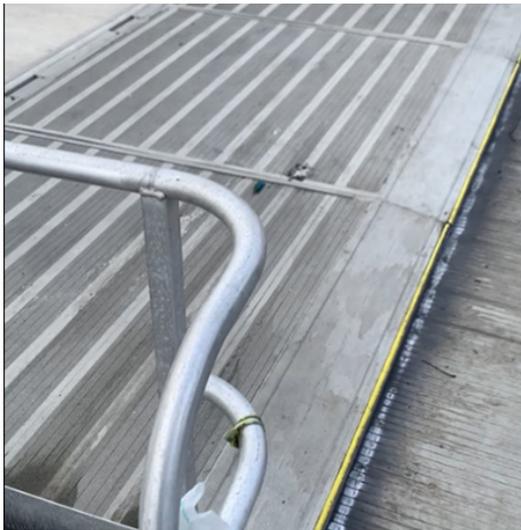
The ADA accessible gangway is approximately 80' long. It has plastic wheels which roll in wheel guides on the landing platform. The wheels are undamaged and the wheel guides shown no signs of corrosion. The gangway itself is in excellent condition with no observable defects.

Aluminum gangplank between the Middle Dock landing attachment

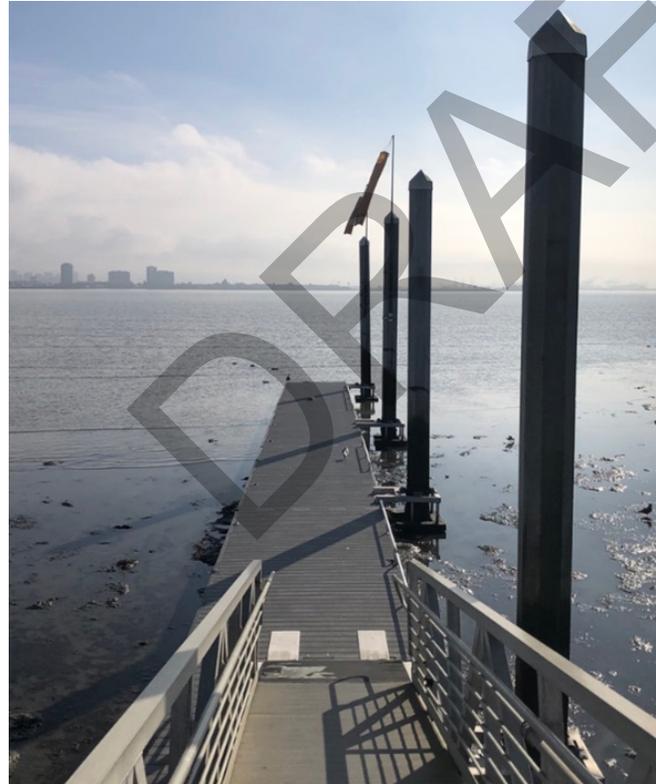
The West Dock has an aluminum frame with composite timber decking. Flotation tubs are attached to the bottom of the frame. The deck, frame, and flotation tubs are all in excellent condition. The piles at this dock are precast concrete and had no observable defects. The steel members of the pile guides and hinges between floats show no signs of rusting or corrosion related damage.

View of the West Dock from its gangway

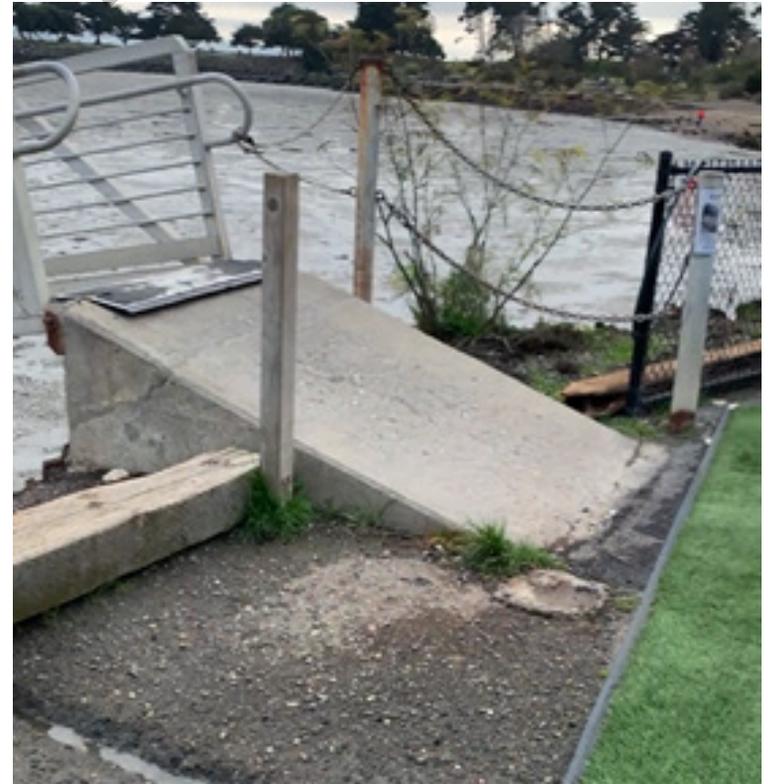
The gangway for the West Dock is approximately 40' long and has a steep slope. The gangway is made of aluminum and skids along plates attached to the dock's deck. The gangway connects to the shore with a link connection that was not replaced with the dock in 2020. The steel members of the connection are discolored from rust, but no further damage as occurred. The abutment to which the link connection is attached to is a concrete ramp built above the seawall. A piece of the railing on the east side of the gangway needs to be reattached, but other than this, the gangway is in excellent condition.

Raised concrete abutment for West Dock's gangway

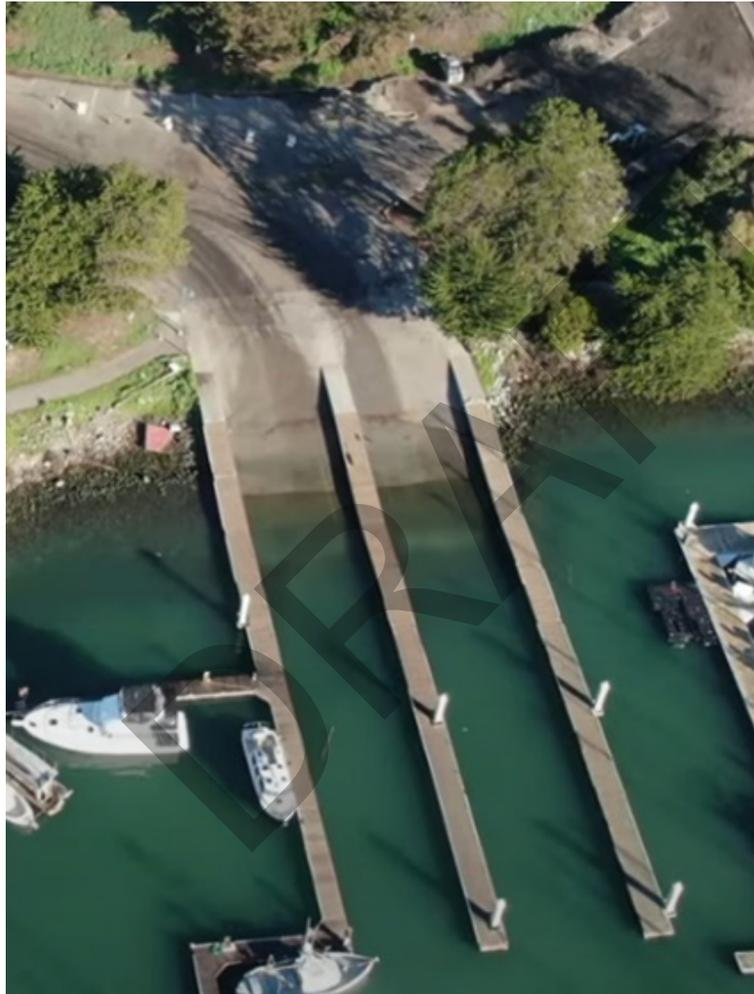
The Boat Launch is located in the northwest corner of the Harbor Basin. The original facility was constructed in 1969 and was replaced in 1988. The launch ramp and associated boarding docks are in good condition.

Aerial photo of Boat Launch

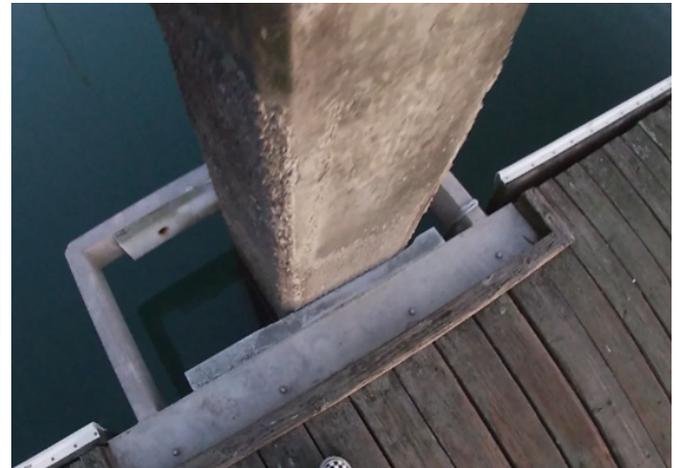
The piles and guides at the boarding docks are in excellent condition. The pile guides are rectangular in shape and their design differs from those found throughout the rest of the marina. These pile guides have concrete rub strips, which are bolted to the long sides of the rectangular guide. Having the concrete pile rub against a concrete rub strip might pose problems in the future, as the rough texture of the concrete will wear down both the pile and the guide at a faster rate.

Pile guide with concrete rub strips

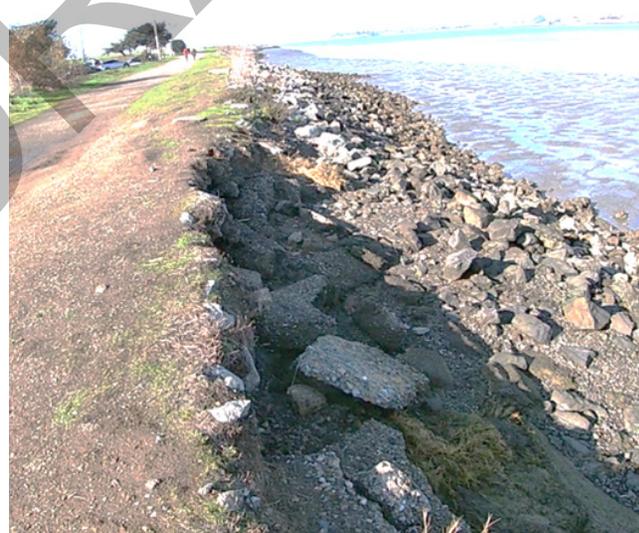
There are occasional scarps (eroded slopes) in the southern 500' of this segment. At these scarps, the smaller 15" rocks have dislodged and fallen to the revetment toe. There are two additional areas where riprap was missing at top of the revetment, approximately 1200' south of the northeast corner of Cesar Chavez Park.

Typical scarp in revetment slope

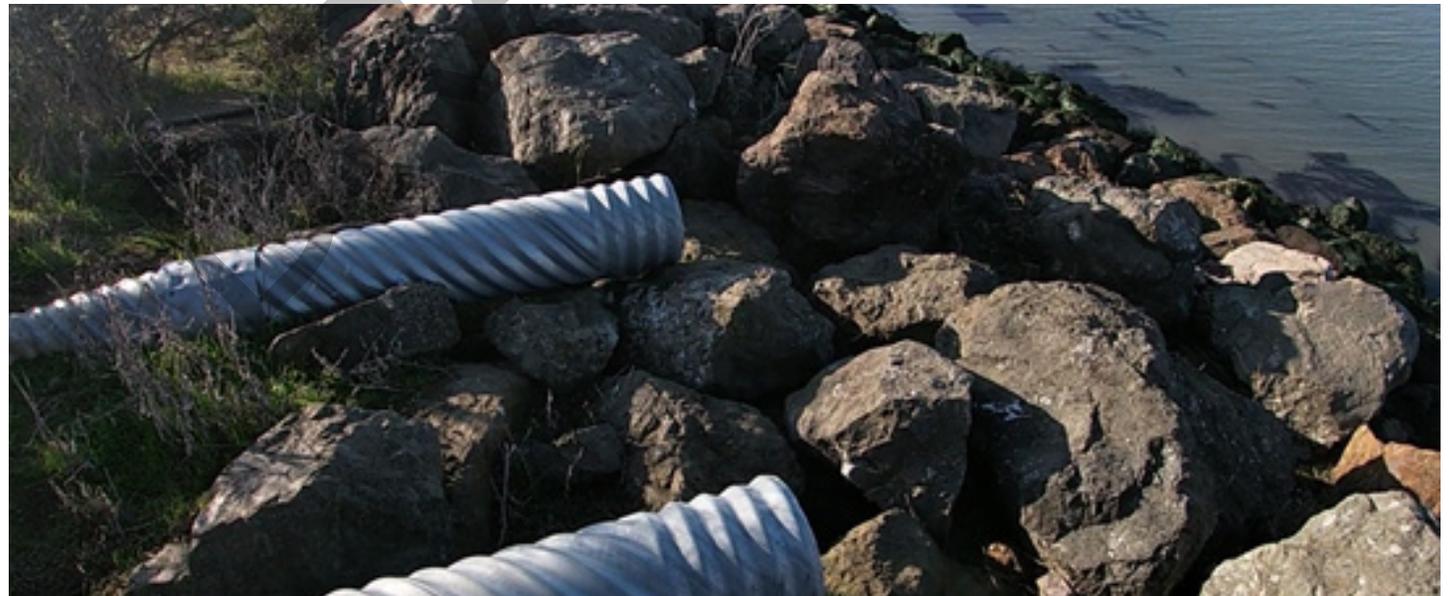
Figure 1-25 Cesar Chavez Park North Revetment

There are two storm drains located 400' west of the park's northeast corner, both of which are in excellent condition. An additional storm drain is located 100' east of the northwest corner of the park and it is also in excellent condition. The rip rap below the storm drain has been grouted to ensure that the storm drain runoff does not displace the rip rap. Rock is missing from the top of the revetment slope approximately 150' east of the northwest corner of the park.

Storms drain atop the Cesar Chavez Park North Revetment

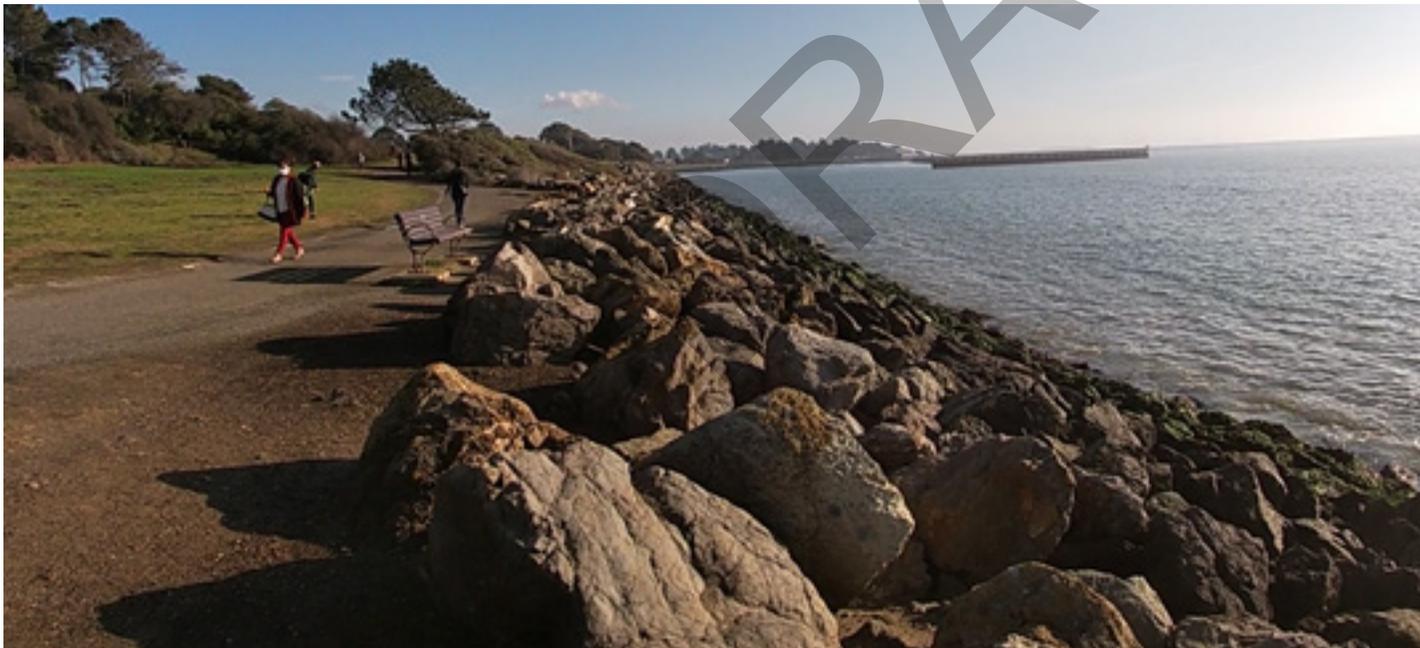
Figure 1-26 Cesar Chavez Park West Revetment

Near the middle of the segment, riprap has fallen from the top of the revetment into the San Francisco Bay. Because the area where the rock fell is near the top of bank, the missing rock has a minimal effect on the integrity of the revetment.

Typical revetment section on the west side of Cesar Chavez Park.

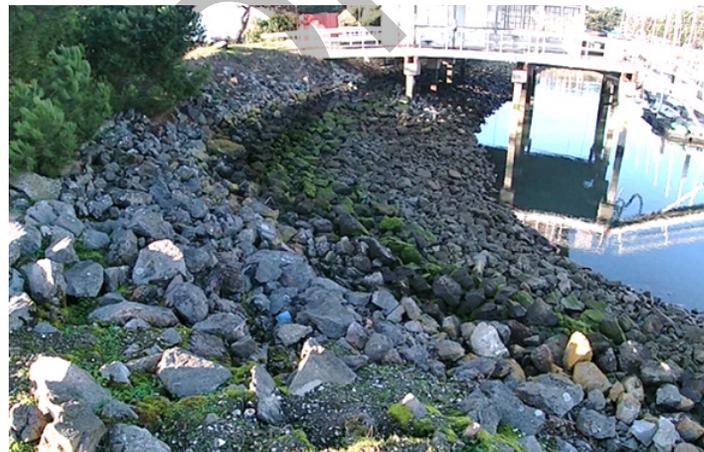
The portion of the revetment west of the B and C Dock gangway is inconsistent, with missing rocks at the top of slope and an inconsistent toe. Rocks dislodging and falling from the top of slope to the bottom are likely the cause.

Revetment section near A Dock

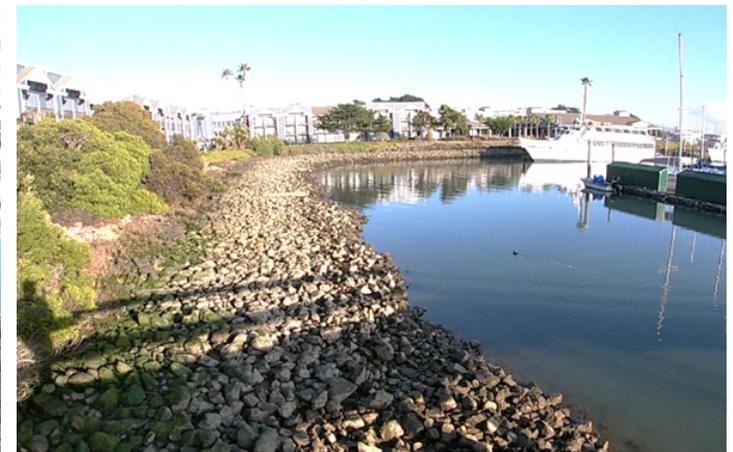
The revetment slope gradually flattens as it nears the segment's east end. Between C and D Docks, the revetment crest is +10.5' with a slope of 4H:1V. East of the D and E Dock gangway, the crest lowers to +9' with a slope of 5H:1V. This span of the revetment is a sea level rise concern because this is the lowest revetment crest elevation within the Harbor Basin and it is near a considerable amount of landside infrastructure. The DoubleTree Hotel is located just behind the low portion of the revetment, so if the revetment is overtopped here as a result of sea level rise, there is potential for costly infrastructure damage.

Revetment east of the D and E Docks

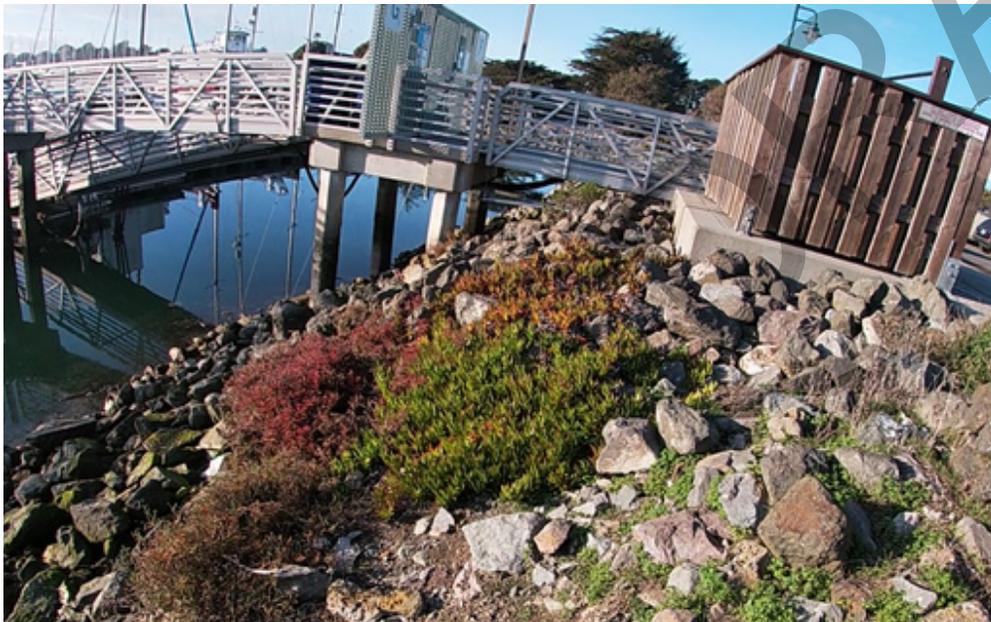
The rock size in this segment remains consistent with the rest of the Harbor Basin, with a nominal size of 12". Some rocks have been dislodged from the revetment crest near the restroom between G and H Docks. Because this segment of the revetment rarely sees significant wave action and the rocks are missing at the top of slope, these gaps do not diminish the integrity of the revetment.

Typical example of the revetment on the Harbor Basin's east shore

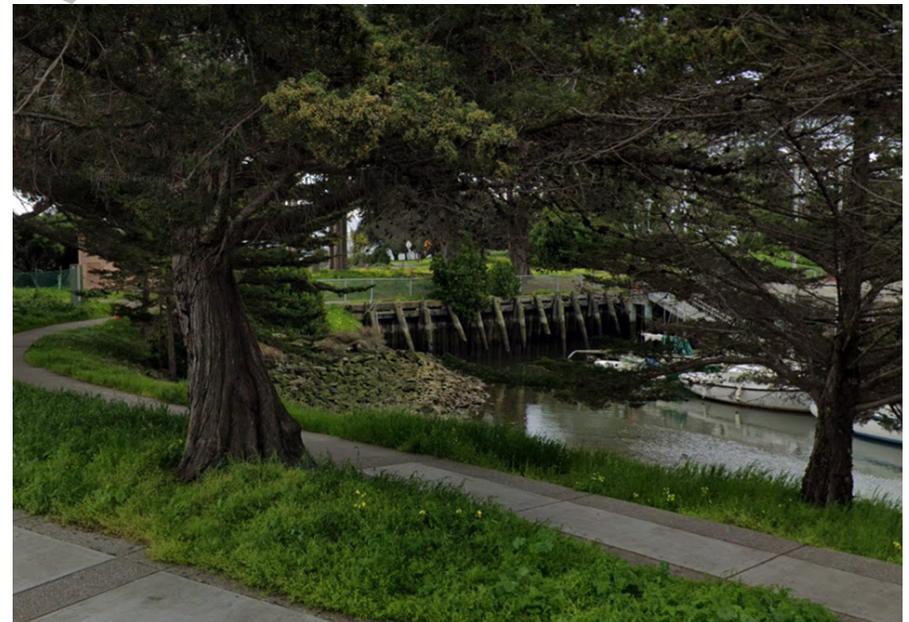
Revetment at the old boat launch facility. Note the crest elevation and top of bank elevation do not match.

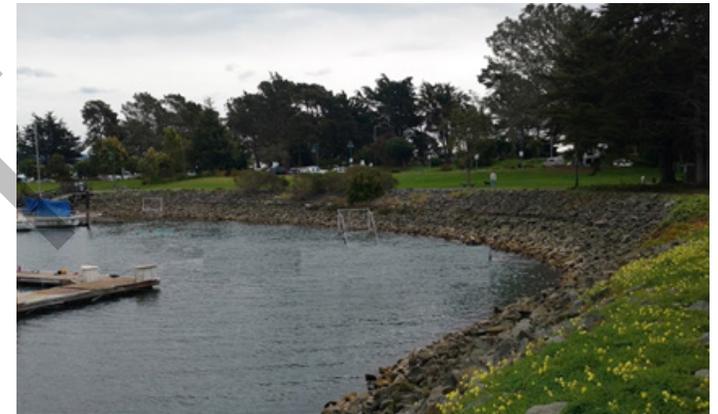
Figure 1-29 Harbor Basin South Revetment

Rock size along this segment is 12". There are occasional instances of missing rocks near the crest of the revetment, where vegetation growth has dislodged the riprap.

Revetment at the southwest corner of the Harbor Basin

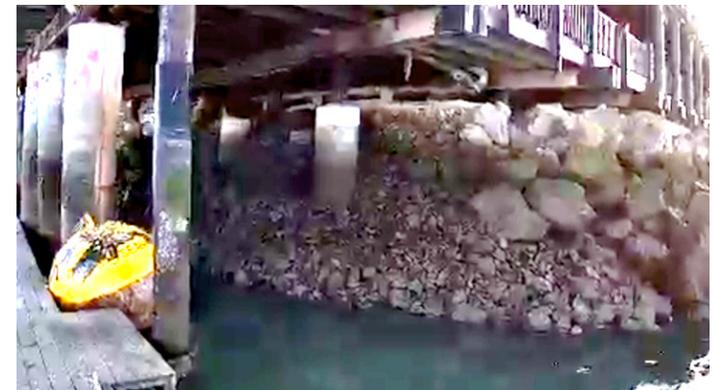
Figure 1-30 Harbor Basin West Revetment

The revetment crest and slope are uniform in this segment, with a crest elevation of +11' NAVD88 and slope of 2.5H:1V. The rock size in this segment is 12" along the Harbor Basin, then abruptly changes to 24" at the harbor entrance where the shore is exposed to stronger waves (shown in the photo below). There were no gaps or missing rocks in this segment of the revetment.

Rock size transition from protected to unprotected shoreline

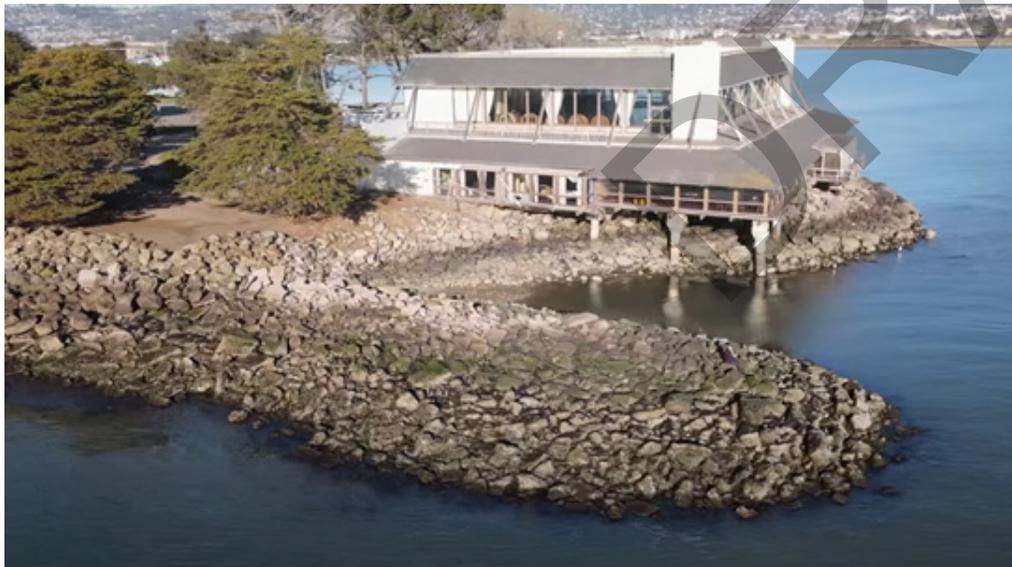
As the revetment approaches the groin at the southern tip of the marina, the revetment slope recedes landward and reveals a low-lying portion of the marina's original revetment. The groin begins at this low-lying area and is partially submerged due to its low finished grade elevation of +6' NAVD88. The purpose of the groin is to provide protection to the pilings supporting the 199 Seawall Drive structure. The riprap making up the groin mostly consists of flat, 10" nominal pieces of demolished concrete and rock at an approximate 4H:1V slope. The armor rock revetment remains inland of the groin with a revetment crest elevation of +13' NAVD88, providing protection of the shoreline and upland areas.

Groin at the southern tip of the Berkeley Marina with 199 Seawall Drive in the background

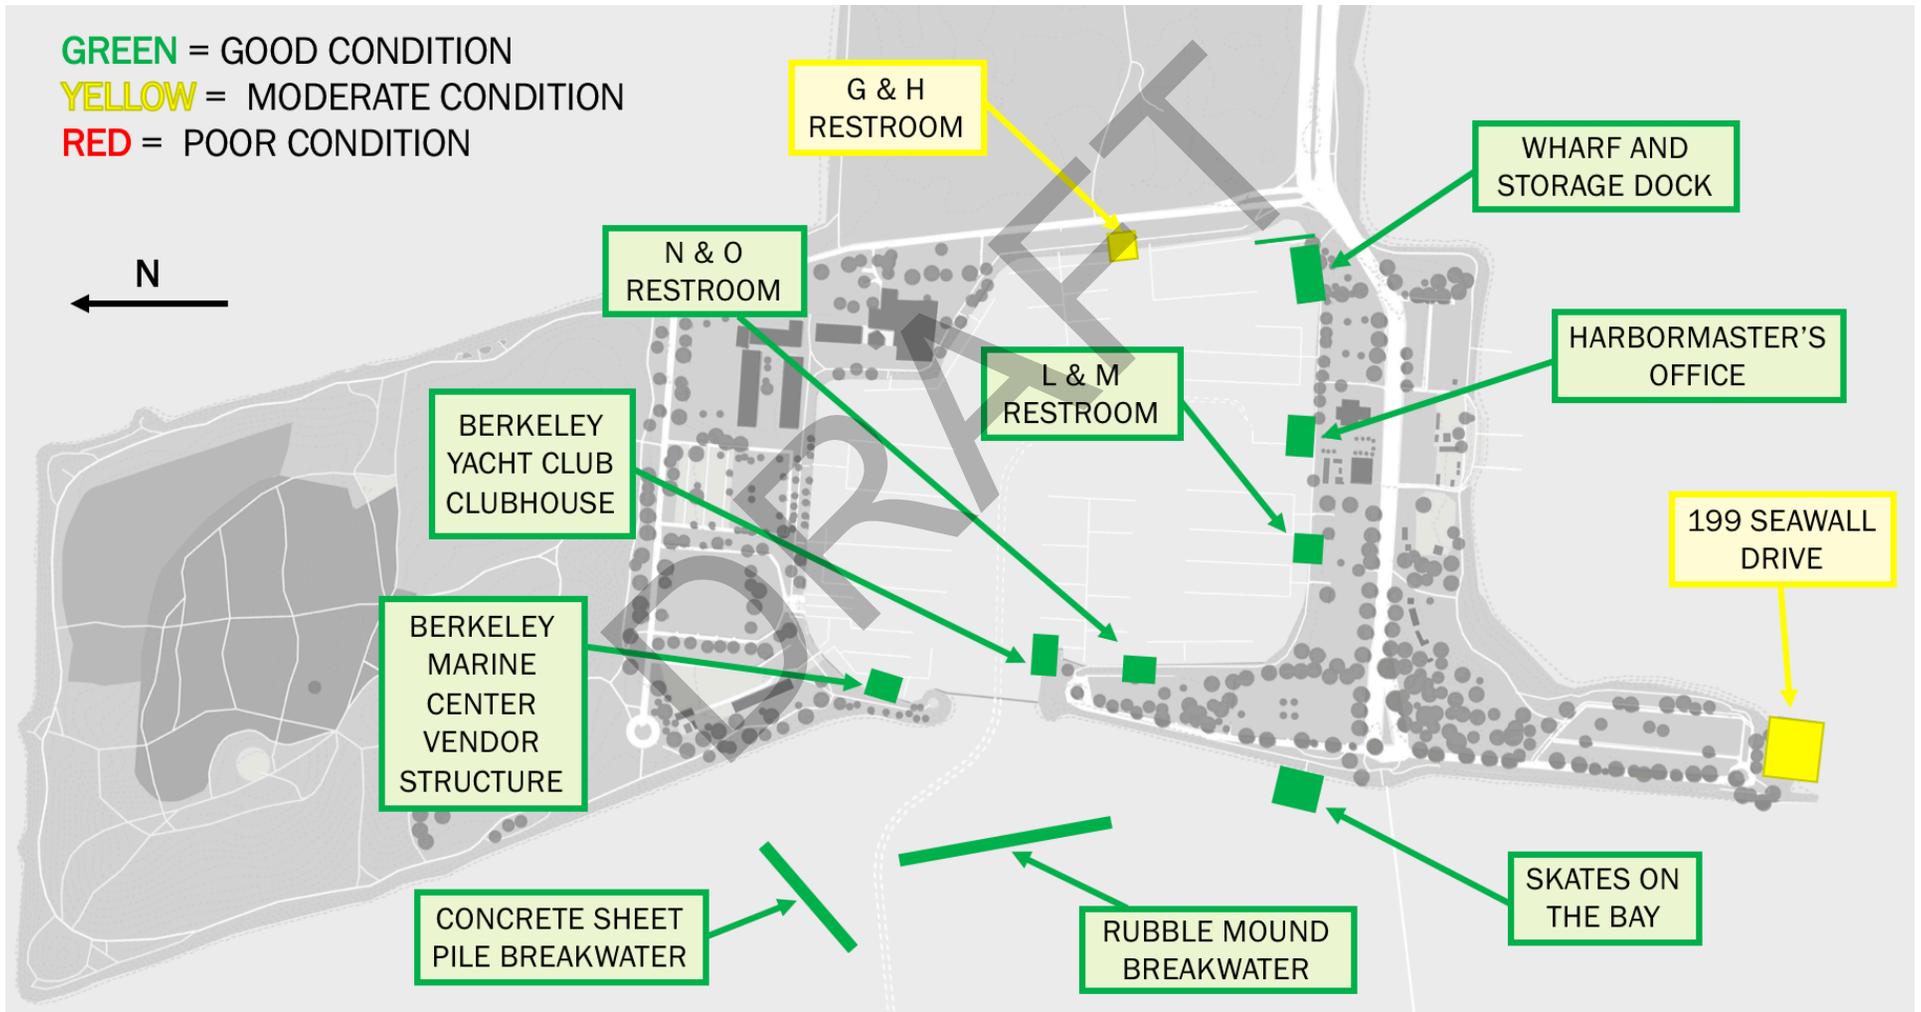
Figure 1-36 Waterside Structures

Figure 1-36 summarizes the findings from the inspection of the waterside structures. Waterside structures were inspected visually and tactilely. Only the foundations of the buildings structures were inspected (pilings and support beams). Inspections of the buildings themselves will need to be done as part of a separate project scope and a more thorough analysis will be required to determine how the stringer-pile connections would respond to seismic loads.

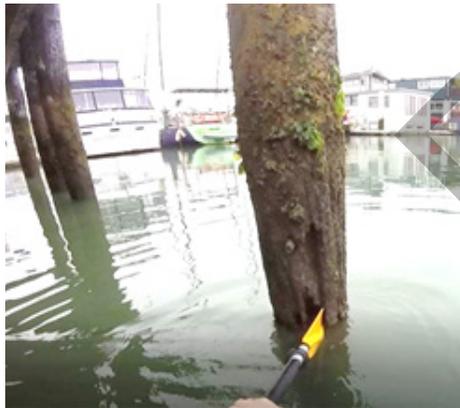
Damaged pile beneath the G and H Dock restroom

The only bad piling beneath the restrooms was the northwest pile at the G and H Dock restroom. This pile showed more than 50% section loss within the tidal zone and will be repaired with a fiberglass jacket as part of the ongoing Selective Piling Replacement project. The rest of the piles are in good condition with no observable defects.

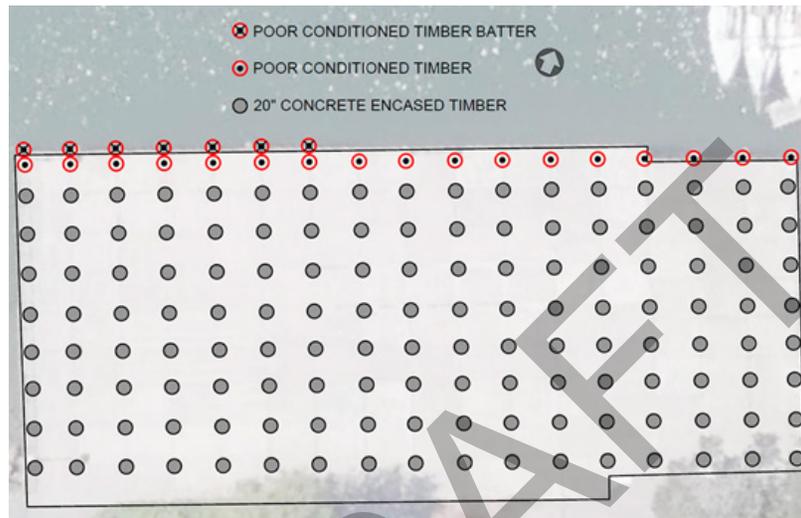
The concrete encased timber piles are square shaped with chamfered edges and a 20" edge-to-edge distance. Of the 136 concrete encased piles, 23 have a noticeable tilt, likely due to issues during the original driving of the piles. 5 of the encased piles have small spalls near their tops.

slab above. Additional timber batter piles (also acting as fenders) are located at the first 7 rows (running north-south) of piles from the west side of the Wharf. The timber fender piles are severely damaged in the tidal zone as a result of wood rot and marine borer infestation.

Pile map and condition summary for the Wharf

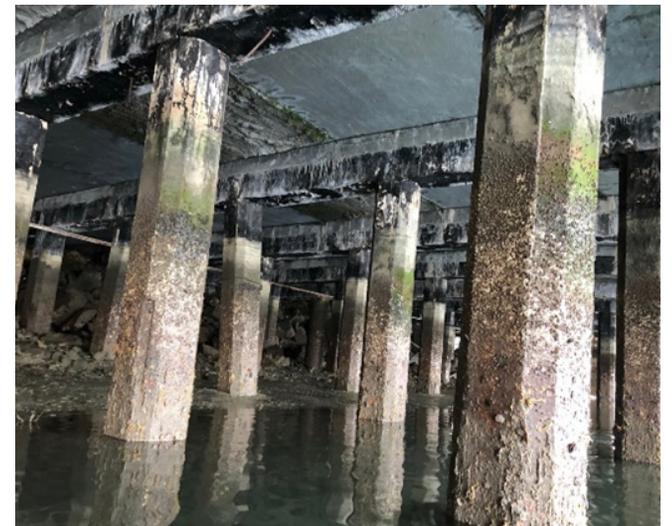
Piles beneath the Wharf. Note the slanted pile in the back

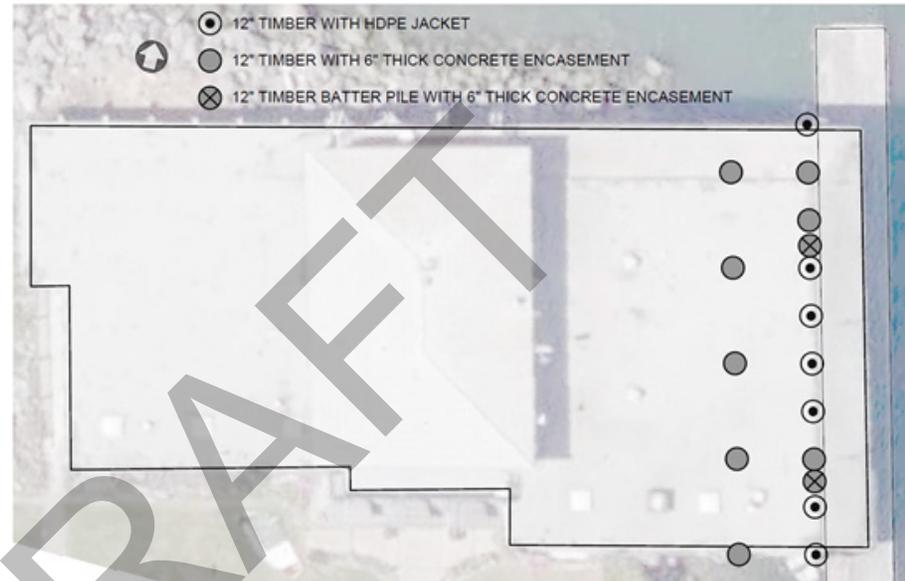
The cantilevered portion of the structure is supported by 17 piles, 12 of which support a stringer beam located 8’ from the structure’s eastern side. All of the piles which support the structure are encased in 6” thick concrete or an HDPE sleeve. The piles were hammer tested and sounded solid, indicating no identifiable deficiencies beneath the jackets and encasements. There were no visible defects to any of the pilings.

Pile map and condition summary of the Berkeley Yacht Club Clubhouse
