Waterfront Specific Plan for the City of Berkeley Public Tidelands Area

BERKELEY MARINA AREA specific plan

INFRASTRUCTURE ASSESSMENT

may 14, 2021

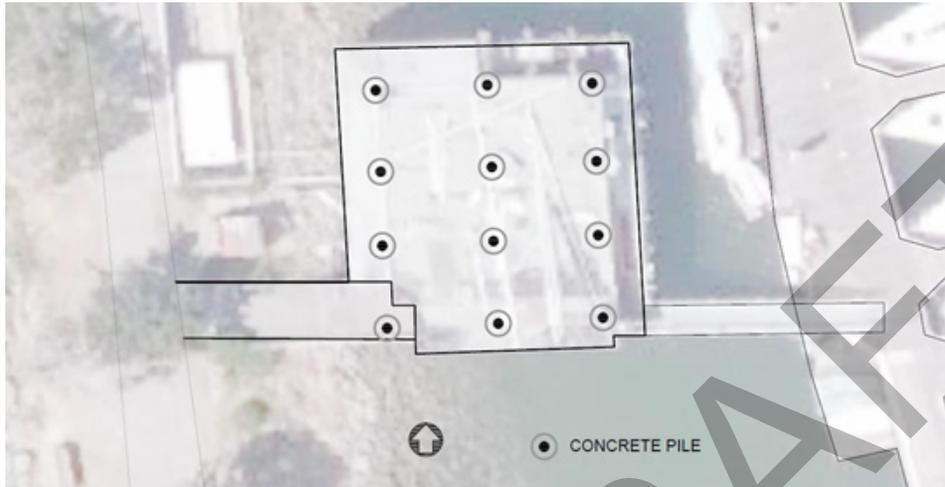
Pile map and condition summary for the Berkeley Marine Center Vendor Structure

running north-south, each with 4 piles. All the piles are 10" square precast concrete with cap blocks. The piles and caps were in excellent condition, with no observable defects.

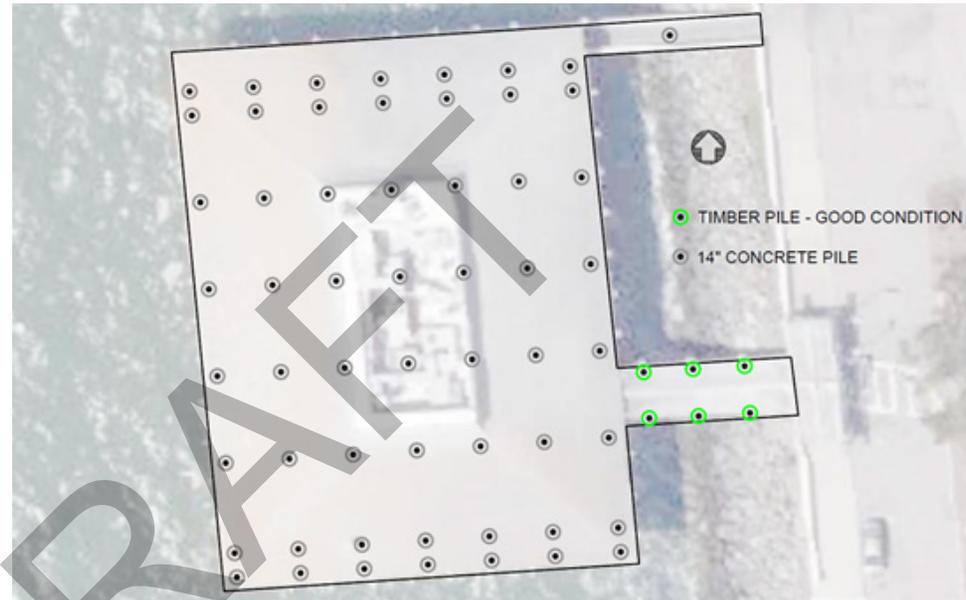
The restaurant structure is supported by 8 cap beams running east-west. Each cap beam is supported by 7 piles, for a total of 56 piles beneath the structure. The piles are 14" square precast concrete. Many of the piles have marine growth/mussel habitation in the tidal zone, but there was no observed damage to the pilings and they are in excellent condition. The cap beams are also in excellent condition with no observed damage.

The restaurant is connected to the shore via two elevated walkways. The southern walkway is supported by 6 timber pilings which connect to the cover above the walkway. The piles are located on each side of the walkway. The northern walkway is supported by one 14" square precast concrete pile, similar to the piles supporting the restaurant structure. This pile is centered beneath the concrete walkway and is in excellent condition.

Pile map and condition summary for Skates on the Bay

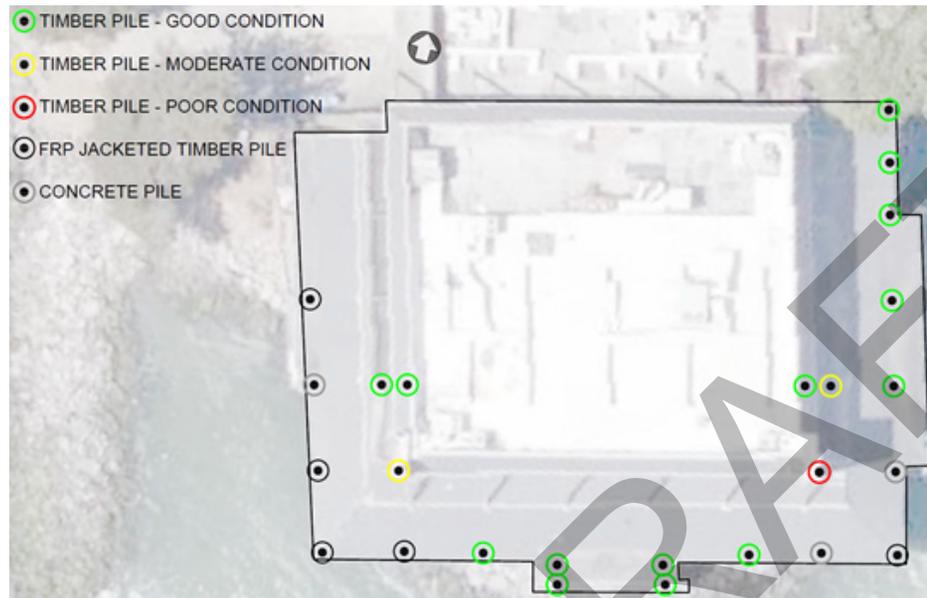
Pile map and condition summary for 199 Seawall Drive

A total of 25 piles support the structure: 3 concrete piles, 5 fiberglass jacketed timber piles, and 17 piles creosote treated timber piles of varying condition. All the piles supporting the structure have been retrofitted with concrete cap encasements at their tops. The caps were constructed around the existing piles and appear to provide improved support and connections to the stringer beams above.

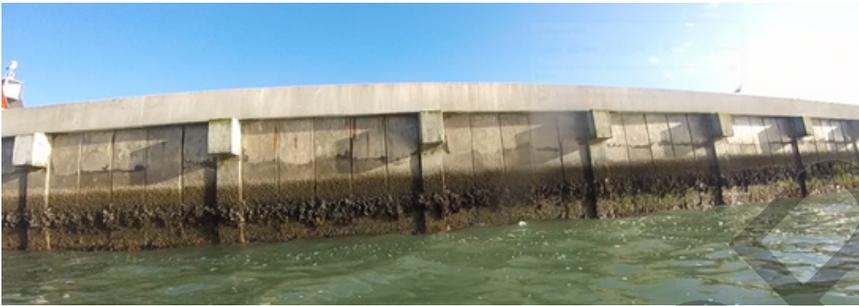
The Concrete Sheet Pile Breakwater is located northwest of the harbor entrance and was constructed in 1980 by the US Army Corps of Engineers. The concrete sheets are supported by capped concrete batter piles along their east side. The breakwater is approximately 440' long and is in good condition. The concrete sheets were inspected visually by kayak and there were no observable defects in the concrete.

West face of the Concrete Sheet Pile Breakwater

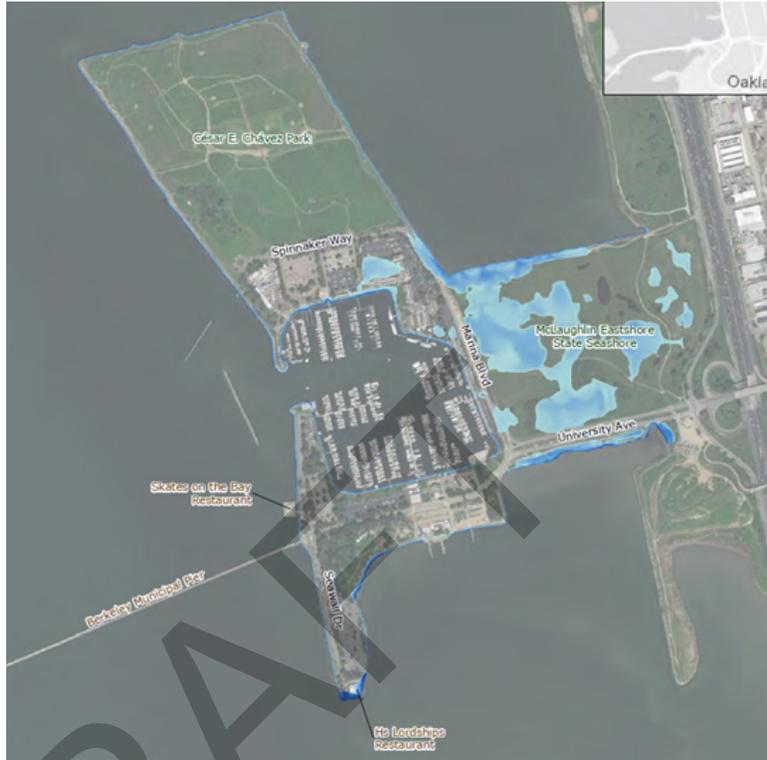
Figure 1-48 2050 Sea Level Rise Impacts at the Berkeley Waterfront

By 2050, the sea level is expected to be +10.8' NAVD88 when a low risk aversion estimate of sea level rise (+1.1') coincides with a 100-year extreme tide event. In this scenario, roadways and parking lots are flooded in the same places as 2030, with the addition of Marina Blvd. adjacent to I Dock and shallow flooding near the intersection of University Ave. and W Frontage Rd. (outside the project area). The shallow flooding at the intersection of University Ave. and W Frontage Rd. will likely not block access to the marina, but some visitors will inevitably turn around at the sight of ponding roadway. The parking lots for D and E Docks and the DoubleTree Hotel experience increased flooding, but no other lots are impacted.

The two northwesternmost buildings at the DoubleTree Hotel will experience flooding in this scenario. No other buildings will be impacted. The access piers for D and E Docks and the Hornblower Cruises Dock will be blocked by flooded trails. Perimeter trails located at the Harbor Basin north and south shore, as well as the trail south of University Ave will be inundated. The South Sailing Basin Seawall has potential to be overtopped in 2050.

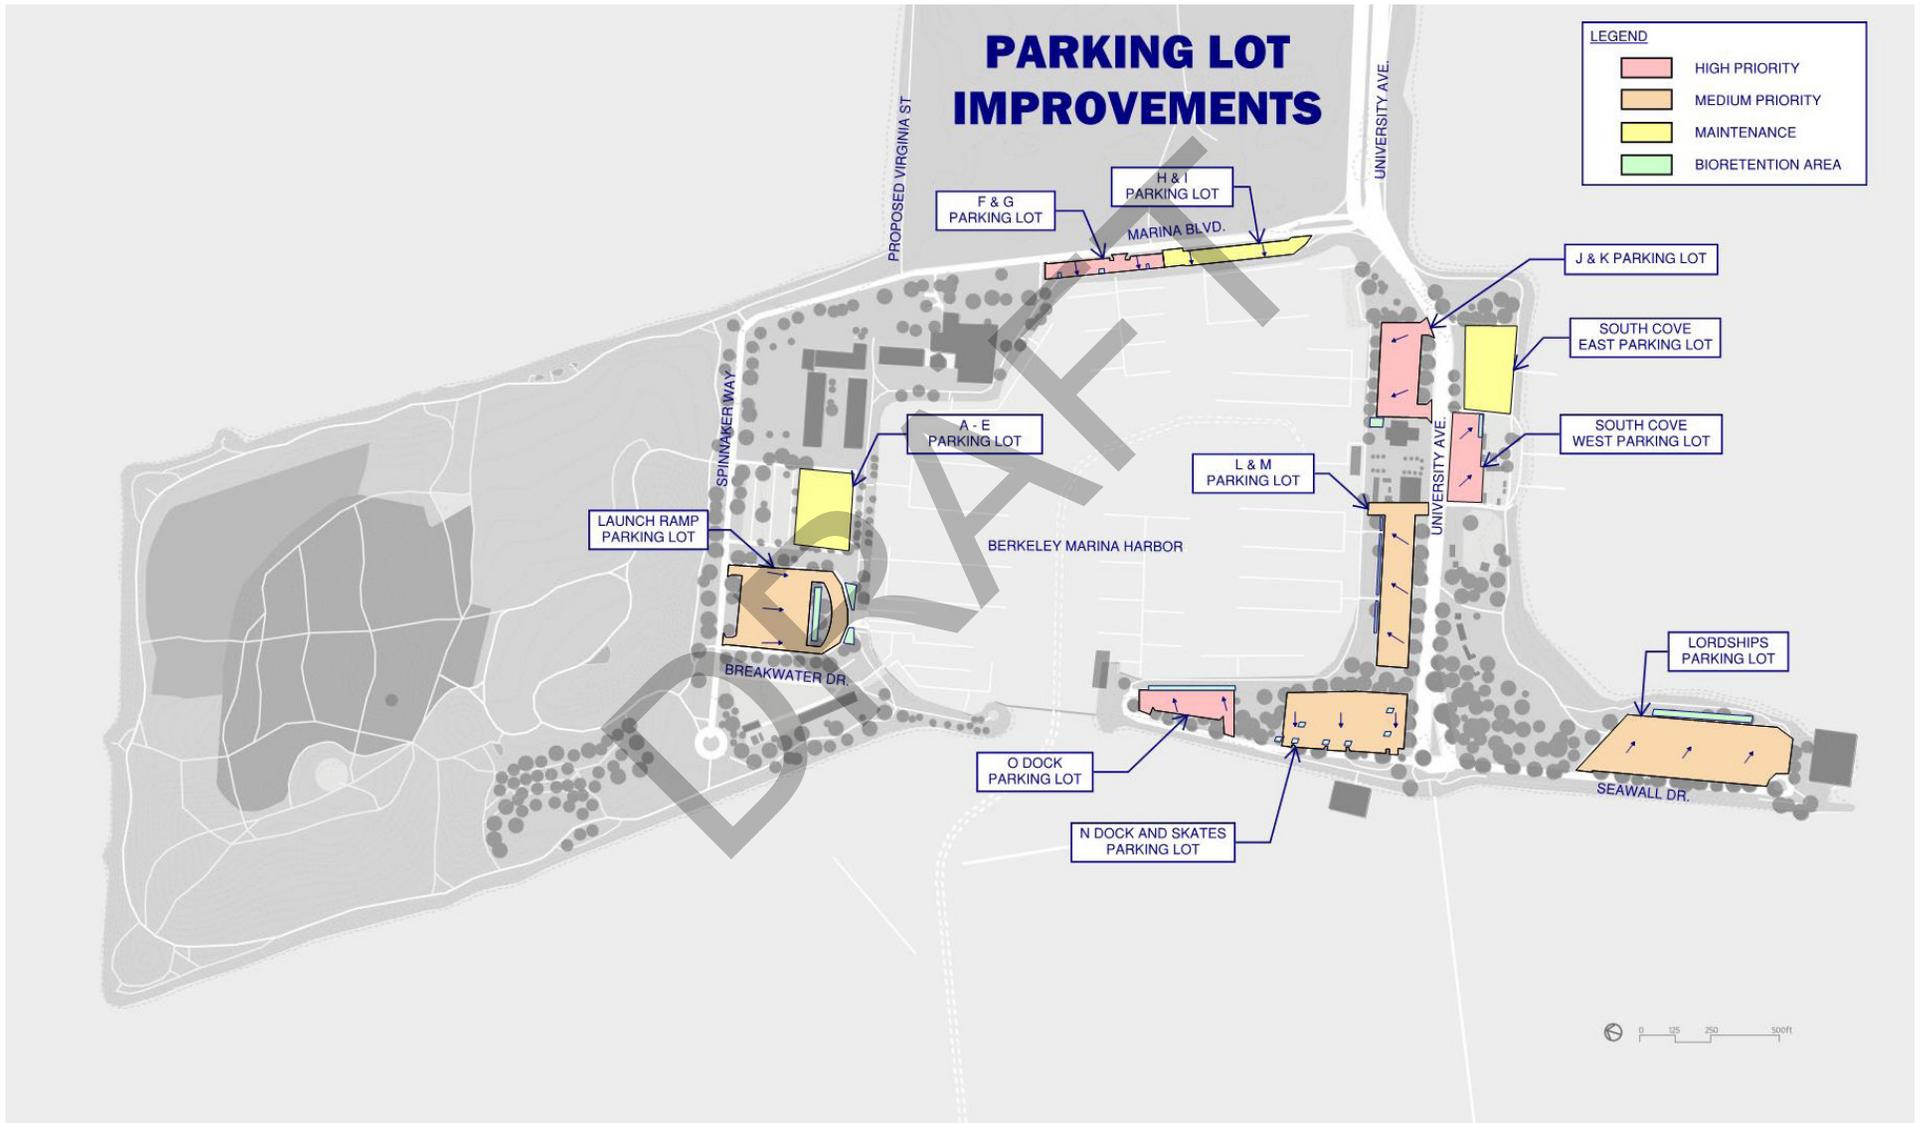
Figure 1-52 Parking Lot Improvement and Ideal Locations for the Bioretention Area

The parking lots serving at the F & G Dock, J & K Dock, O Dock, and Launch Ramp have severely failed pavement throughout the entire parking area. Some areas also appear to have recurring ponding issues and other areas appear not to be paved at all. These lots should be considered a high priority for repaving. Due to the level of pavement damage, the full pavement section needs replacement and each lot should be regraded to facilitate drainage. The South Cove West Lot should also be considered a high priority for improvements, as it is currently unpaved. This lot is progressing through the design phase, but requires funding for construction.

Skates, and Seawall Drive also need repaving to avoid further damage. Extensive alligator cracking and deteriorating pavement is present in all three lots. Each lot will require replacement of the full asphalt section and regrading to facilitate drainage. During design of the parking lots, value engineering and further pavement assessment may allow less extensive pavement repair methods in some areas to control costs.

Stormwater treatment requirements should be considered while improving these parking lots by installing bioretention areas, or other treatment measures outlined in Alameda County’s C.3 Stormwater Technical Guidance. The Marina’s parking lots directly discharge into the San Francisco Bay and the Marina’s harbor, and bioretention areas will assist in removing trash, debris, and pollutants before the stormwater is discharged. Figure 1-52 shows ideal locations for the bioretention area based on available space and general drainage patterns, and Table 1-51 estimates bioretention area sizing that achieves Alameda County stormwater treatment standards.

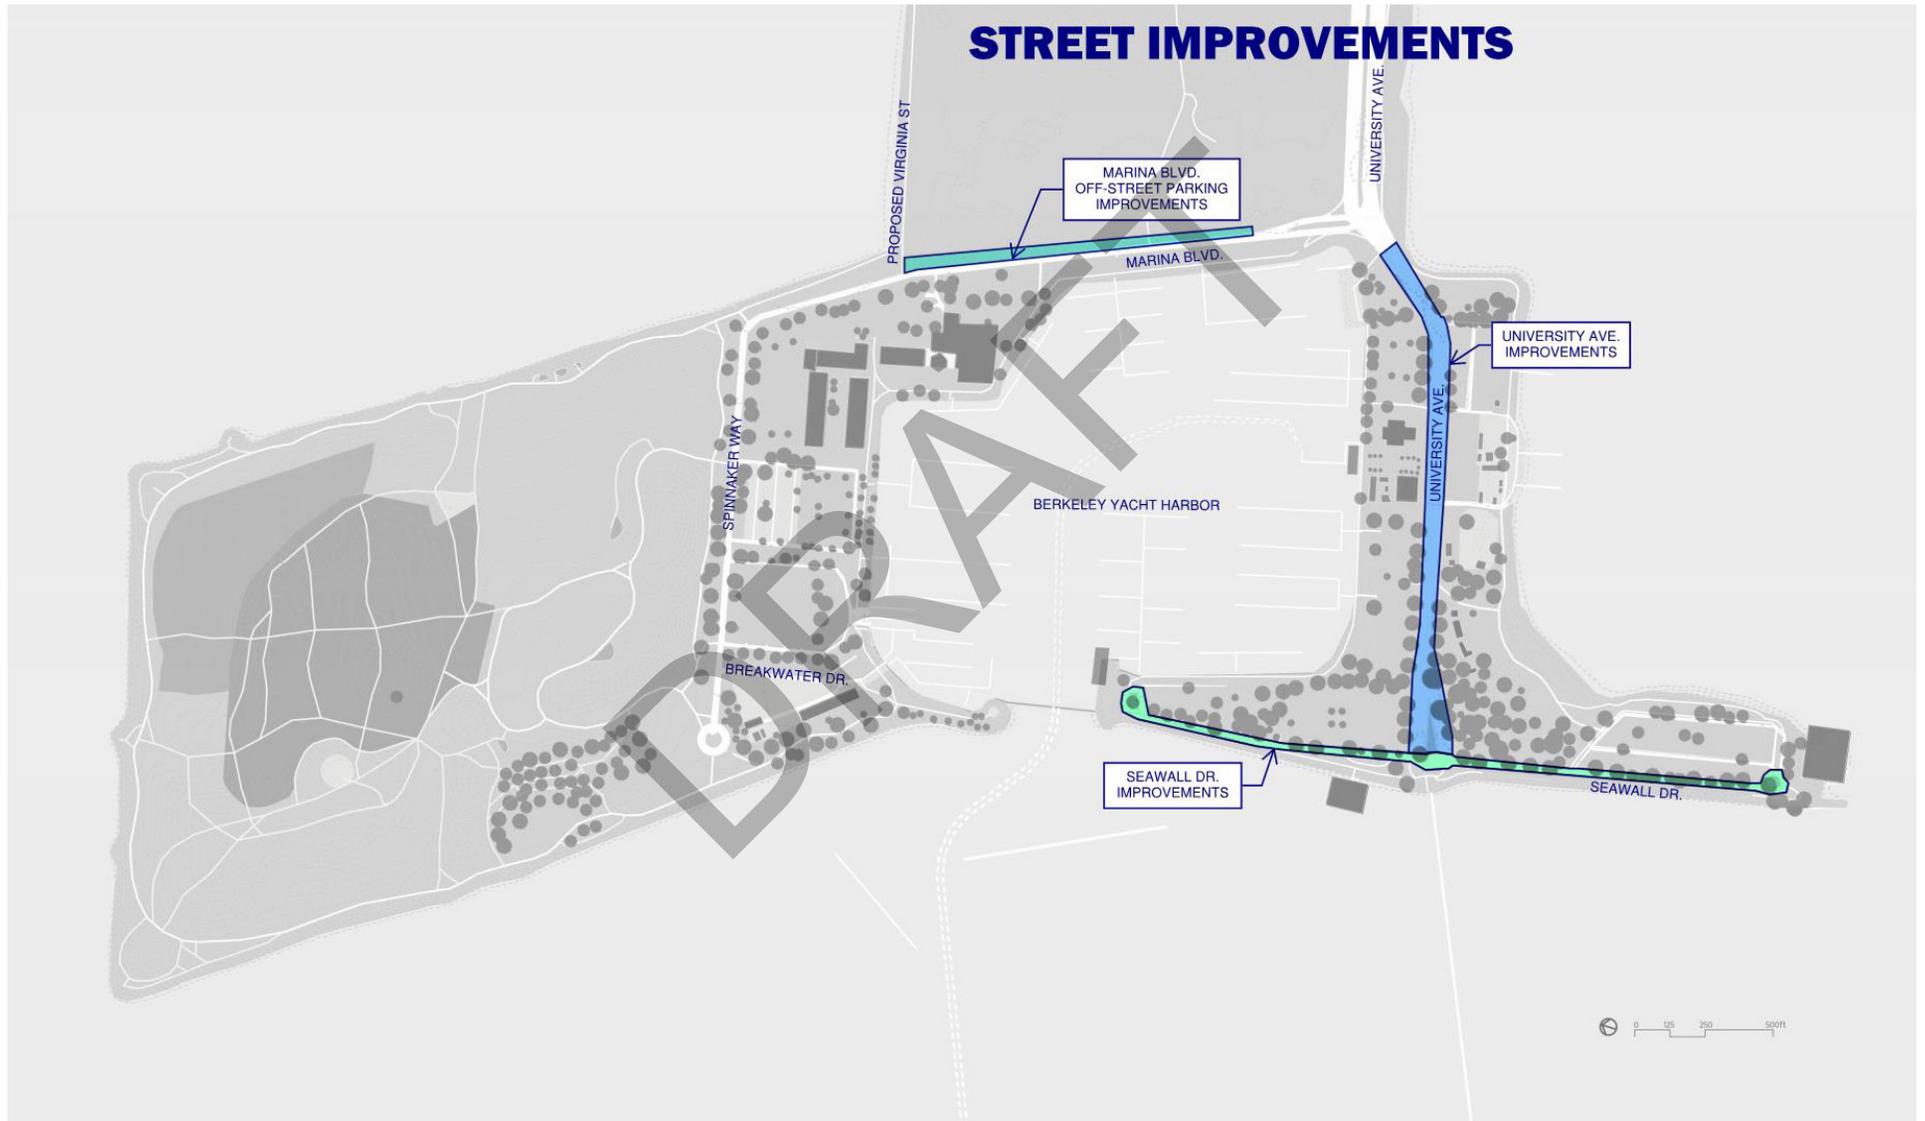
Figure 1-53 Street Improvements

The University Avenue pavement from Marina Boulevard to Seawall Drive is worn, cracking, and showing root intrusion in some areas. Due to the extensive alligator and longitudinal cracking, it is recommended the full asphalt section be replaced similarly to the eastern segment of University Avenue, which is slated for pavement rehabilitation. Full depth reclamation may be utilized to maximize material reuse and limit off haul. The existing asphalt sidewalks should be replaced on both the north and south sides of the street in conjuncture with the roadway. It is recommended the sidewalks be widened and replaced with concrete for longevity of the pavement. Using concrete increases the life of the infrastructure, and a wider sidewalk creates a more receptive and accessible path.

The Seawall Drive pavement is also worn and cracking and in need of pavement rehabilitation. Similar to University Avenue, full depth reclamation can be performed to maximize material reuse and limit off haul. Seawall Drive should shift to the east to accommodate a larger water front path that meets the Bay Trail requirements. It is recommended that the Bay Trail in this area be completed in conjuncture with the Seawall Drive improvements for more a seamless process through design and construction, and it would also reduce overall construction costs. Refer to the Pathways section for recommendations regarding the Bay Trail.

Additionally, there are currently wheel stops protecting the walkway from parked vehicles; however, the wheel stops don't provide adequate clearance to the walkway and are missing in some areas. A more appropriate barrier should be installed and setback for better separation of vehicles from the walkway.

The existing off-street parking to the west of Seawall Drive will also need pavement rehabilitation. The completed street rehabilitation plans for Spinnaker Drive show pervious pavement installation for the off-street parking along Spinnaker Drive. It is recommended to install pervious pavement west of Seawall Drive as well for the off-street parking and stripe parking stalls to maximize parking efficiency. The pervious pavement will treat the stormwater runoff from both the parking stalls and drive aisle, which will remove trash, debris, and pollutants prior to discharging into the San Francisco Bay.

East of Marina Boulevard is off-street parking in an unpaved area. By improving the parking infrastructure in this area, it will create a more inviting parking option for easy access to walking trails in Cesar Chavez Park. Pervious pavement is also recommended for the Marina Boulevard off-street parking east of Marina Boulevard, as well as parking stall striping to maximize parking efficiency. The pervious pavers

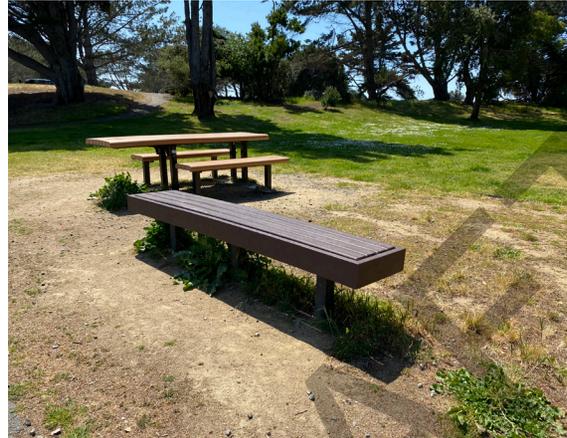
Benches and furnishings are newer and in good condition. Paths leading to furnishings have been worn out from foot traffic.

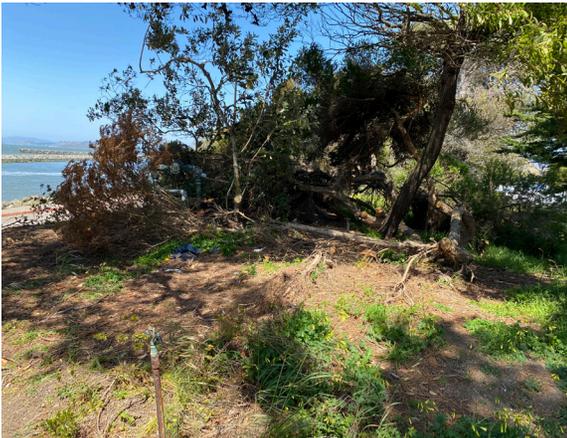
Vegetation is overgrown and needs maintenance

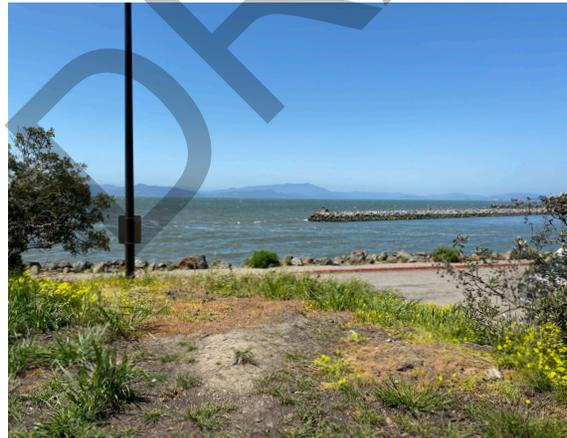
Vegetation is overgrown and trampled in several spots. Needs regular maintenance and upkeep.

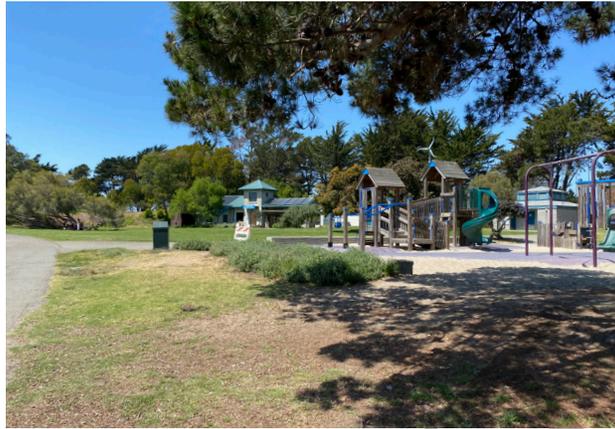
Rough patches of dirt within turf

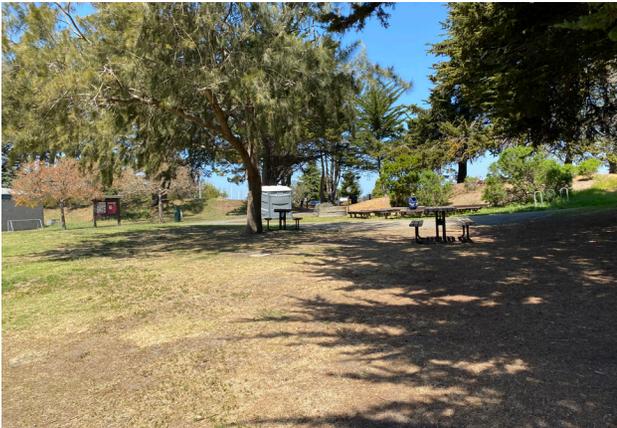
Evidence of poor irrigation with brown patches in turf.

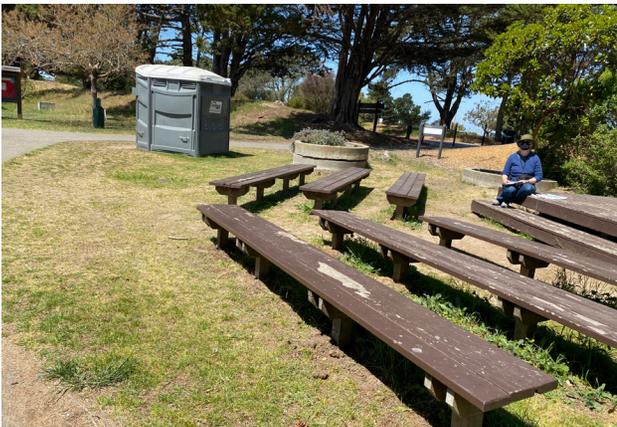
Outdoor amphitheater is in poor condition

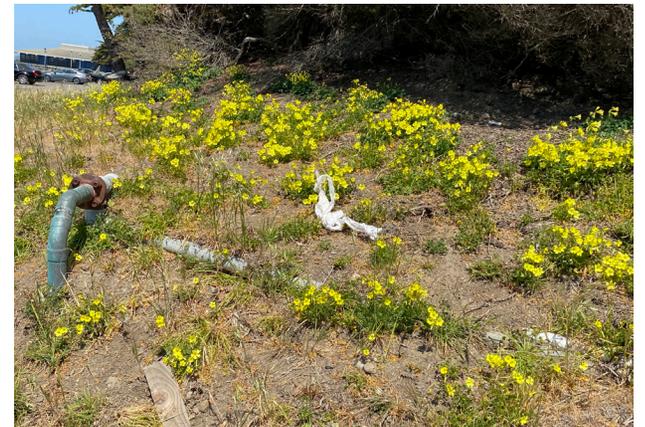
Some of the vegetation is poorly maintained.
