LANDMARKS  
PRESERVATION  
COMMISSION  
STAFF REPORT

## 1401 Le Roy Avenue – John Galen Howard House

**Structural Alteration Permit (#LMSAP2024-0002) to alter the roofing material and to complete an exterior façade restoration at a City Landmark property.**

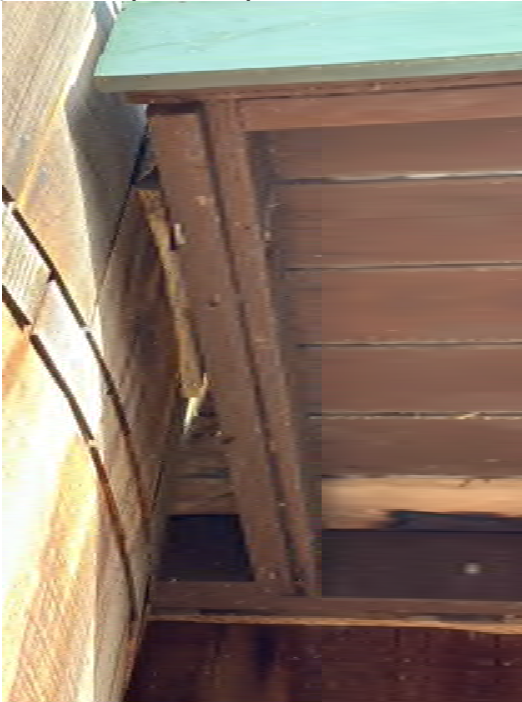
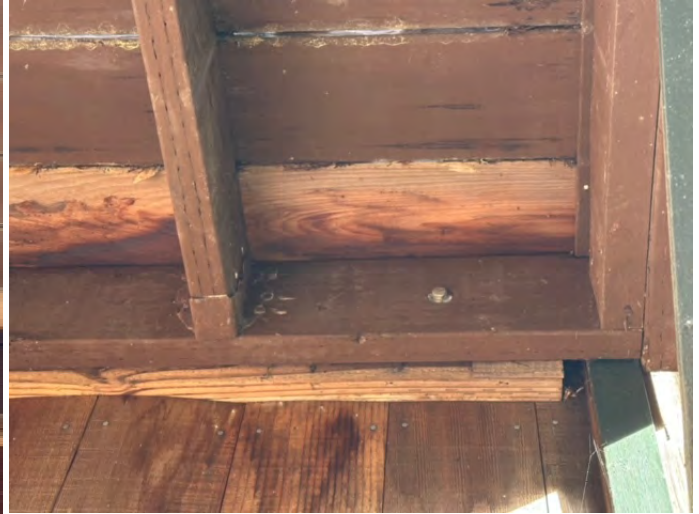
**JM Library Balcony:**

The only proposed addition is for the structural reinforcement of the library balcony. The proposed structural brace could be removed in the future if desired. However, the balcony would likely fail structurally. Similarly, the proposed railing could be removed if desired. However, since there is no record of the original railing - the balcony would be left without a railing altogether. Both conditions would result in a balcony that is unsafe and unusable.

Balcony not tied to structure.

5. Repair and structurally reinforce the library balcony, and replace the (non-original) 28" high railing with a code compliant rail.

| ITEM | MEASURE | HISTORIC APPROACH | FIRE RESISTANCE | ENERGY EFFICIENCY | STRUCTURAL STENGTHENING |
|---|---|---|---|---|---|
| 5 | Rehabilitated library balcony | <b>Restoration &amp; Rehabilitation</b> - Repair and structurally reinforce the library balcony and replace the (non-original) railing. | | | 1. Deck joists will be replaced in kind and a structural redwood brace - modeled on a similar brace already in use on the south balcony - will be added.<br>2. A code compliant guardrail will be added, with a design modeled on the interior stair railing. |
