Asbestos, Lead, and Other Hazardous Building Materials Investigation

City of Berkeley Corporation Yard
Assembly Building
1326 Allston Way
Berkeley, CA

February 2021

Acumen Project No. COB 2125

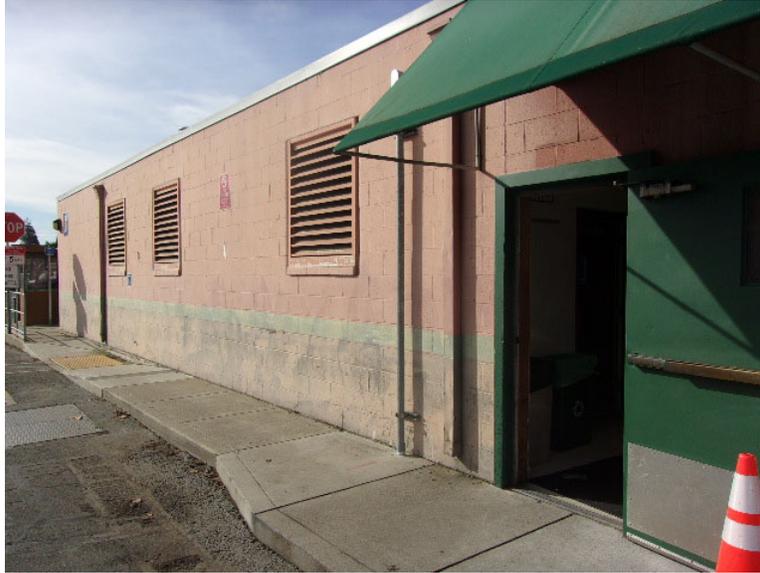
Photo 1

The one-story assembly building was built slab-on grade with concrete masonry unit (CMU) perimeter walls (Photo 1). According to records, this building was last remodeled back in 1992. Interior finishes of the building consist of painted drywall with taping mud that were found not to contain asbestos. The flooring throughout the building consists of vinyl floor tile and ceramic floor tile that were both found not

1326 Allston Way, Berkeley, CA – Berkeley Corporation Yard Assembly Building.
