City of Berkeley
Berkeley Municipal Pier
Structural Assessment Report

June, 2021

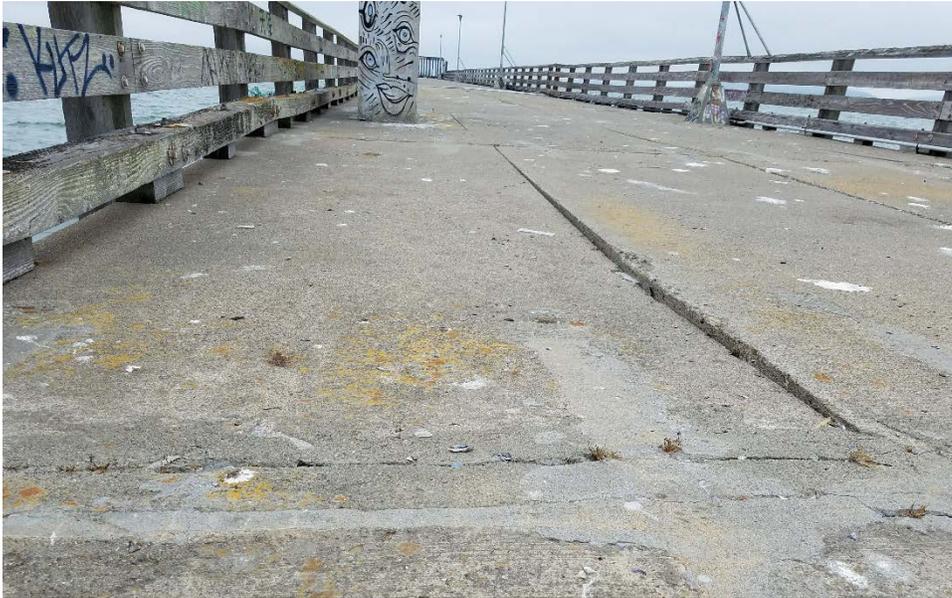
Photo 3-3: Severe Deflection at Section 2 Panel

From the top surface, many of the panels exhibit noticeable deflection, with a transverse crack at the centerline. Photo 3-3 shows a panel with significant deflection.

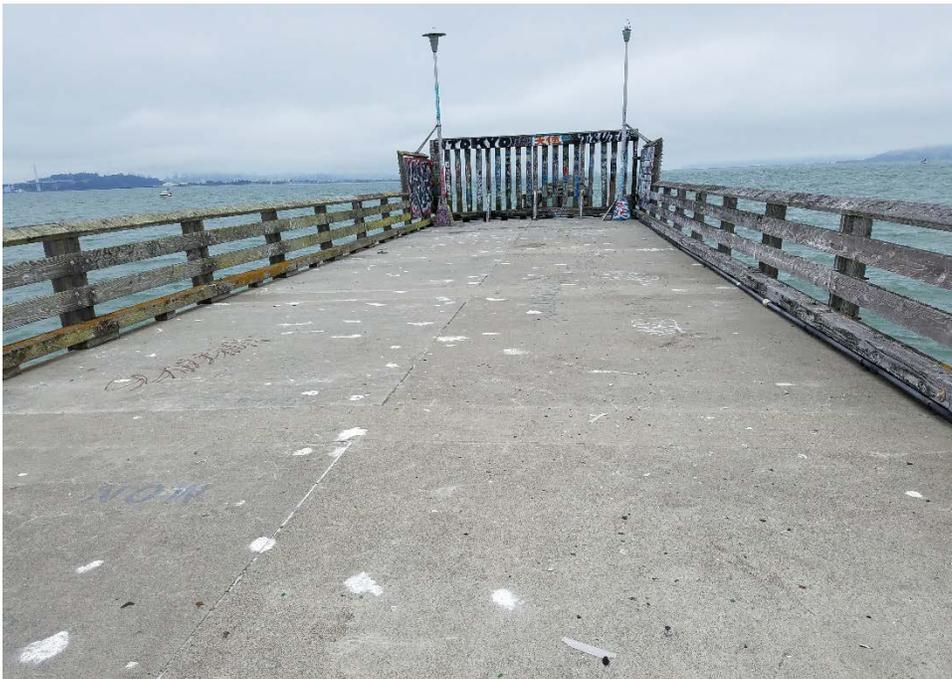
Photo 3-4: Typical Above Deck Condition of Section 3 Panels

Section 3 (bents 452-467) of the pier was likely installed in the 1990s and is in good condition. It consists of two precast concrete panels that span concrete bent caps at 16.5-foot spacing. There are no observable deterioration of concrete. Photo 3-4 shows the typical condition.

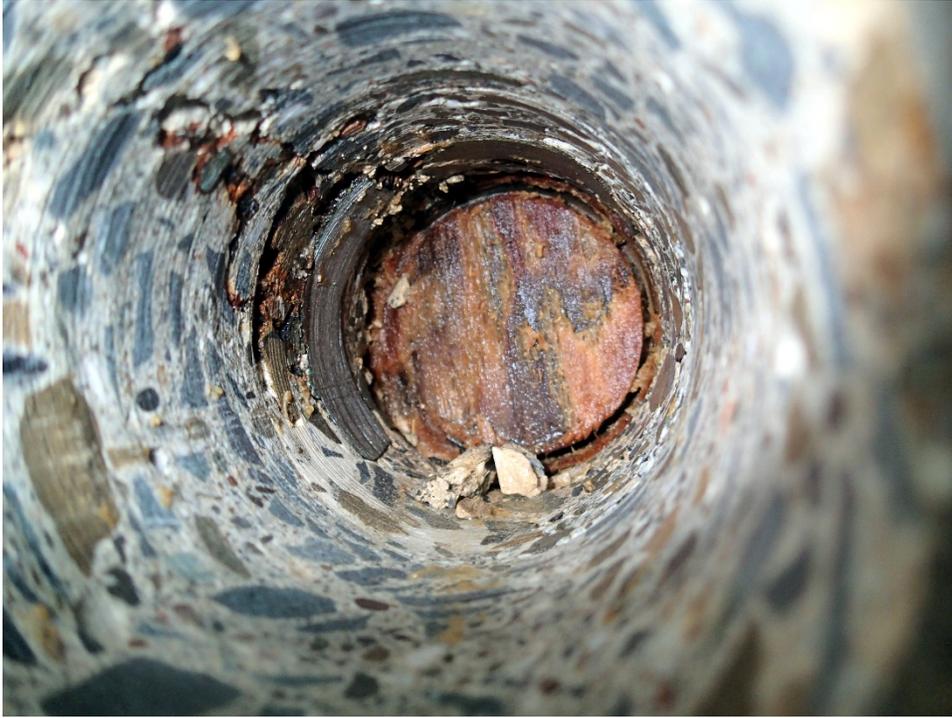
Photo 3-11: Inside view of concrete core showing timber pile

There are a total of 172 precast concrete bent caps within sections 1 and 2 with three concrete encased plumb timber piles per bent cap that appear to be from the original construction. The concrete encased timber piles are in poor condition due to widespread corrosion cracks, localized closed and open spalls, and isolated structural cracks. Pile damage is typically located in the splash zone, between the Mean High Water (MHW) elevation and the bent cap. At four locations, divers core drilled the concrete encasement to inspect the timber piles which appeared to be in fair condition. See Photo 3-10 and Photo 3-11 for cored piles and Photo 3-12 for underwater spall.

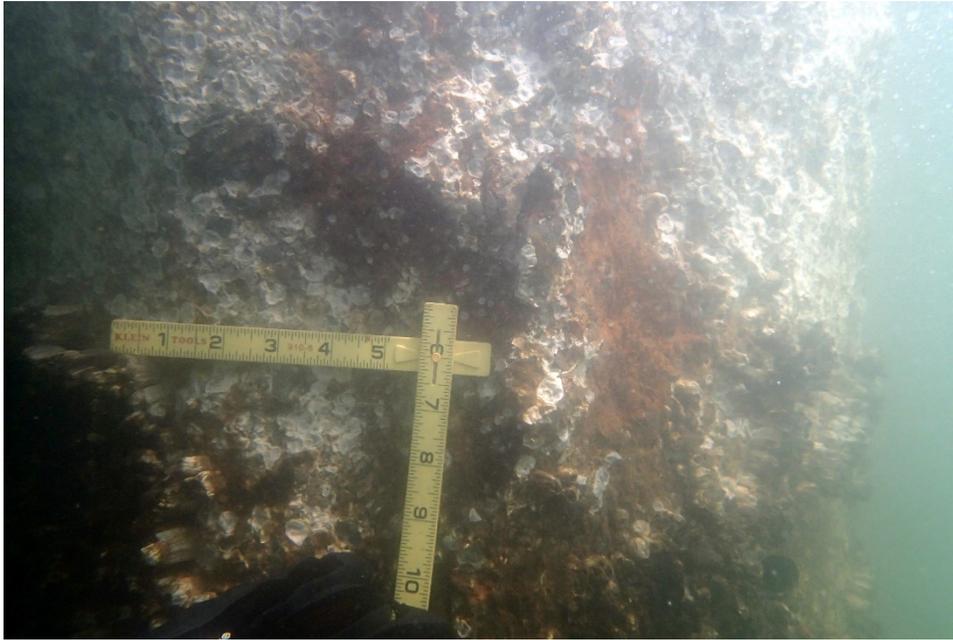
Photo 3-12: Underwater open spall on pile

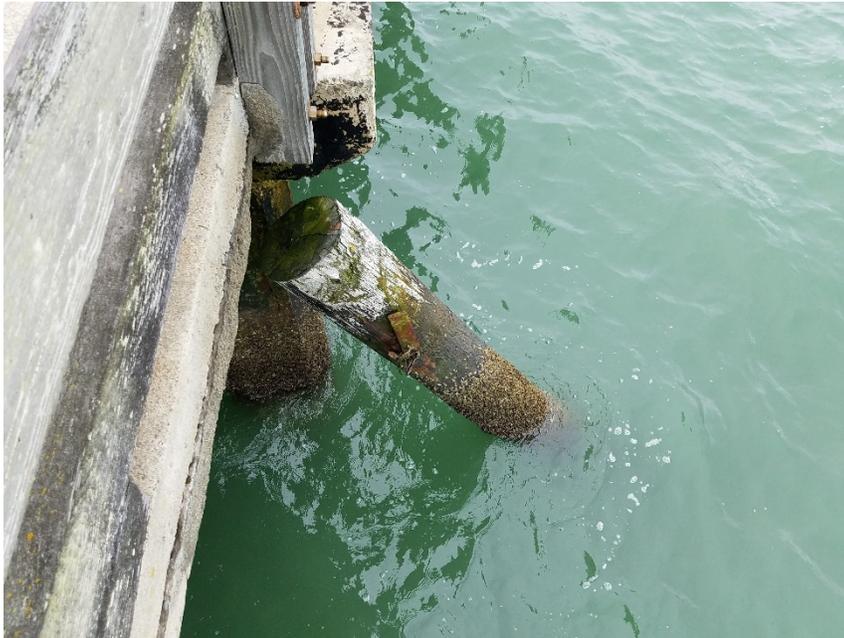
At every two bents, the record drawings indicated a battered timber pile that alternated between the north and south sides. However, the timber battered piles are typically missing or in severely degraded condition due to section loss from the effects of marine borer infestation and steel

corrosion resulting in piles disconnected from bent caps. In general, the battered piles provide no lateral stability to the Municipal Pier, as shown in Photo 3-13.

Photo 3-13: Timber Pile Disconnected from Bent Cap

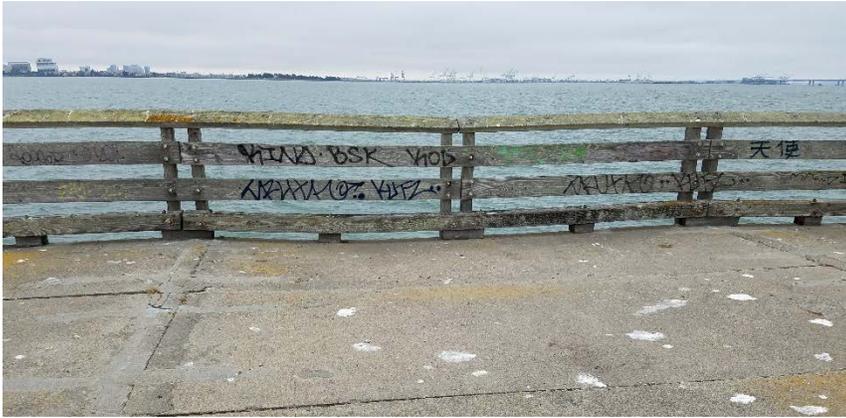
The timber guardrails are in fair condition throughout the pier. There was no noticeable deterioration or section loss with the exception of the guardrails at Section 2 where the guardrails are deformed due to the deflection of the concrete panels. See Photo 3-14.

Photo 3-14: Deformed Guardrail Due to Concrete Deflection

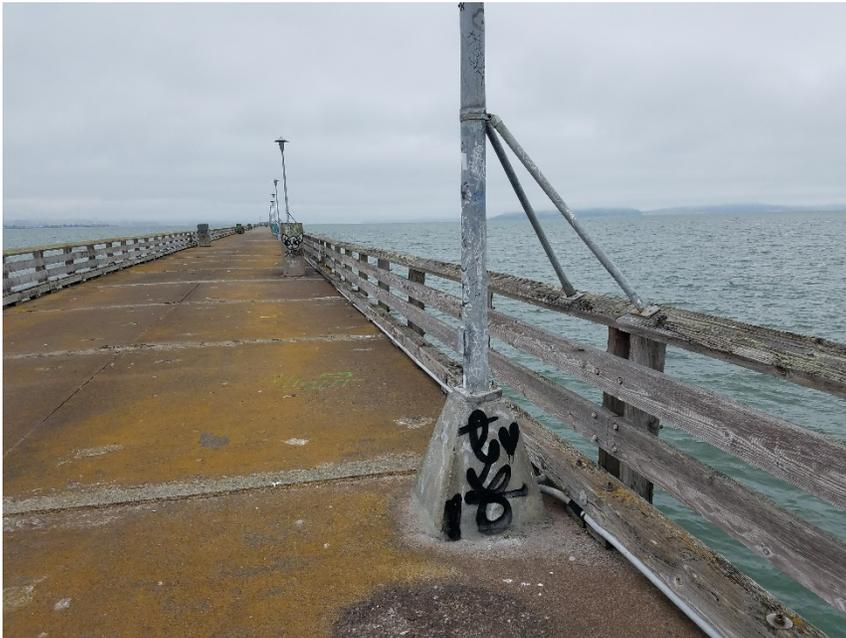
Photo 3-15: Typical Luminaire

The luminaires generally appear to be in fair condition. There are no significant deterioration at the concrete pedestal or steel poles. Below deck, the anchor bolts extend beyond the concrete panels and the ends exhibit corrosion or may be a source of corrosion. See Photo 3-15.

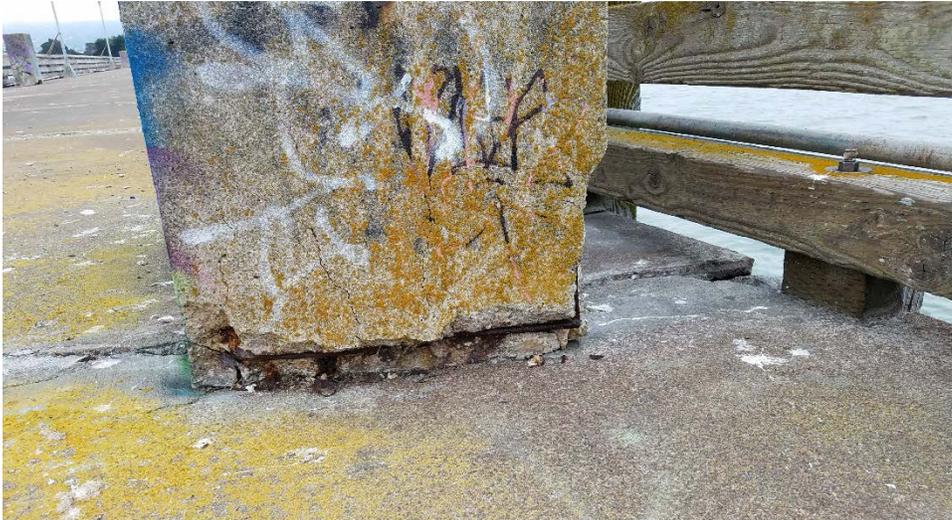
The benches are primarily constructed of reinforced concrete to act as a wind break with timber planks as bench seats. Most of the benches are in very poor condition with extensive spalling and rebar corrosion particularly at the base. Additionally, many benches are missing the seats. See Photo 3-16.

Photo 3-16: Typical condition of bench with concrete spalls

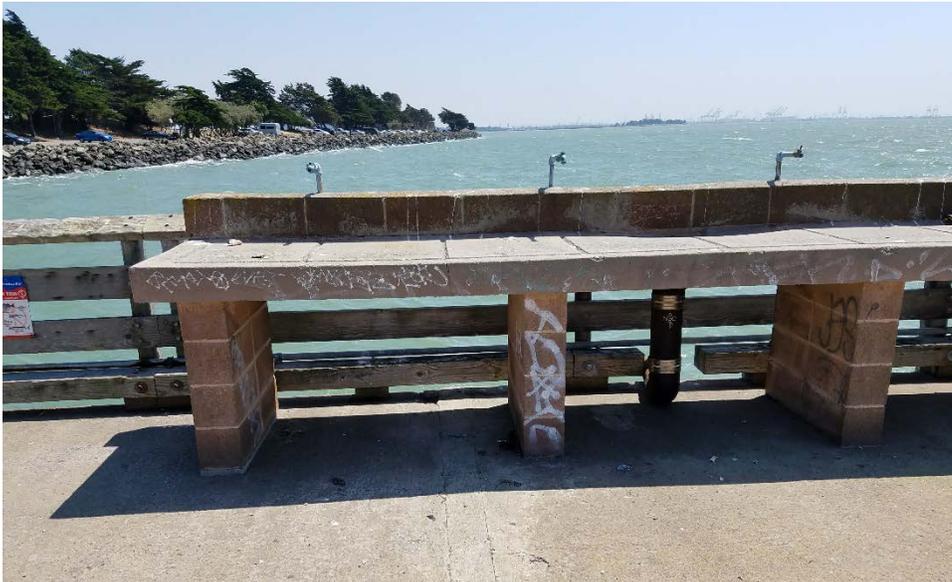
Photo 3-17: Fish Washing Station

There are two fish cleaning stations and appear to be in serviceable condition. The stands and backsplash are composed of concrete masonry units, and the surface appears to be precast concrete. See Photo 3-17.

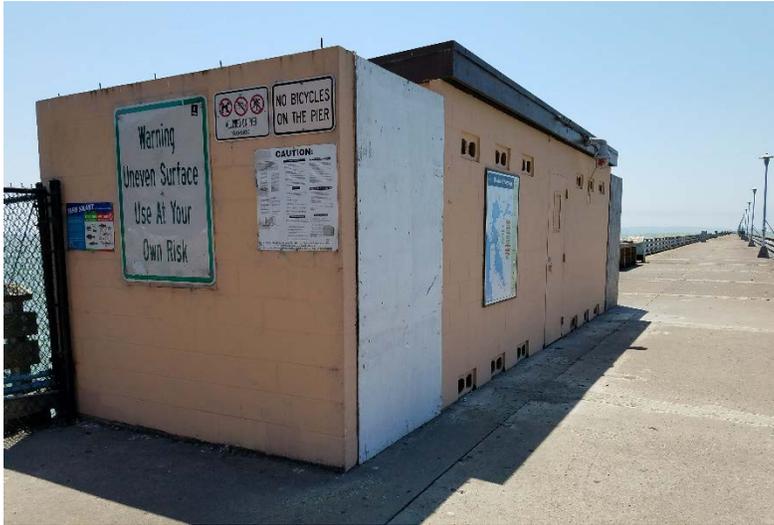
Photo 3-18: Restroom

The restroom building near the start of the pier is constructed out of concrete masonry units but was boarded up and inaccessible. There was little structural deterioration noted at the visible outside face. See Photo 3-18.

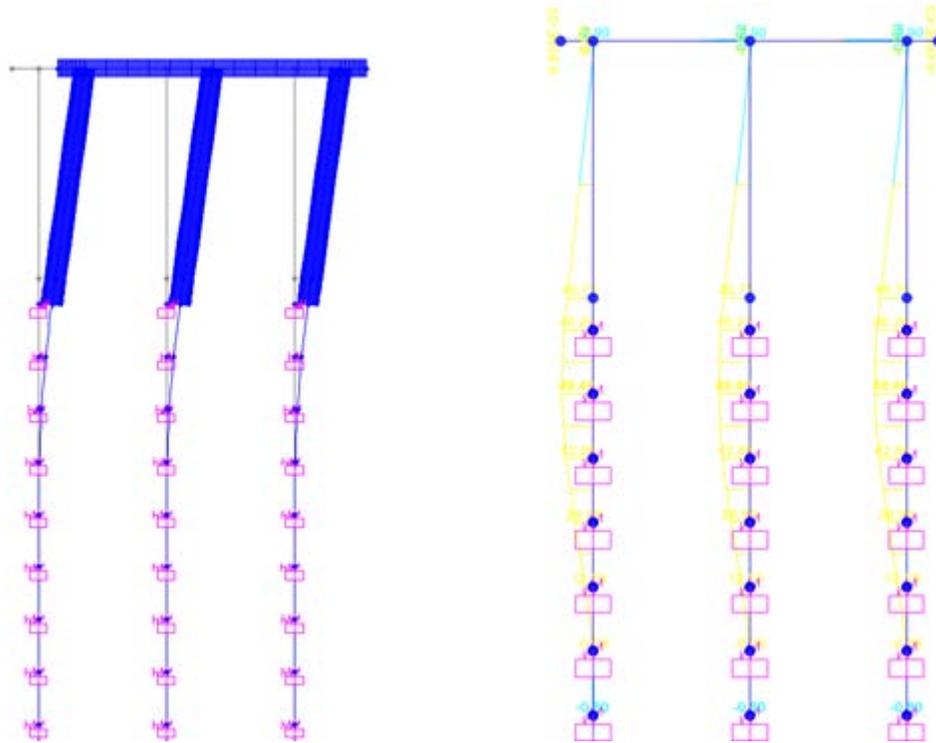
Figure 5-4: Displaced Shape and Pile Moment Diagram

Figure 5-2 above represents the basic model of existing conditions. For this condition, bending in the piles just below the mudline resists lateral movement of the deck structure due to earthquake. Timber piles are typically not modeled with non-linear hinges since they have very little rotational capacity beyond their ultimate moment strength. In this case the model was pushed at the top deck a distance of 2.5 feet and the resulting pile moments were monitored. Figure 5-4 shows a plot of the displaced shape at a deflection of 1.75 feet at the deck with the corresponding moment distribution in the piles for that deflection. The pile moment at this push step is indicated as 49 kip-feet.

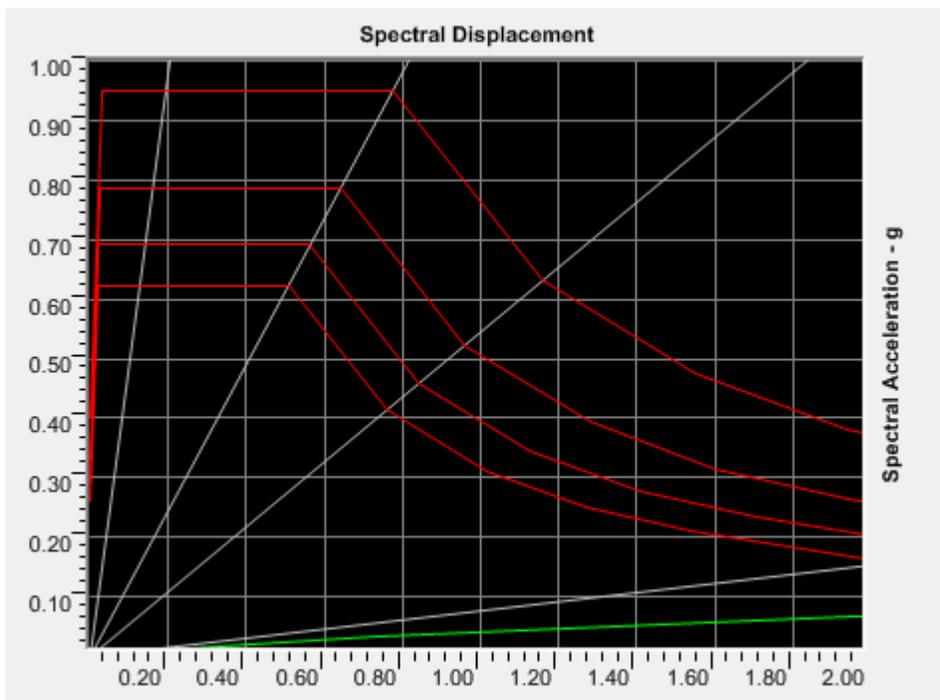
Figure 5-5: Acceleration Displacement Spectrum for Existing Timber Pile Condition

Further the pushover curve created was evaluated against the required BSE-1E and BSE-2E earthquakes. A plot of the structures ADRS spectra is shown in Figure 5-5. The green line is the structural capacity curve and the red lines are demand capacity curves for various damping levels. As can be seen by comparison to Figure 3, there is no intersecting performance point indicating a successful solution. This means in this case that the demand deflection far exceeds the capacity of 1.75 feet at the maximum pile moment. For the maximum earthquake case the structure can be expected to suffer extreme deflections and possible collapse.

This information informs us about the maximum displacement that can be tolerated in existing structure when combined with retrofit schemes. In this case, retrofit schemes must limit the displacement to 1.75 feet or less and must also have a capacity curve that intersects successfully with a performance point on the ADRS plot.

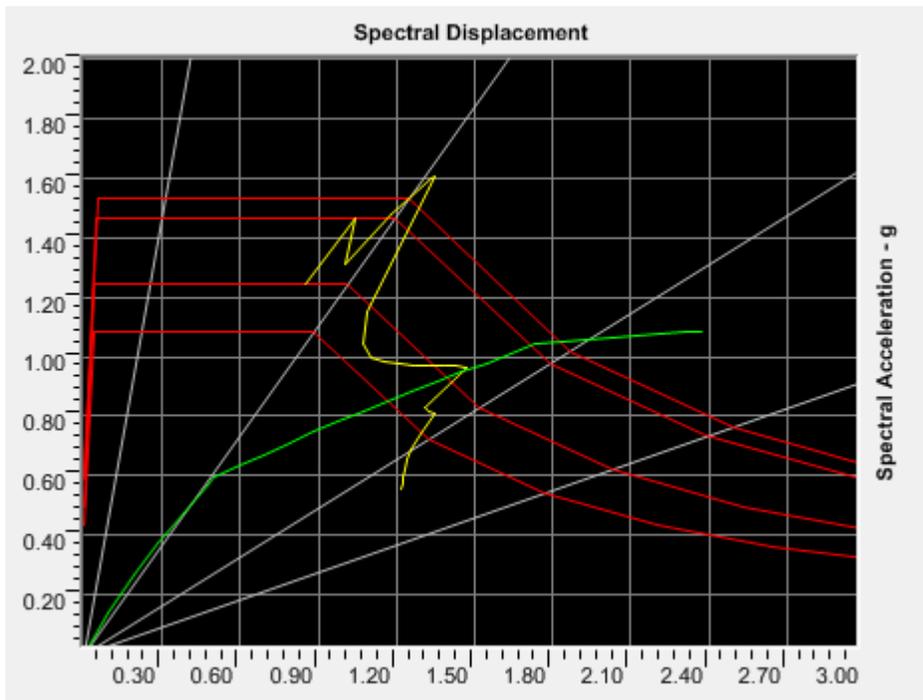
Figure 5-8: ADRS for P4 Retrofit Model

Figure 5-8 shows the green pushover curve for the retrofit pile moment frame model. The green curve is much taller indicating much more capacity compared to the original structure shown in Figure 5. The yellow line represents the the plot of each trial evaluation of effective structural period and it's corresponding displacement value. A solution, the performance point, is found where the yellow line intersects the green line. This occurs at 1.5 feet of deck displacement.

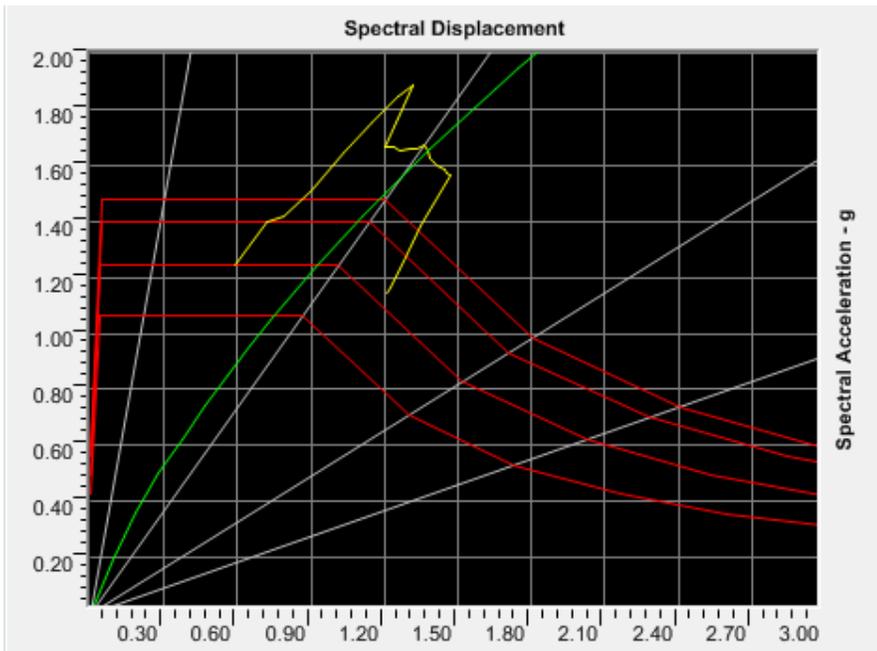
Figure 5-10: ADRS for P5 Retrofit Model

Figure 5-10 shows the ADRS plot for this retrofit scheme. In this plot the performance point at the intersection of the green and yellow lines occurs at about 1.4 feet. This demand displacement is less than that which can be tolerated by existing timber piles so it is a successful retrofit scheme. In this case essentially all of the non-linear action occurs in the soil springs. The cantilevered piles remain elastic for this solution.

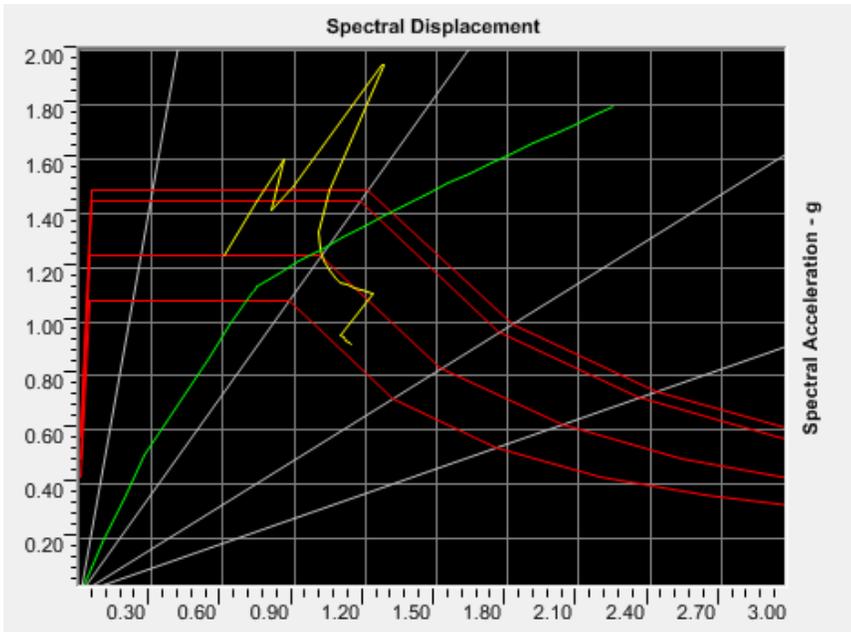
Figure 5-11: ADRS for P6 Retrofit Model

Figure 5-11 shows the ADRS plot for model P5. The performance point occurs at a deflection of approximately 1.1 feet which is well within the expected deflection capacity of the original timber pile structure.

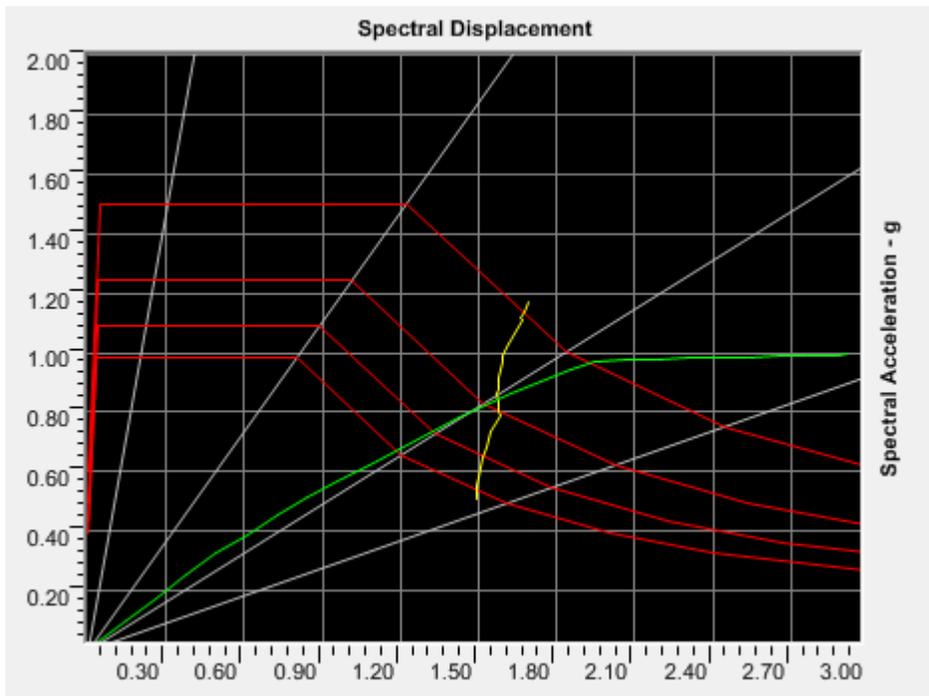
Figure 5-12: ADRS for P8 Retrofit Model

Figure 5-12 shows the ADRS for the P8 model. For this solution the performance point occurs at about 1.5 feet. For this case essentially all inelastic non-linear action occurs in the soil springs. The cantilevered monopile section remains elastic up to the performance point demand displacement.

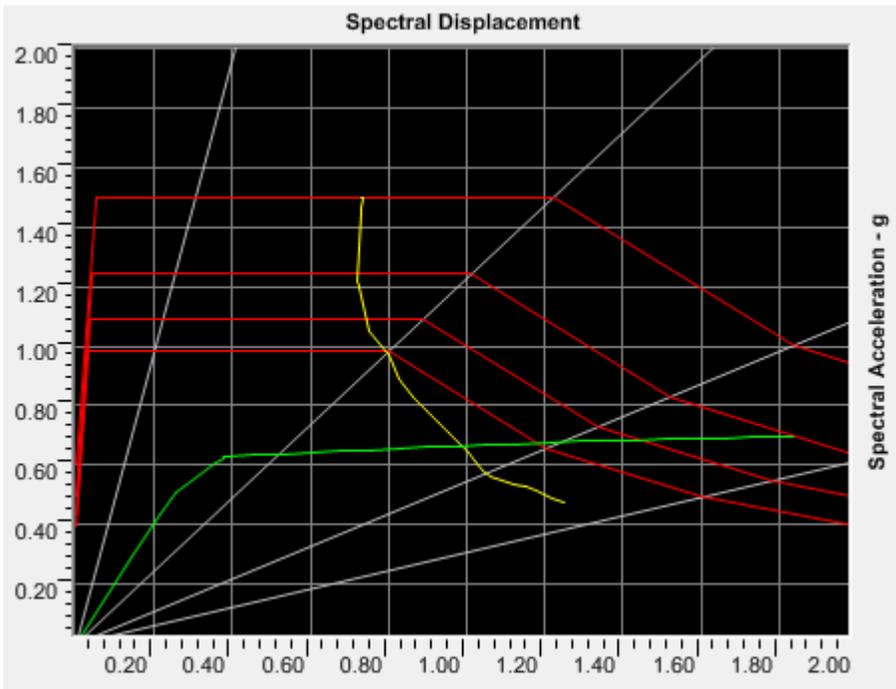
Figure 5-14: ADRS for P10 Model

Figure 5-14 shows the ADRS for the P10 model. For this solution the performance point occurs at about 1 foot. For this case a significant amount of non-linear deformation occurs within the precast pile at about 18 feet below the mudline. Some inelastic actions are also observed at the pile to pile cap connection. This deformation would be addressed by proper detailing of the pile to cap connection for the required ductility. For the design earthquake, some pile damage could be expected well below the mudline. This damage would be unrepairable.

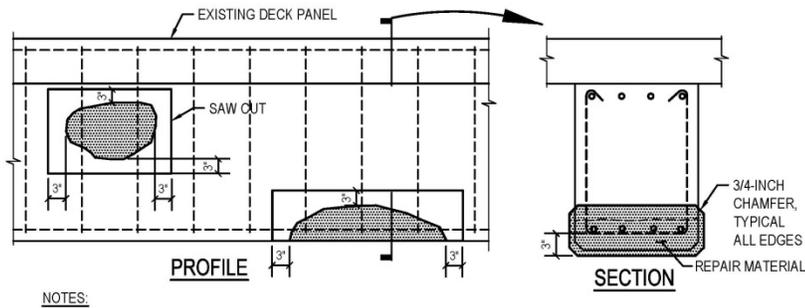
Figure 6-3: Typical Bent Cap Repair

The reinforced concrete beams and bent caps have suffered extensive damage along the bottom and sides of the section due to delamination of the concrete cover and corrosion of the reinforcing steel.

The recommended repair consists of the use of fiber-reinforced shotcrete applied to form a built-up section and provide encasement for the reinforcing bars. The synthetic fibers are added to the shotcrete mix and have the benefit of reducing shrinkage of the repair material which is important in the marine environment. The spalled and loose concrete is first removed and the exposed steel is cleaned of rust and scale and an epoxy coating is applied to protect the reinforcing and increase bonding for the shotcrete.

Replacement of the existing reinforcing bars will be required if damage due to corrosion is extensive. The new sections of reinforcing bars may be lapped with the existing steel or mechanical couplers may be used. A bonding agent is spray-applied to the concrete surface and galvanized steel mesh or fabric is then attached to the concrete and the shotcrete applied. A sketch of the shotcrete beam repair detail can be seen below in Figure 6-3 below.

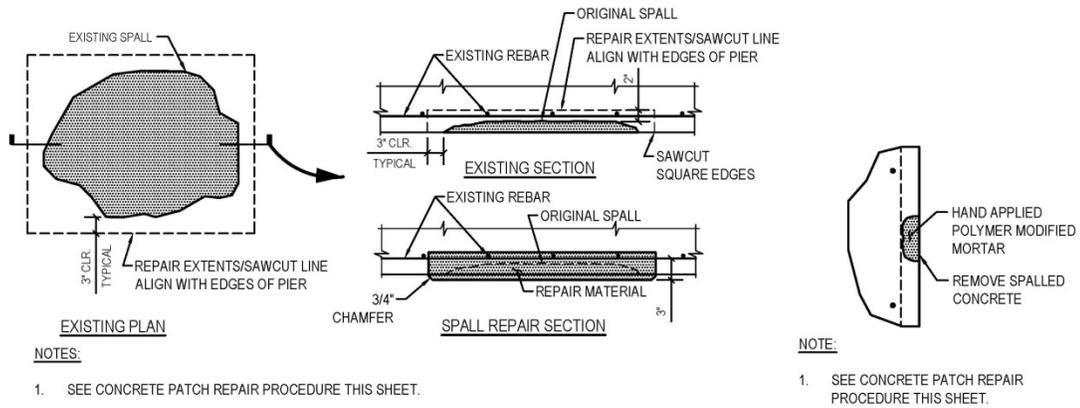
Figure 6-4: Deck Slab Repair

The concrete is missing or spalled at many locations on the underside of the deck slab. This is damage commonly seen as the concrete forms tensile cracks over time due to shrinkage of the concrete or sustained loading. This provides a path for moisture from the marine environment allowing for a reaction with the reinforcing steel. As the steel rusts, the corrosion expands and occupies a volume greater than the original steel. This expansion creates the spalled condition observed.

The repair will consist of removing the spalled concrete and chipping away the concrete surrounding the existing reinforcing. The reinforcing will be cleaned to remove the rust and scale and then coated as described above. If the reinforcing is found to have deteriorated to the point where a significant percentage of the original section has been lost, additional reinforcing will be doweled into the concrete and spliced with the existing steel. Alternatively, the damaged reinforcing may be cut out and a new section attached using mechanical connectors. The new reinforcing may be of a smaller diameter with less spacing to reduce the lap lengths required. The prepared area will then be patched with an epoxy mortar or grout suitable for the overhead application or a shotcrete method will be utilized.

A sketch of the shotcrete deck slab repair detail can be seen on Figure 6-4.

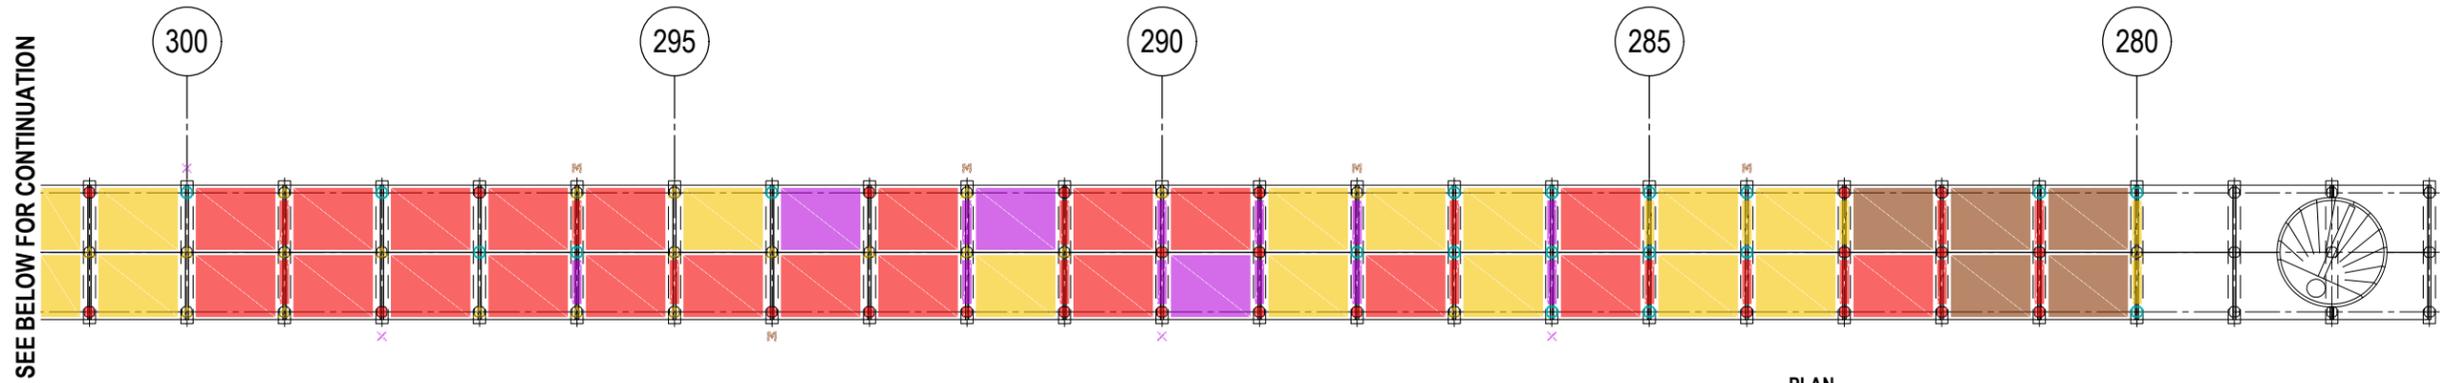
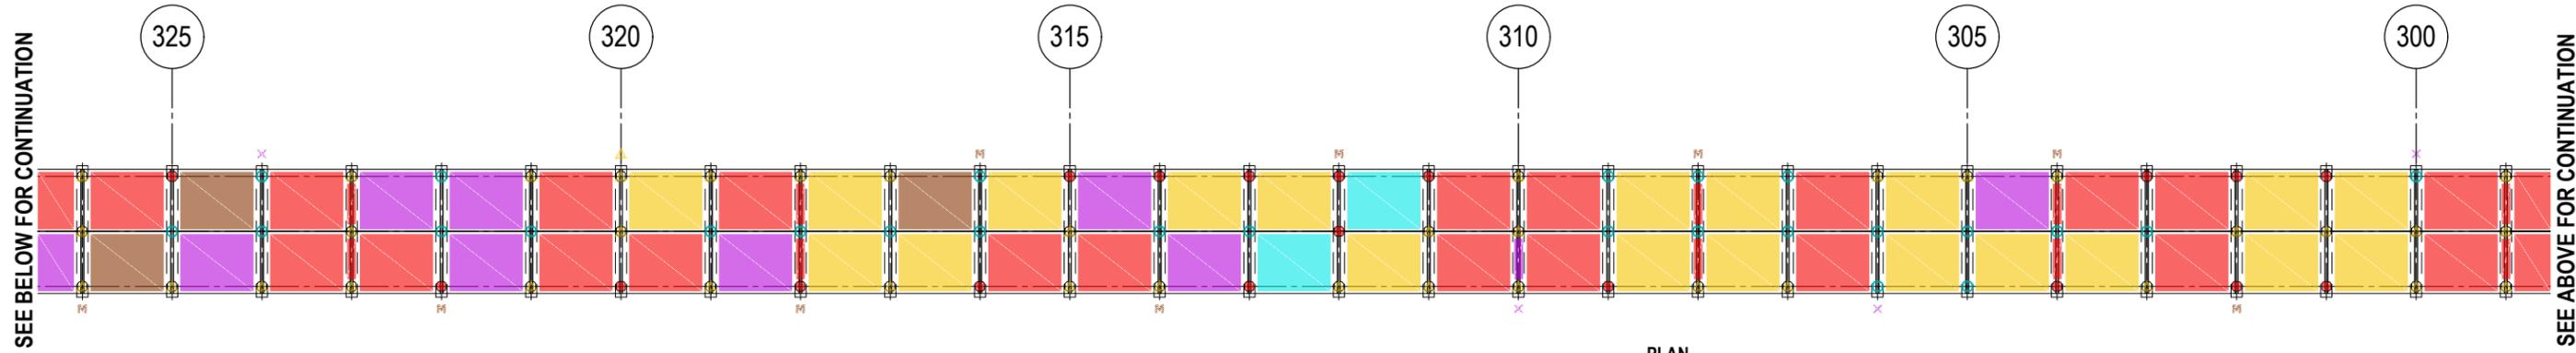
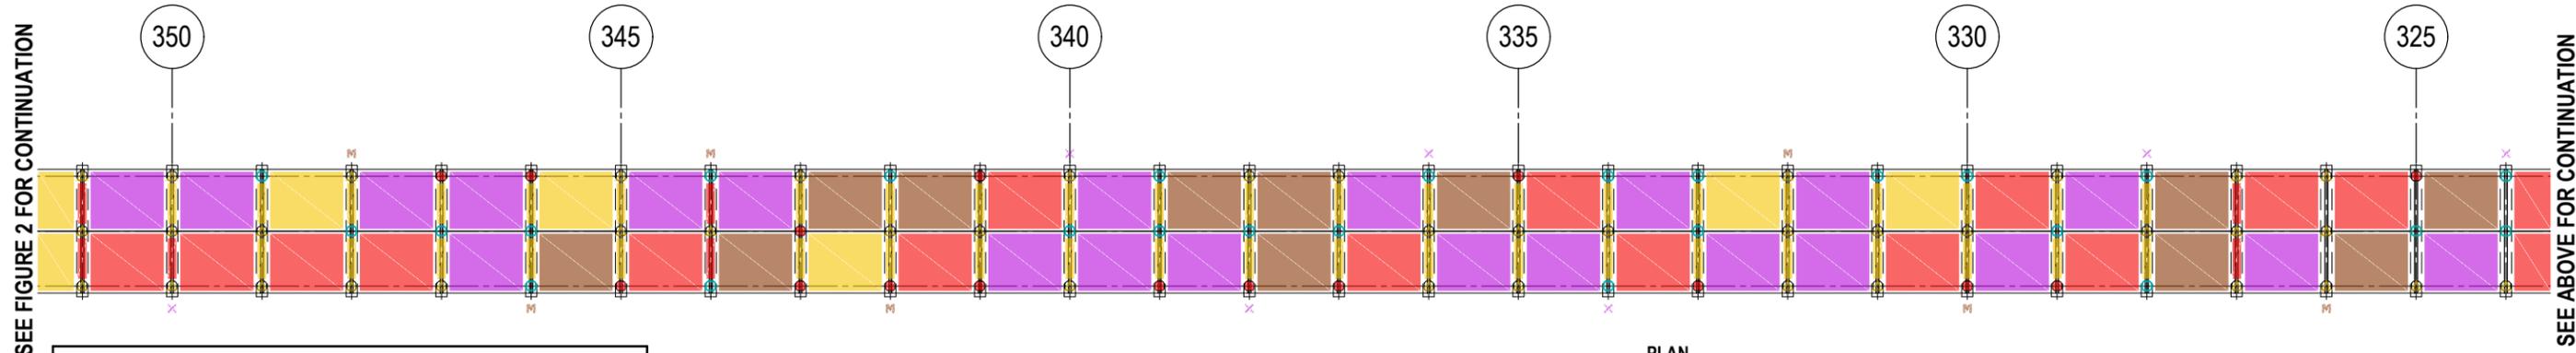
FIGURE B-5

1 PARTIAL DECK PLAN - PIER RATING
SCALE: 1"=30'

2 PARTIAL DECK PLAN - PIER RATING
SCALE: 1"=30'

3 PARTIAL DECK PLAN - PIER RATING
SCALE: 1"=30'

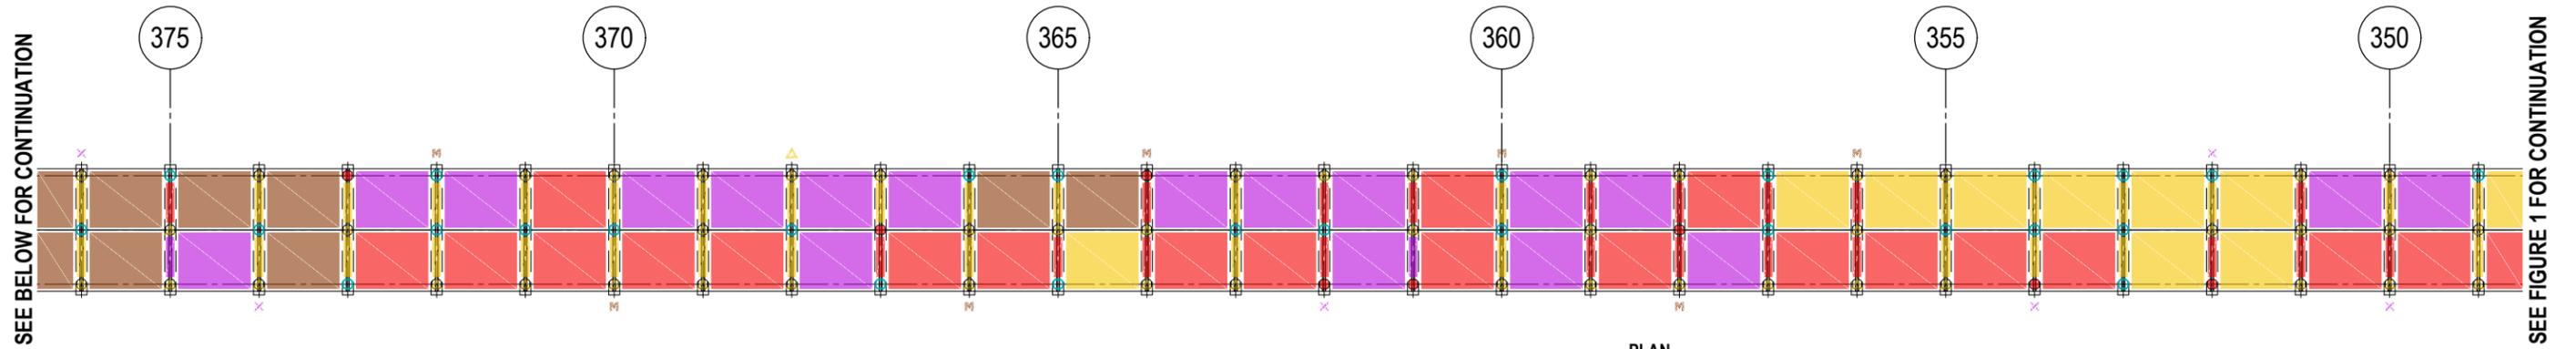
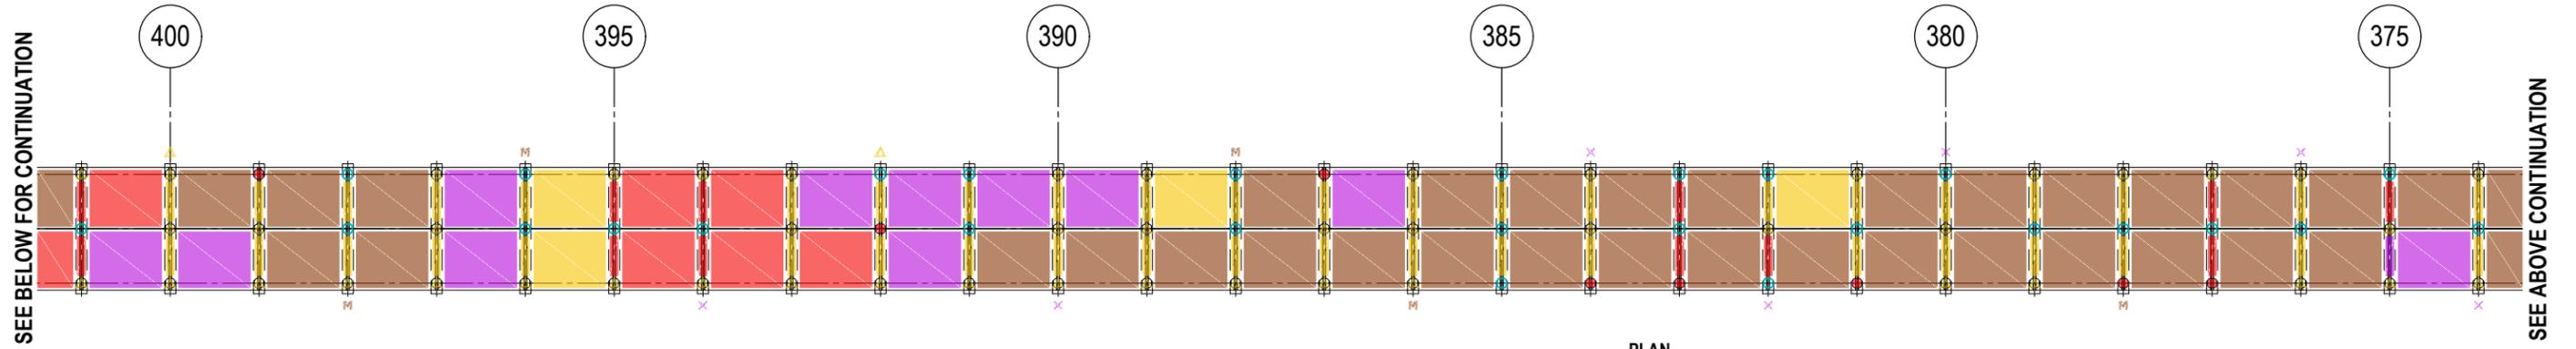
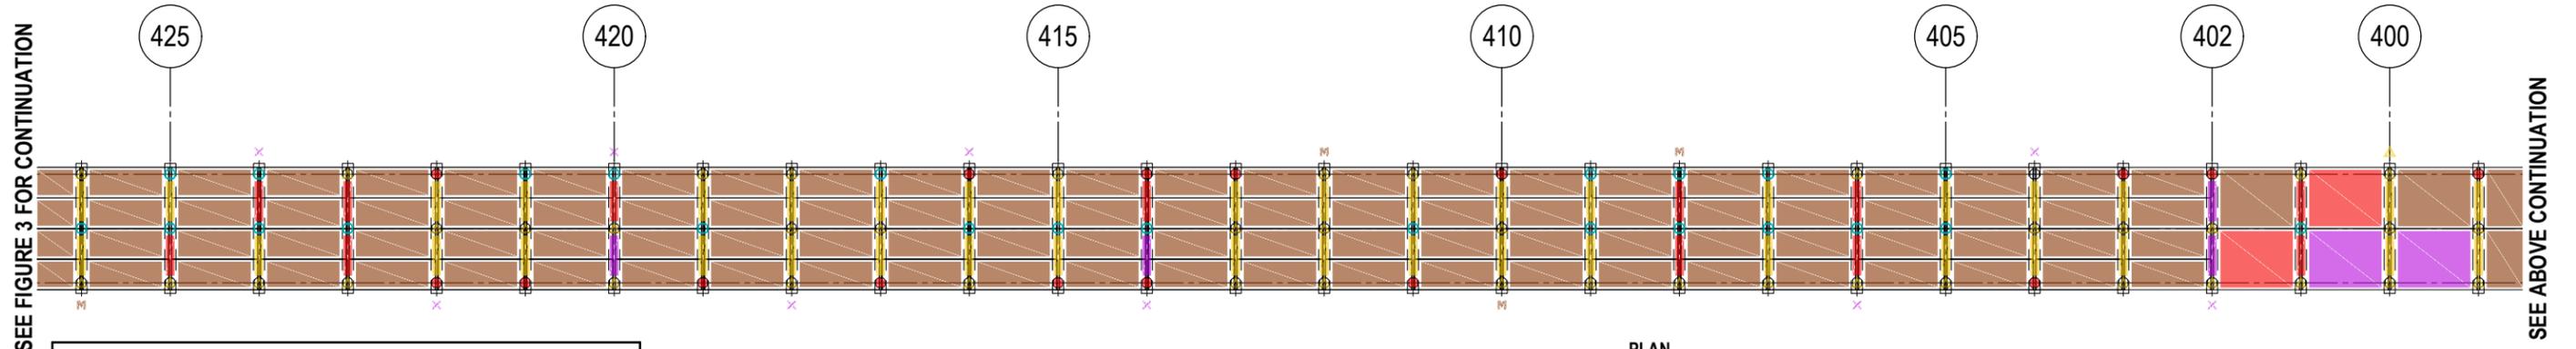
FIGURE B-6

4 PARTIAL DECK PLAN - PIER RATING
SCALE: 1"=30'

5 PARTIAL DECK PLAN - PIER RATING
SCALE: 1"=30'

6 PARTIAL DECK PLAN - PIER RATING
SCALE: 1"=30'

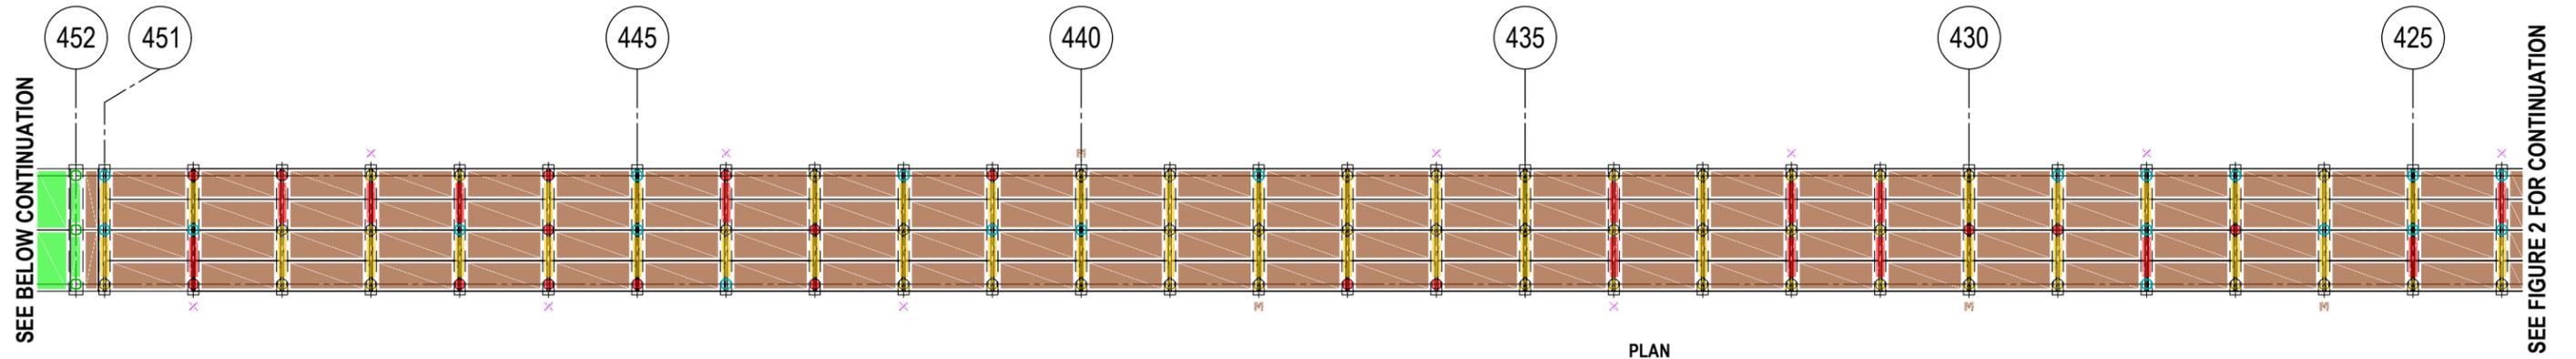
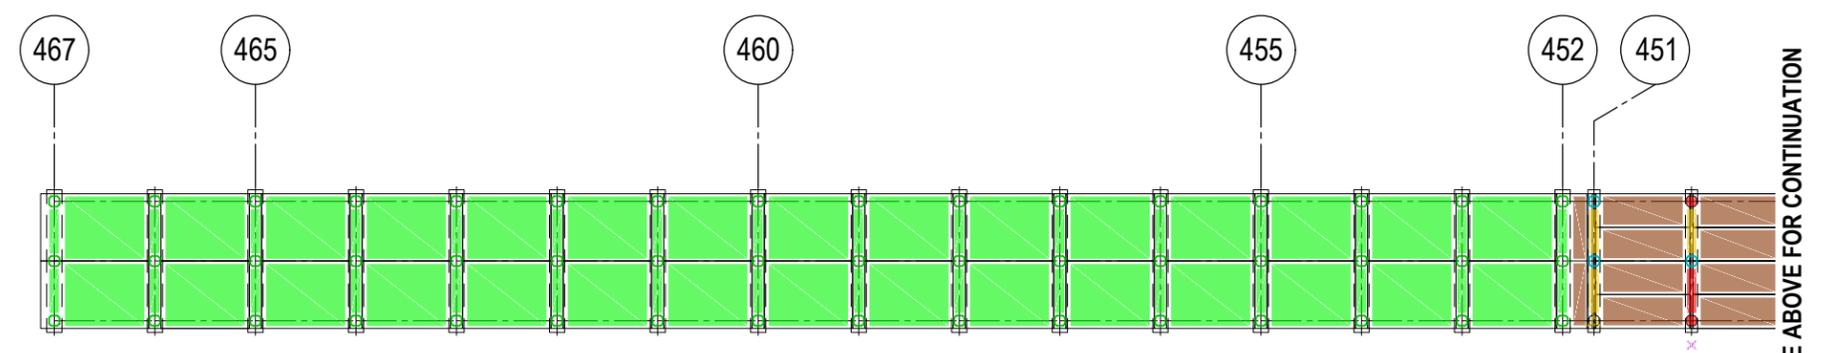
6 PARTIAL DECK PLAN - PIER RATING
SCALE: 1"=30'

7 PARTIAL DECK PLAN - PIER RATING
SCALE: 1"=30'

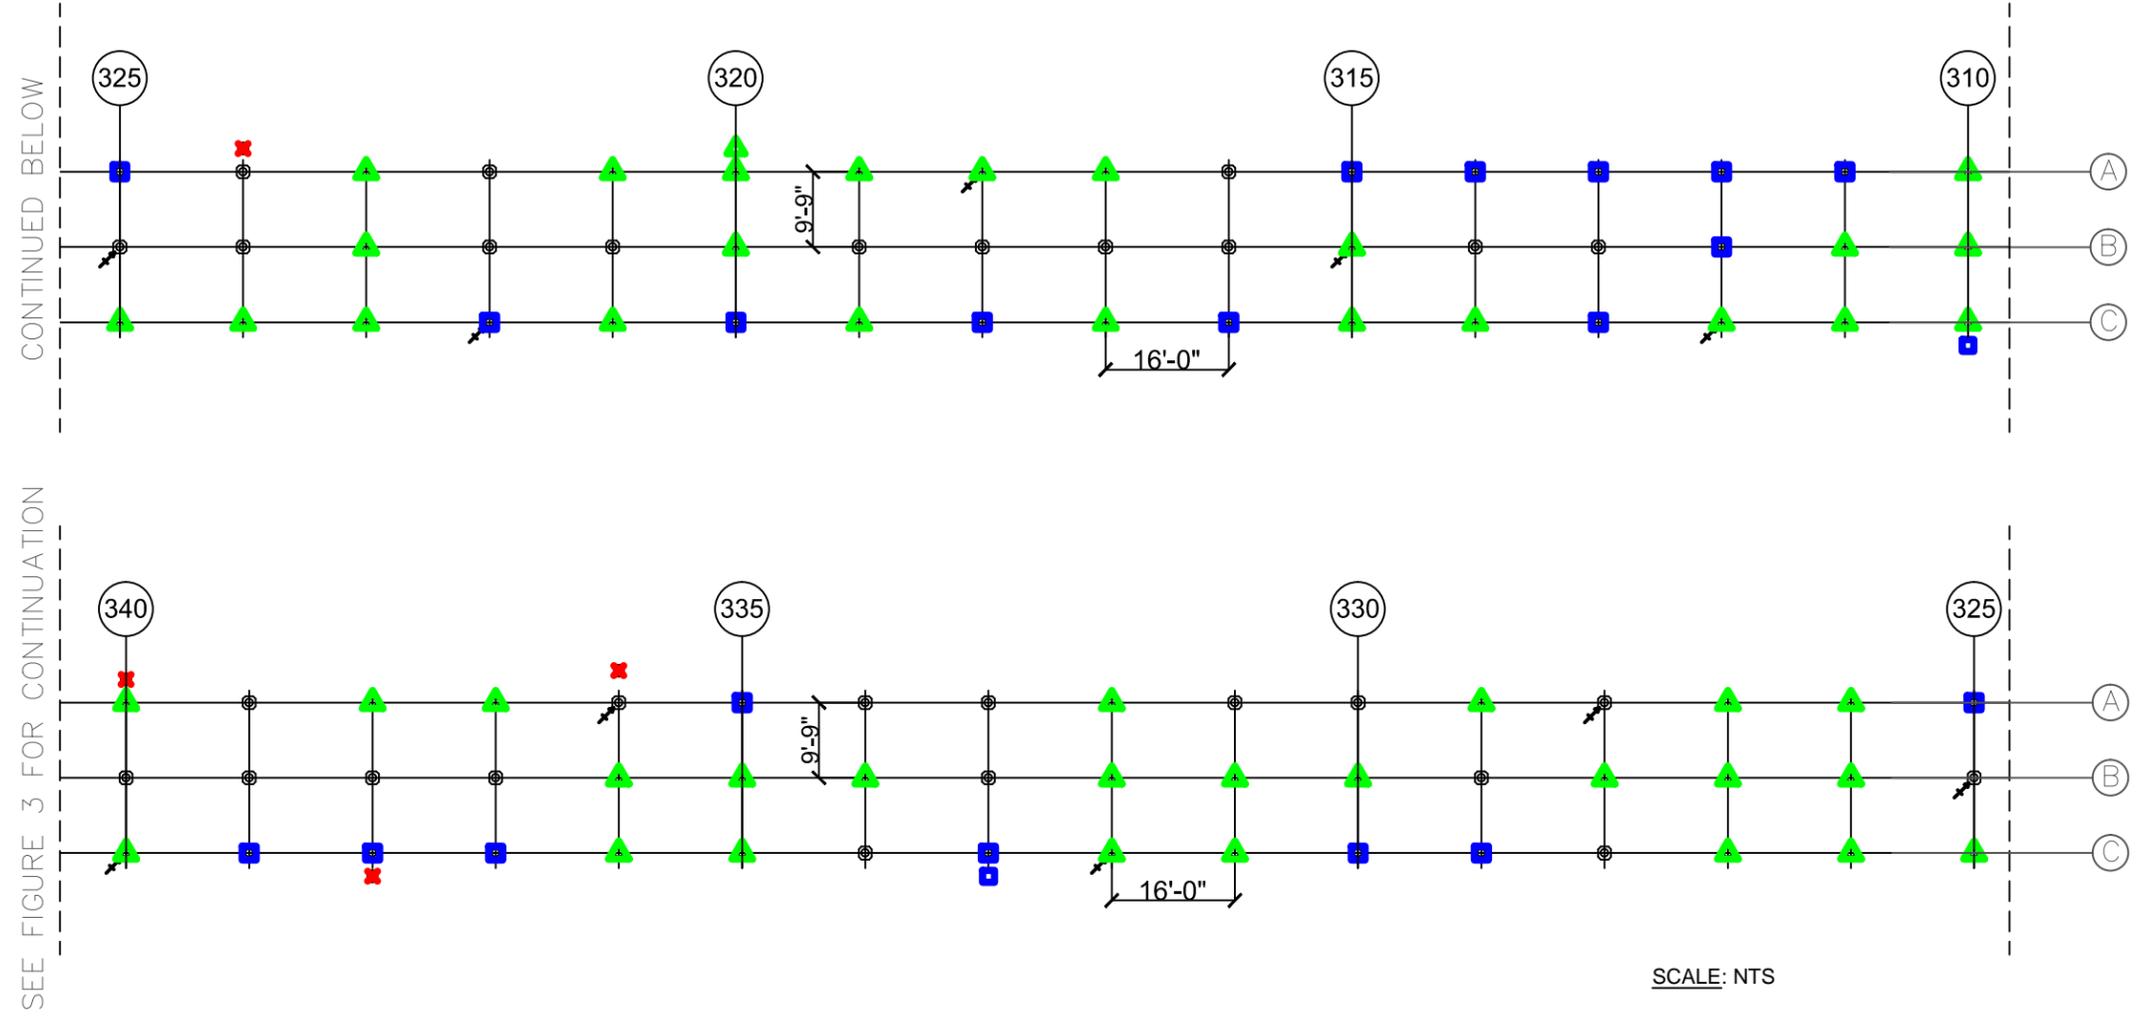
FIGURE NO. 1 RING 1/6

BERKELEY MUNICIPAL PIER
 CONDITION PLAN (1/6)
 UNDERWATER
 INSPECTION REPORT
