City of Berkeley
Berkeley Municipal Pier
Structural Assessment Report

June, 2021

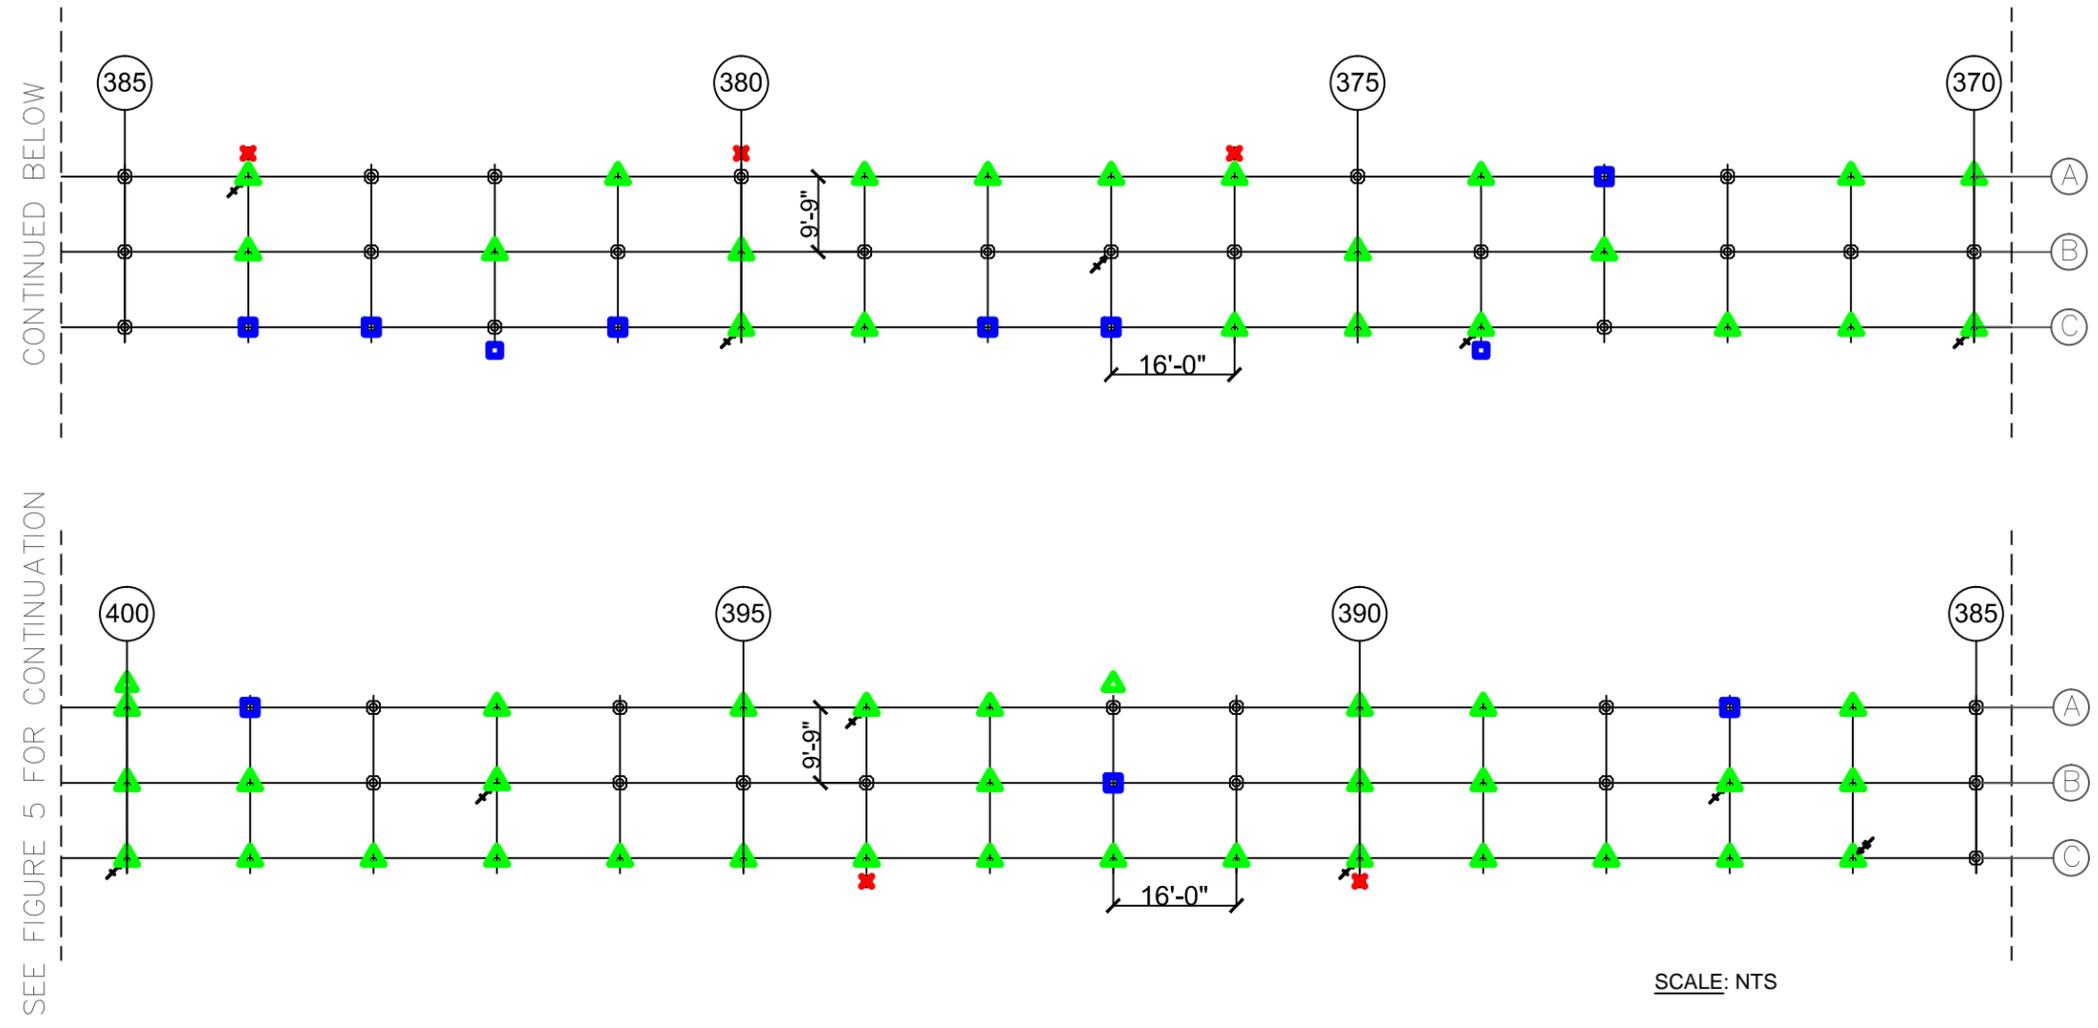
FIGURE NO. 3 RING 3/6

BERKELEY PIER
 MUNICIPAL
 CONDITION PLAN (3/6)

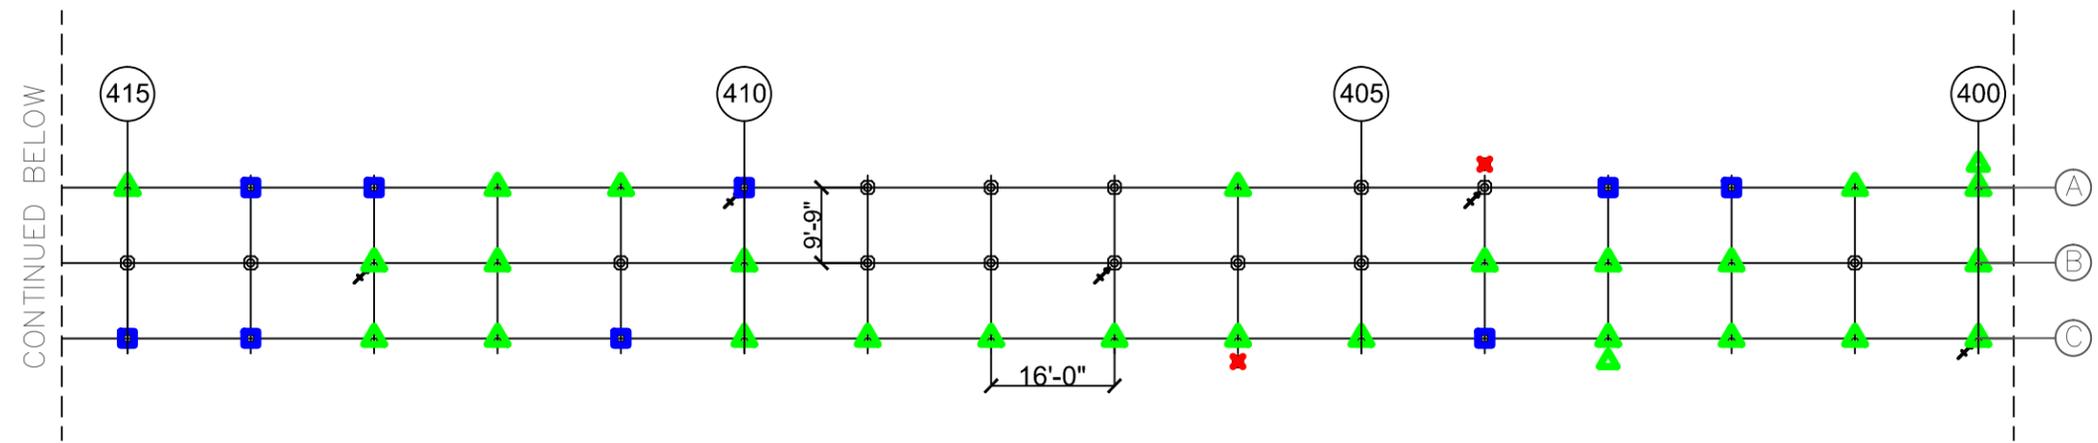
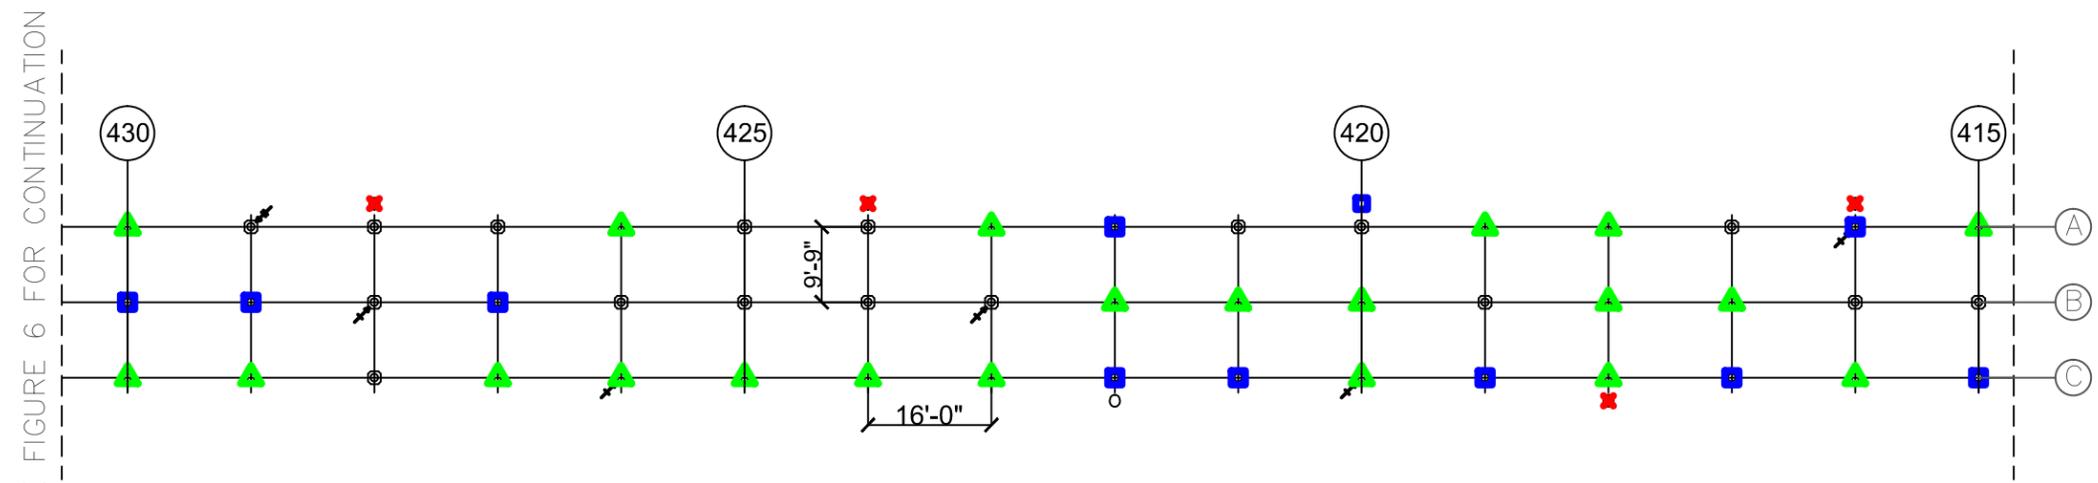
BERKELEY PIER MUNICIPAL CONDITION PLAN (4/6)	UNDERWATER INSPECTION REPORT

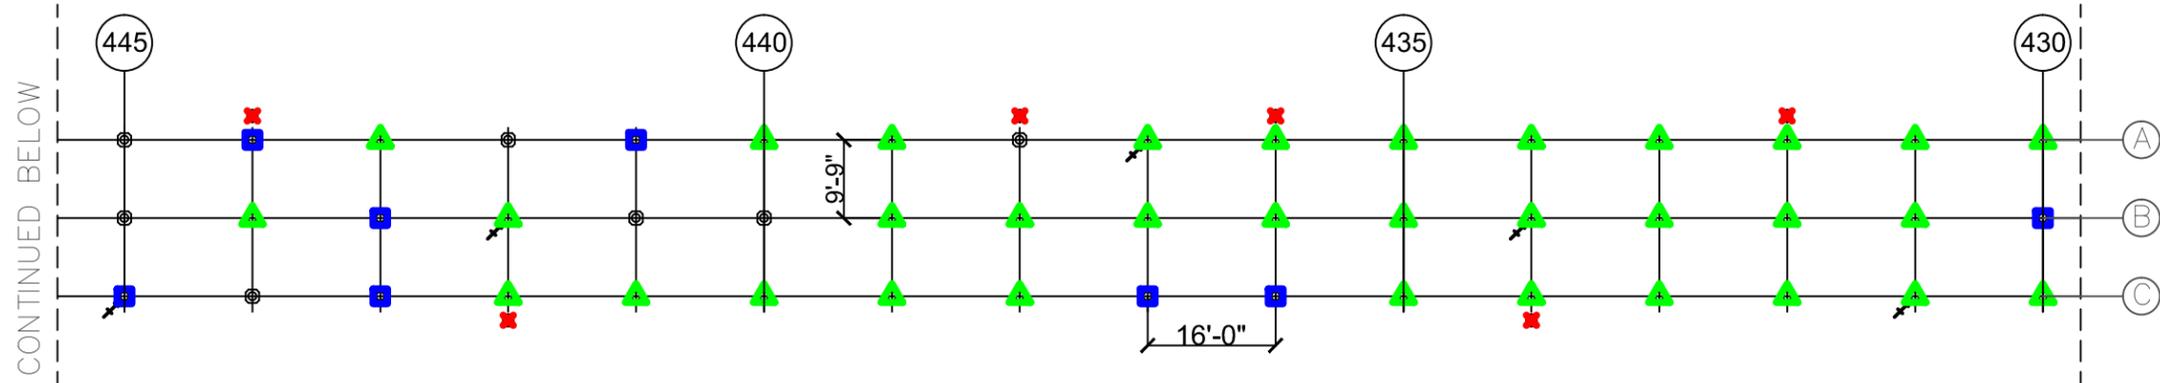
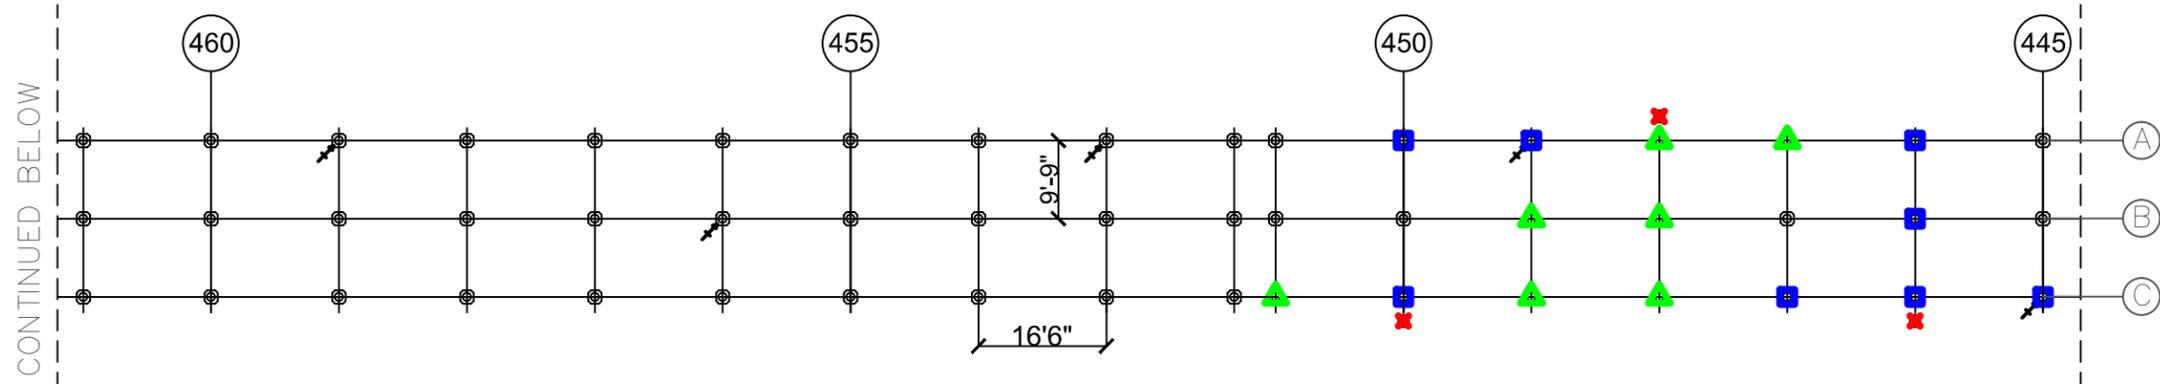
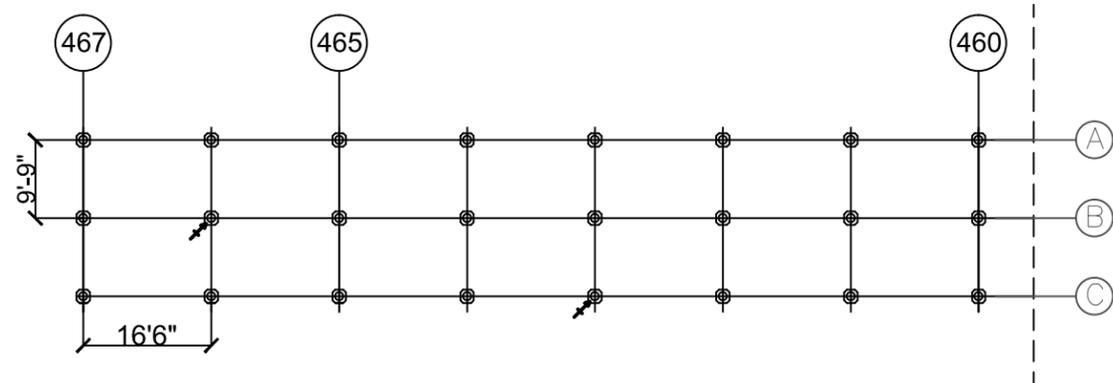
FIGURE NO. 5 RING 5/6

BERKELEY MUNICIPAL PIER
 CONDITION PLAN (5/6)
 UNDERWATER
 INSPECTION REPORT

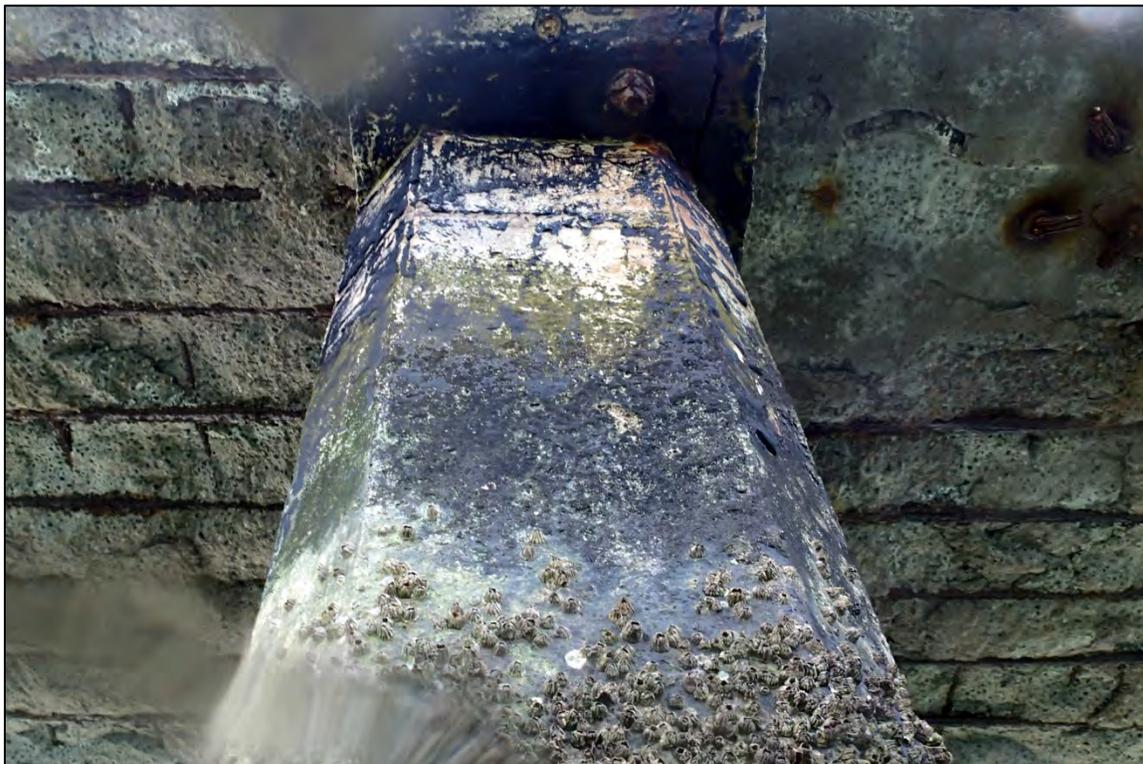
PHOTOGRAPH 20: Pile 366A, undamaged

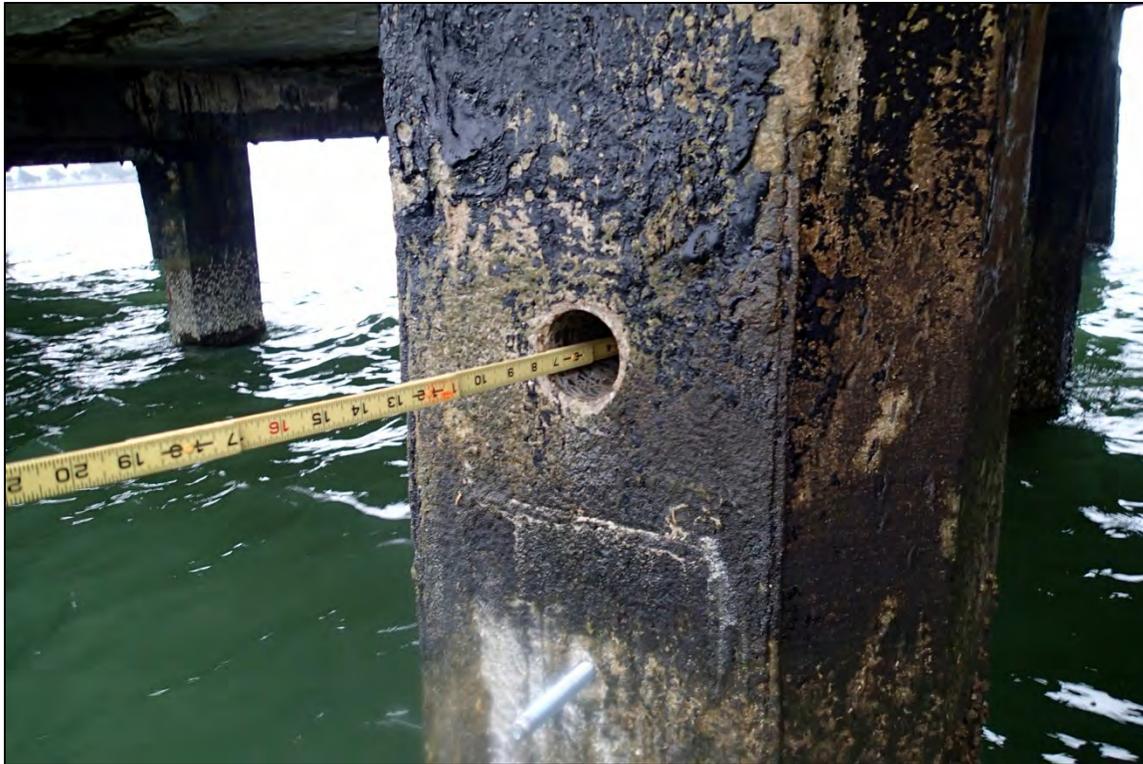
PHOTOGRAPH 21: Pile 429A, Level III concrete core hole

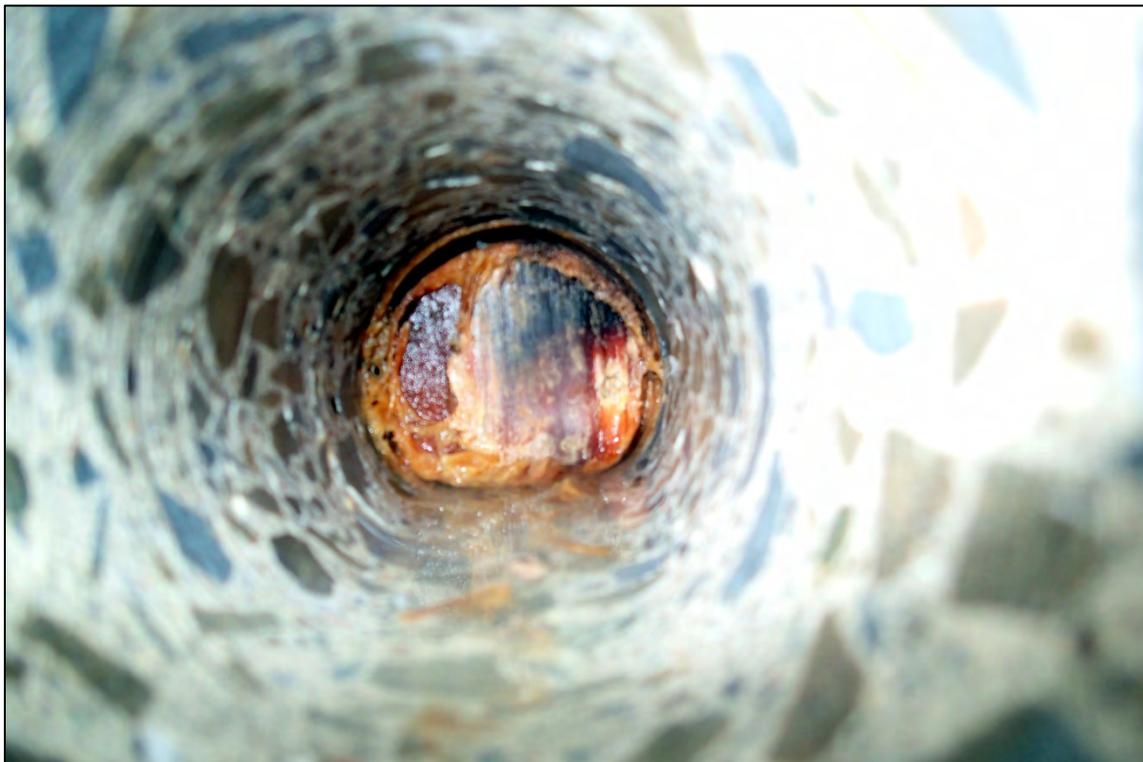
PHOTOGRAPH 22: Pile 429A, view of concrete and timber inside Level III core hole

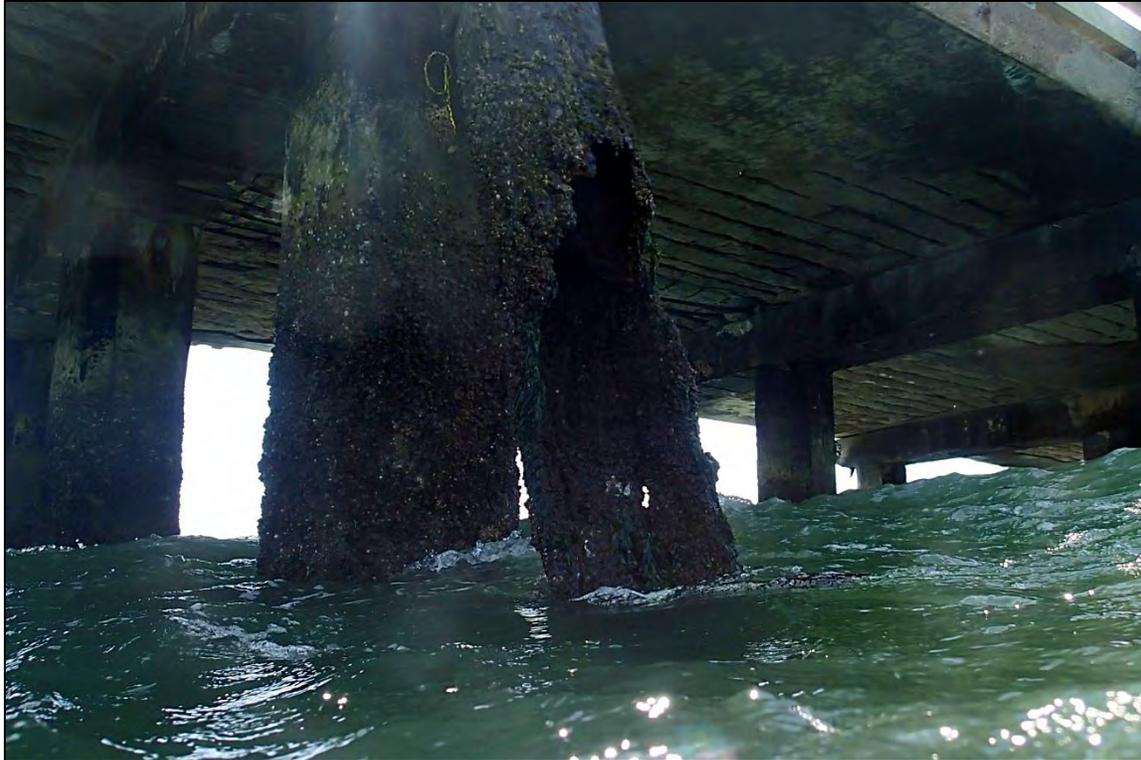
Berkeley Municipal Pier timber batter piles are in **Critical** condition due to section loss from the effects of marine borer infestation (See Photograph 23) and piles disconnected from pile caps.

PHOTOGRAPH 23: Pile 376A-BATT, Severe section loss from marine borer
