DATE February 28, 2025

PROJECT NO A203047

## City of Berkeley East Timber Docks at South Sailing Basin Inspection Report

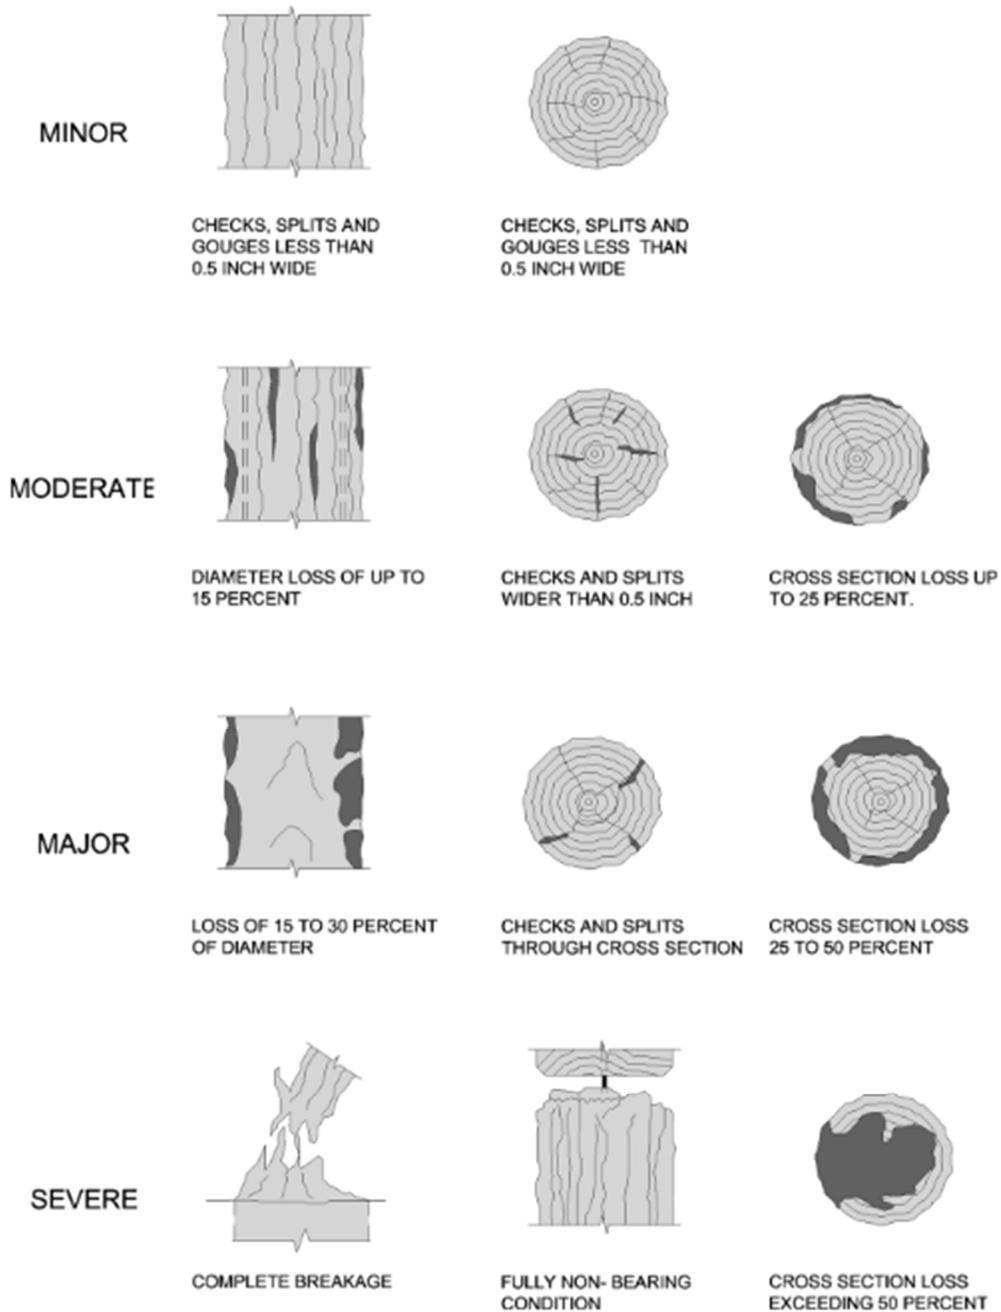
*Fig. 2-2. Condition ratings for timber elements  
Source: Courtesy of CH2M HILL, Inc. and Ben C. Gerwick, Inc., reproduced with permission.*

As we relayed at the site, we found that damage to the piles at the pier approach is "Severe" leaving several with very little vertical load carrying capacity. Refer to Figure 2-2
