**Asbestos and Lead Survey for Interior Improvements**

West Berkeley Service Center  
1900 Sixth Street  
Berkeley, CA

February 2024

Acumen Project No. COB 2440

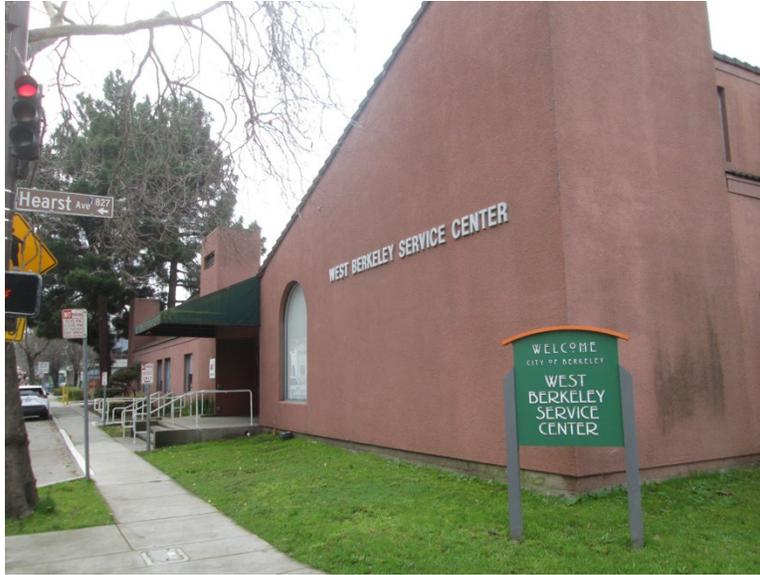
**Photo 1**

West Berkeley Service Center, located at 1900 Sixth Street in Berkeley, California (Site). The Site is a one story, slab-on grade building completed in 1981.
