**RE:** ZAB April 9, 2026 – Agenda Item 6-C – Use Permit Modification #ZP2025-0113 – 2128 Oxford Street – URGENT ADA VIOLATIONS: REQUEST TO PULL FROM CONSENT CALENDAR AND IMPOSE ADDITIONAL CONDITIONS

2128 Oxford Street -Supplemental Submission-Photographic Evidence  
Steven Schuyler

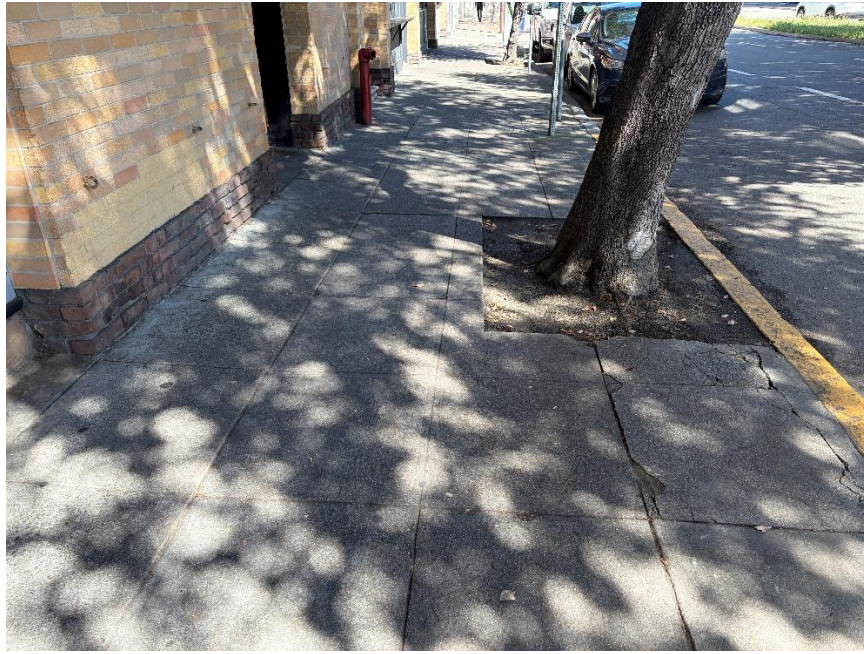
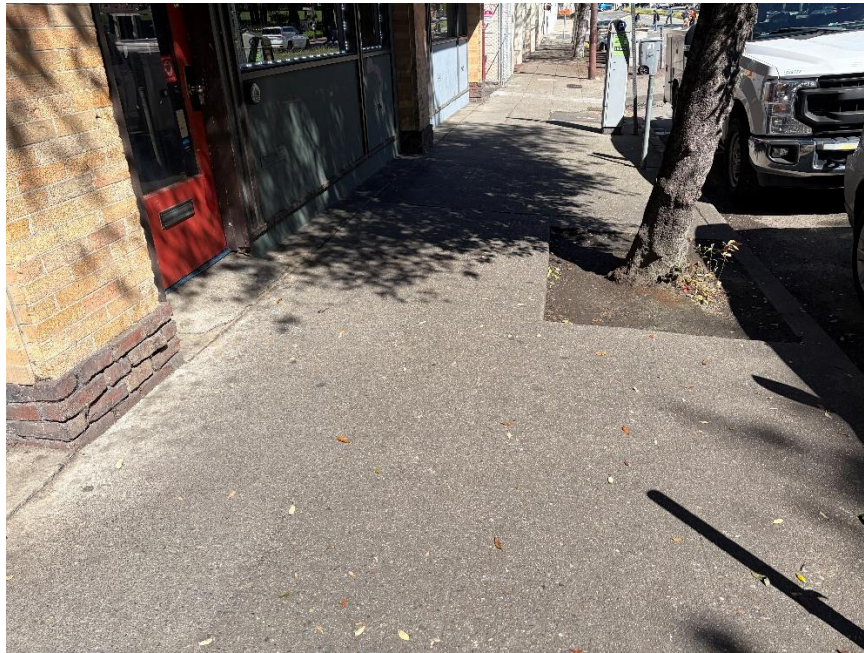
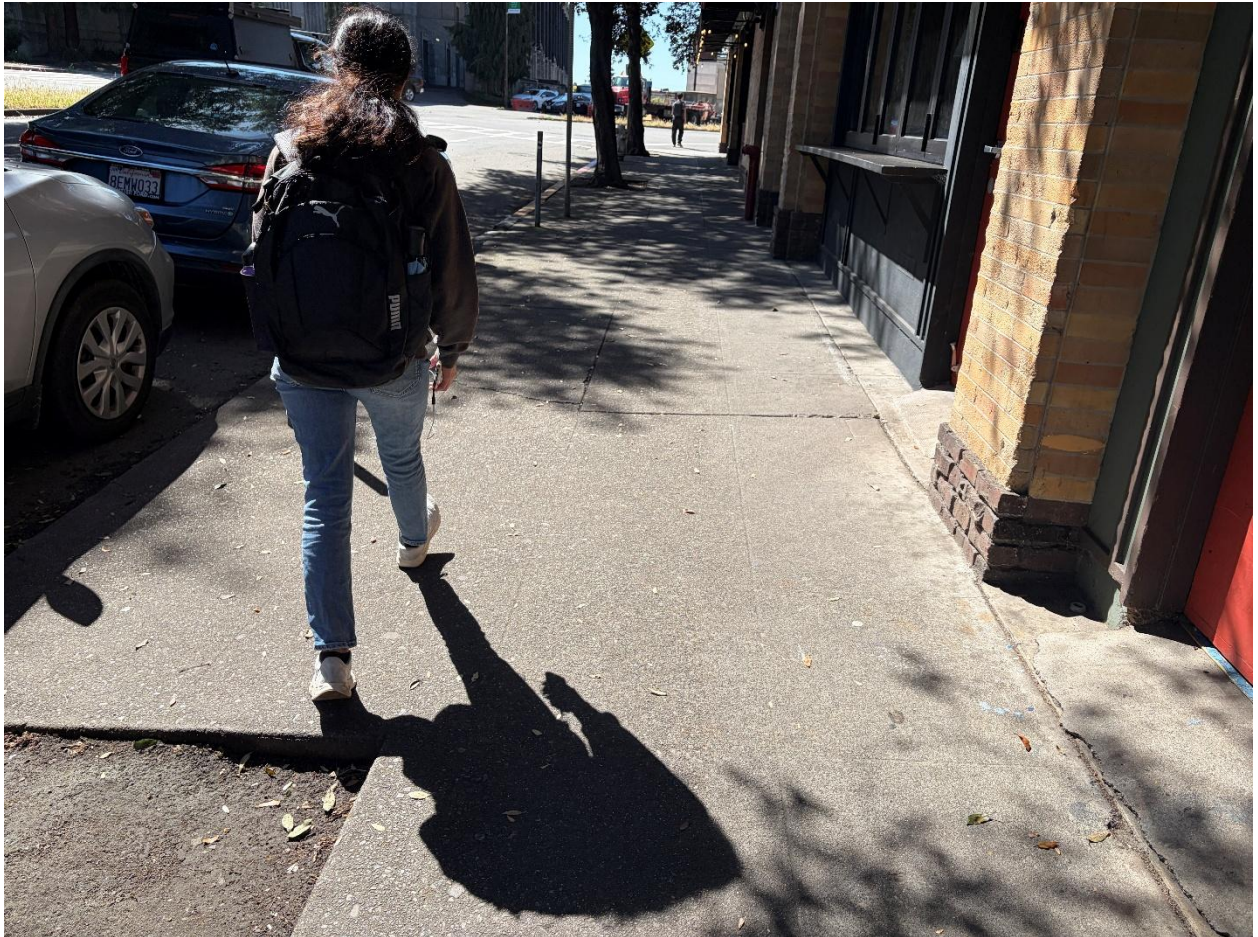
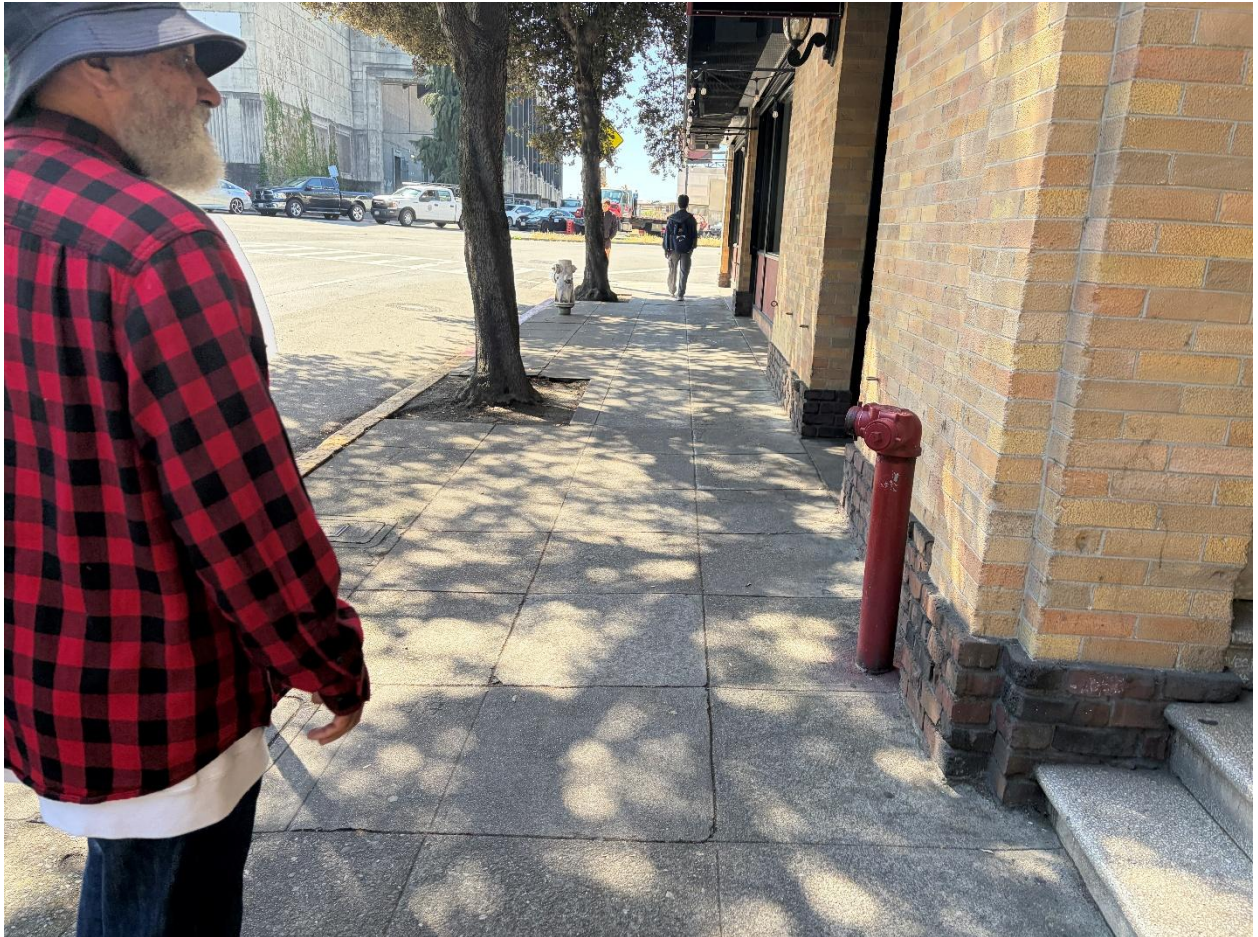
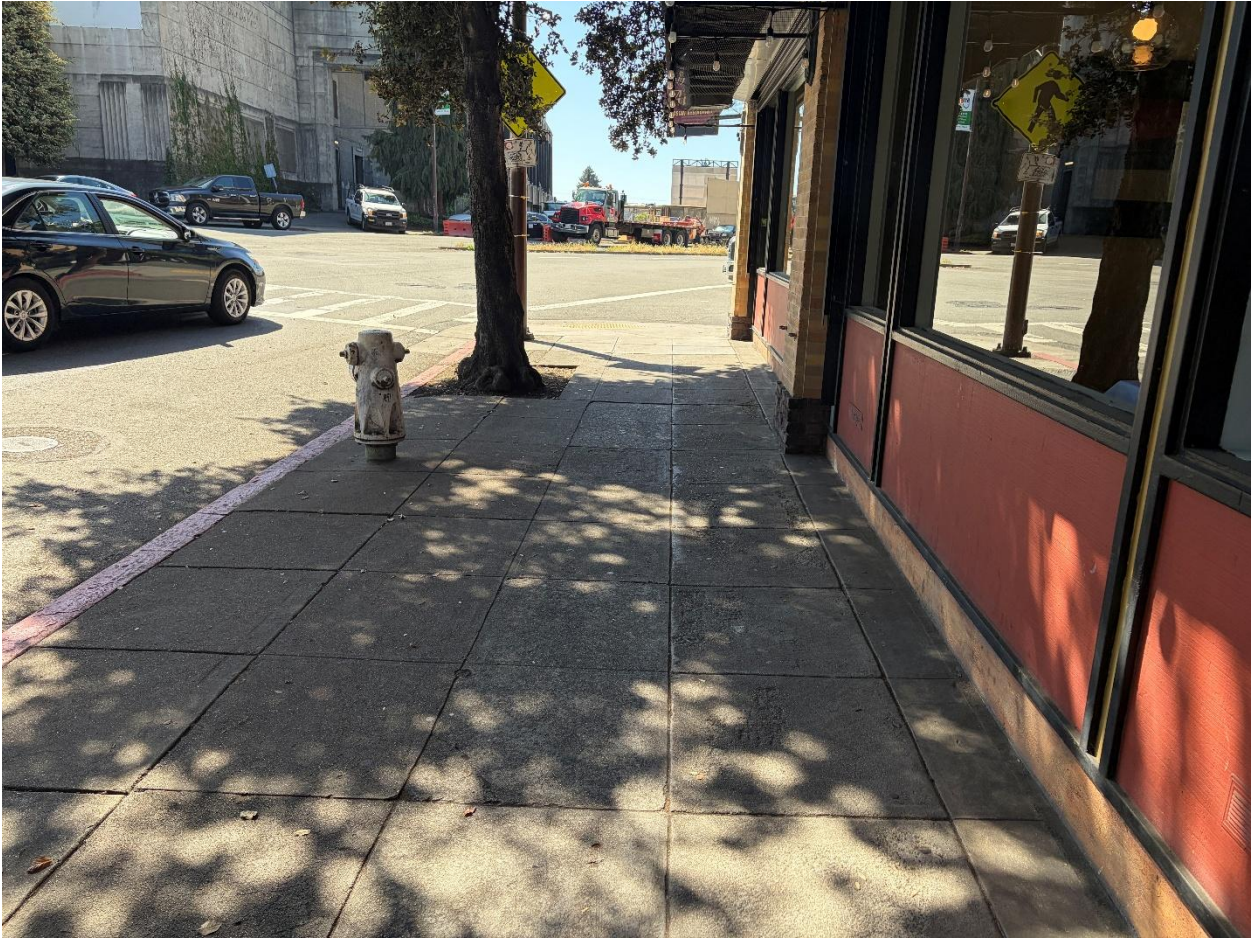
These pictures are of the trees on the sidewalk on Oxford Street between Oxford Lane and Alston Way. As you can see, the tree wells are open with no covers and regardless of technical compliance of ADA measurements of the sidewalks, disabled people especially blind people either with or without guide dogs as well as those in wheelchairs can very easily get stuck or injured by stepping into these wells which if not mitigated can expose the city to litigation by anyone who gets injured at any one of these tree wells.

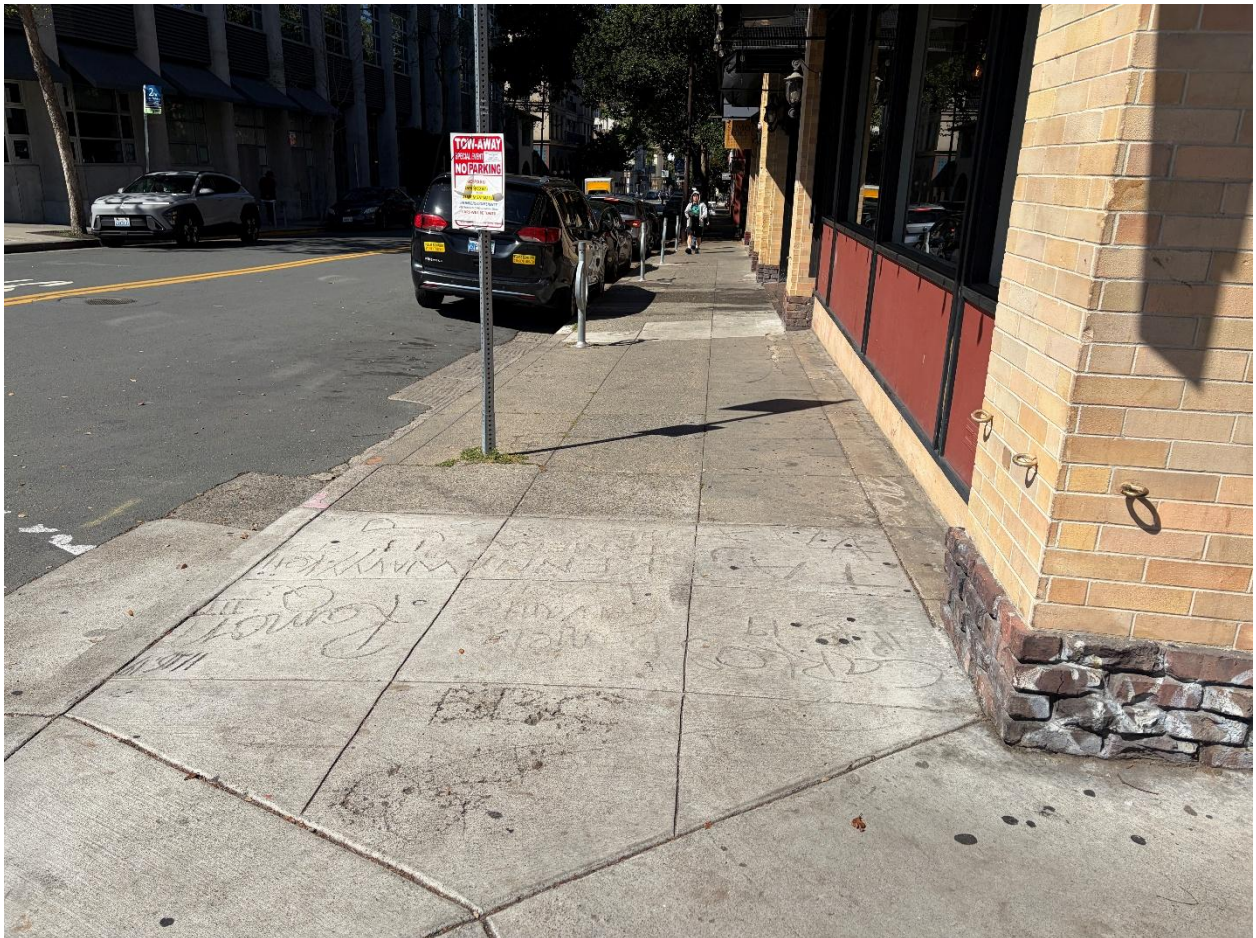
This picture shows just around the corner of Alston Way and you can clearly see that despite ADA measurement compliance, that does not account for a high-rise building being put at or very near a sidewalk of this narrow size!

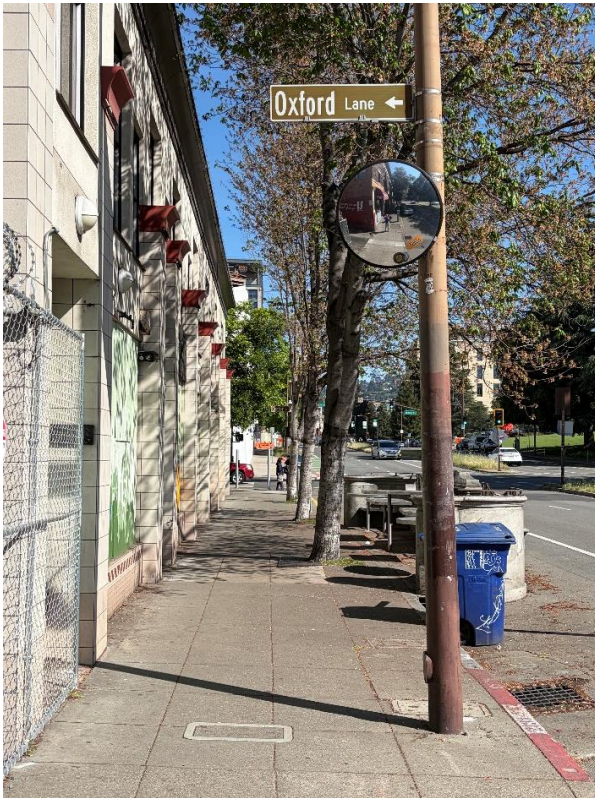
Exhibit 1: Northbound view of Oxford Street starting at Oxford Lane, heading towards Center Street directly along the proposed 2128 Oxford Street job site frontage. Permanent concrete structures and municipal infrastructure already severely constrict this baseline pedestrian right-of-way. Furthermore, the blue rolling bin currently resting in the street illustrates the constant threat of unpredictable, dynamic urban obstacles. If placed on the sidewalk—as these bins routinely are—it instantly chokes the path below the legal minimum for a wheelchair. This image proves why granting a permanent 0-foot setback directly along this specific frontage, without first conducting a Pedestrian Level of Service (PLOS) analysis, is legally indefensible.

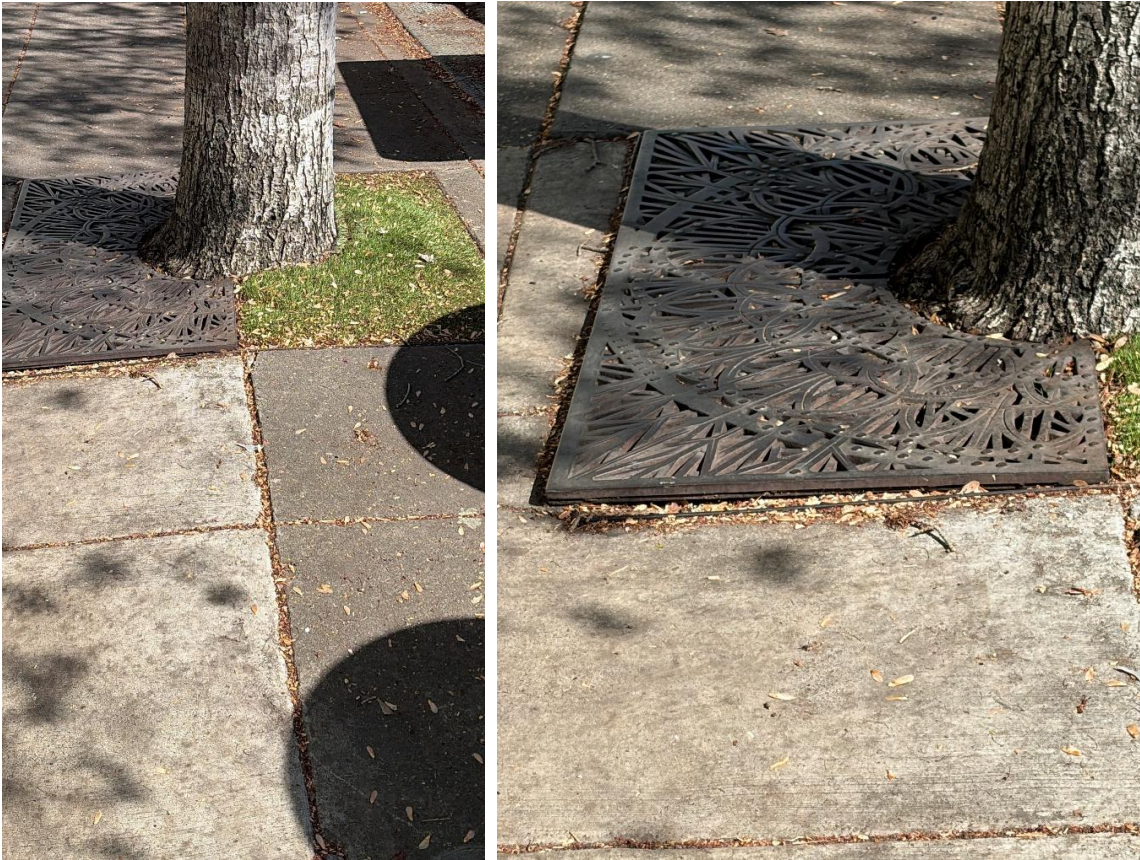
**Exhibits 2 and 3:** Close-up views of the first tree well heading north along the proposed 2128 Oxford Street job site frontage. I physically measured the distance between this specific tree well and the existing building's 0-foot setback, and it is a mere 68 inches. This is narrower than the 72-inch nominal corridor required during construction under Berkeley Standard Plan §315. Approving Use Permit Modification #ZP2025-0113 with a permanent 0-foot setback eliminates the City's ability to ever widen this failing 68-inch choke point.

Furthermore, these images document severe, active hazards within this narrow path. The heavy metal grate is improperly fitted and severely lifted above the concrete, creating a sheer vertical lip that directly violates the "Change in Level" restrictions of PROWAG R302.6.2 and California Building Code (CBC) §11B-303 (which strictly prohibit unramped vertical shifts exceeding  $\frac{1}{4}$  inch). Additionally, the missing grate section exposes a patch of grass and dirt directly adjacent to the walking path, violating the requirement for a "firm, stable, and slip-resistant" surface under CBC §11B-402.1. This creates a severe tripping and tipping hazard for wheelchair users and blind pedestrians forced to navigate this exact 68-inch bottleneck.

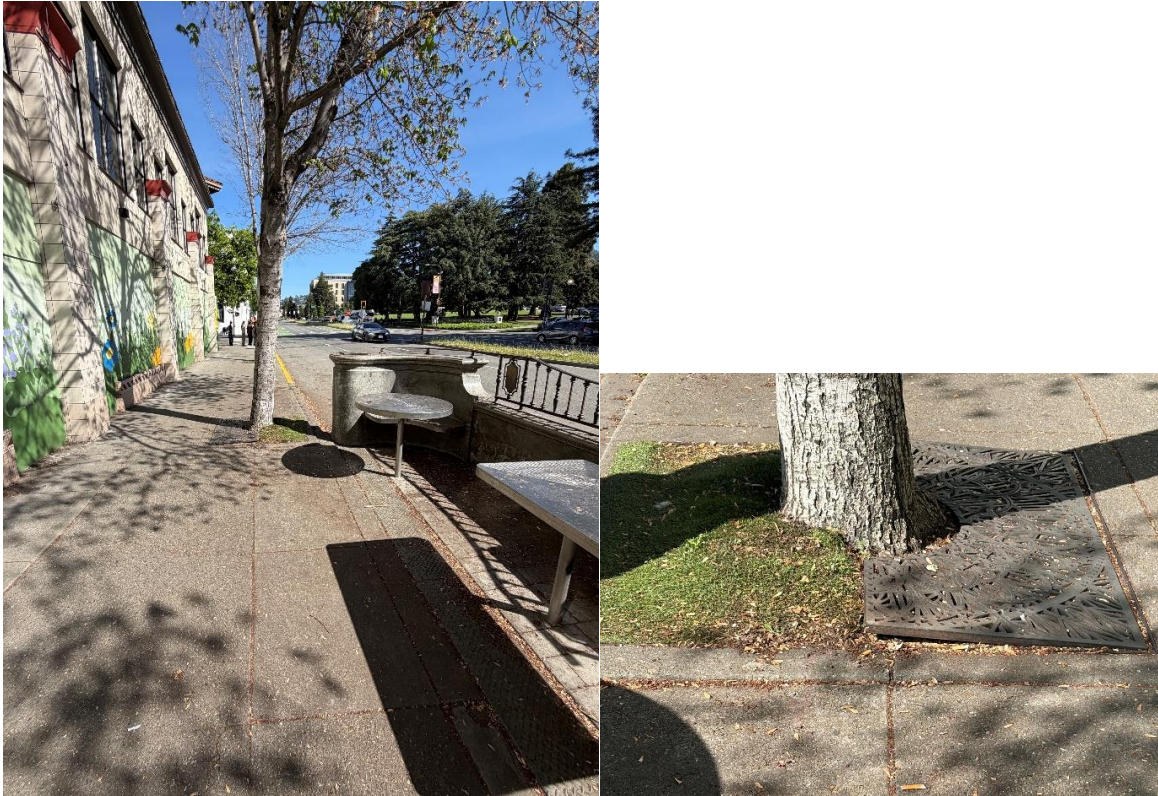
Exhibit 4: Northbound view directly along the existing building at 2128 Oxford Street (the exact site of the proposed 26-story tower). The pedestrian path here is choked by a massive, permanent concrete seating structure and heavy municipal hardscape that juts deep into the right-of-way, forcing pedestrians into a dangerously narrow channel against the building line. Approving a 0-foot setback waiver for the new tower permanently locks this unmitigable bottleneck in place. It is physically impossible to safely funnel thousands of new pedestrian trips through this severely compromised corridor without first conducting a comprehensive Pedestrian Level of Service (PLOS) analysis."

"Exhibit 5: Close-up of the tree well located directly adjacent to the concrete barrier in Exhibit 4. The heavy metal grate is severely lifted above the surrounding concrete, creating a sheer, unramped vertical lip that blatantly violates the 'Change in Level' restrictions of PROWAG R302.6.2 and California Building Code (CBC) §11B-303 (which prohibit unramped vertical shifts exceeding ¼ inch). Furthermore, half of the tree well is left as exposed grass and soil, failing the requirement for a 'firm, stable, and slip-resistant' accessible route (CBC §11B-402.1). In a tight choke point where wheelchair users have no room to maneuver around obstacles, this raised metal lip acts as a direct, unavoidable tripping and tipping trap.

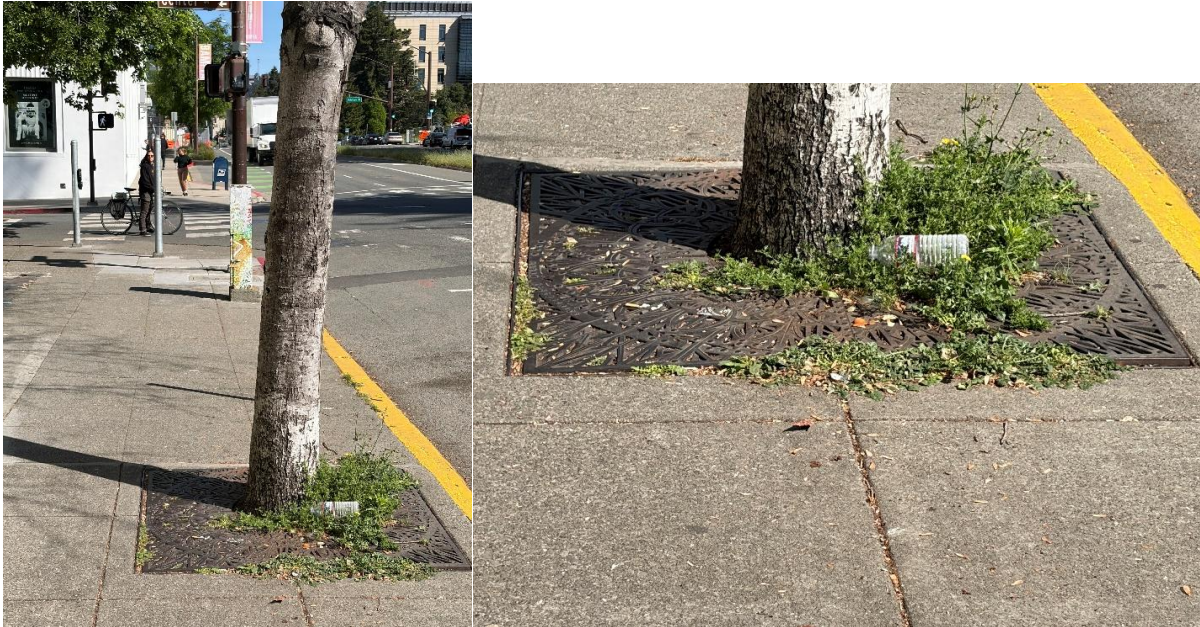
Exhibits 6 and 7: Northbound view and close-up of the final tree well on the proposed 2128 Oxford Street job site frontage, located exactly at the Center Street intersection. While a metal grate is technically present here, it is severely overgrown with thick weeds and accumulated trash, demonstrating the City's systemic failure to maintain its existing pedestrian infrastructure. Allowing this path to degrade into an unkempt catch-basin directly violates the requirement to maintain a 'firm, stable, and slip-resistant' accessible route (PROWAG R302.7 and CBC §11B-402.1). If the City cannot manage basic ADA maintenance on the existing frontage today, it is legally unjustifiable to grant a permanent 0-foot setback that locks in these physical constraints while dumping hundreds of new pedestrian trips into this already neglected corridor.

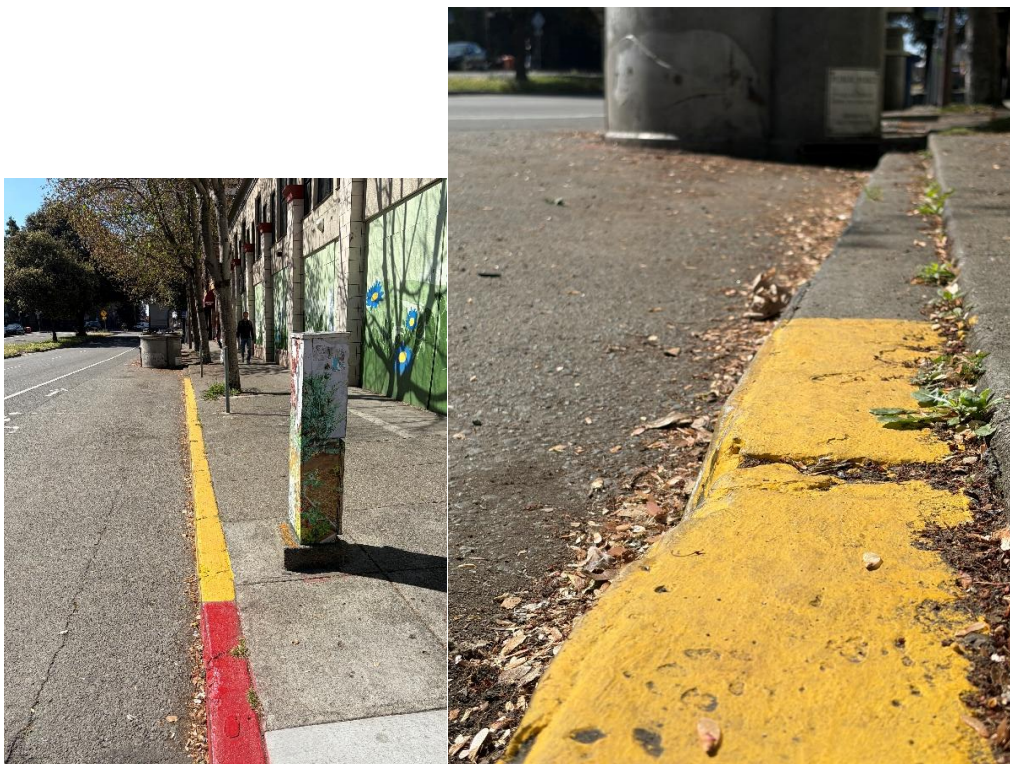
Exhibits 8 and 9: Wide view and close-up of the severe curb degradation directly along the proposed 2128 Oxford Street job site. As clearly visible, the yellow-painted curb edge is actively crumbling, deeply cracked, and features a massive, unramped vertical drop-off that vastly exceeds the maximum allowable ¼-inch change in level dictated by PROWAG R302.6.2 and California Building Code (CBC) §11B-303. Furthermore, the broken concrete and encroaching weeds destroy the integrity of the path, directly violating the requirement for a 'firm, stable, and slip-resistant' surface (CBC §11B-402.1). This hazardous, crumbling edge presents a severe and immediate danger to wheelchair users and blind pedestrians navigating this perimeter. Relying on this actively failing municipal infrastructure to safely absorb thousands of new daily pedestrian trips from a 26-story tower—without first conducting a Pedestrian Level of Service (PLOS) analysis and mandating comprehensive repairs—is a blatant dereliction of the City's ADA Title II obligations.

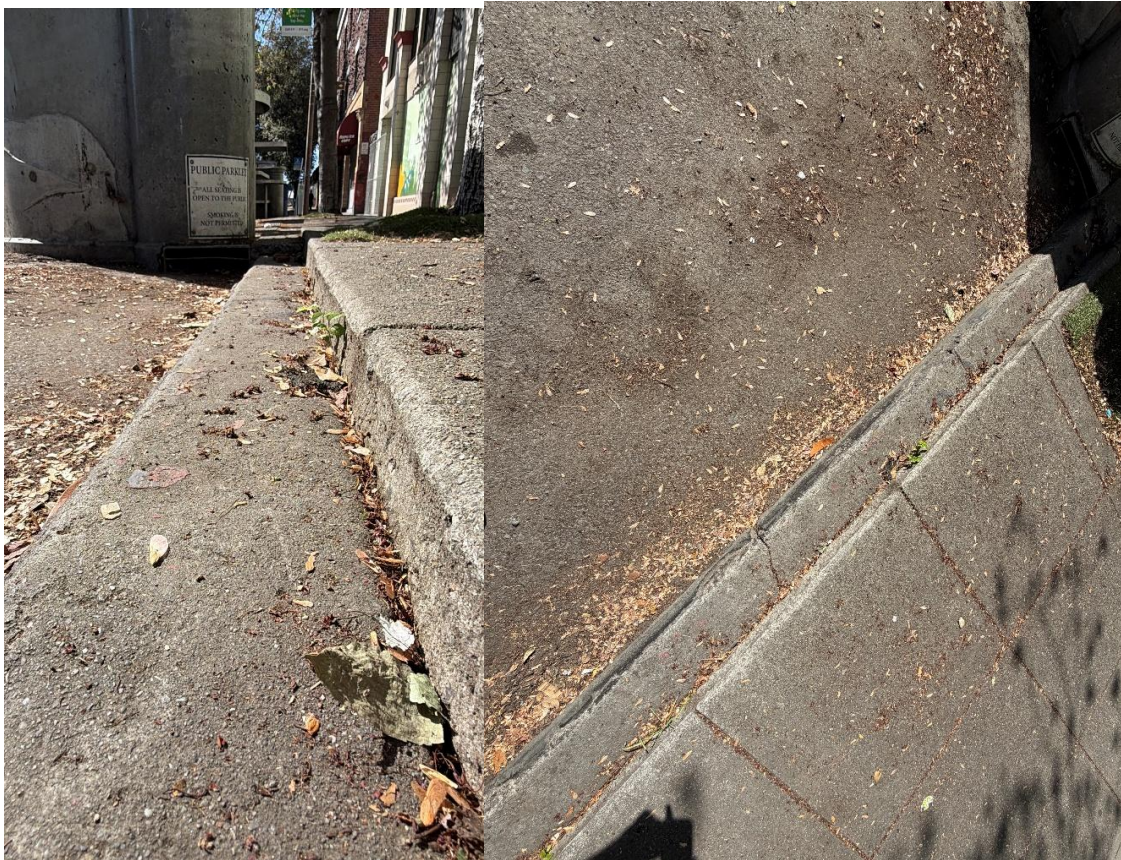
Exhibits 10 and 11: Ground-level and overhead top-down views of the degraded right-of-way continuing along the project's perimeter. Exhibit 11, taken from directly above, explicitly captures the severity of a massive, debris-filled fissure where the concrete sections have completely separated. This deep, unmitigated gap creates a hazardous trap for wheelchair casters and white canes, blatantly violating the fundamental ADA Title II requirement for a 'firm, stable, and slip-resistant' accessible route (PROWAG R302.7 and California Building Code §11B-402.1). Dumping hundreds of new daily pedestrian trips directly onto this actively failing municipal hardscape—without first requiring a comprehensive Pedestrian Level of Service (PLOS) analysis and full infrastructure replacement—is legally indefensible.

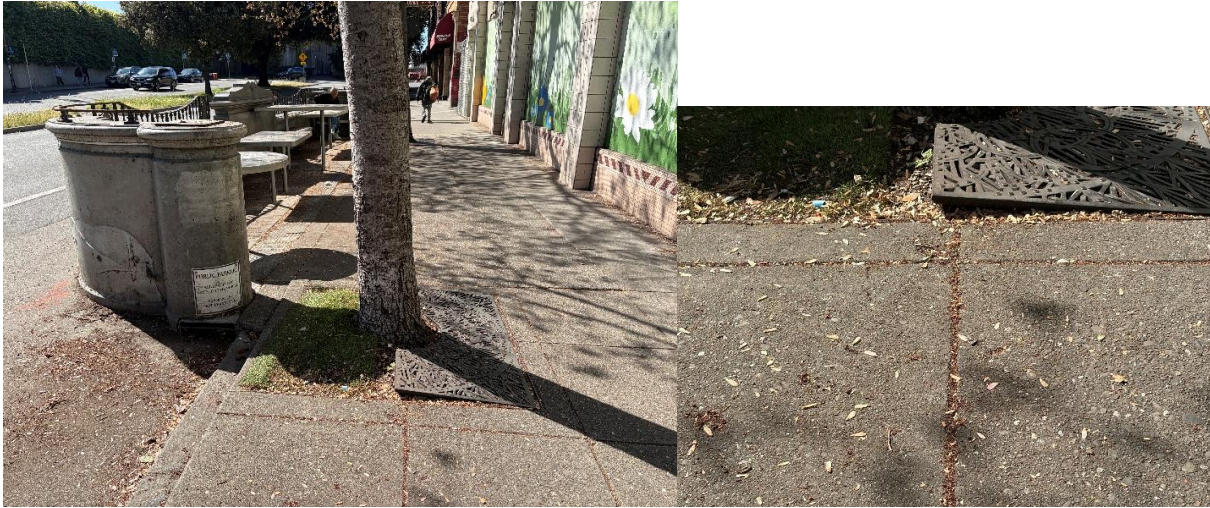
**Exhibit 12: Southbound view along the Oxford Street frontage of the proposed development site, looking back toward the southern half of the block (the direction of the bar). The pedestrian path here is severely choked by a massive, permanent concrete municipal structure (labeled 'Public Parklet'), which forces pedestrians into an extremely narrow channel against the property line. Granting the developer a permanent 0-foot setback waiver completely eliminates the City's ability to ever widen the sidewalk around this unyielding concrete obstacle, actively funneling thousands of new pedestrian trips directly into the downstream 72-inch bottlenecks."**

**Exhibit 13: Close-up of the tree well shown in Exhibit 12. The heavy metal grate is completely dislodged, askew, and lifted out of its frame, creating a massive, sheer vertical lip that blatantly violates the 'Change in Level' restrictions of PROWAG R302.6.2 and California Building Code (CBC) §11B-303 (which strictly prohibit unramped vertical shifts exceeding ¼ inch). Combined with the exposed dirt and severe concrete fissures, this neglected municipal infrastructure acts as a direct, unavoidable tripping and tipping trap precisely at the narrowest point of the corridor.**

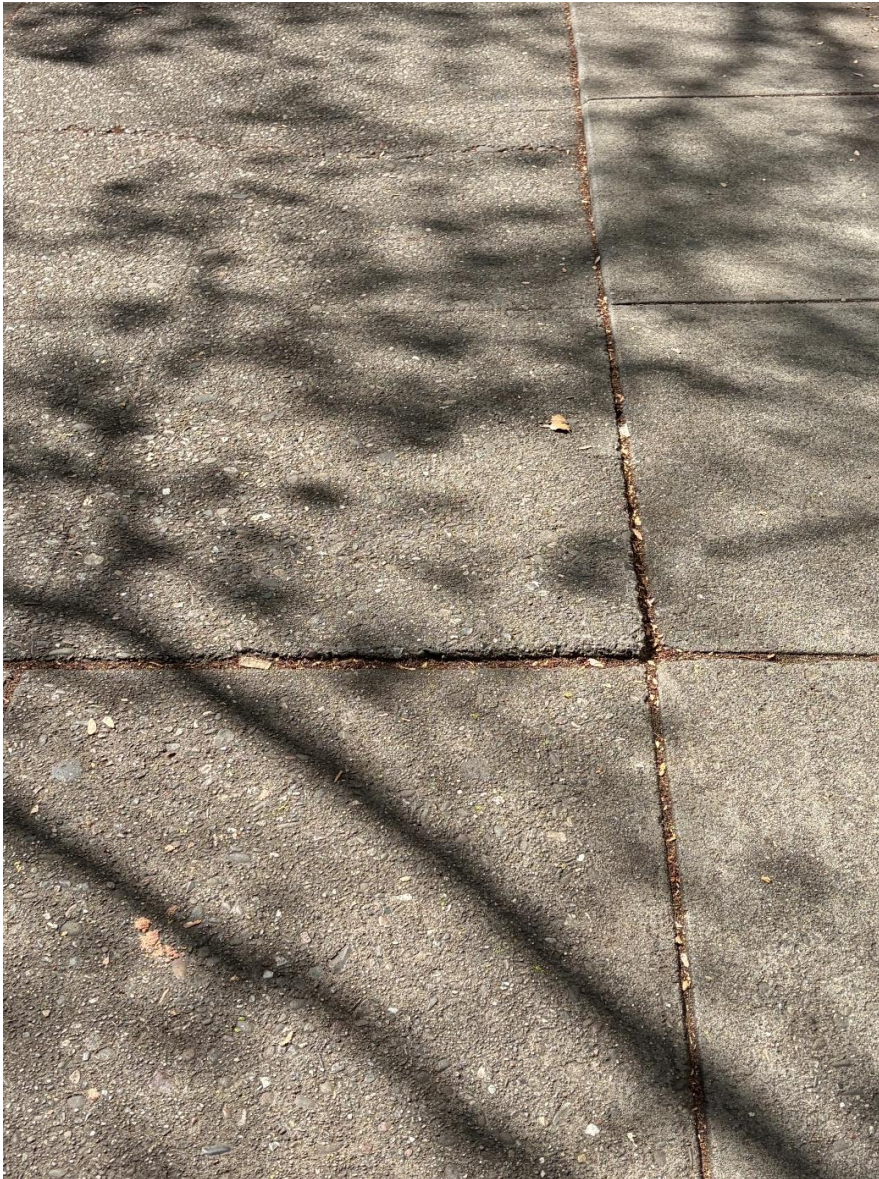
Exhibit 14: Close-up of the Oxford Street pedestrian corridor documenting severe structural failure of the concrete path. The concrete slabs have separated into deep, wide, debris-filled fissures. This structural decay blatantly violates the fundamental ADA Title II requirement that accessible routes be firm, stable, and slip-resistant (PROWAG R302.7 and California Building Code Section 11B-402.1). Unmitigated gaps of this width pose an immediate entrapment hazard for wheelchair caster wheels and blind pedestrians navigating with white canes.

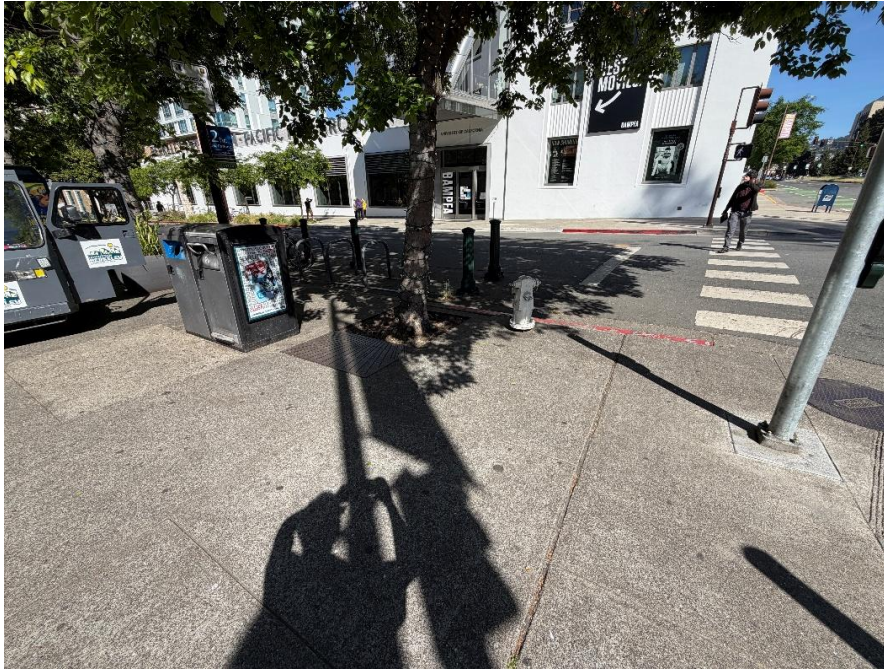
Exhibit 15: Northbound view along the Oxford Street corridor approaching the Center Street intersection and crosswalk. The pedestrian right-of-way is heavily congested with fixed municipal infrastructure, including a large trash receptacle, a fire hydrant, bike racks, and an open tree well. The City's failure to maintain safe, clear, and compliant surfaces on the existing block proves that dumping hundreds of new daily pedestrian trips from a 433-unit tower into this exact corridor—without mandating comprehensive infrastructure replacement and a Pedestrian Level of Service (PLOS) analysis—is legally unjustifiable.

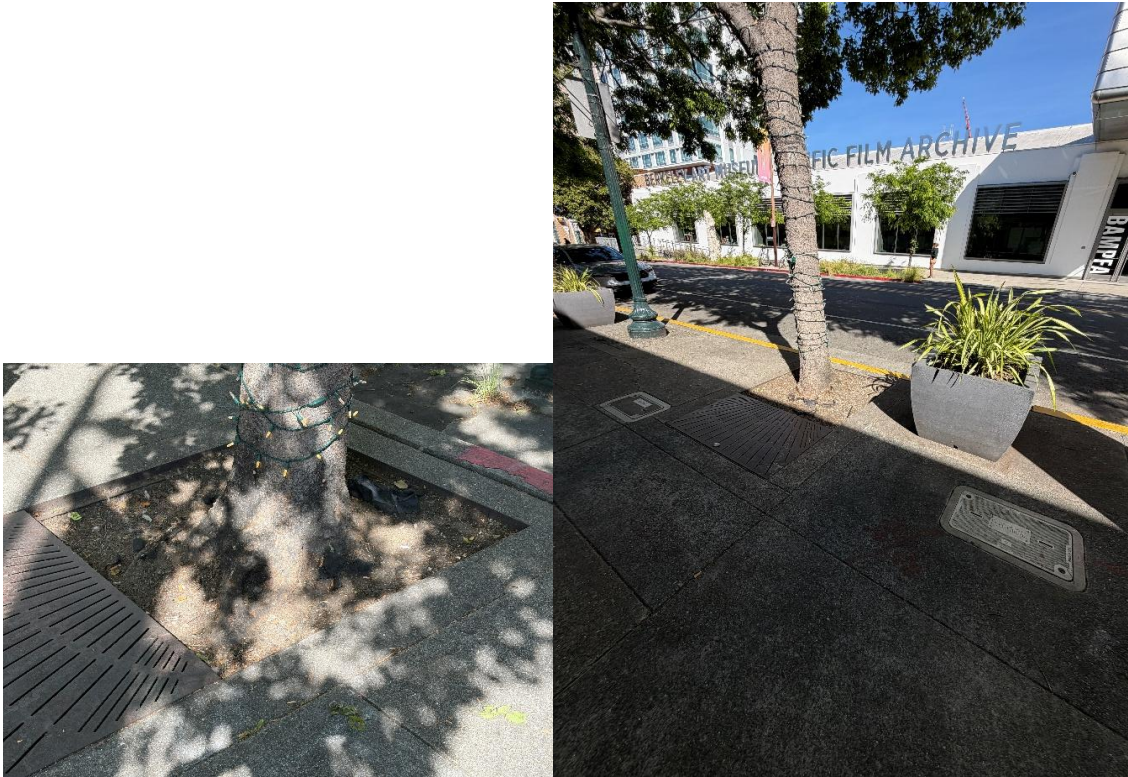
**Exhibit 18:** Close-up of another severely degraded tree well along the Center Street frontage of the proposed 2128 Oxford Street development. While the overall sidewalk width on Center Street is generally wider than on Oxford Street, these open, unprotected tree wells remain a direct and actionable ADA violation. The metal grate is missing or improperly fitted, leaving a large area of exposed, unstable dirt. This directly violates the requirement for a firm, stable, and slip-resistant accessible route (PROWAG R302.7 and California Building Code Section 11B-402.1). Regardless of sidewalk width, this neglected infrastructure creates a severe tripping, tipping, and entrapment hazard for blind pedestrians and wheelchair users.

**Exhibit 19:** Wide view along Center Street, looking across toward the BAMPFA building, showing the context of the degraded tree well in Exhibit 18. Although this specific pedestrian path does not suffer from the extreme 68-inch and 72-inch physical choke points found on Oxford Street, the consistent pattern of broken, missing, and unmaintained tree grates proves the City's ongoing failure to provide safe, ADA-compliant pedestrian infrastructure. The developer proposes to funnel hundreds of new daily pedestrian trips around this corner. Approving Use Permit Modification #ZP2025-0113 without mandating comprehensive tree well remediation—specifically requiring flush-mounted, load-bearing grates along this entire perimeter—leaves these active hazards in place and exposes the City to deliberate civil rights liability.

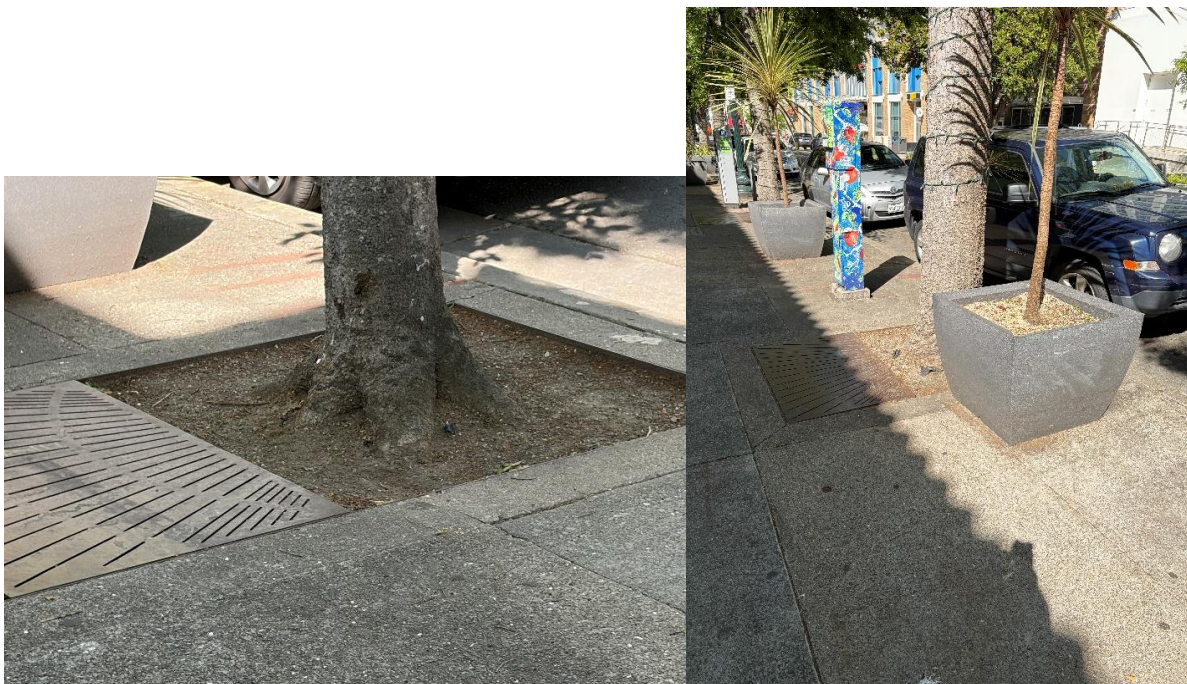
Exhibit 20: Close-up of another severely degraded tree well continuing along the Center Street pedestrian corridor. The municipal infrastructure is actively failing, with the metal grate only partially covering the well and leaving a large section of exposed, unstable dirt directly adjacent to the walking path. This ongoing neglect violates the fundamental ADA Title II requirement that accessible routes must be firm, stable, and slip-resistant (PROWAG R302.7 and California Building Code Section 11B-402.1). Allowing this basic infrastructure to decay into an active tripping and entrapment hazard visually demonstrates that the City is currently failing to maintain safe program access on this block today. Dumping thousands of new daily pedestrian trips from a 433-unit tower into this environment without first mandating comprehensive, block-wide tree well remediation is legally indefensible.

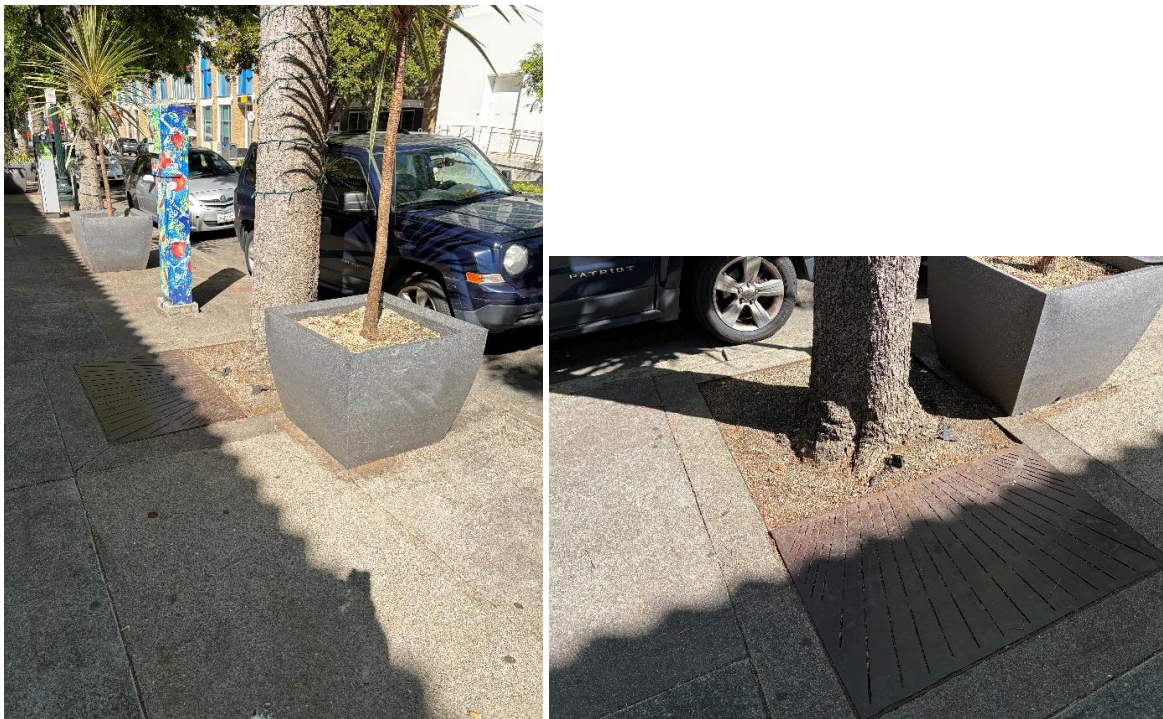
Exhibits 21 and 22: Continuing westbound along the Center Street frontage of the proposed 2128 Oxford Street development. These images provide further undeniable evidence of a systemic, block-wide failure to maintain basic ADA compliance along the project's perimeter. The tree wells here continue to exhibit missing, degraded, or improperly fitted metal grates, exposing unramped vertical lips and unstable dirt right at the edge of the pedestrian travel path. This persistent decay directly violates the firm, stable, and slip-resistant surface requirements of PROWAG R302.7 and California Building Code Section 11B-402.1. The City cannot legally grant a Use Permit Modification for a massive 433-unit high-rise without mandating a comprehensive perimeter remediation plan—specifically requiring flush-mounted, load-bearing grates for every tree well—to resolve these active, documented civil rights violations.

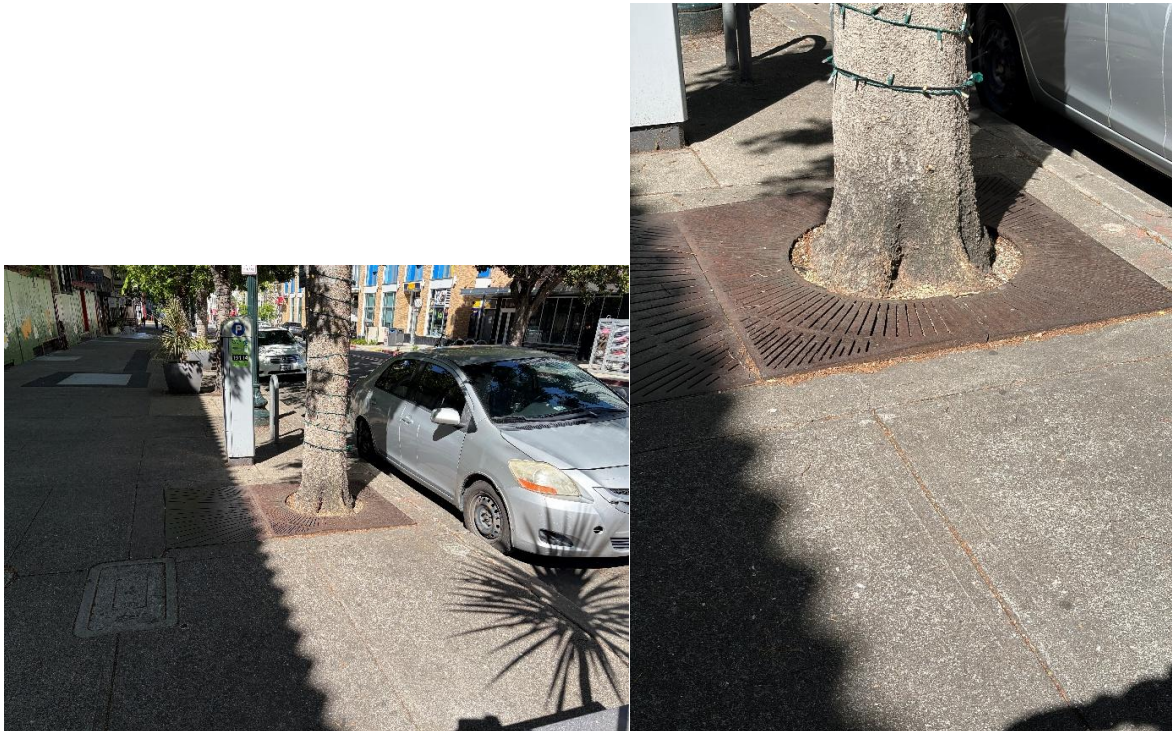
Exhibits 23 and 24: Wide view and close-up of a grated tree well located along the pedestrian corridor. While the City has installed a flush-mounted metal grate here—visually proving they possess the exact physical hardware required to maintain a compliant surface—they have allowed it to fall into severe disrepair. As explicitly detailed in Exhibit 24, the grate is actively degrading, and the inner protective rings are broken or missing entirely, creating a hazardous, unmitigated gap. This proves that the City’s ADA Title II failures are both systemic and willful; even when the correct infrastructure is installed, the City refuses to maintain it in a firm, stable, and slip-resistant condition (PROWAG R302.7 and California Building Code Section 11B-402.1). Approving a 433-unit high-rise without mandating strict, block-wide infrastructure replacement and ongoing maintenance is legally indefensible.

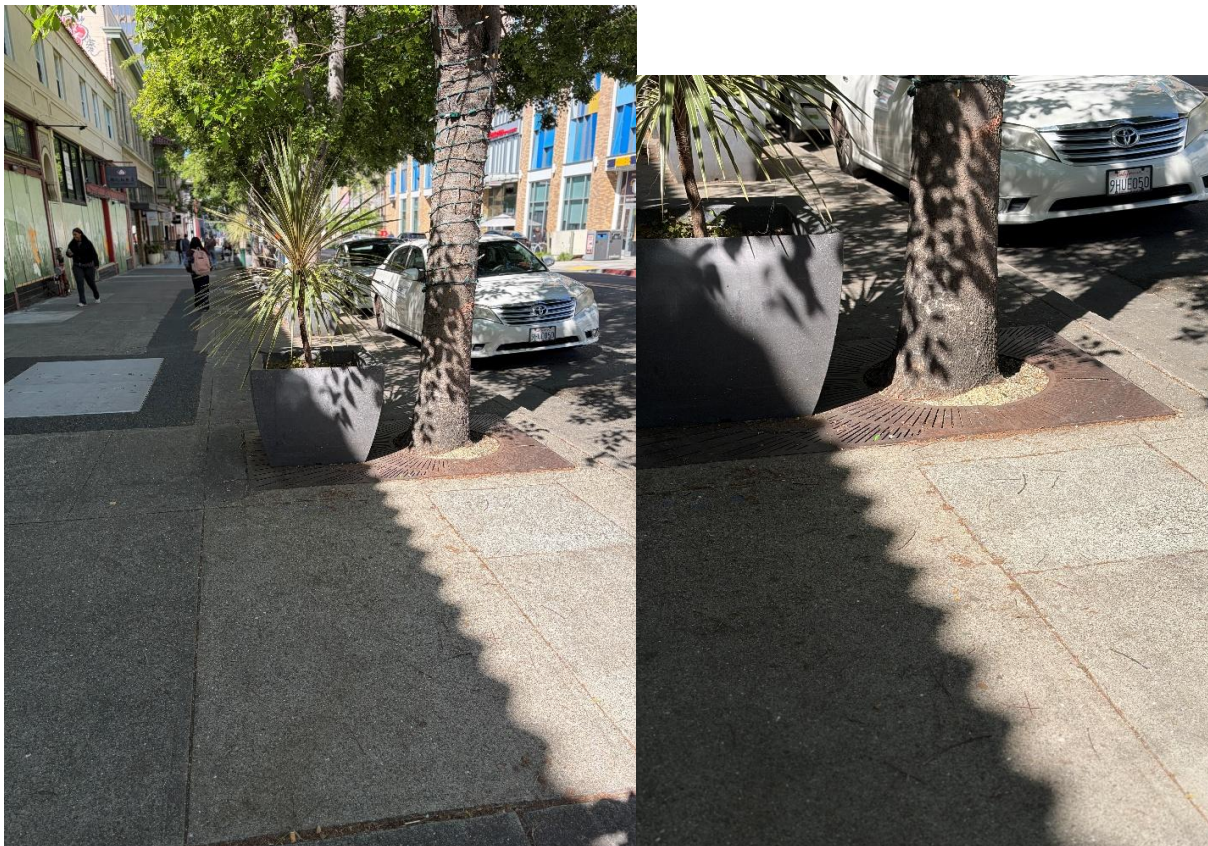
Exhibits 25 and 26: Continuing along the Center Street pedestrian corridor, these images document yet another actively failing tree grate. This specific hazard is geographically undeniable and well-known to City officials, as it is located precisely at the prominent silver construction plate and asphalt patchwork. While the outer frame of the metal grate is present, the inner sections are severely degraded or missing entirely, exposing a wide, uneven dirt gap directly adjacent to the walking path. This creates an unramped vertical lip and an unstable surface that blatantly violates the firm, stable, and slip-resistant requirements of PROWAG R302.7 and California Building Code Section 11B-402.1. This repeating, inescapable pattern of broken and neglected municipal infrastructure proves that the entire perimeter of the proposed 2128 Oxford Street development is an active ADA hazard zone. The City is currently failing to manage the existing pedestrian right-of-way and cannot legally absorb hundreds of new daily pedestrian trips without first mandating a comprehensive Pedestrian Level of Service (PLOS) analysis and full infrastructure remediation.

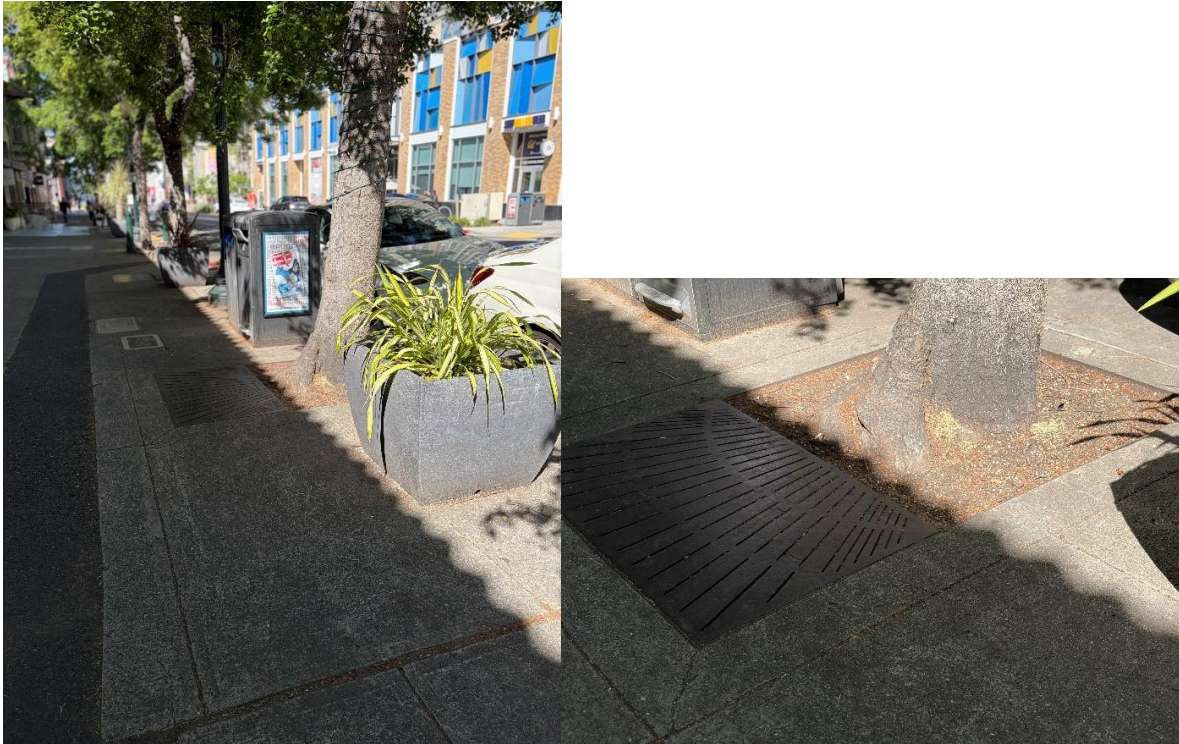
Exhibit 27: Wide view continuing along the Center Street pedestrian corridor of the proposed 2128 Oxford Street development. While this specific frontage benefits from a wider overall sidewalk than Oxford Street, this image provides critical context for the City's systemic failure to maintain the actual walking surface. Rather than a lack of physical space, the ADA violations here stem from severe, ongoing infrastructure neglect. The City has allowed the walking surfaces and tree wells to actively decay, proving that adequate sidewalk width means nothing if the surface itself is hazardous and non-compliant.

Exhibit 28: Close-up of the tree well shown in Exhibit 27. Even where the City has attempted to install a metal grate, the hardware is improperly sized and fails to safely cover the opening. A large section of exposed, uneven dirt remains entirely unprotected around the base of the tree, creating an immediate tripping and entrapment hazard right at the edge of the travel path. Regardless of the surrounding sidewalk width, this ongoing failure to maintain a continuous, firm, stable, and slip-resistant surface blatantly violates PROWAG R302.7 and California Building Code Section 11B-402.1. The City cannot legally justify adding hundreds of new daily pedestrian trips to this perimeter without mandating a full, block-wide remediation of these active surface hazards.
