**RE:** ZAB April 9, 2026 – Agenda Item 6-C – Use Permit Modification #ZP2025-0113 – 2128 Oxford Street – URGENT ADA VIOLATIONS: REQUEST TO PULL FROM CONSENT CALENDAR AND IMPOSE ADDITIONAL CONDITIONS

2128 Oxford Street -Supplemental Submission-Photographic Evidence  
Steven Schuyler

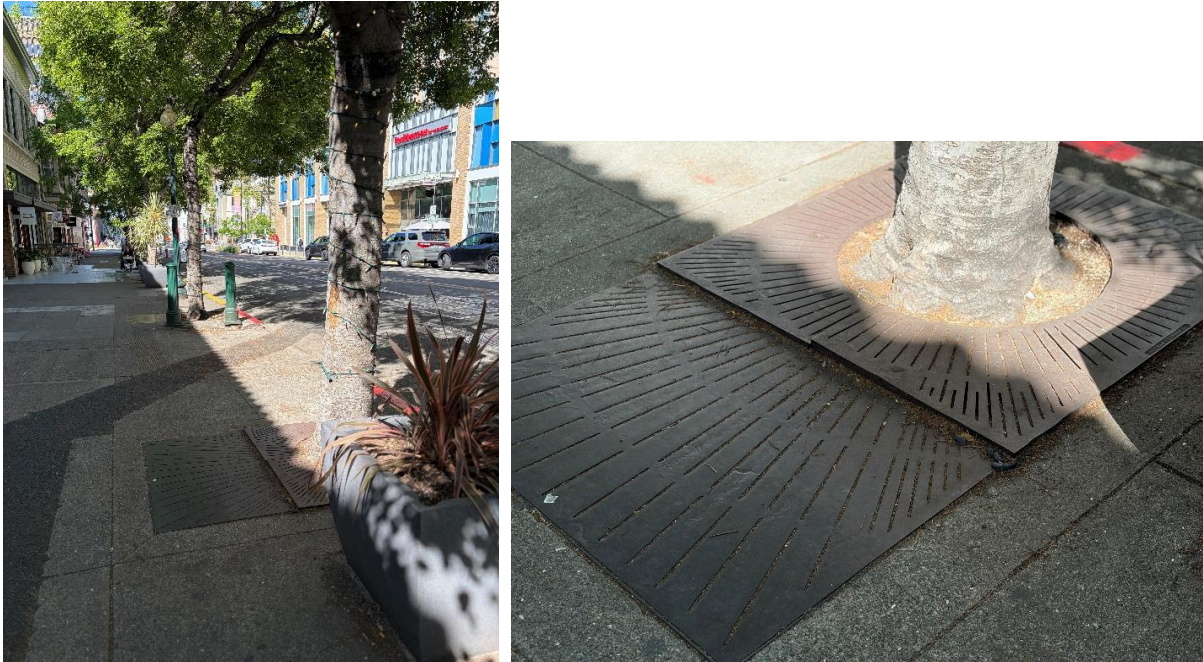
Exhibit 29: Wide view looking along the Center Street pedestrian corridor. This image further demonstrates that while the physical width of this specific sidewalk is adequate, the City has completely abandoned the maintenance of the actual walking surface

The continuous, visible presence of degraded municipal infrastructure proves that adequate sidewalk width means nothing if the surface itself is hazardous. Adding hundreds of new daily pedestrian trips to this perimeter is unsafe and legally indefensible until a comprehensive surface remediation plan is mandated

This structural decay blatantly violates the strict Change in Level limitations of PROWAG R302.6.2 and California Building Code Section 11B-303, which strictly prohibit unramped vertical shifts exceeding  $\frac{1}{4}$  inch. Furthermore, it violates the fundamental requirement for a firm, stable, and slip-resistant surface (PROWAG R302.7 and CBC Section 11B-402.1). The City has allowed this heavy metal hardware to become a direct, unmitigated tripping trap.

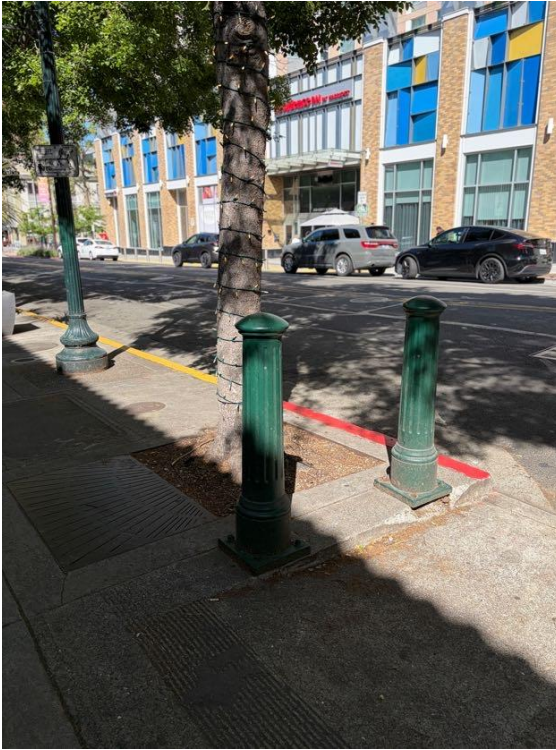
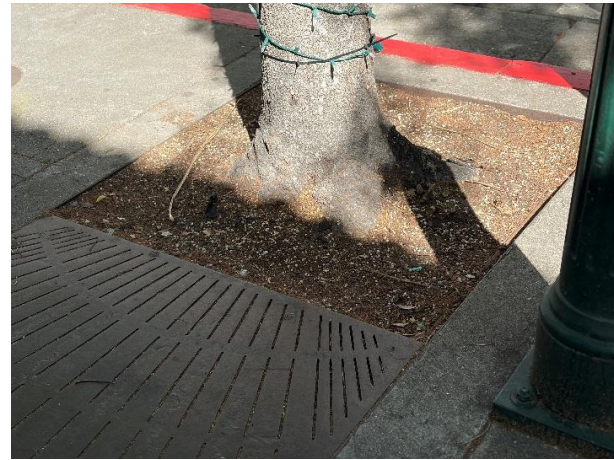
Exhibit 32: Wide view continuing along the Center Street pedestrian corridor. This image captures two green municipal bollards installed directly next to a severely neglected tree well. While the City clearly has the resources to install these heavy metal bollards, it has simultaneously failed to maintain or install the necessary metal grating to cover the exposed dirt at the tree base. This visual evidence proves that the failure of infrastructure integrity on this block is a result of deliberate municipal neglect. The City is actively prioritizing other installations while ignoring its ADA Title II obligations to maintain a firm, stable, and slip-resistant pedestrian surface, making the approval of a massive 433-unit tower without mandatory perimeter remediation legally unjustifiable.

Exhibit 33: Close-up of the tree well and metal grate shown in Exhibit 32. The heavy metal grate abruptly ends, leaving a massive, unmitigated gap of exposed dirt around the tree trunk. The sudden transition from the metal grate to the sunken dirt creates a severe, unramped vertical drop-off that blatantly violates the strict Change in Level limitations of PROWAG R302.6.2 and California Building Code Section 11B-303. Furthermore, the exposed, unstable soil completely fails the fundamental ADA requirement that an accessible route be firm, stable, and slip-resistant (PROWAG R302.7 and CBC Section 11B-402.1). Forcing disabled pedestrians to navigate next to these continuous, unmitigated tripping traps proves that the entire project perimeter is structurally compromised.

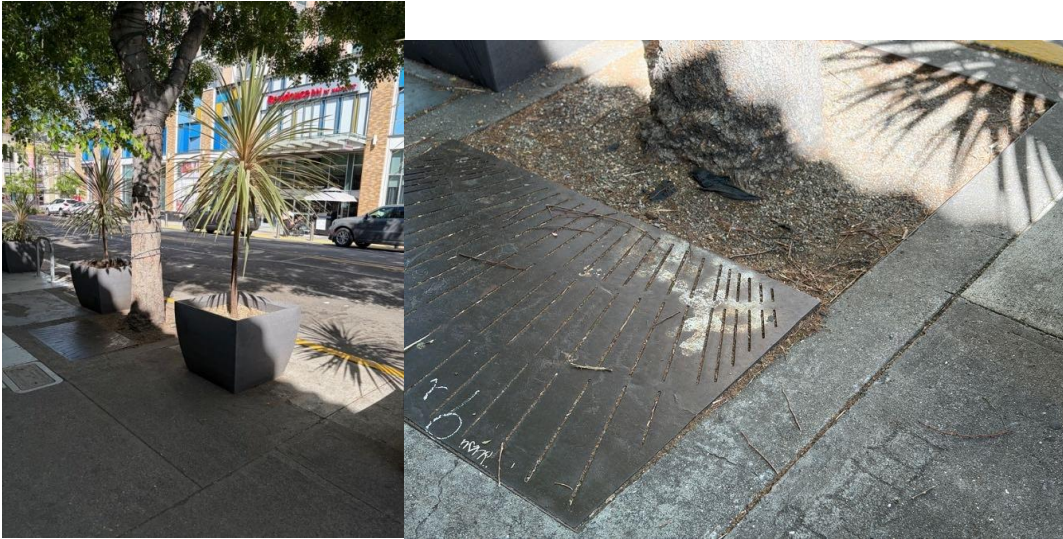
Exhibit 34: View along the Center Street pedestrian corridor. While this specific section of the sidewalk is physically wide, the City continues to fail in its fundamental obligation to provide a safe, compliant walking surface. The tree well visible here completely lacks a protective metal grate, leaving a large, sunken area of exposed dirt directly adjacent to the pedestrian travel path. This ongoing failure to install and maintain basic surface infrastructure creates an active tripping and entrapment hazard that violates the firm, stable, and slip-resistant requirements of PROWAG R302.7 and California Building Code Section 11B-402.1. The City's willingness to let these structural hazards persist across the entire block proves that the perimeter is not prepared to safely absorb the massive pedestrian impact of a 433-unit high-rise without a mandatory remediation plan.

Exhibit 35: Close-up of the Center Street pedestrian corridor revealing a massive, degrading asphalt patch directly in the public right-of-way. Marked with municipal construction spray paint reading 5x5, this haphazard repair replaces the concrete sidewalk with a severely uneven, sunken surface. The jagged, deteriorating transitions between the broken concrete and the temporary asphalt create unramped vertical lips that blatantly violate the strict Change in Level limitations of PROWAG R302.6.2 and California Building Code Section 11B-303. Furthermore, this actively crumbling surface fails the fundamental ADA Title II requirement for an accessible route to be firm, stable, and slip-resistant (PROWAG R302.7 and CBC Section 11B-402.1). The City's reliance on deteriorating, unmaintained asphalt patches to serve as the permanent pedestrian hardscape proves systematic infrastructure neglect. Approving a 433-unit high-rise that will force thousands of new daily pedestrian trips over these structural hazards without mandating a comprehensive surface remediation plan exposes the City to deliberate civil rights liability.

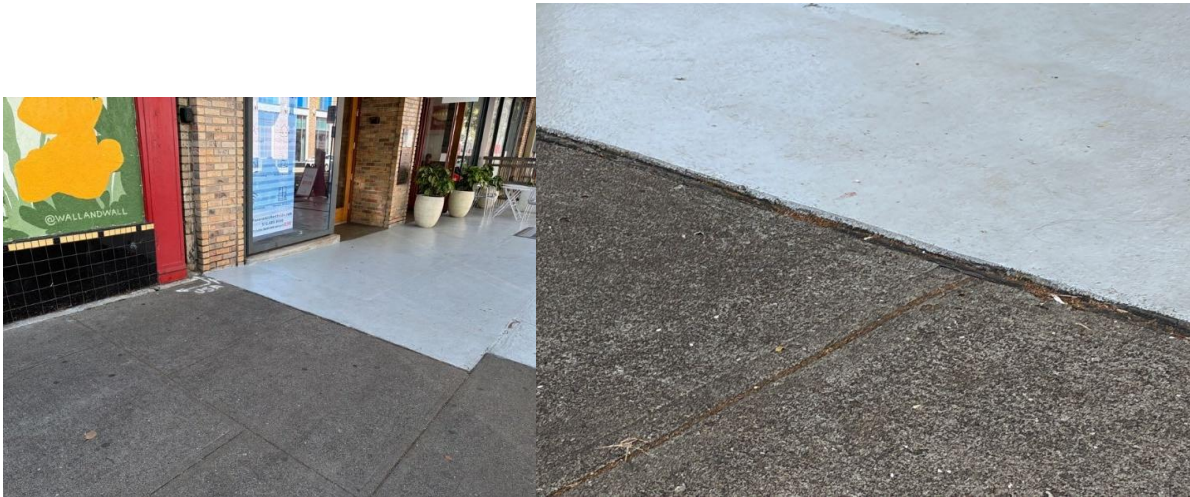
Exhibit 38: Wide view of the Center Street pedestrian corridor revealing a massive, dark asphalt trench patch running directly through the center of the concrete walking path

This sprawling, haphazard repair creates an uneven, unstable surface that blatantly violates the firm, stable, and slip-resistant requirements of PROWAG R302.7 and California Building Code Section 11B-402.1. It provides undeniable visual evidence that the City relies on degrading, non-compliant asphalt patches rather than properly maintaining the permanent pedestrian hardscape. Approving a 433-unit high-rise without mandating the complete removal and concrete replacement of these hazard zones is a deliberate failure to provide safe program access.

This creates yet another severe tripping and entrapment hazard directly on the accessible route, further violating the strict Change in Level limitations of PROWAG R302.6.2 and CBC Section 11B-303. This final image cements the undeniable reality of this corridor: the entire block is an active ADA hazard zone suffering from systemic municipal neglect.

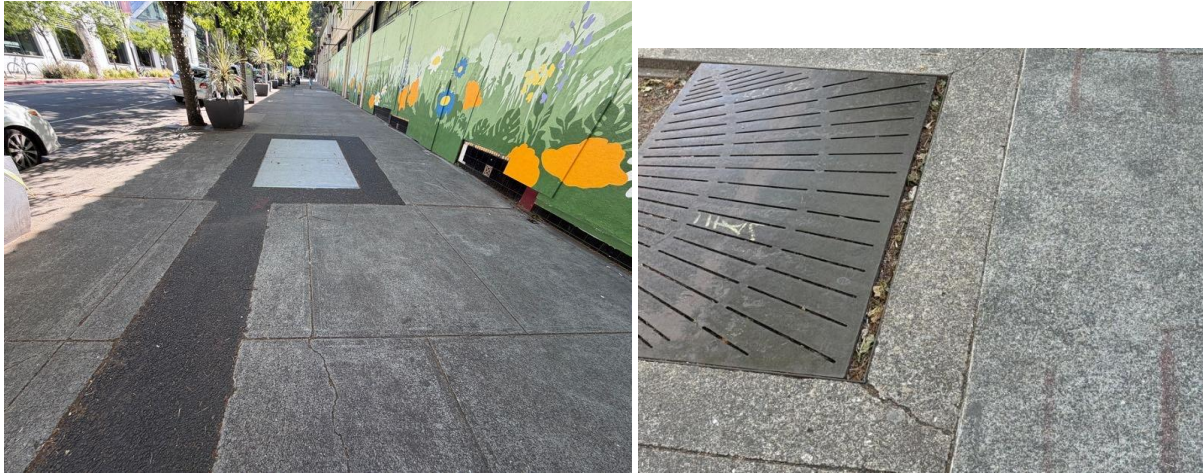
**Exhibit 38:** Wide view of the Center Street pedestrian corridor revealing a massive, dark asphalt trench patch running directly through the center of the concrete walking path.

This sprawling, haphazard repair creates an uneven, unstable surface that blatantly violates the firm, stable, and slip-resistant requirements of PROWAG R302.7 and California Building Code Section 11B-402.1. It provides undeniable visual evidence that the City relies on degrading, non-compliant asphalt patches rather than properly maintaining the permanent pedestrian hardscape. Approving a 433-unit high-rise without mandating the complete removal and concrete replacement of these hazard zones is a deliberate failure to provide safe program access.
